Department of Environmental Conservation

**ST. LAWRENCE RIVER  
AT MASSENA  
REMEDIAL ACTION PLAN  
—STAGE I—**

November, 1990

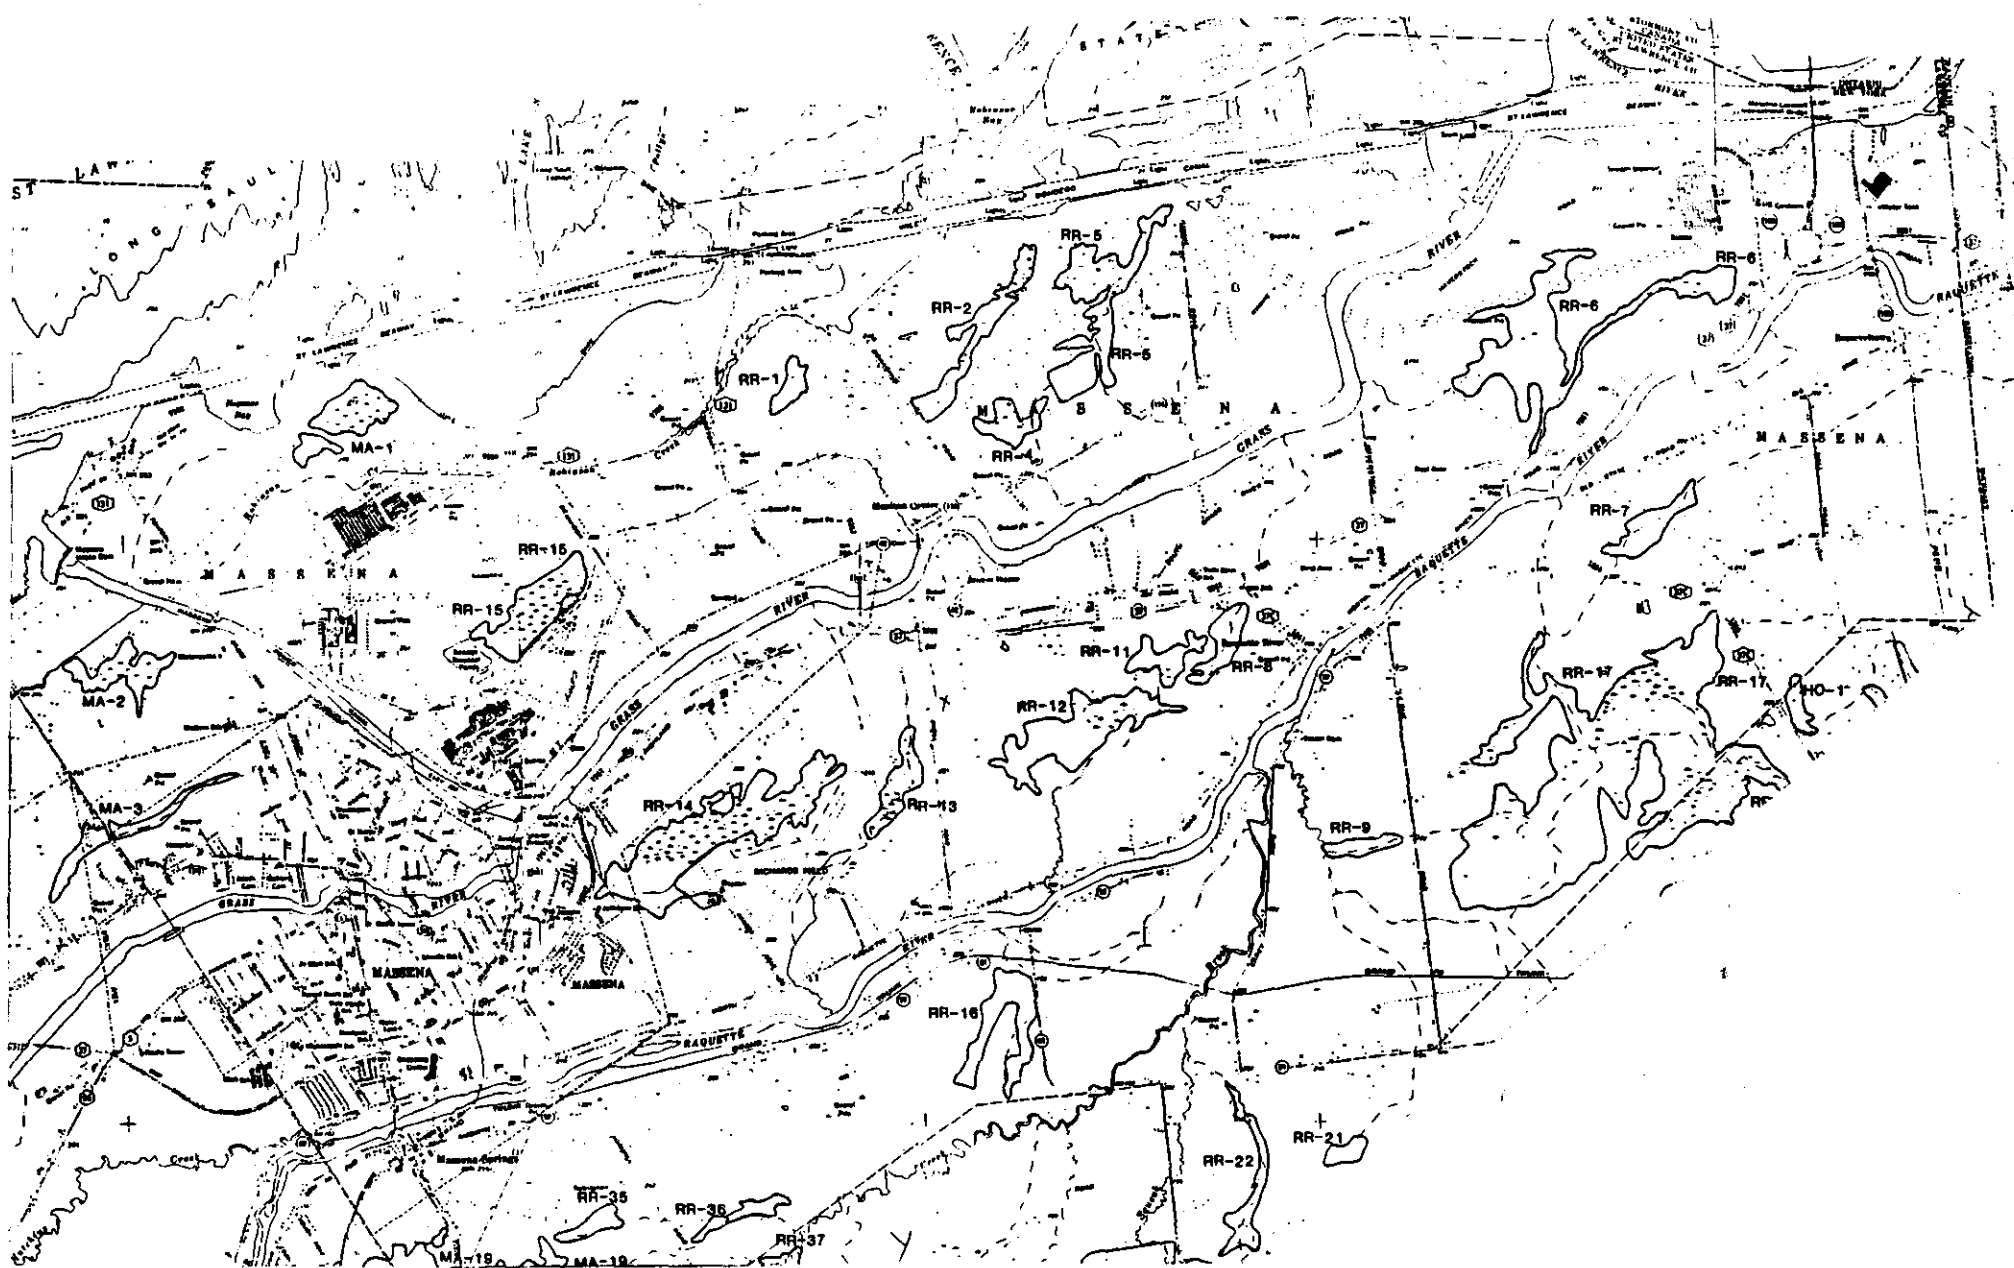
Figure IV-1. Wetlands in the Massena AOC. (Numbering designations refer to NYSDEC wetlands inventory mapping program)

A 170 acre (68 ha) wetland is located in the vicinity of the Reynolds Metals and General Motors property. Sampling and analysis in 1988 in the area of the wetland just south of the Reynolds Solid Waste Landfill (see Appendix B), documented PCB levels ranging from less than 0.1 ppm to 9.4 ppm in sediment (NYSDEC 1989d). The highest levels in sediment were found at the sites closest to the landfill. Two water samples collected from the same area had total PCB levels of 1348.6 ppt and 9111.0 ppt.

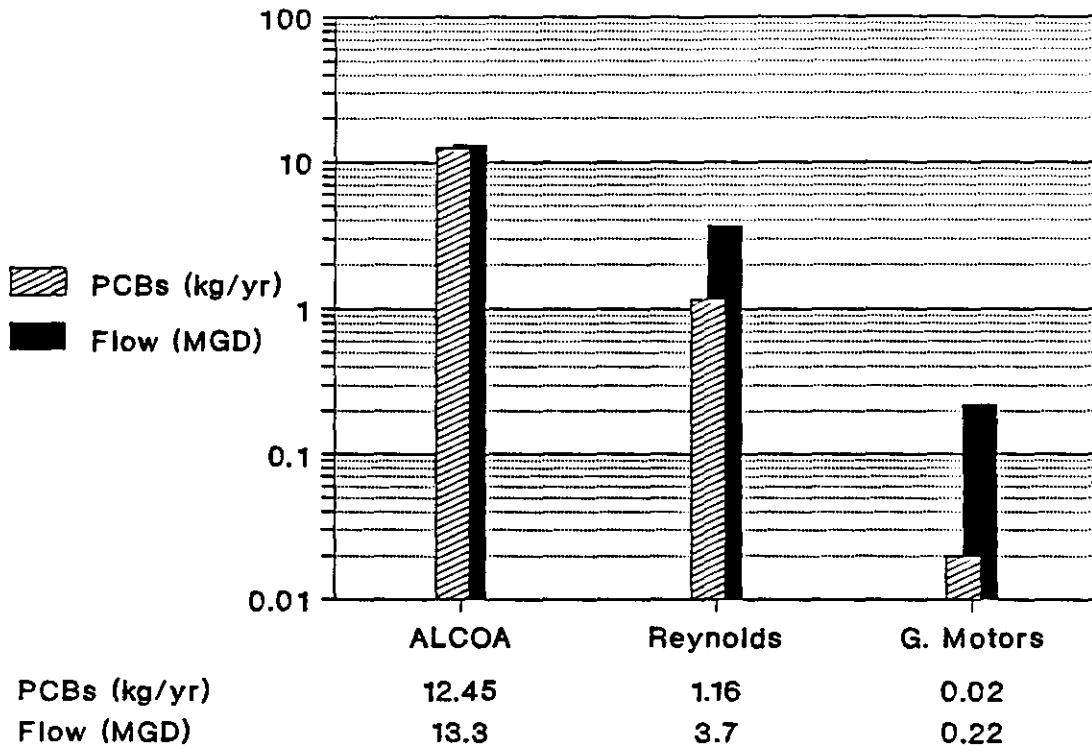
Figure V-4. Estimated annual discharge of PCBs and relative flows for Massena AOC industries (1989 data)

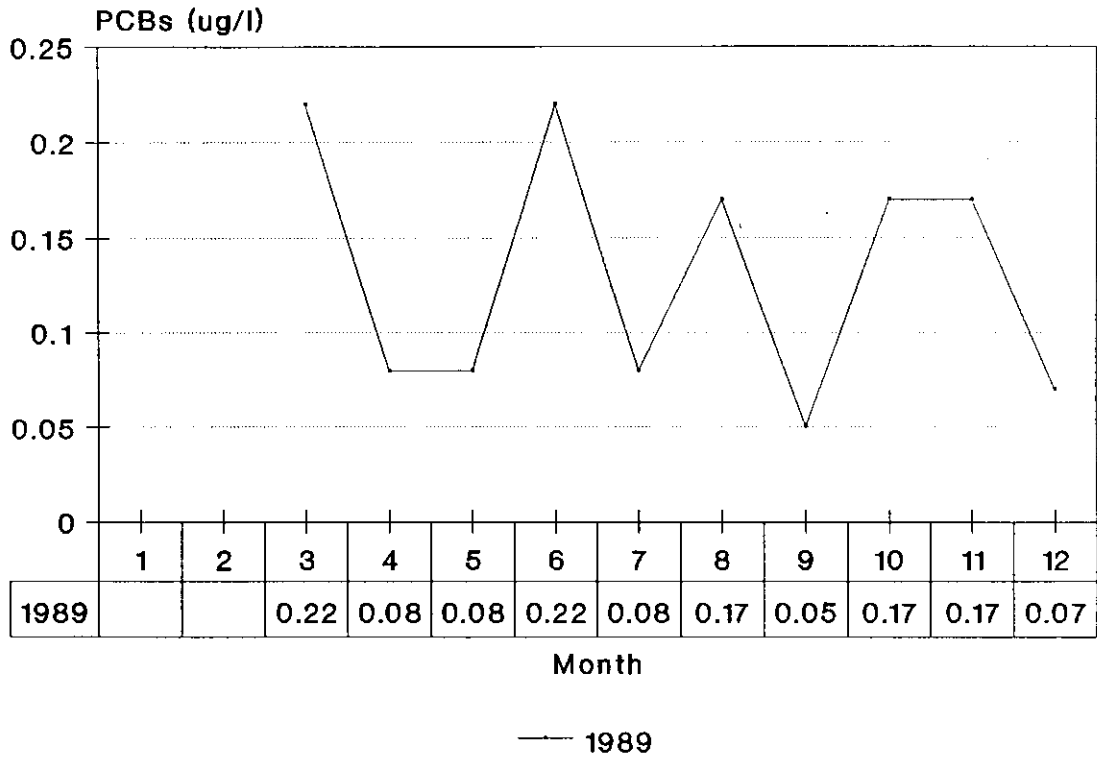
Outfall 003

Figure V-9. Monthly maximum discharge of PCBs at Reynolds Metals outfall #003 (detection limit = 0.05 ug/l)
