# 2008 HURRICANES IN THE CARIBBEAN

Gonaives, Haiti  
September 9, 2008

# Post Hurricane Hanna/Ike Damage Overview

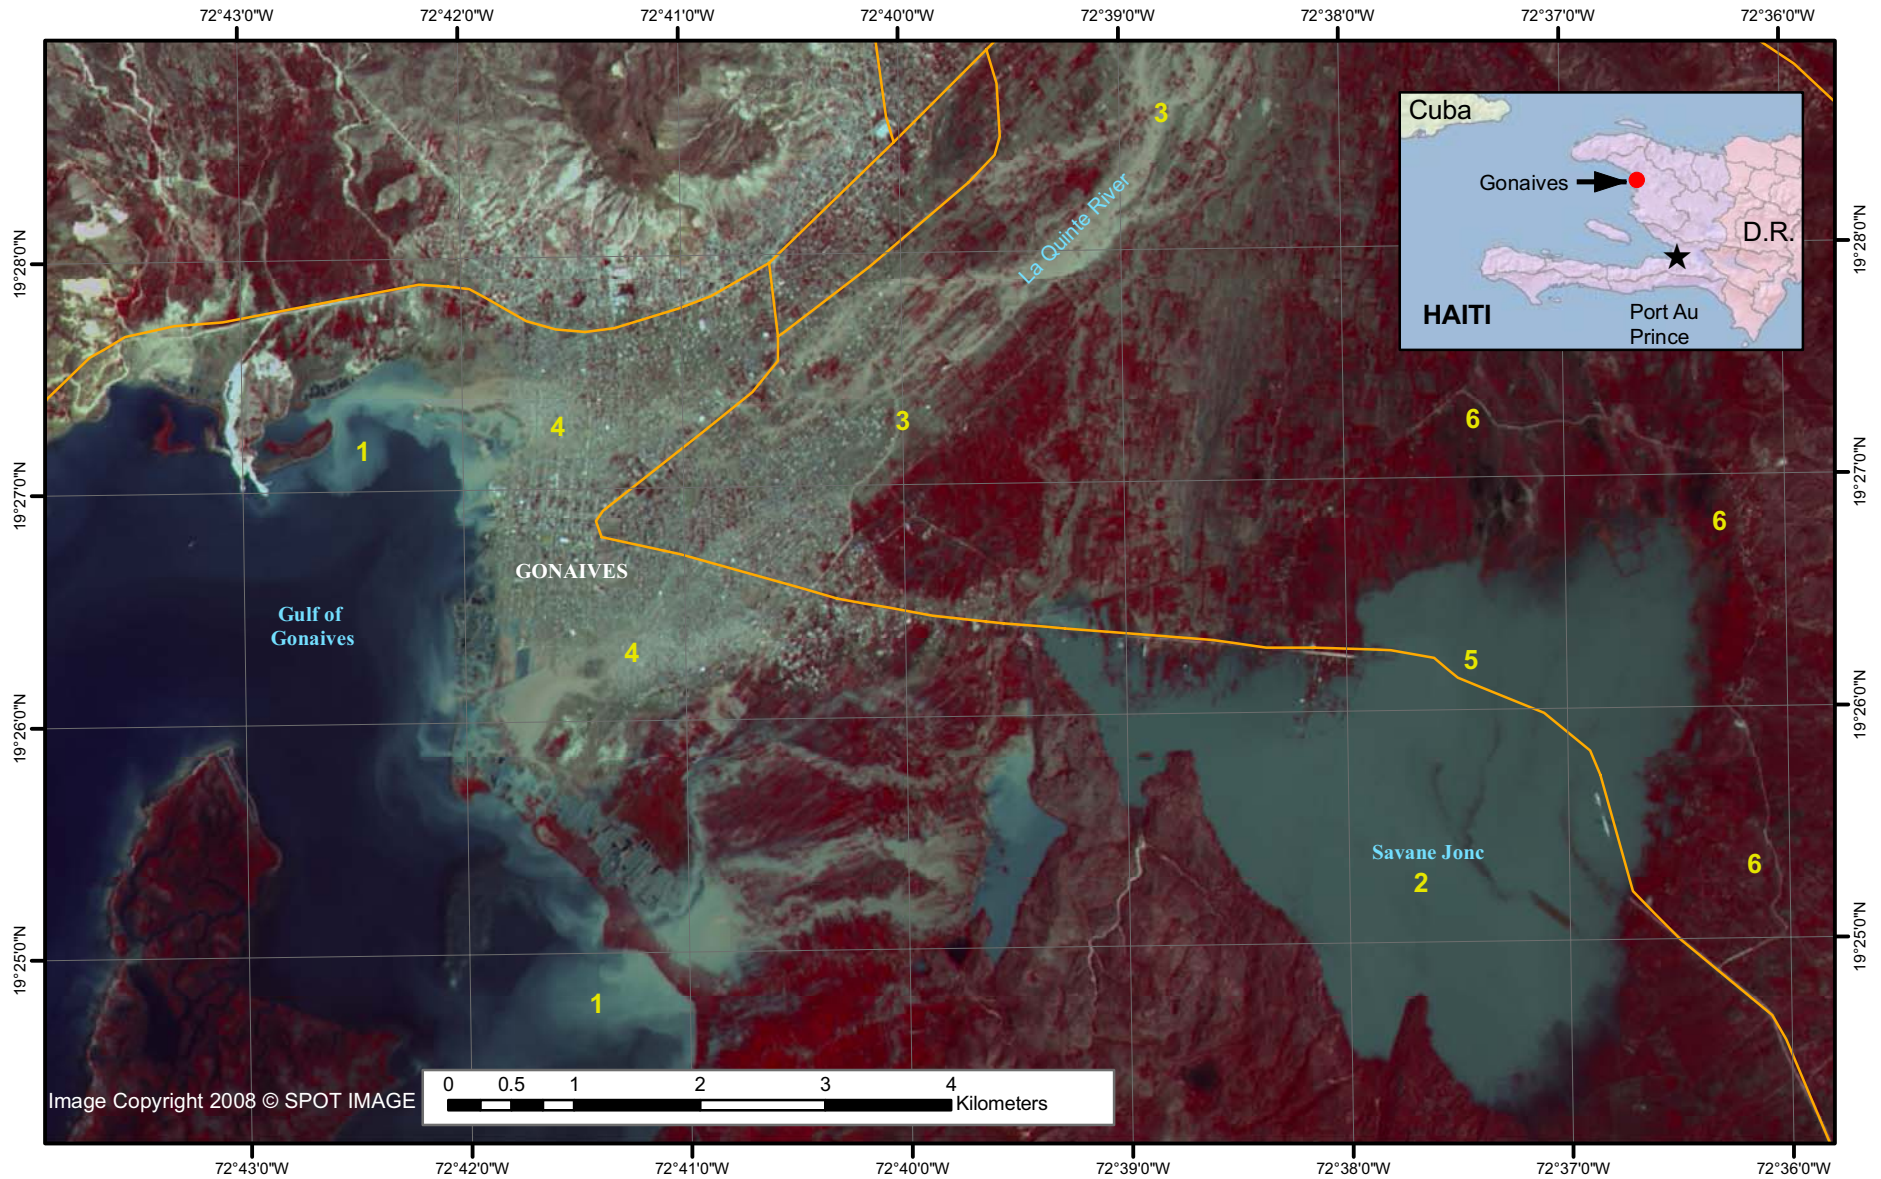
The effects of extreme rainfall related to Hurricanes Hanna and Ike cause flooding, destruction and loss of life in Gonaives and other regions of Haiti. This image clearly shows the sediment loaded runoff still coloring the water bodies, including the Gulf of Gonaives (1) and the Savane Jonc (2). The La Quinte River has deposited significant quantities of sediment outside of its channel (3) and changed its route to the sea, cutting directly through the city of Gonaives (4). The Savane Jonc has swollen and submerged the causeway linking to points south (5). Engineers are working to increase the capacity of a detour to handle the increased traffic loads (6).
