USDA Hurricane Georges Recovery Program Special Objective 1

“Damaged Rural Watersheds Rehabilitated through Strengthened Local Capacity.”

E. COUNTRY PROGRAM DESCRIPTION-- Dominican Republic

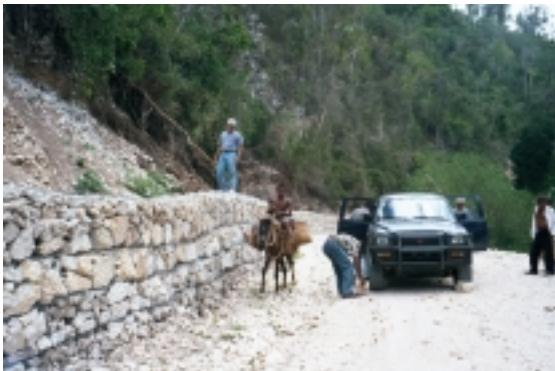
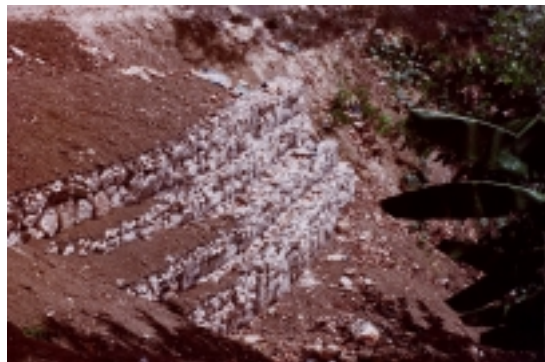
Figure 1. Gabions constructed under this project protect key farm-to-market road in the Dominican Republic

Landslide Protection, through construction of gabions and furrow drains, for main rural farm-to-market road in Panzo and Majagual watersheds.

This protection activity was completed through a grant of \$69,753 to World Vision in conjunction with field-based technical review and advice from USDA. The effort included construction of 953 cubic meters of stone-filled wire baskets, 382 square meters of concrete/stone walls, and 67 cubic meters of furrow drains, all of which contribute to increase local capacity to withstand future storm effects. Blockage and washout of roads during severe storms and hurricanes have a quick and serious impact on economic activity in affected areas. World Vision determined that in the Majagual watershed, the communities of Los Arroyitos, Rio Grande, Gran Plena, Canada de la Vaca, Batista, Mundito, and La Rosa all are benefiting from this road protection. In the Panzo watershed, Apolinar Perdomo, Los Guineos, La Petaca, El Aguacate, El Botao, El Pozo, El Copey, and Las Canas are community beneficiaries.

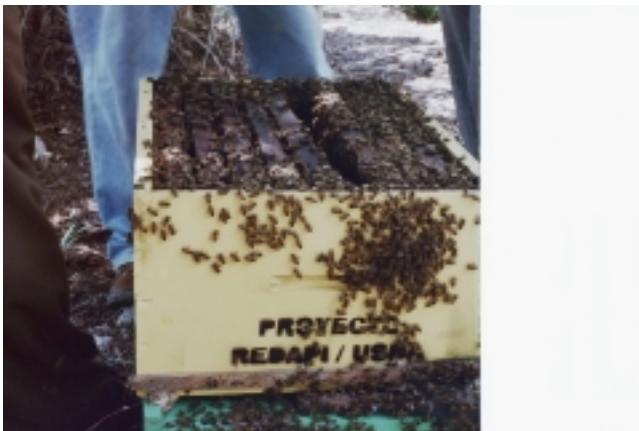
Figure 2. Bees thriving in one of the new hive boxes constructed to USDA specifications

Through a \$7,000 grant to CEDAF and technical assistance from the USDA Agricultural Research Service (ARS), bee-honey production was successfully re-started in this Georges-affected area. 50 double beehives were constructed and installed according to USDA specifications, and farmers can now produce a better quality product through the improved hive construction. ARS also provided specific technical assistance in fighting the Varroa bee mite, a parasite.

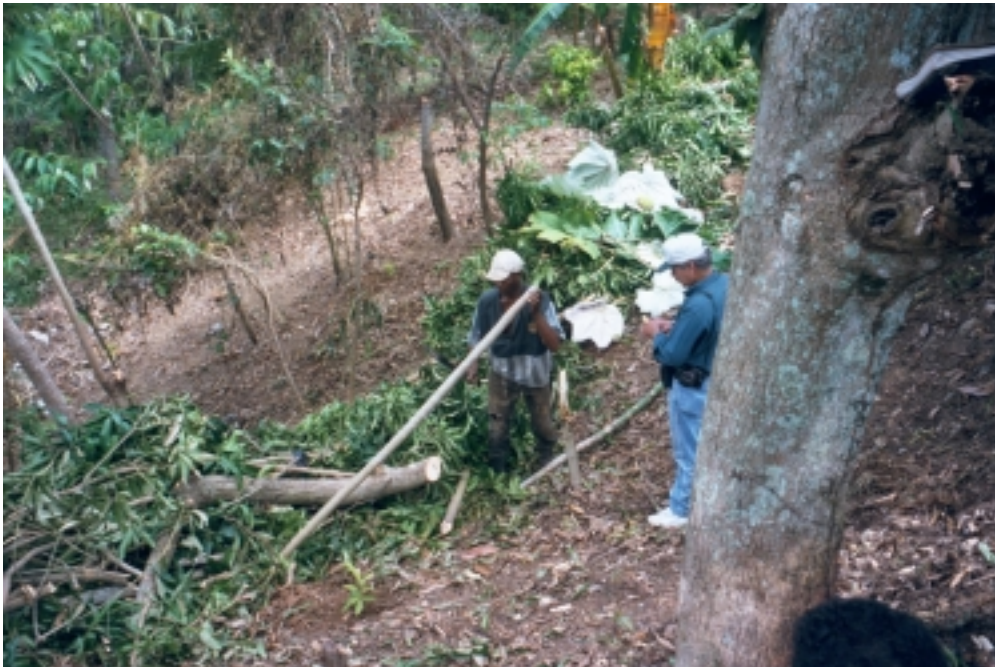
Figure 3. Establishing barriers to soil erosion along contours in sustainable agriculture demonstration sites

With technical advice and an \$11,581 grant from USDA, Fundación Natura Dominicana (Natura) has established and incorporated these 4 farm demonstration sites into their ongoing operation. The sites use organic fertilizer produced on-site and feature both live and dead barriers along their contours to stem soil erosion and excessive water runoff. Live barriers included pineapple and black sugar cane. In addition to the grant, USDA NRCS also provided field training in the use of hand levels to establish contour lines and grade.
