# Effects of Vapor-Based Decontamination Systems on Selected Building Interior Materials: Vaporized Hydrogen Peroxide

**Edgewood Chemical Biological Center**

**United States Environmental Protection Agency**

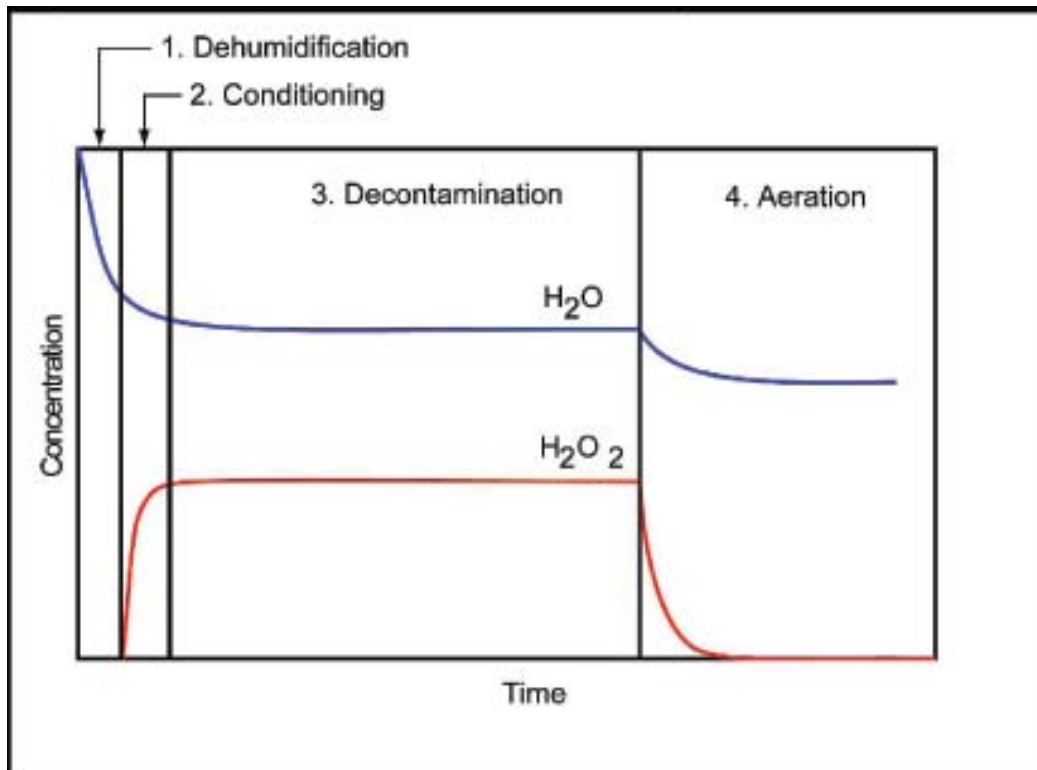
**Figure 3.1:** The Steris VHP® Decontamination Cycle

Decontamination of an interior space using VHP is a four-phase process involving preparation of the building interior air (dehumidification), achieving a steady-state decontaminant level (conditioning), performing the decontamination, and then aerating for safe reentry (Figure 3.1).<sup>3</sup>

*Dehumidification:* Hydrogen peroxide vapor can co-condense with water vapor producing an undesired condensate high in hydrogen peroxide. High relative humidity (RH) and/or cold temperatures are likely to permit condensation, but it can be prevented by circulating dry, heated air through the interior prior to injection of the hydrogen peroxide vapor. The target humidity level is determined by the concentration of vapor to be injected and the desired steady-state concentration for the decontamination. The lower relative humidity permits a higher concentration of hydrogen peroxide without reaching a saturation point. For this study, the maximum RH at start-of-run (prior to introducing decontaminant) was 30%.

*Conditioning:* During the conditioning phase, the injection of hydrogen peroxide vapor is initiated at a rapid rate to achieve the desired chamber concentration set point without condensation. Once the target concentration is achieved, the injection rate is lowered to maintain the set-point concentration.

*Decontamination:* Decontamination is a timed process dependent on the hydrogen peroxide vapor concentration. In actual building applications, a decontamination timer counts down from the preset decontamination time. If the concentrations or temperature values fall below the set point, the timer stops. This ensures that during the decontamination phase the building interior is exposed to at least the minimum decontamination conditions for the desired exposure time. For this laboratory-scale study, the enclosure VHP concentration was maintained within the target concentration range.

*Aeration:* After completion of the decontamination phase, the hydrogen peroxide injection is terminated. Air is introduced into the chamber and displaces the hydrogen peroxide. The space is monitored until the hydrogen peroxide concentration falls to a safe level for coupon removal.

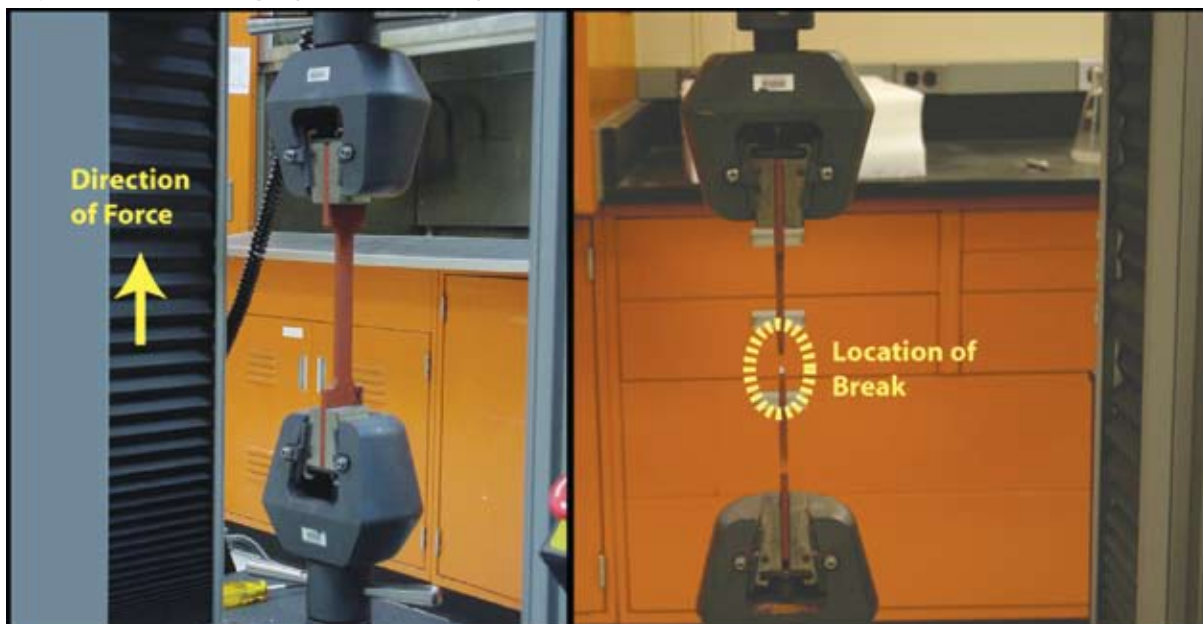
**Figure 6.1** Photograph-Steel Coupon Test

was conducted by suspending a certified weight from the fixture and recording the weight. Three sets of five coupons were tested for each concentration (full-target and half-target) and four sets were tested for the controls (0 ppm). The load required to rupture the steel coupons was measured in Newtons (N). The tensile strength is the maximum tensile stress that a material is capable of sustaining and is calculated by dividing the amount of force required to rupture a specimen by the specimen cross-sectional area. The cross-sectional area for the steel, dog bone shaped coupon is the center width of the coupon multiplied by the center thickness. No precision or bias requirements have been established for this test method. The results for control coupons were compared against the results for decontaminant-exposed coupons. A statistical analysis of the data was conducted to determine whether the decontaminant-exposed steel coupon results were statistically different from the control steel coupon results. A photograph of a representative steel sample before and after testing is provided in Figure 6.1.

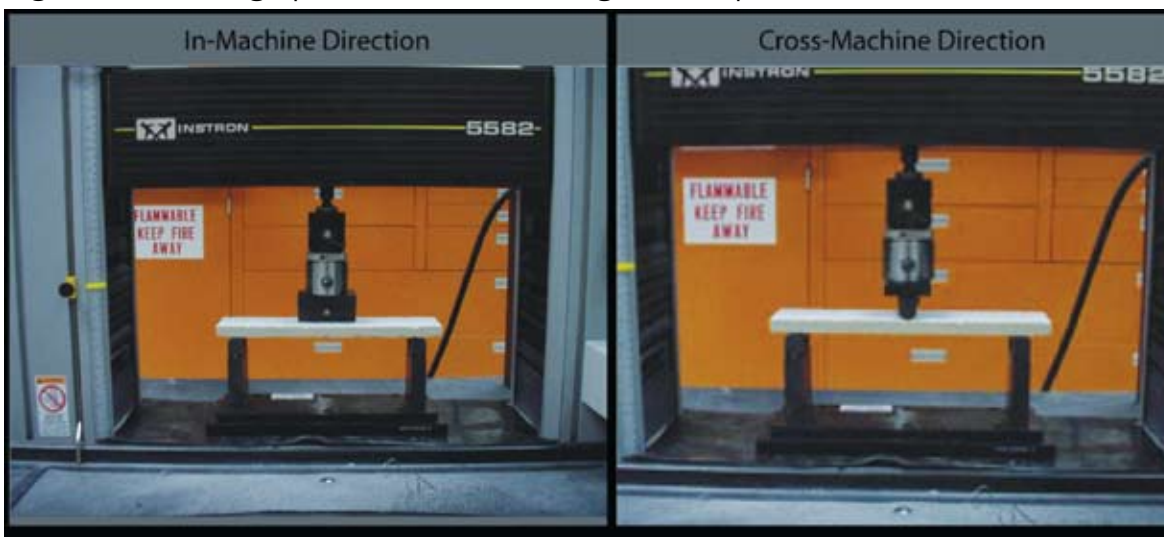
**Figure 8.1** Photograph – Acoustical Ceiling Tile Coupon Test

The acoustical ceiling tile samples were removed from storage, visually inspected, and measured. The samples were brought to moisture equilibrium such that the weight of the sample did not change by more than 1% on successive weighings at a minimum interval of two hours. The sample preparation was conducted within a range of 18–24 °C and 48–75% RH. The testing was conducted in accordance with ASTM Test Method C367-99. The Instron fixture for the ceiling tile test was installed prior to testing. The Instron universal testing machine operation was verified by suspending a certified weight from the fixture and recording the weight. For each test the coupons from chamber positions 1 through 8 were selected for testing; this selection resulted in placing all coupons in the chamber during a single fumigation trial. Ceiling tile coupons were tested in two directions — with the mandrel parallel to the axis of the

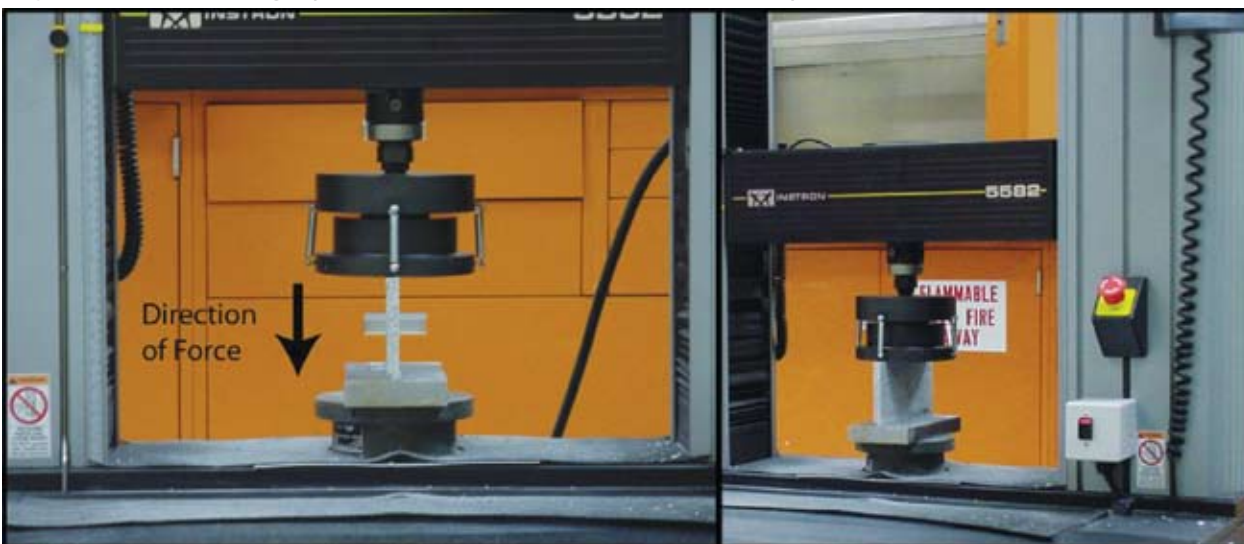
**Figure 10.1** Photograph – Concrete “Cinder Block” Coupon Test

80% RH for 48 hours prior to testing. The testing was conducted in accordance with ASTM Test Method C140-03. The Instron fixture for the concrete cinder block test was installed prior to testing. A photograph of a concrete cinder block coupon loaded into the Instron test apparatus is shown in Figure 10.1. The Instron universal testing machine operation and calibration verification was conducted by suspending a certified weight from the fixture and recording the weight. Three sets of three coupons were tested for each concentration (0 ppm, full-target, and half-target). The load required to rupture the coupons was measured in  $\text{kgf}/\text{mm}^2$  and can be found in Table 10.1. No precision or bias requirements have been established for this test method. The results for control coupons were compared to the results for decontaminant-exposed coupons. A statistical analysis of the data was conducted to determine whether the decontaminant-exposed coupon results were statistically different from the control coupon results.

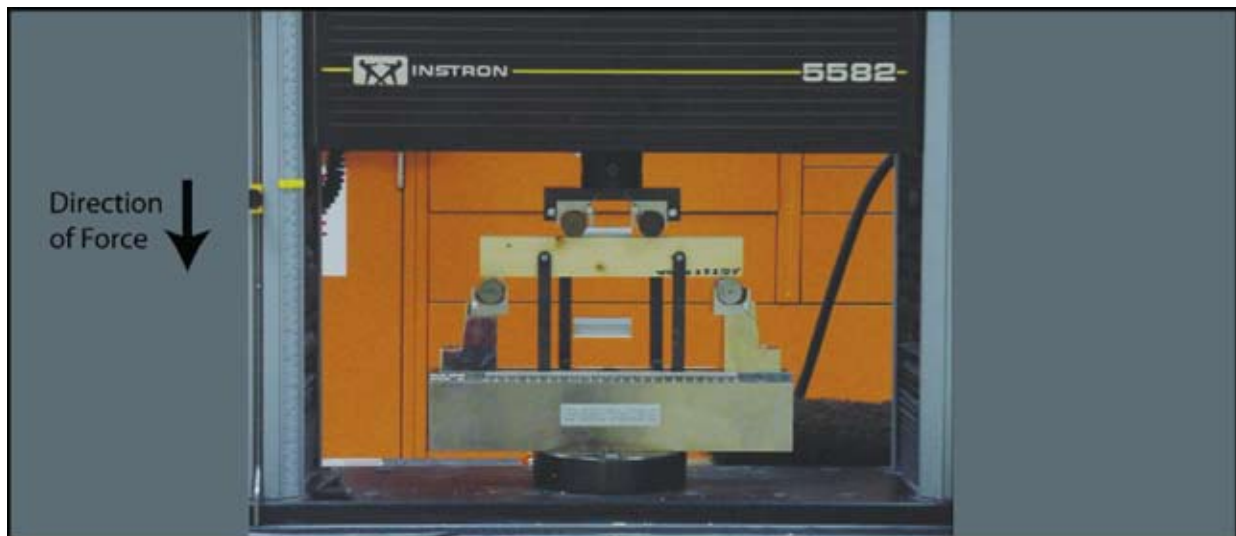
**Figure 11.1** Photograph – Wood Coupon Test

weighings at a minimum interval of two hours. The sample preparation was conducted within a range of 15–25 °C and 48–75% RH. The testing was conducted in accordance with ASTM Test Method D4761-02a. The Instron fixture for the wood test was installed prior to testing. The Instron universal testing machine operation and calibration verification was conducted by suspending a certified weight from the fixture and recording the weight. Three sets of five coupons were tested for each concentration (0 ppm, full-target, and half-target). The load required to rupture the wood coupons was measured in N. The setup of the Instron for testing the wood furrings can be seen in Figure 11.1. No precision or bias requirements have been established for this test method. The results for control coupons were compared to the results for decontaminant-exposed coupons. A statistical analysis of the data was conducted to determine whether the decontaminant-exposed coupon results were statistically different from the control coupon results.

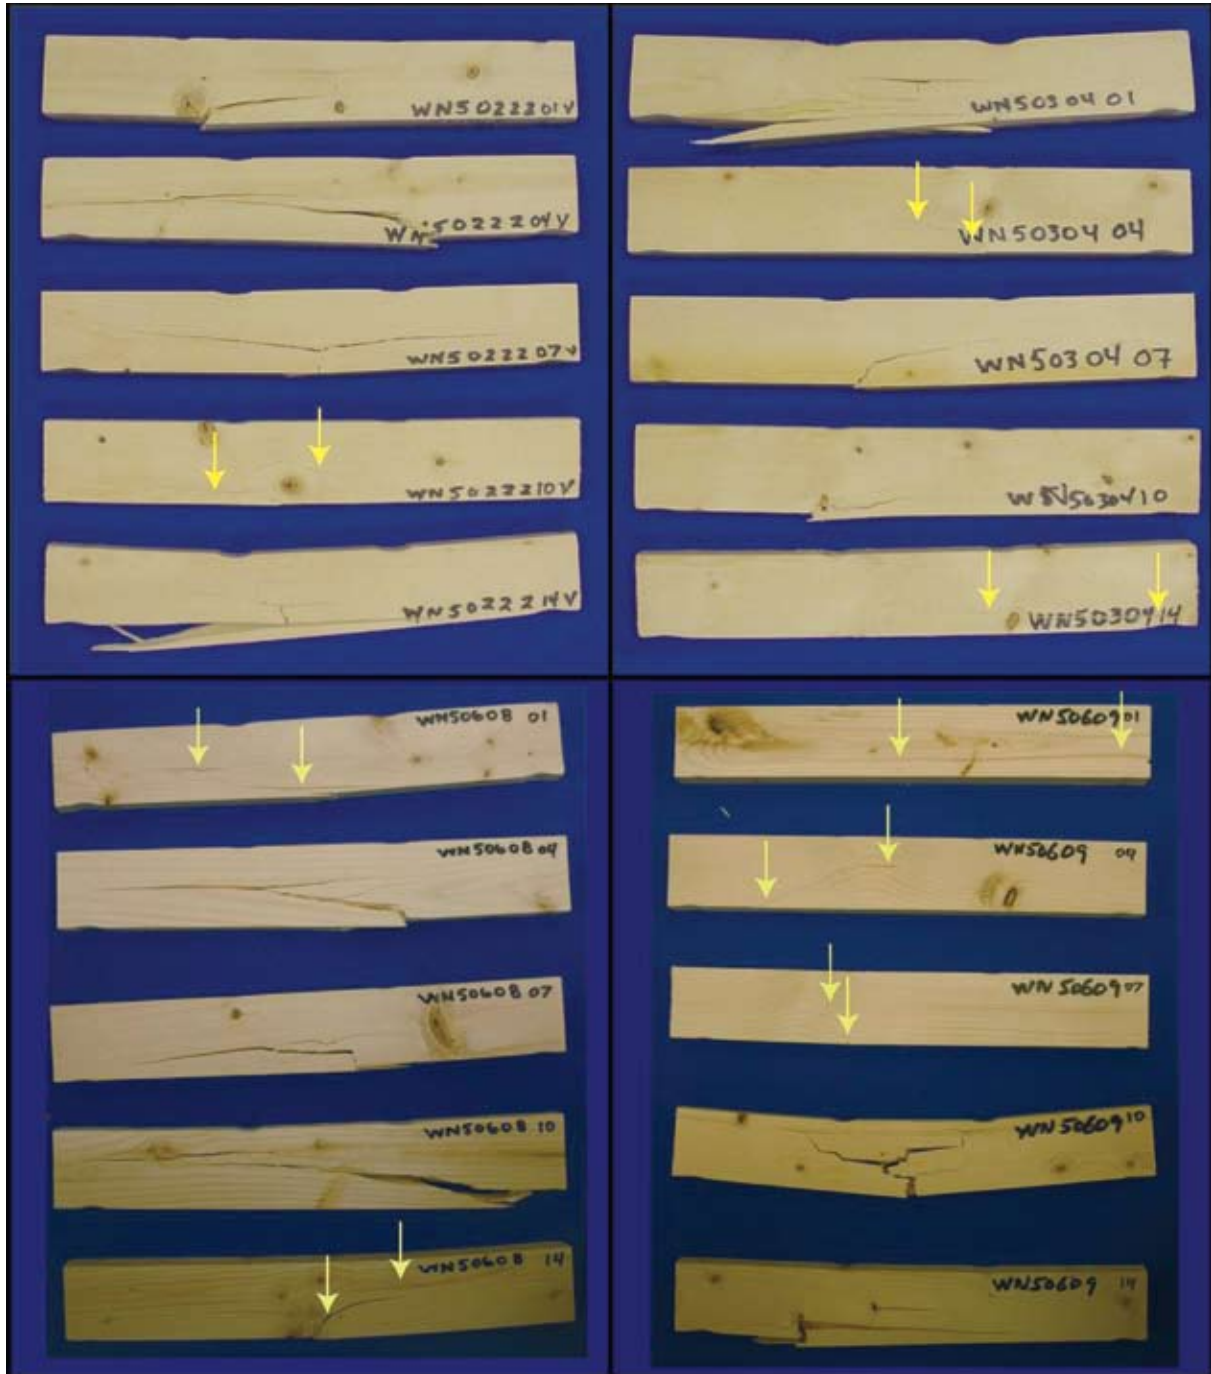
**Figure C-1:** Location of Break, Wood Coupons – VHP Control Set

arrows are used on samples where the photograph contrast may not clearly show the location of the break.
