**Re: GE-Pittsfield/Housatonic River Site
Silver Lake Area (GEC600)
Pilot Study Report for Silver Lake Sediments**

**Pilot Study Report for Silver Lake
Sediments**

Prepared for:
General Electric Company
Pittsfield, Massachusetts

Prepared by:
ARCADIS of New York, Inc.
6723 Towpath Road
Syracuse
New York 13214-0066
Tel 315.446.9120
Fax 315.445.9161

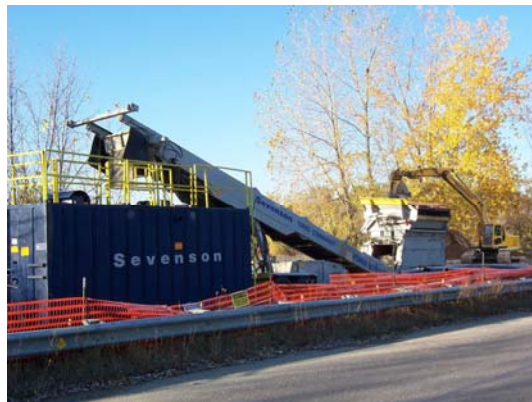
An excavator placed dry mixed isolation layer materials into a feed hopper at the foot of a conveyor system used to supply the mix tank. Initial test runs established a dry isolation layer material feed rate of approximately 1 cy per minute to create a slurry of the target consistency (approximately 7 to 10% solids).

After isolation layer materials were mixed, the resultant slurry was gravity fed into a separate compartment within the mix tank where a modified dredge pump was used to pump the slurry through an 8-inch high-density poly-ethylene (HDPE) pipe to the spreader barge that traversed the Pilot Study area as described in Section 3.4. The pipe

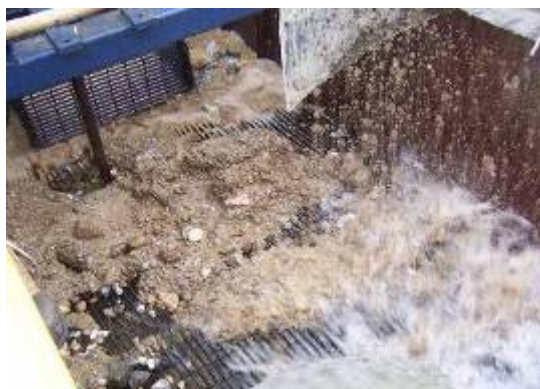
On several occasions, the mixing process had to be temporarily shut down due to clogging caused by rocks, stones, and other debris found in the dry isolation layer materials. Initially, a metal screen was added at the feed-hopper to pre-screen debris from the mixed materials, thereby limiting the potential for clogging within the mix tank. However, too much debris remained in the mixed materials, and clogging continued to be a problem. To help address the problem,

the top-soil materials received from Clarksburg were transported to PS&G and screened using a 5/8-inch Trommel screen.

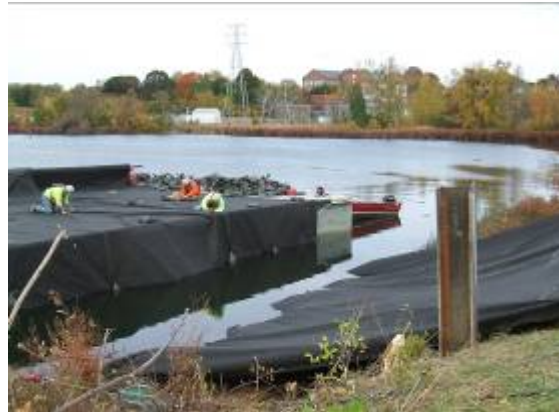
The barge was slowly pulled away from shore along the approximate centerline of the non-woven geosynthetic test-area, using the cable system described above. As the barge was moved progressively further from shore, additional materials were unrolled, the adjacent edges sewn together, and weighted with sandbags along its length. Material guides and rolling clamps on the barge were used to try to keep the geotextile extended to the full width of the material.

As the barge moved further away from shore, difficulties with placement of the non-woven geotextile were observed (e.g., puckering, necking) that appeared to be related to the buoyancy of the non-woven geotextile, and/or the tension in the fabric.. GE discussed these concerns with EPA and agreed to perform an interim assessment of the geosynthetic placement prior to initiating isolation layer placement.

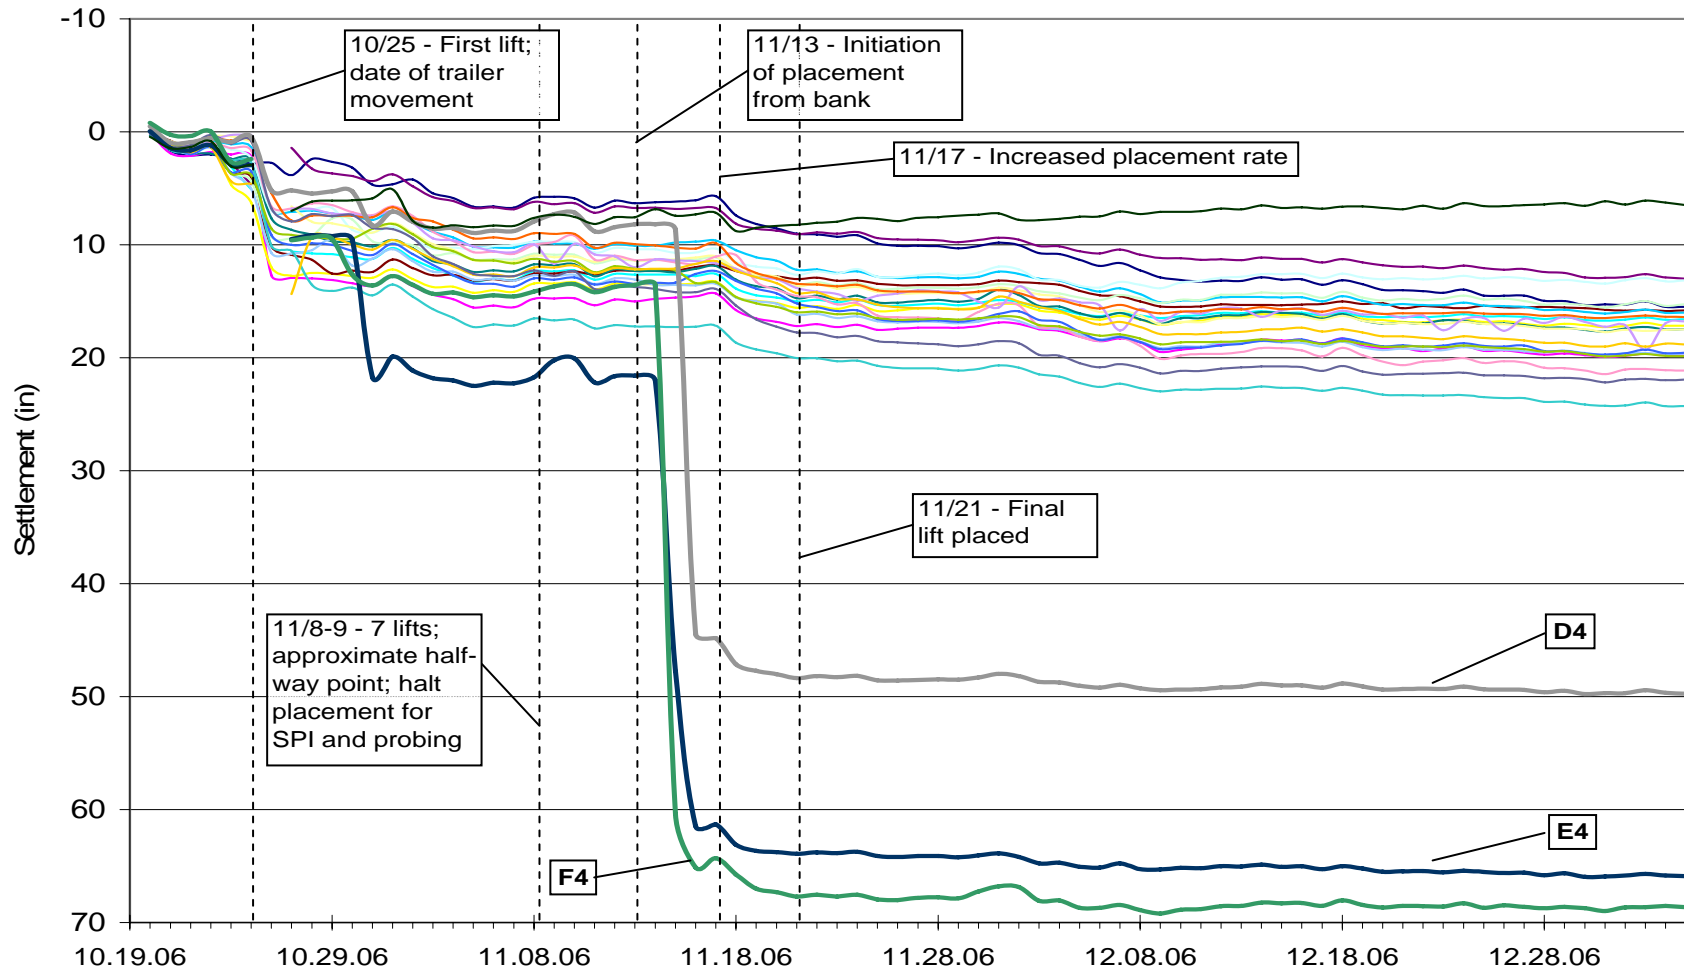
FIGURE 11

1. TIME SERIES PLOT REPRESENTS ESTIMATED SEDIMENT SETTLEMENT BASED ON VIBRATING WIRE SETTLEMENT CELL DATA.
2. CERTAIN CELLS (E.G., A1, A4, B2, C3, and G4) EXHIBITED ERRATIC BEHAVIOR, AND REPORTED DATA WERE NOT INCLUDED IN OVERALL ASSESSMENT OF SETTLEMENT.

In general, the VW settlement cells show a decreasing sediment surface elevation over time. Figure 11 depicts the data output from the 23 usable VW settlement cells obtained over the course of the study through the end of 2006. As depicted on Figure 11, the settlement data are relatively consistent; however, apparent abrupt settlement is noted in a few locations which can be associated with other activities that were occurring on-site.

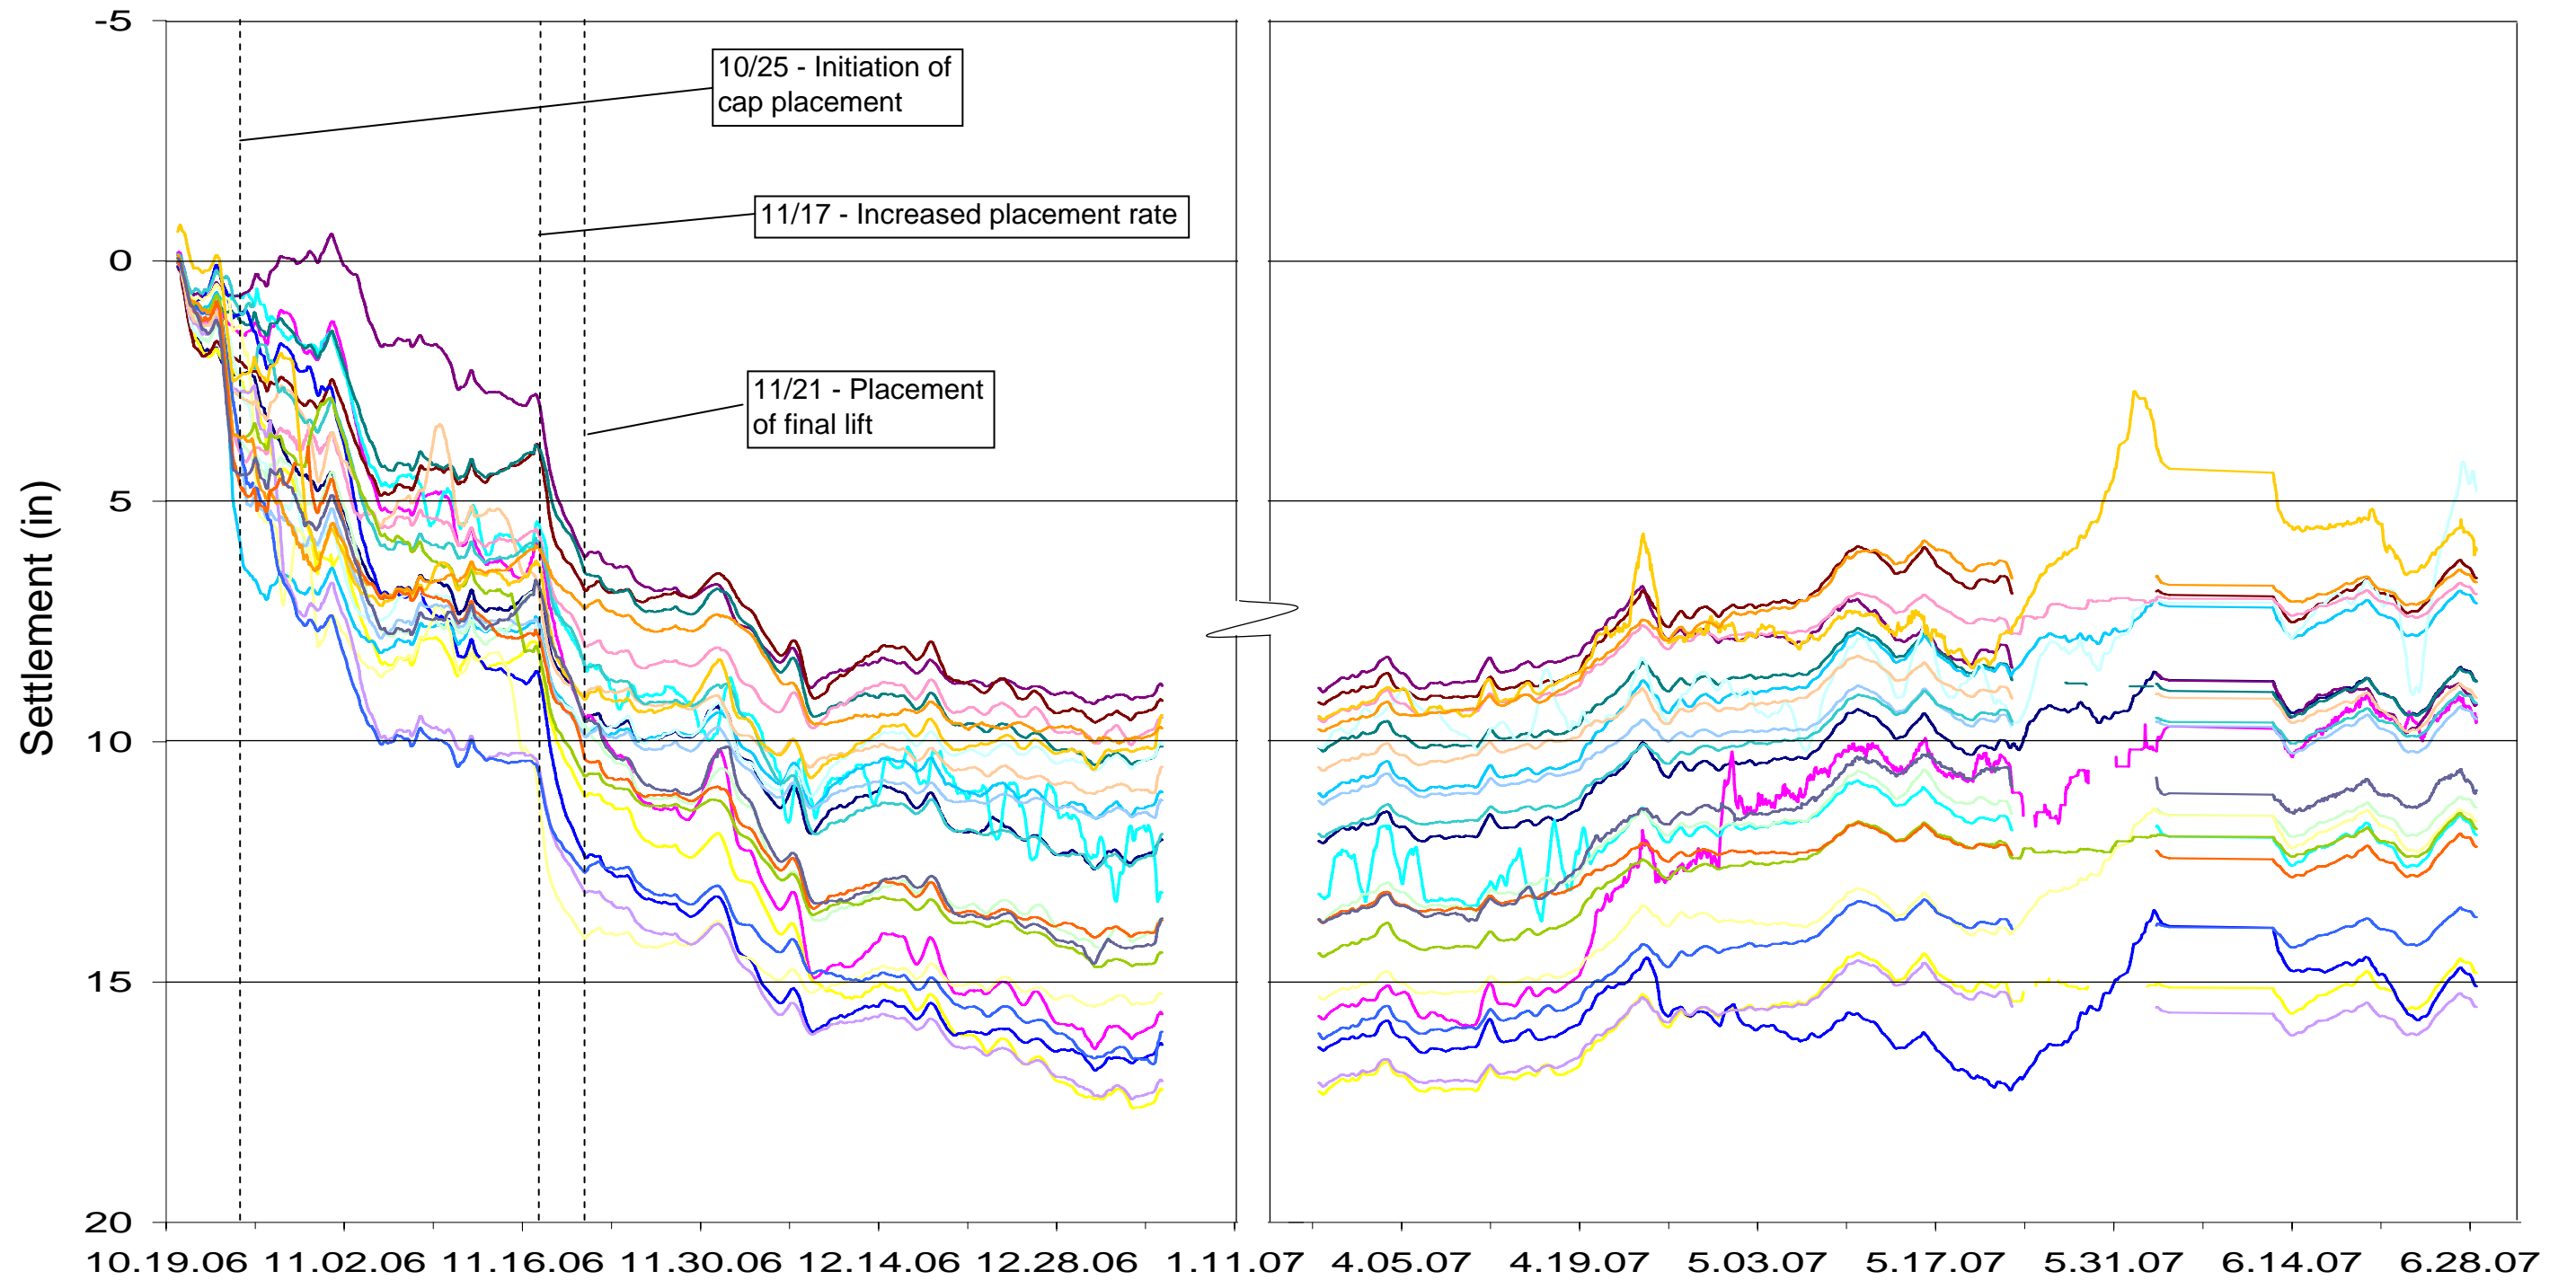
1. GRAPH REPRESENTS ESTIMATED AVERAGE SETTLEMENT ACROSS ENTIRE PILOT STUDY AREA BASED ON ADJUSTED/SMOOTHED VW SETTLEMENT CELL DATA.
2. DATA BETWEEN JANUARY 5 AND MARCH 28, 2007 WAS UNRETRIEVABLE. CHART HAS BEEN MODIFIED FOR CLARITY.

These other activities may have resulted in physical disruptions of the VW equipment³. Making adjustments to the data to account for these physical disruptions, a revised plot of the settlement data is presented on Figure 12. As depicted, the average area wide settlement noted through the end of 2006, ranged from 9.1 inches at location B4, to 17.5 inches at cell B1 with a mean of 12.9 inches. Between the end of 2006 and June of 2007, the average change in elevation of the VW wire settlement cells was approximately 0.9 inches, and data from only three locations suggest net settlement of more than 2 inches during this period.
