Source Area Characterization Report
Pittsfield Massachusetts
FIGURE 3.3.2-9
INTERPRETED GROUNDWATER
CONTOUR MAP, EAST STREET AREA 2-1996

Source Area Characterization Report
Pittsfield Massachusetts
Mcp East Street Area 2/USEPA Area 4

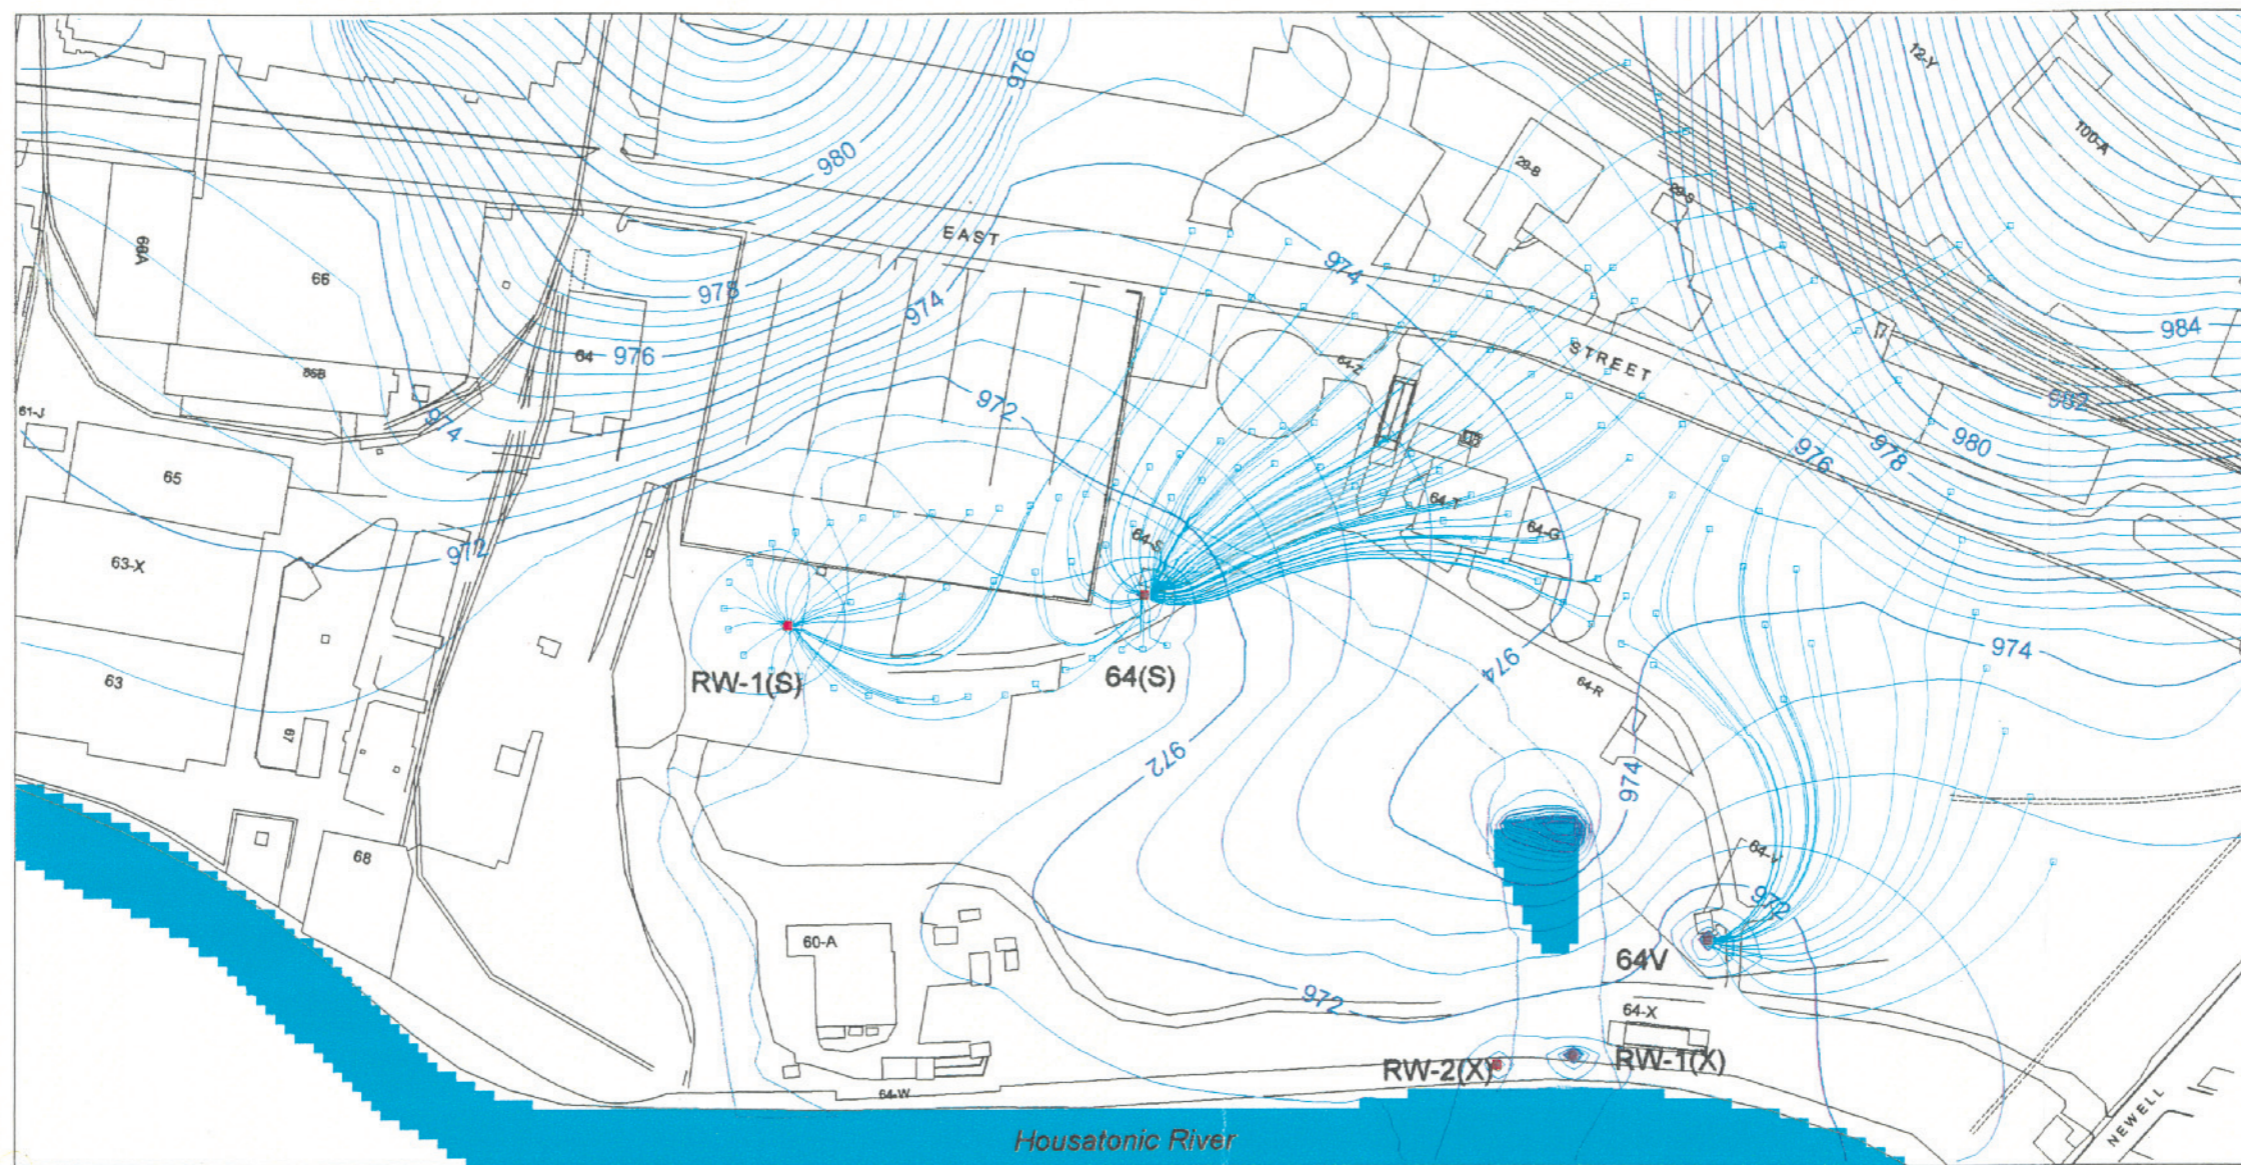
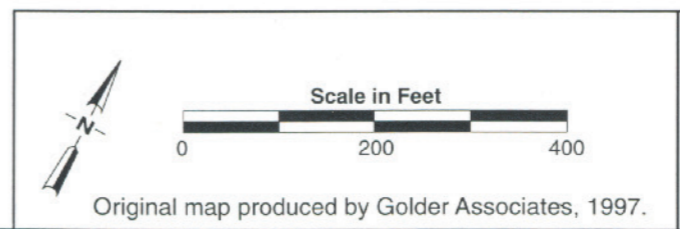
Computer Run: A2c20.gww

Source Area Characterization Report
Pittsfield Massachusetts
FIGURE 3.3.2-10
GROUNDWATER FLOW SIMULATION-
EAST STREET AREA 2 RECOVERY SYSTEM, 1997

- 3.3.2-10 [Groundwater Flow Simulation—East Street Area 2 Recovery System—1997](#)
- 3.3.2-11 [Riverbank Area Groundwater Elevation Contour Map—6/4,5/97](#)

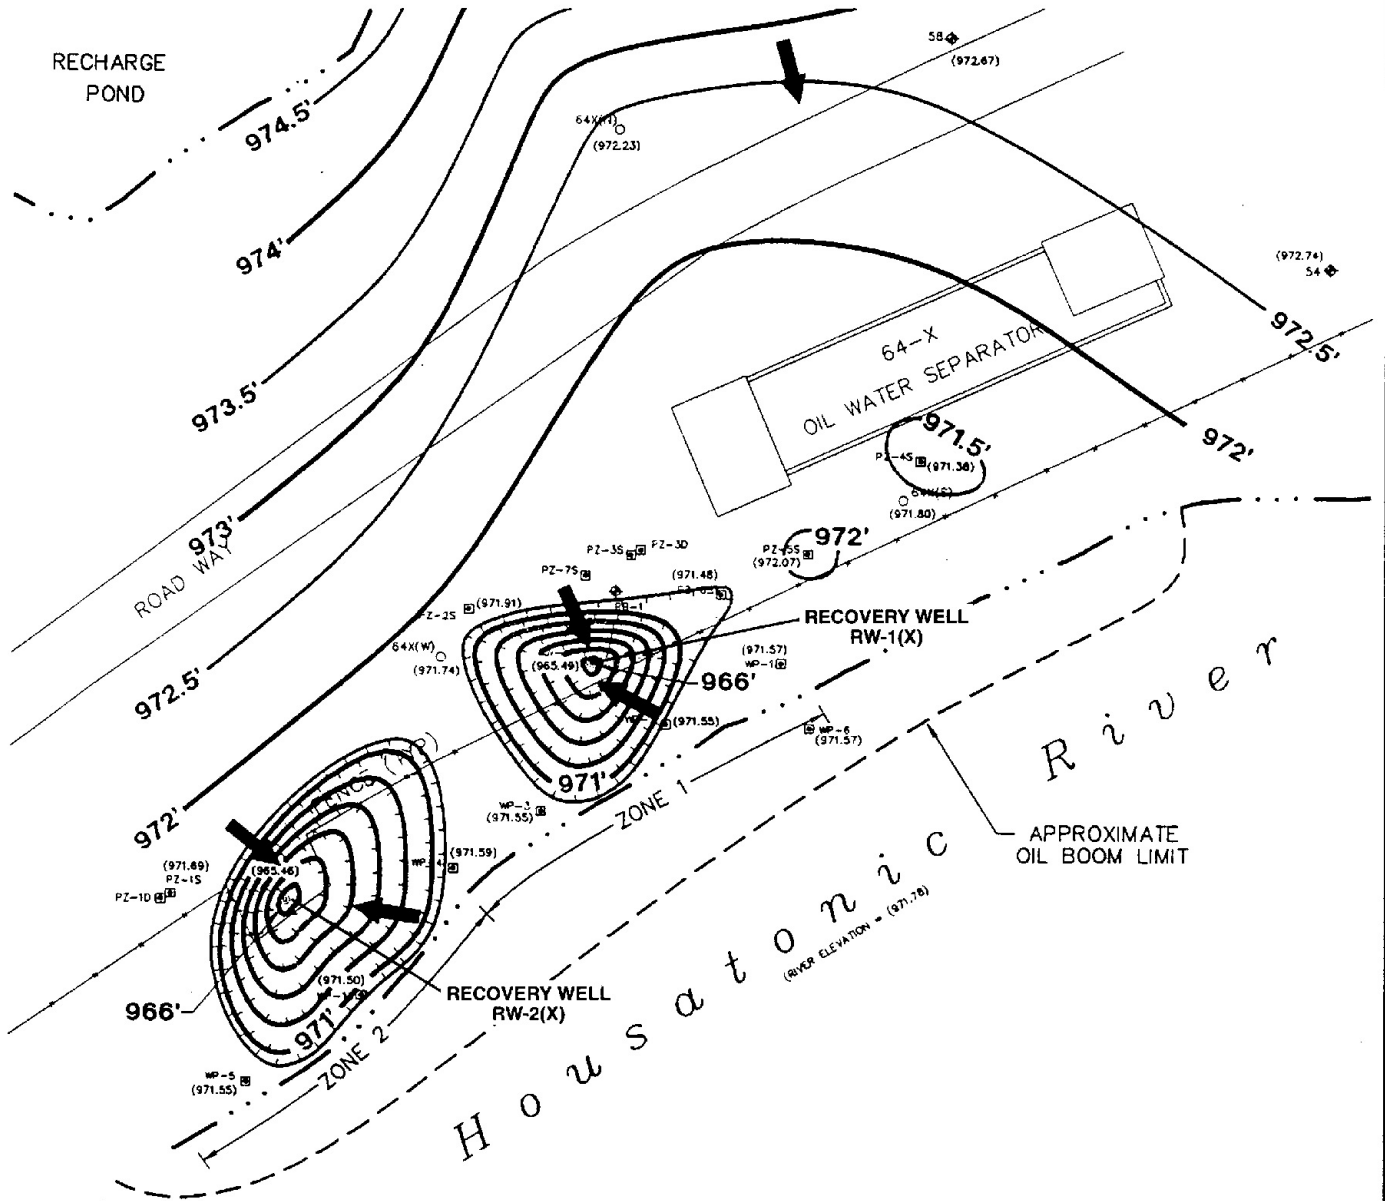
FIGURE 3.3.2-11
RIVERBANK AREA GROUNDWATER
ELEVATION CONTOUR MAP - 6/4,5/97

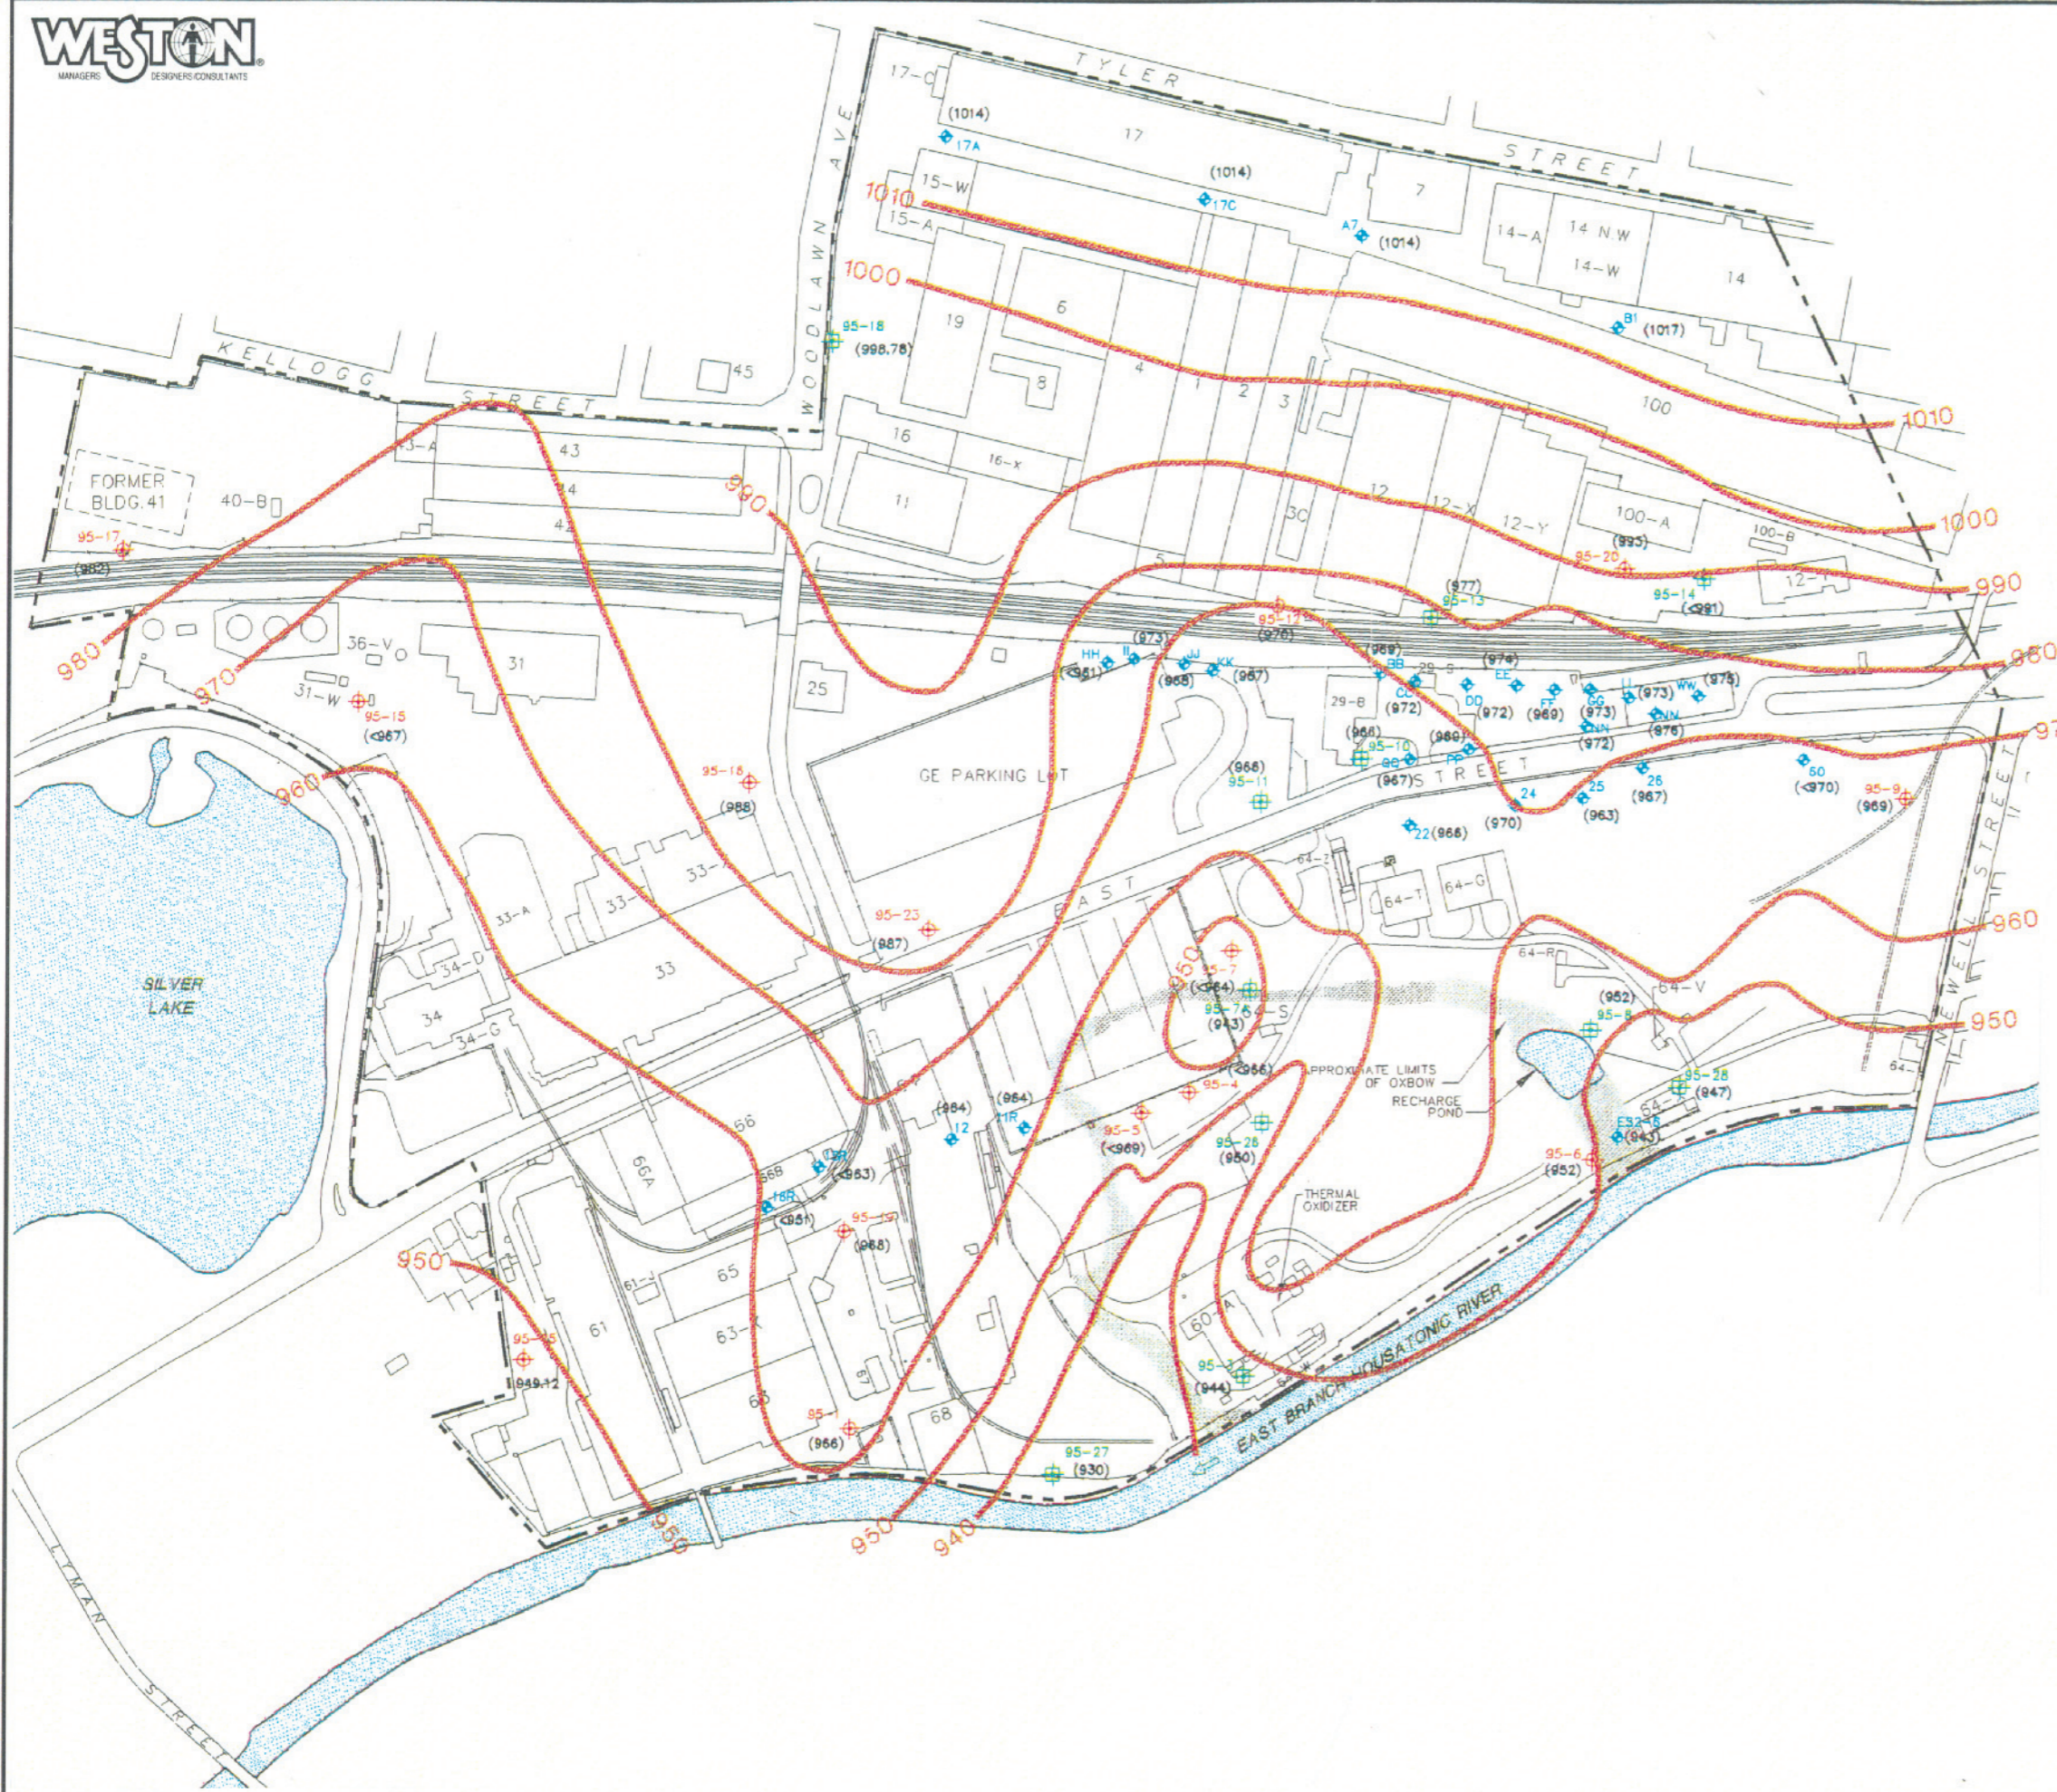
Source Area Characterization Report
Pittsfield Massachusetts
FIGURE 3.3.2-12
INTERPRETED CONTOUR MAP-TOP OF TILL,
EAST STREET AREA 2

- 3.3.2-12 [Interpreted Contour Map Top of Till—East Street Area 2](#)
- 3.3.3-1 Hill 78 Area Potential Source Areas
- 3.3.3-2 Pipelines Retained for Phase III Analysis
