Subject: Transmittal of Modifications of Northwest Corner Affected Soil Removal Report
Administrative Order on Consent for Corrective Action ("Order")
Docket Number 1091-11-20-3008(h)
Former Rhone-Poulenc East Marginal Way Facility
Container Properties L.L.C./Rhodia, Inc.

Northwest Corner Affected Soil Removal Report

Former Rhone-Poulenc Site

Tukwila, Washington

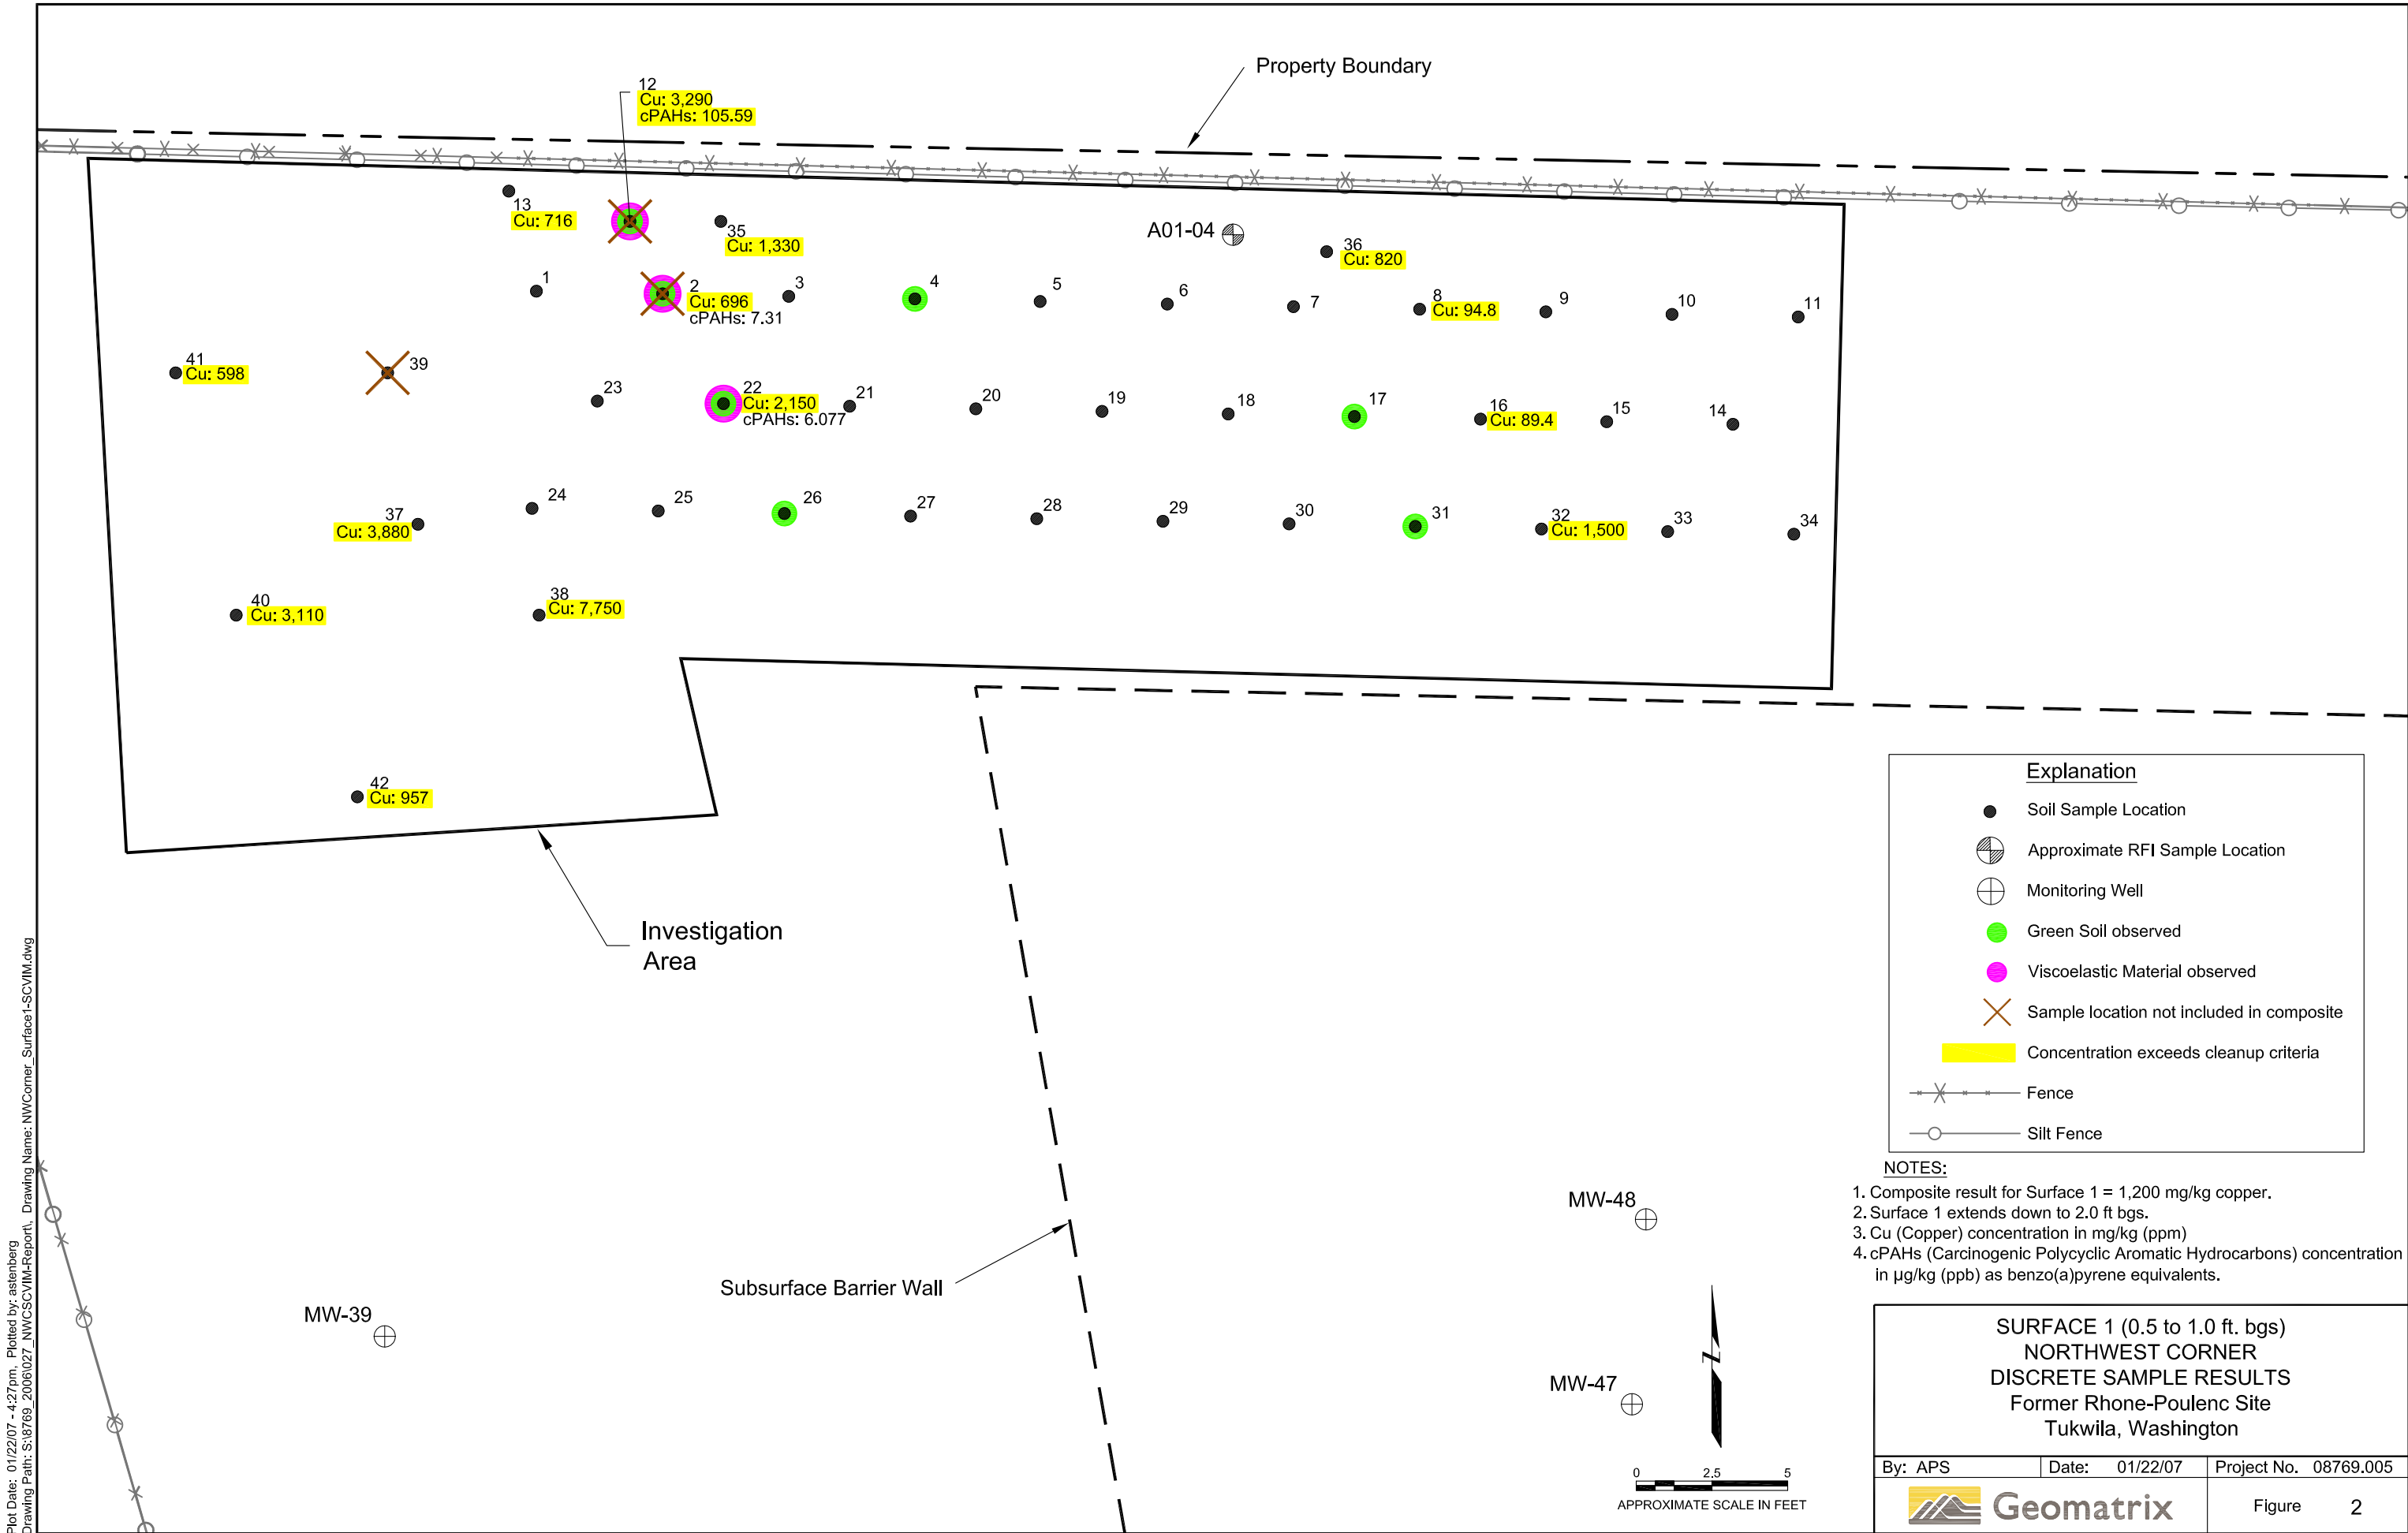
SURFACE 1 (0.5 to 1.0 ft. bgs) NORTHWEST CORNER DISCRETE SAMPLE RESULTS Former Rhone-Poulenc Site Tukwila, Washington		
By: APS	Date: 01/22/07	Project No. 08769.005
		Figure 2

1. Composite result for Surface 1 = 1,200 mg/kg copper.
2. Surface 1 extends down to 2.0 ft bgs.
3. Cu (Copper) concentration in mg/kg (ppm)
4. cPAHs (Carcinogenic Polycyclic Aromatic Hydrocarbons) concentration in µg/kg (ppb) as benzo(a)pyrene equivalents.

Analytical results from the discrete soil samples selected for copper analysis are presented in Table 2. Analysis of discrete samples showed that copper exceeded the interim cleanup level in all Surface 1 archive samples that were analyzed and in 19 of 39 Surface 2 archive samples. These results are also shown on Figures 2 and 3 for Surfaces 1 and 2, respectively.

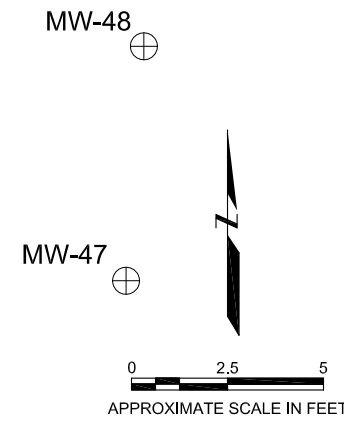
- Soil Sample Location
- ⊗ Approximate RFI Sample Location
- ⊕ Monitoring Well
- Green Soil observed
- Viscoelastic Material observed
- Odor, Sheen, or PID detection (>30ppm)
- ✕ Sample location not included in composite
- Concentration exceeds cleanup criteria
- ✕ Fence
- Silt Fence

The results from analysis of discrete, archive samples from Surfaces 1 and 2 were used to identify the area to be excavated. As shown by the data of Table 2 and Figure 2, the archive samples selected from Surface 1 for analysis were all above the interim cleanup level. All archive samples for Surface 2 were analyzed for copper; these results were used to identify the areal extent of the excavation. The results of the Surface 2 archive sample analyses are shown on Figure 3. The sample collected from Location 24 was taken at a depth of 3.5 to 4.5 feet bgs. Although this sample was labeled as a Surface 3 sample, it was collected at a depth shallower than Surface 3 and has been included with Surface 2. The eastern boundary of the excavation was established west of borings NWC-X-11 and NWC-X-34 and east of boring NWC-X-14; the Surface 2 archive sample results from these borings were all below the interim cleanup

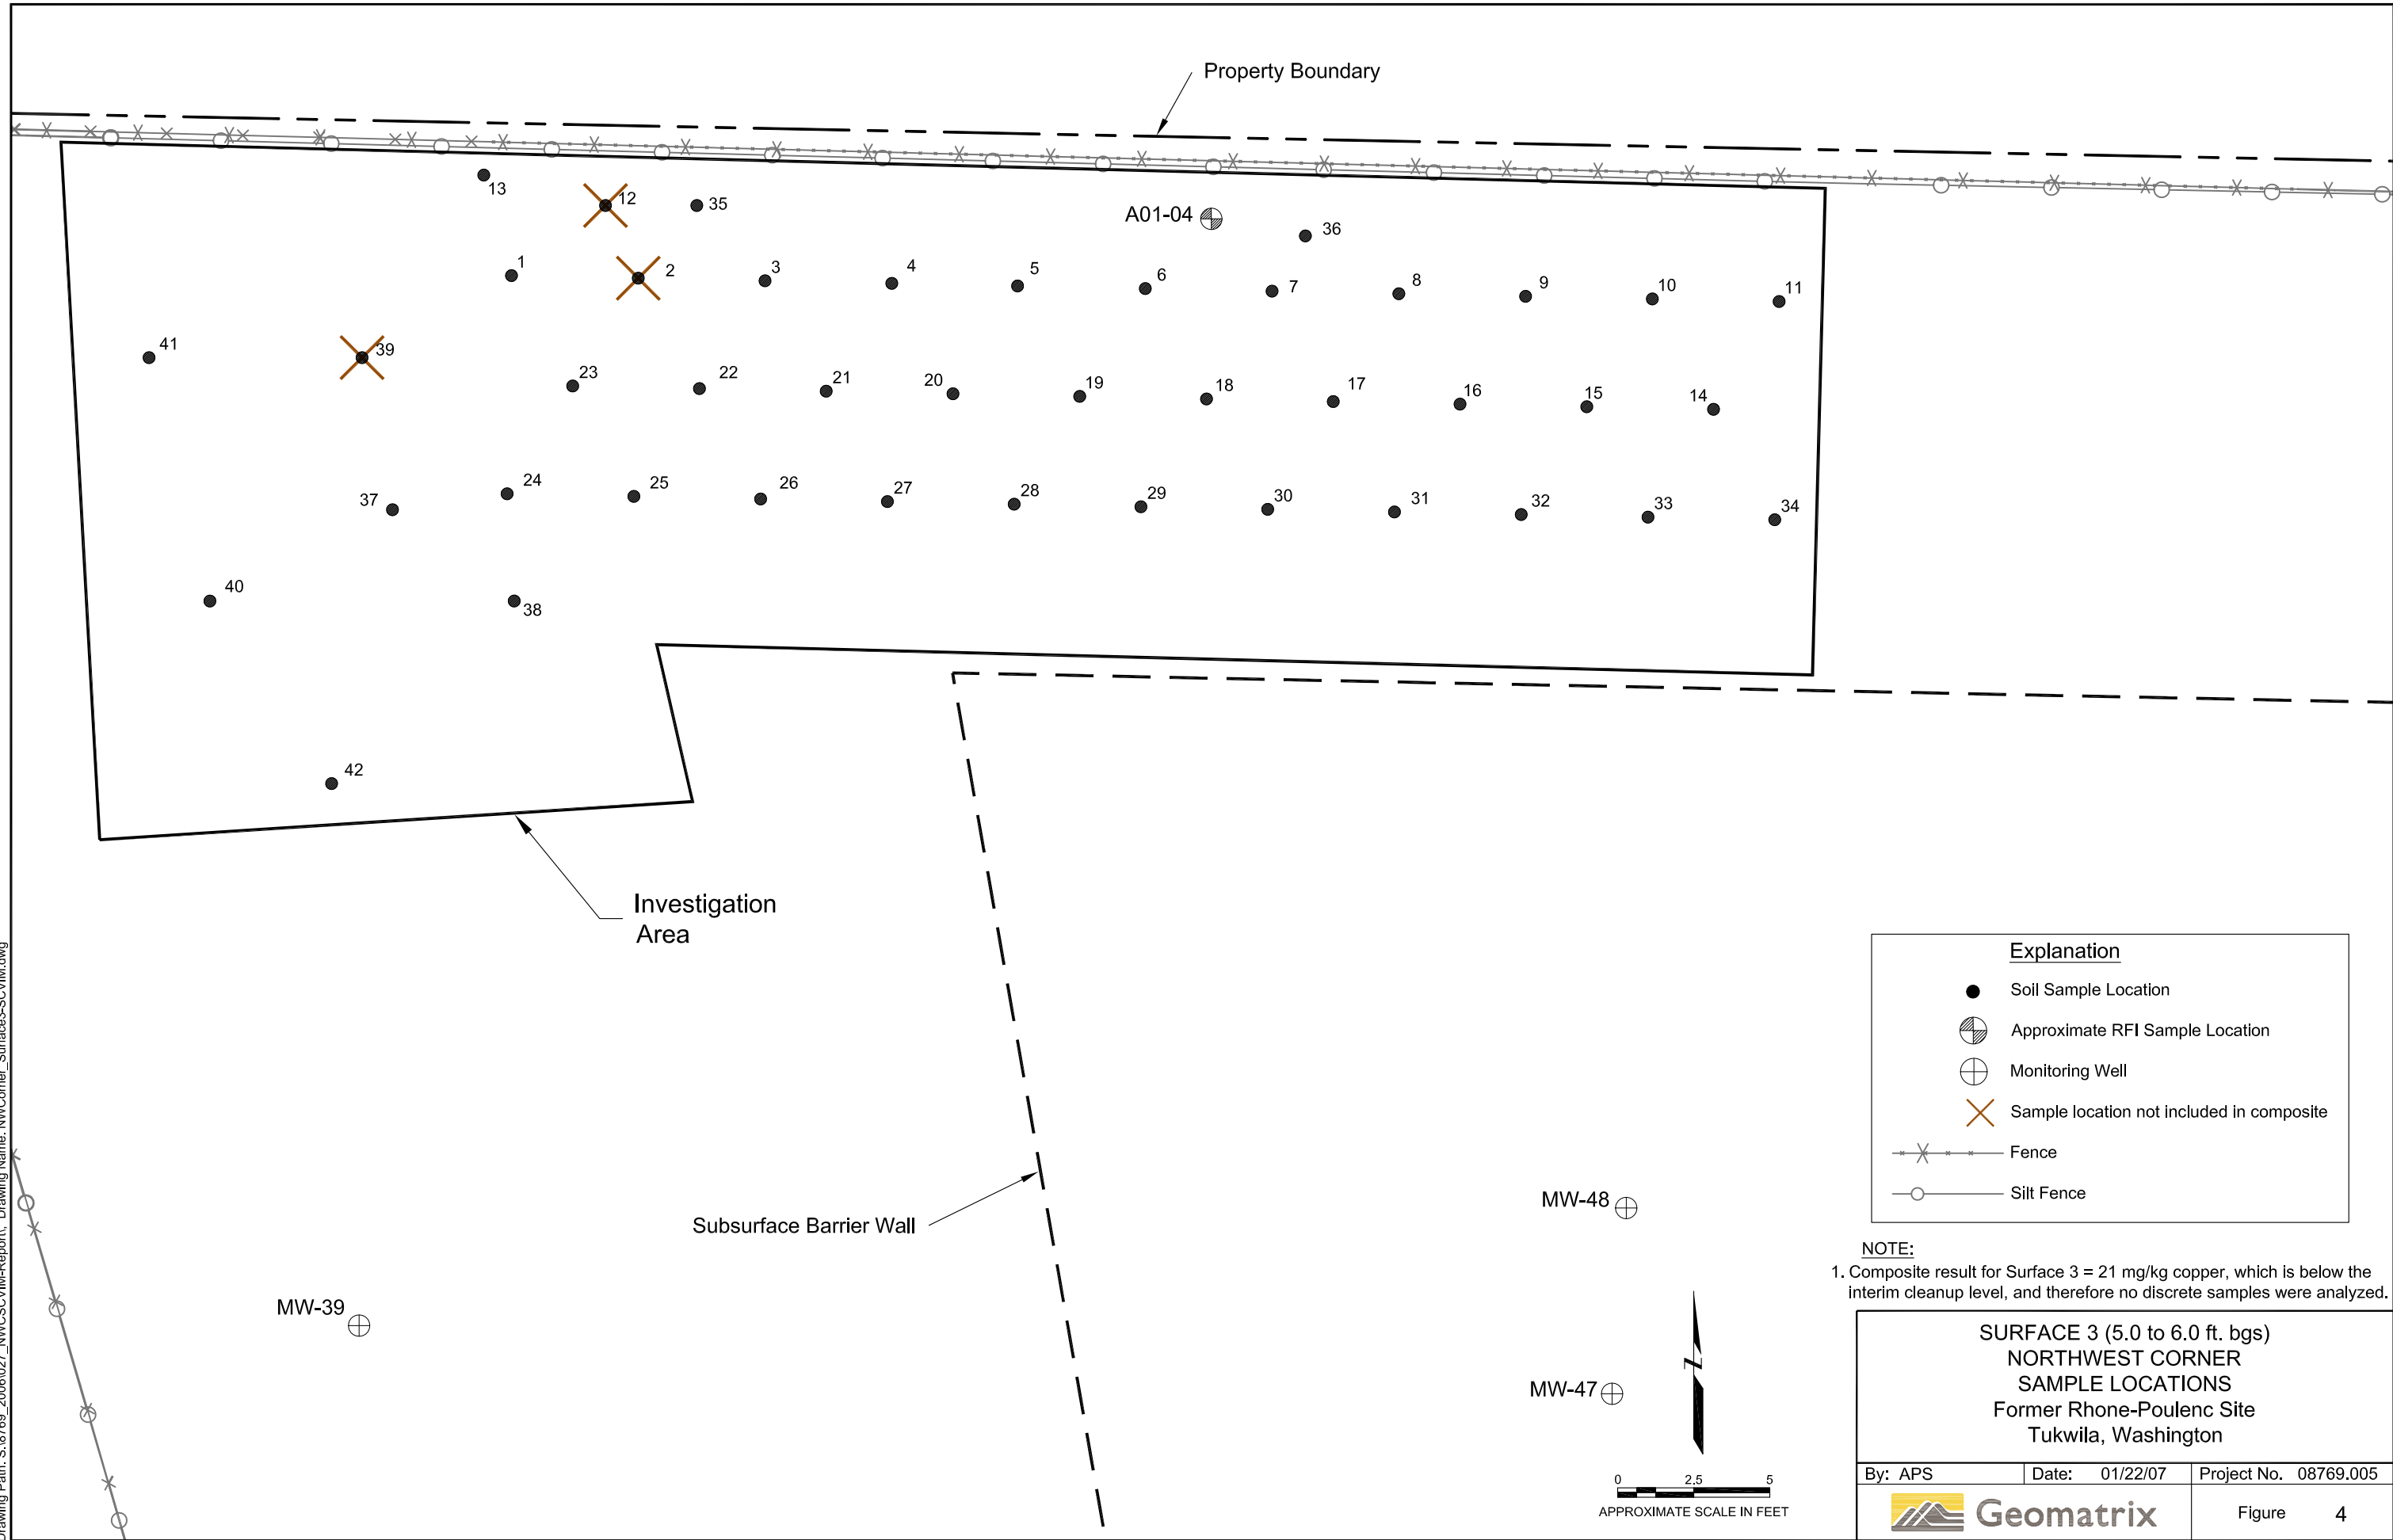
SURFACE 3 (5.0 to 6.0 ft. bgs) NORTHWEST CORNER SAMPLE LOCATIONS Former Rhone-Poulenc Site Tukwila, Washington		
By: APS	Date: 01/22/07	Project No. 08769.005
		Figure 4

NOTE:
 1. Composite result for Surface 3 = 21 mg/kg copper, which is below the interim cleanup level, and therefore no discrete samples were analyzed.

As noted previously, analytical results for the multi-incremental composite samples indicated that Surfaces 1 and 2 exceeded the interim cleanup level for copper. Surface 3, at a depth of 5 feet, was characterized as meeting the interim cleanup level for copper; therefore, it was determined that soil within the Northwest Corner investigation area required excavation to 5 feet bgs. The Surface 1 multi-incremental composite sample was substantially above the interim cleanup level while the Surface 2 multi-incremental composite sample was an order of magnitude lower in concentration. Thus, it was concluded that soil excavated to a depth of 2 feet (i.e., to Surface 2) required off-site landfill disposal; due to lower contaminant concentrations, soil excavated from a depth of 2 feet to 5 feet was determined to be acceptable for use as fill within the areas in the West Parcel with known contamination and that are enclosed by the subsurface barrier wall.

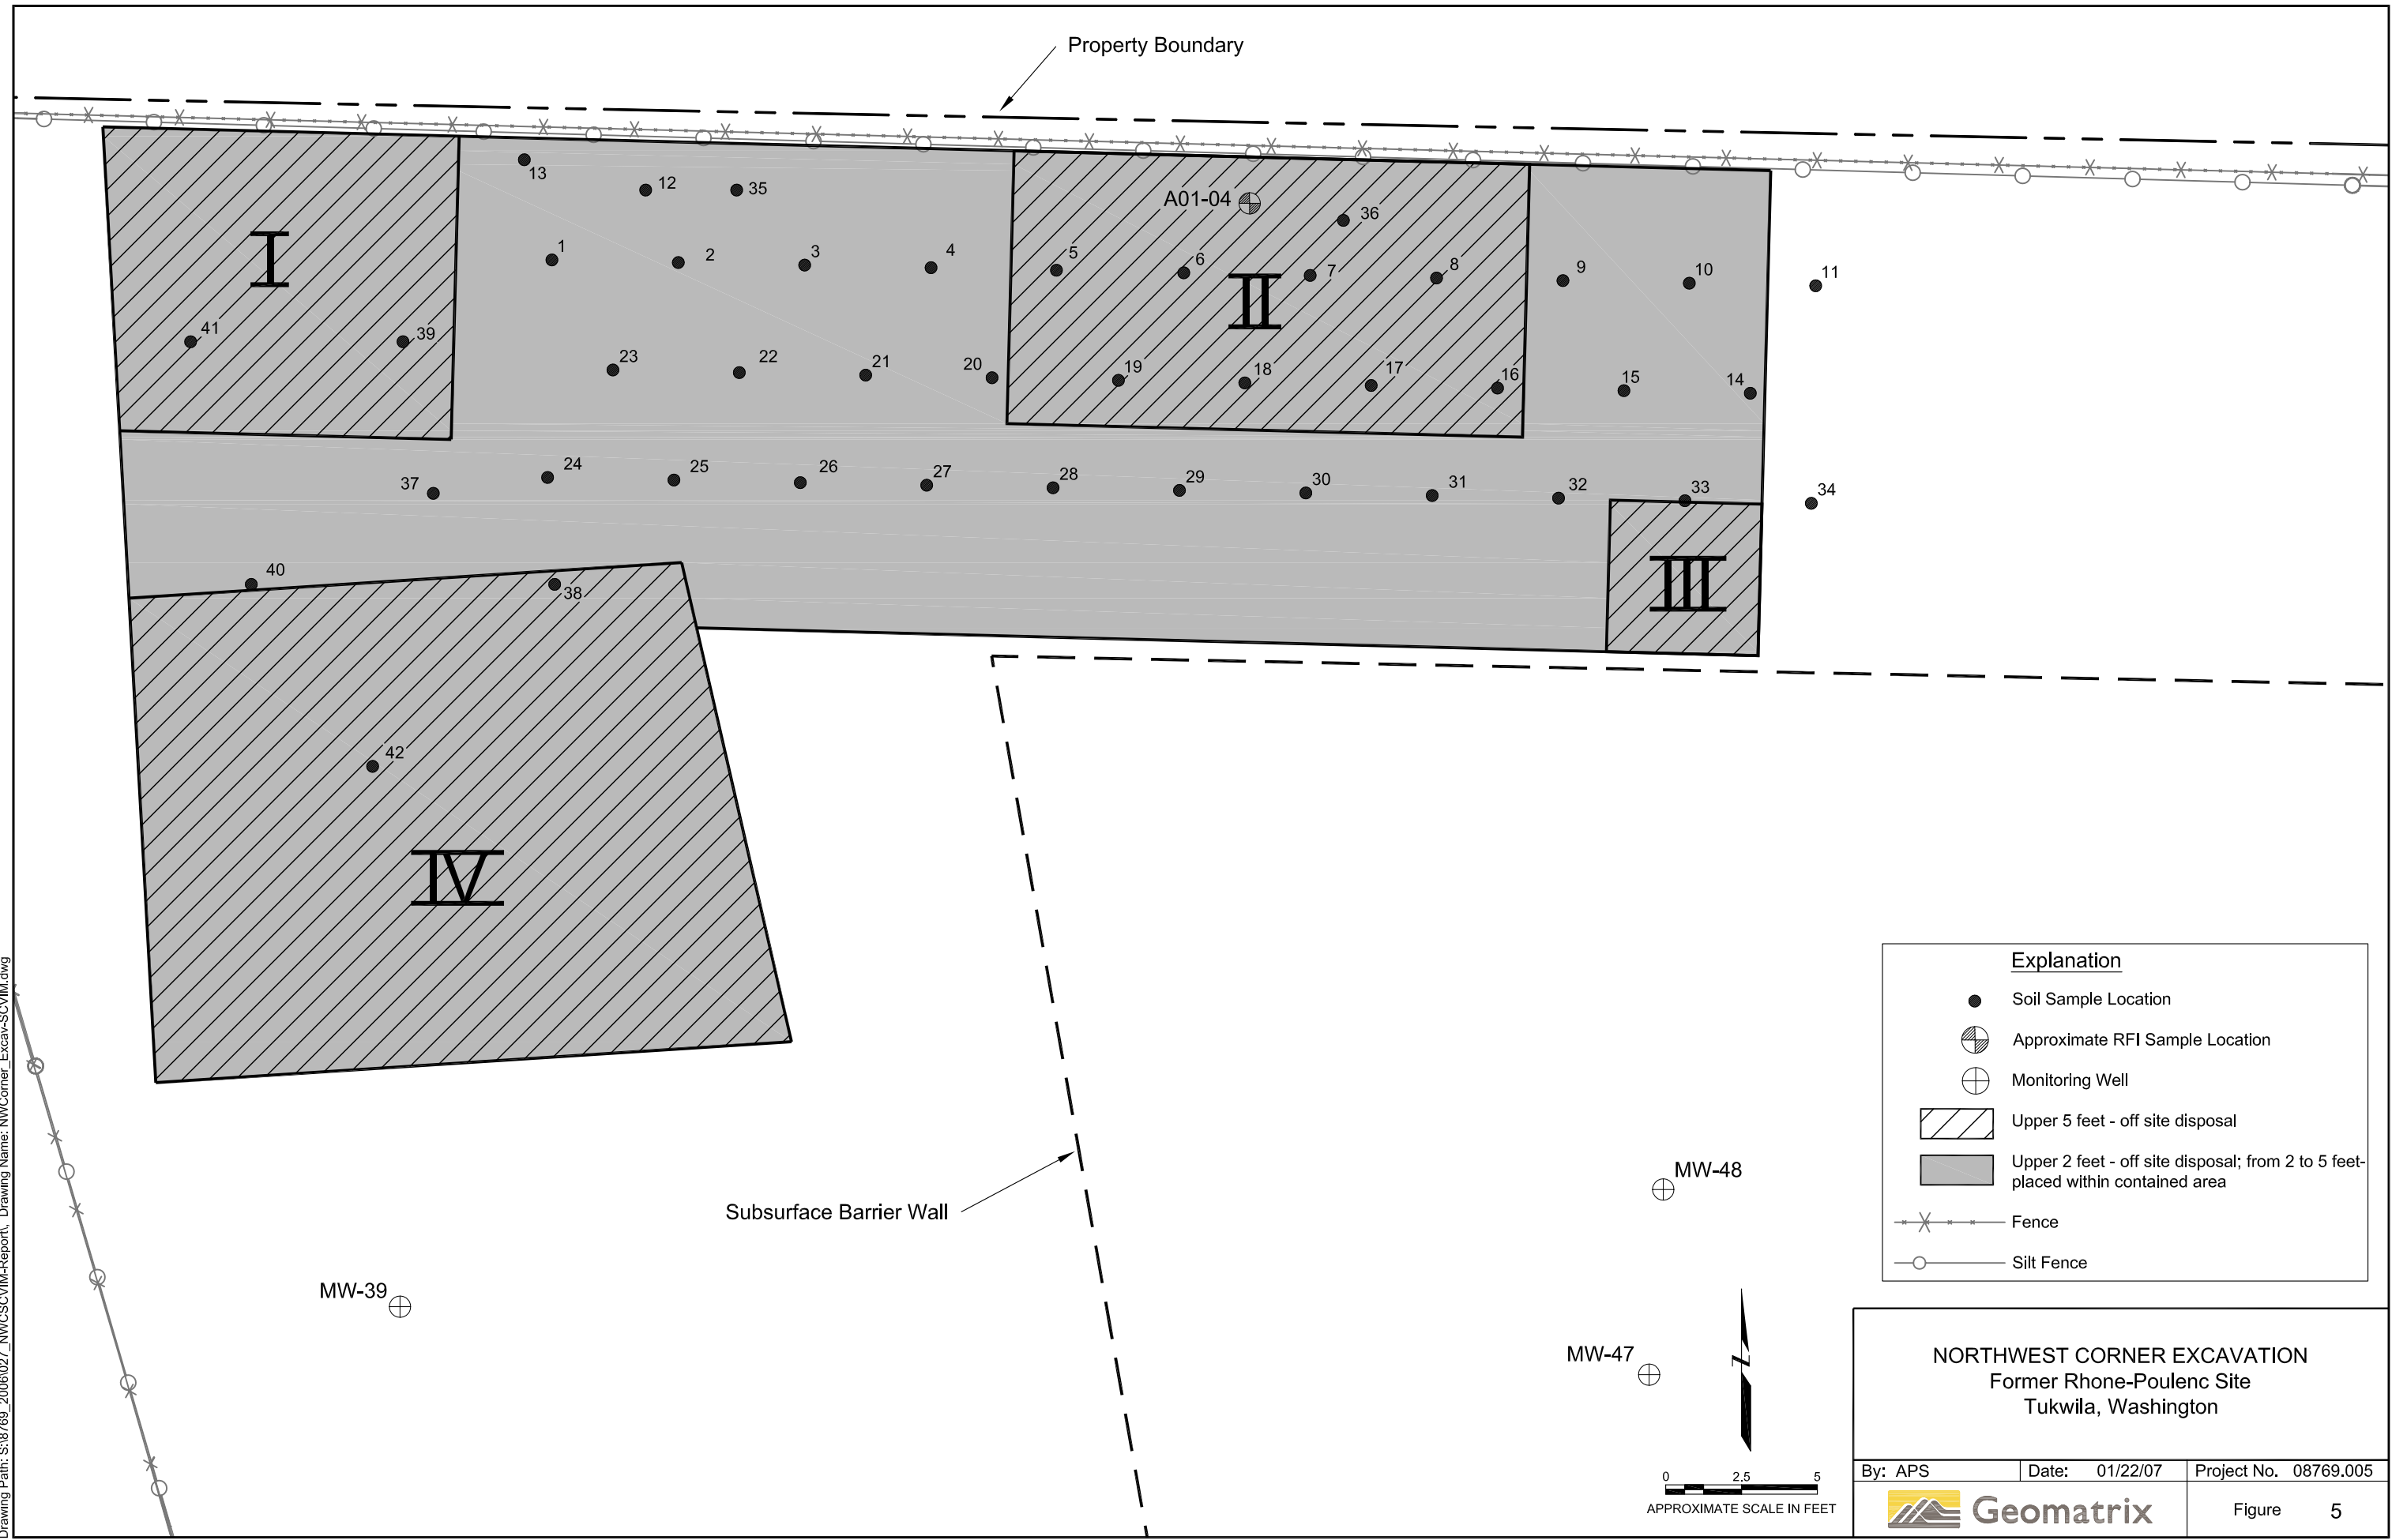
NORTHWEST CORNER EXCAVATION
 Former Rhone-Poulenc Site
 Tukwila, Washington

Explanation	
●	Soil Sample Location
⊕	Approximate RFI Sample Location
⊕	Monitoring Well
	Upper 5 feet - off site disposal
	Upper 2 feet - off site disposal; from 2 to 5 feet-placed within contained area
	Fence
	Silt Fence

Photographs of the excavation process are included as Appendix D. The extent of the excavation was constrained due to the barrier wall and well MW-39 to the south, the fence line and embankment to the west, and the property/fence line to the north. The lateral and vertical extent of the excavation was based on analytical data for copper and field observations of staining or odor. Known soil contamination in the upper 5 feet was excavated from the Northwest Corner. As noted by Figures 2 and 3, the full extent of soil affected by TPH to the west and south has not been determined. Field observations indicate that TPH-affected soil appears to remain to the north of the excavation, which extends to the north property line (Figure 5).
