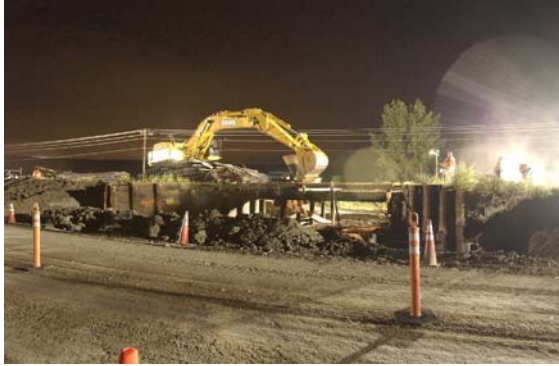
*At about 7:30 PM, Friday, demolition began. The old bridge was rapidly ripped apart and moved out of the way.*

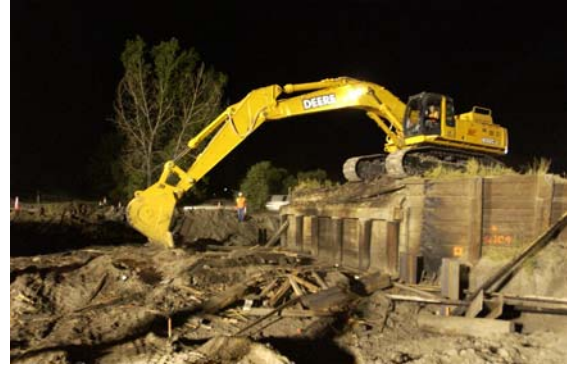
*Existing timber pile piers are broken off, abutments and wingwalls are torn out.*

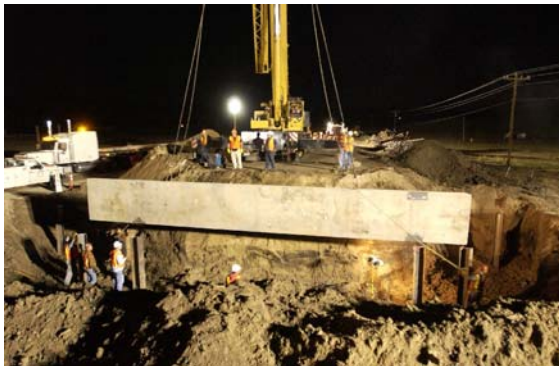
*The first precast member, the west "hide wall" is delivered shortly after midnight.*

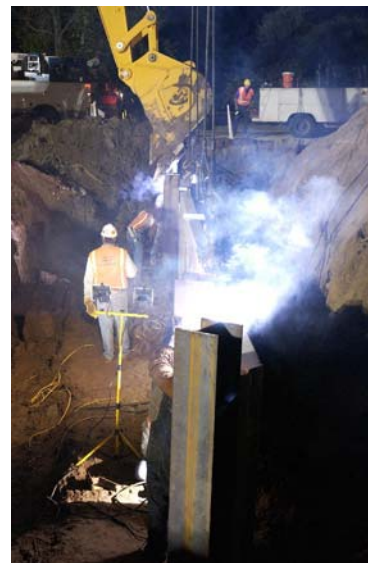
*The hidewall is welded to the previously driven piles.*

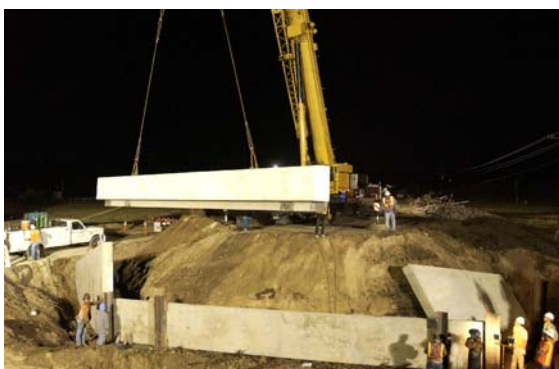
*The abutment cap is brought in to complete the abutment.*

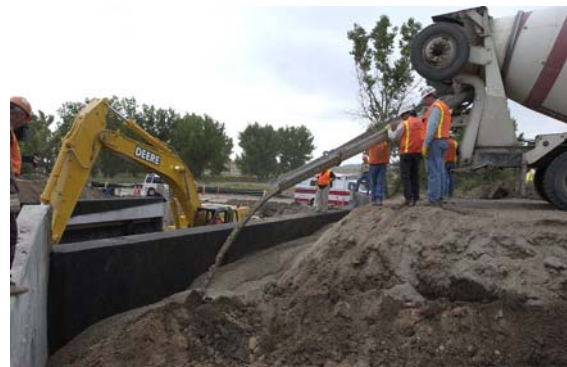
*After both abutments were placed, the backface was lined with geofabric and flowfilled.*

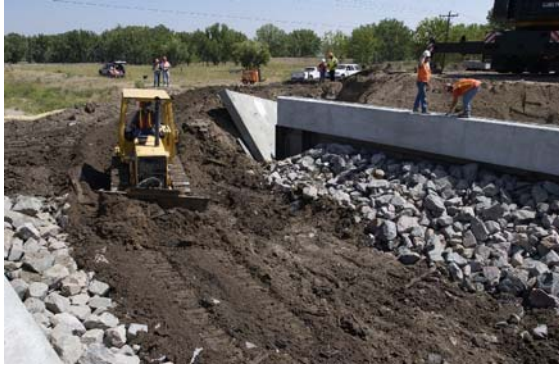
*Rip-rap was placed concurrently with the flowfill and partially buried*

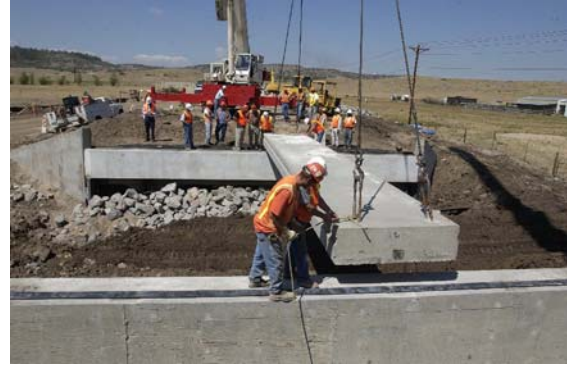
*The first girder was placed mid-morning.*

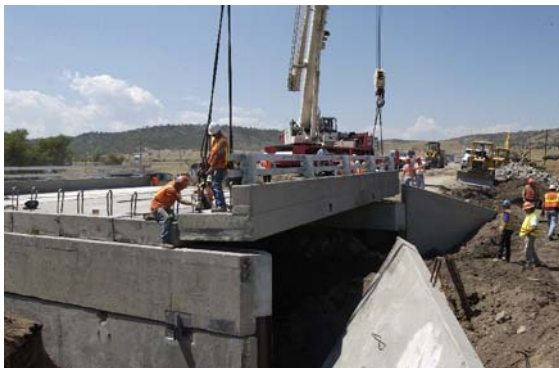
*The outside girders were precast with the curb in place and the bridge rail was attached beforehand.*

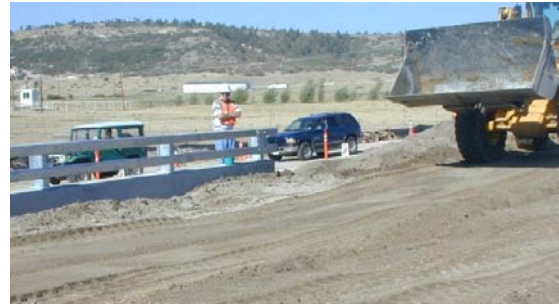
*After the girders were post-tensioned together, grouted, and welded to the abutment, aggregate base course (ABC) was placed and compacted.*

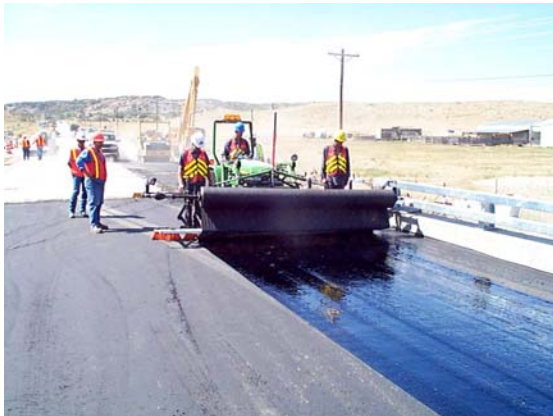
*The bottom layer of hot bituminous pavement (HBP) was placed on the ABC, followed by geotextile with a heavy tack coat for waterproofing and abutment reinforcement.*

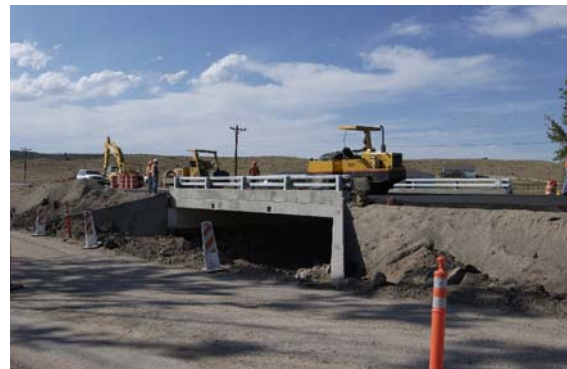
*Another lift of HBP was placed before opening the road to traffic Sunday at 5PM.*
