In: Proceedings of 4th International bridge engineering conference; 1995 August 28–30; San Francisco, CA. Washington, DC: National Academy Press: 381-394; 1995. Vol. 2.

Dynamic Response of Stress-Laminated-Deck Bridges

M. A. Ritter, Forest Service, U.S. Department of Agriculture
D. L. Wood, T. J. Wipf, and Chintaka Wijesooriya, Iowa State University
S. R. Duwadi, Federal Highway Administration

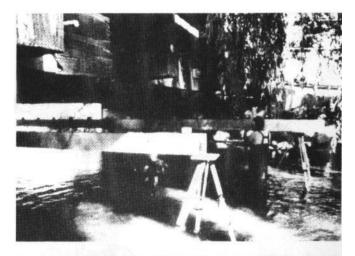
FIGURE 3 Layout of instrumentation for displacement transducer data.

surveying tripods supporting a board 50.8 x 304.8 mm (2 x 12 in.) was used to support the displacement transducers (Figure 3). Data were collected using a Hewlett-Packard (HP) 3852A data acquisition/control system (DAS) equipped with two HP 44711 24-channel FET multiplexers and an HP 44702 14-bit high-speed voltmeter. The DAS was controlled and the data were processed and stored in a portable 486DX-33 PC running IBASIC for Windows. Figure 4 (top) is a schematic of the test components, and Figure 4 (bottom) is a photograph of the DAS setup in the field. The entire system was powered by a portable generator and triggered when the vehicle crossed the tap switch at the bridge entrance.

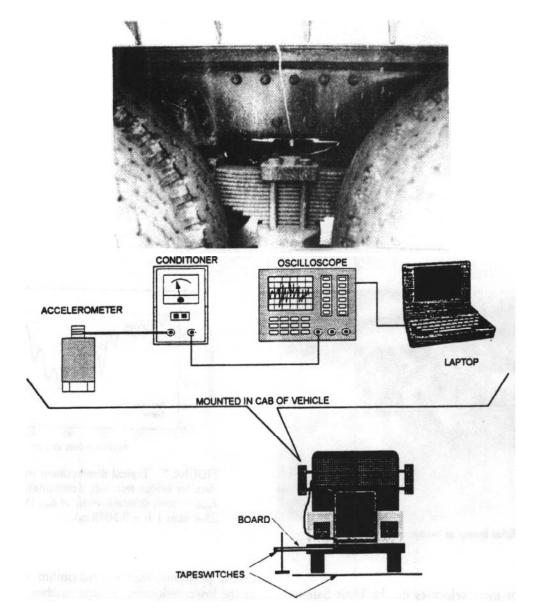
FIGURE 5 Vehicle data acquisition system: top, accelerometer mounted on frame; bottom, schematic of layout.

Acceleration data were also collected on the vehicle simultaneously with the bridge displacement transducer data. The setup consisted of a Gould digital storage oscilloscope (DSO) and two PCB accelerometers. The accelerometers were high-sensitivity integrated-circuit piezoelectrics with a quartz trishear design. The accelerometers were mounted on the vehicle frame over the front and rear axles (Figure 5). They were wired

A tape switch that was mounted to the front bumper of the vehicle was used to trigger the DSO. A board 50.8 x 304.8 mm (2 X 4 in.) was attached parallel to the bumper to extend the tape switch approximately 0.61 m (2 ft) to the side of the truck to hit a vertical rod placed on the roadway that would trigger the DSO. The rod was positioned so that the DSO was triggered simultaneously with the DAS. This allowed data from both files to be combined to analyze the interaction responses between the vehicle and bridge. A schematic of the vehicle DAS layout, which was located in the passenger cab of the vehicle, is shown in Figure 5 (bottom).

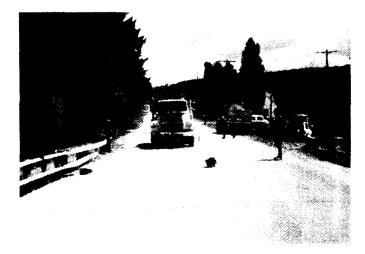
FIGURE 6 Artificial bump at bridge entrance.

bridge. The artificial rough approach condition was simulated using a board 50.8 x 304.8 mm (2 x 4 in.) placed at the bridge entrance (Figure 6).

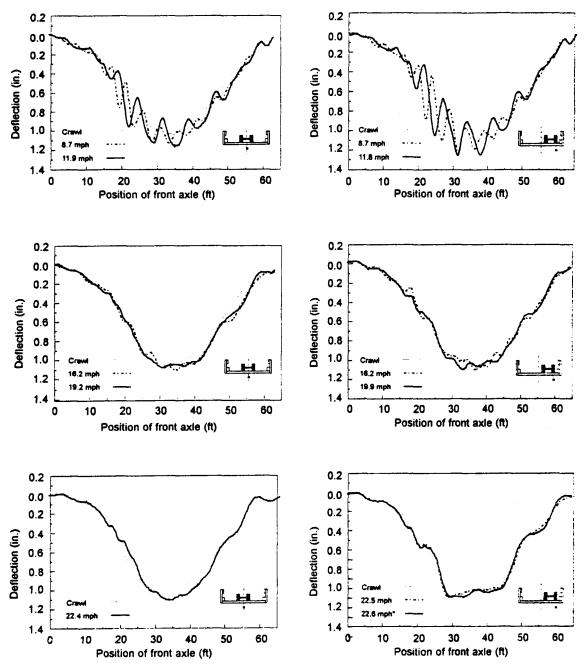
FIGURE 8 Dynamic response for Trout Road Bridge (1 in. = 25.4 mm; 1 ft = 0.3048 m).

Plots of bridge deflection and vehicle position (using the front axle as the reference point) for various speeds and both in situ and artificial rough approaches are shown in Figures 8 through 10 for each bridge. The legends

indicate transverse axle positions (eccentric or concentric), location of the displacement transducer data used for the plot, vehicle velocity, and in situ or artificial rough approach, denoted by (b) for bump along with the vehicle velocity. The Trout Road bridge, as previously mentioned, had an inherently rough approach as a result of ruts in the asphalt surface immediately in front of the bridge approach; therefore, these data should be assumed to be similar to a rough approach condition even though the data are presented as in situ.

To clearly quantify the dynamic behavior shown in the plots, the DAFs were calculated for each test for the three bridges and are shown in Figure 11. The maximum DAF for the Trout Road Bridge was 1.20 and occurred for an eccentric load position. As shown, the trend in DAF was similar for both concentric and ec-

centric positions, with the maximum values occurring at the lower velocities. Bridge roadway horizontal geometry did not allow tests to be performed at speeds in excess of 40.3 km/hr (25 mph).
