EVACUATION TESTS FROM AN SST MOCK-UP

J. D. Garner
and
John G. Blethrow

December 1970

Department of Transportation
FEDERAL AVIATION ADMINISTRATION
Office of Aviation Medicine

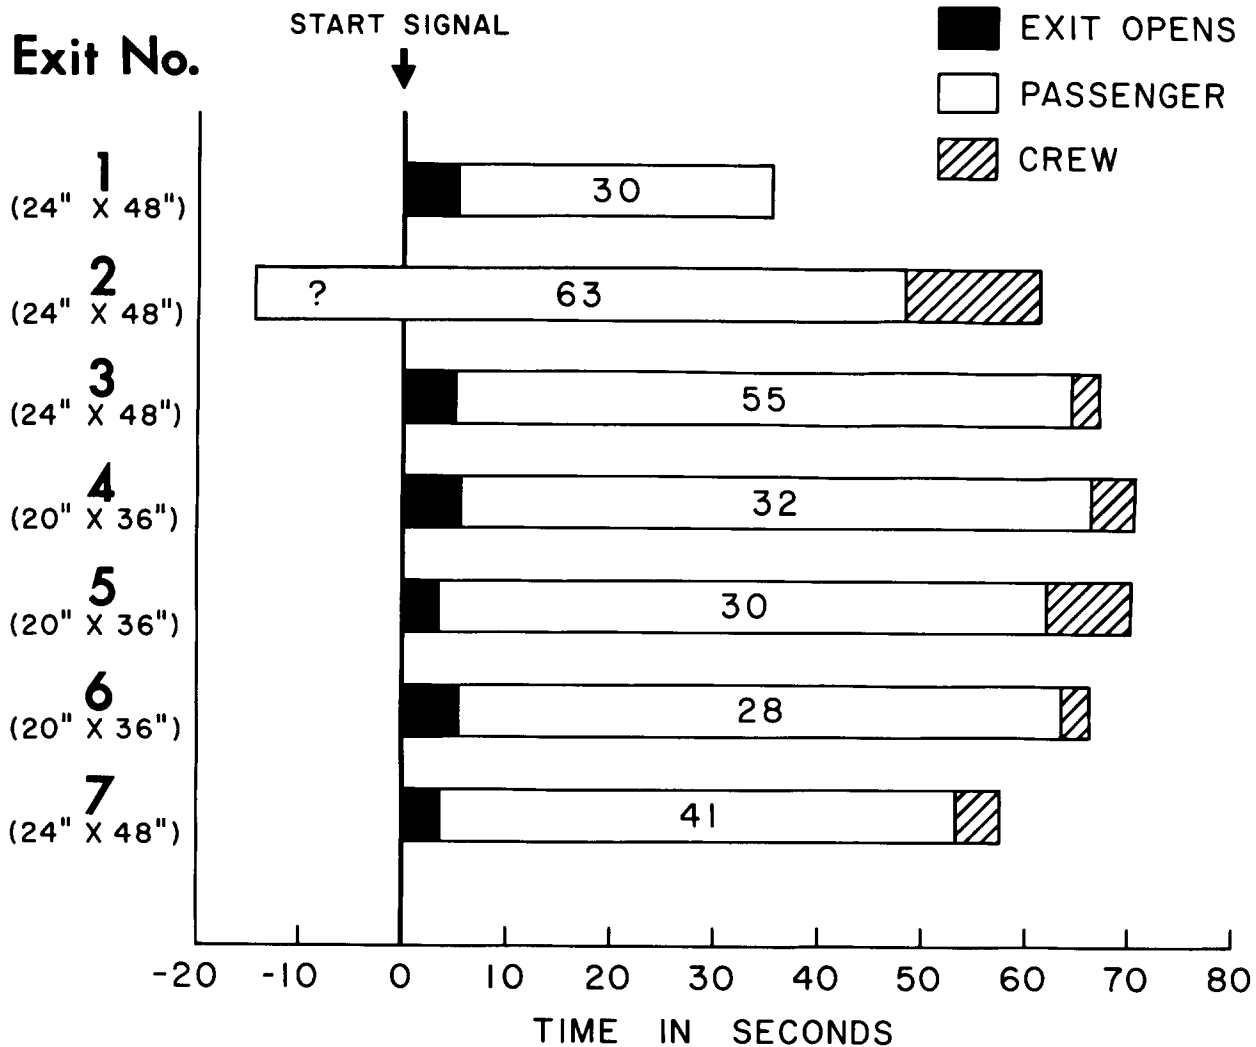
TEST 1 ESCAPE TIMES

FIGURE 3. Escape times for Test 1 are shown for all seven exits. Number of passengers (excluding crew members) using each exit. Also shown—15 passengers evacuating during the crash sounds at Exit 2 within a 14-second time period before the start signal.

Evacuation Times. All passengers and crew members evacuated the fuselage through the seven exits on the right side in 70.7 seconds, the last person, a stewardess, leaving at Exit 4. The last passenger was out in 66.6 seconds. Evacuation times for each exit are shown in Figure 3.

Exit-opening times (Figure 3) determined from the start signal until the exit was perceptibly "cracked open", averaged 4.5 seconds, with a range of 3.2-5.0 seconds, for six of the seven exits (excluding Exit 2, prematurely opened). These exit-opening times are about 60% less than the average of 11-14 seconds found in an analysis of airline evacuation demonstrations performed for certification of various aircraft.

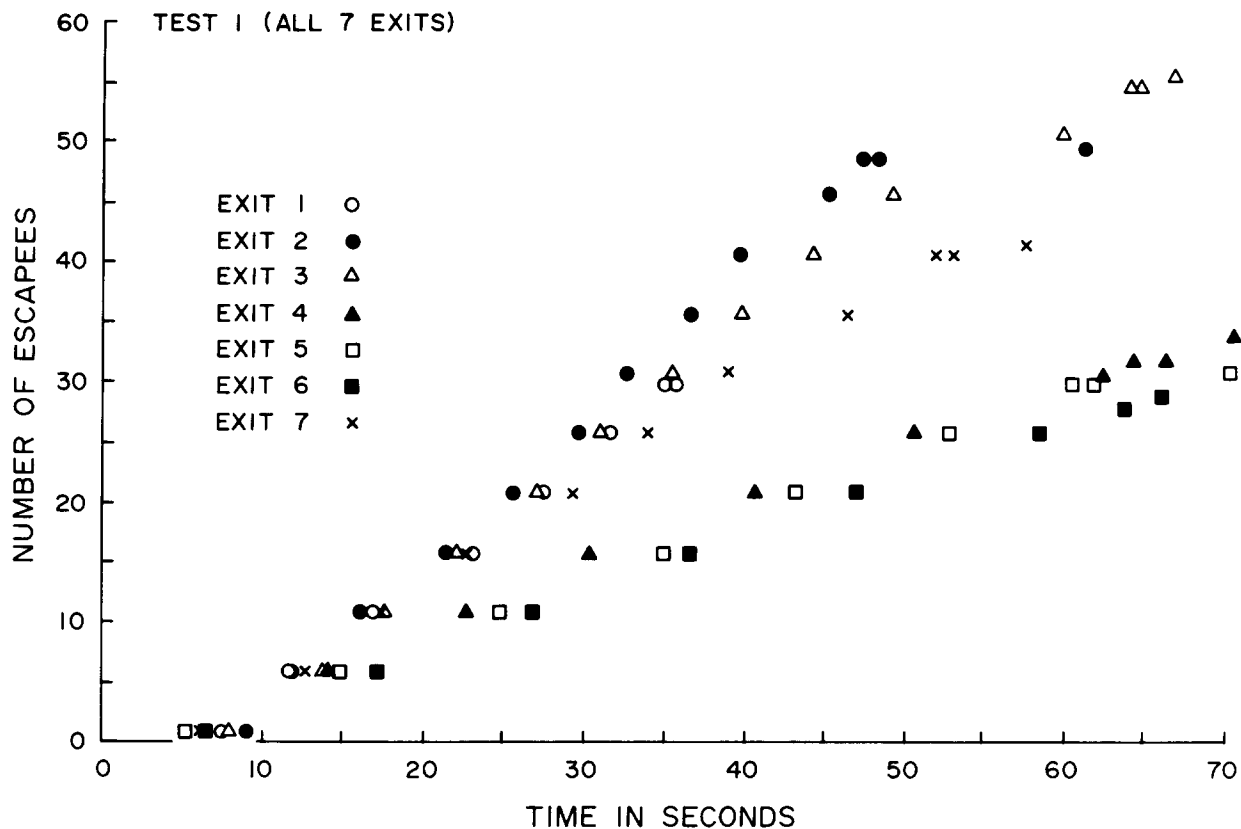
FIGURE 5. A plot of the number of escapees and time shows relationship of the seven exits in Test 1. Exits 4, 5 and 6 are window, overwing, exits with a 27-inch step-down to the wing surface which is evident by the rate of escapees for these Type III exits compared to the four Type I exits.

Figure 5, an escapee-time plot of all seven exits, shows that the three window exits (Exits

4, 5 and 6) had slower flow rates. Among the four Type I exits, Exit 2 maintained the highest flow rate, with Exit 7 lagging slightly behind Exits 1 and 3. A further analysis of Test 1 flow rates (Table III) documents the evacuation times for three different time segments for the evacuation. Also, groups of 20 consecutive evacuees were timed during the evacuation at each exit to determine variations in flow rates as the evacuation progressed (Table IV).

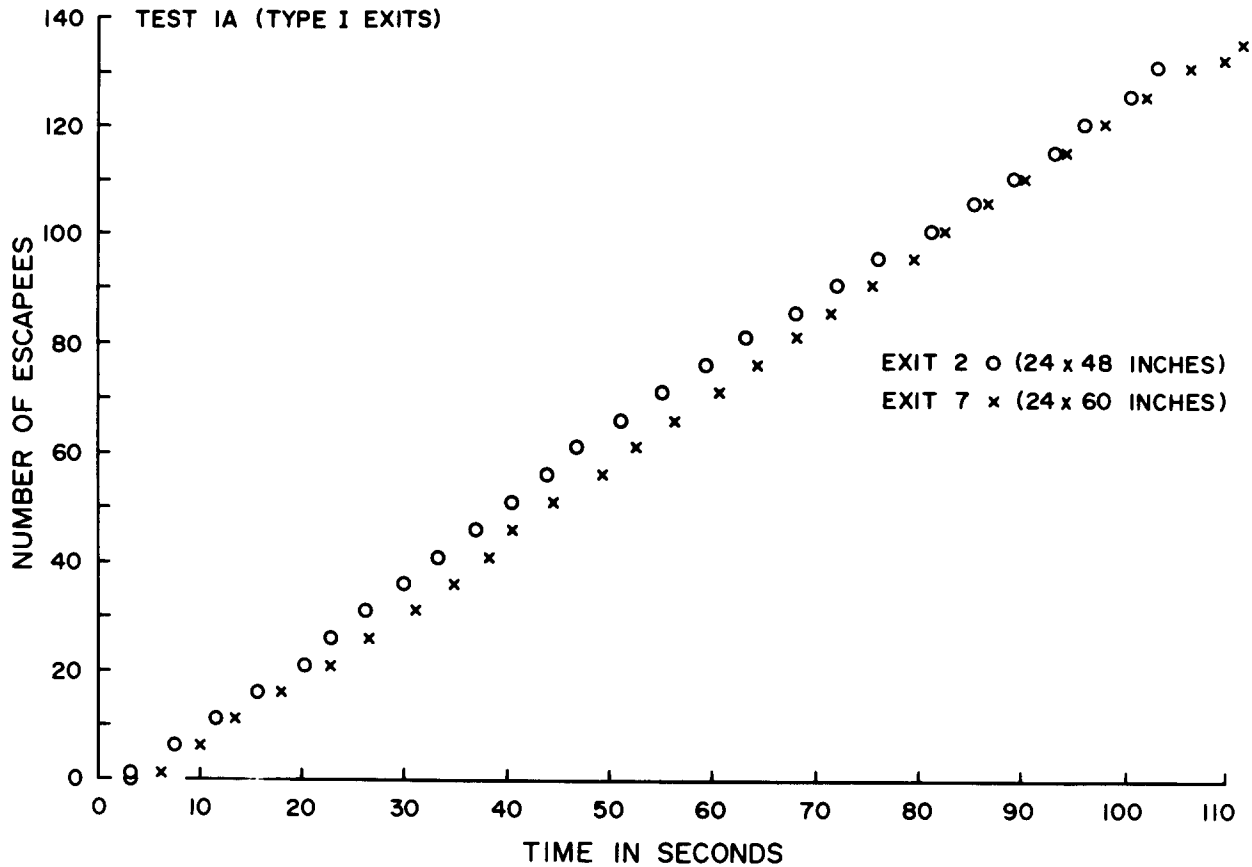
FIGURE 8. The escapee-time plot of Test 1A through Exits 2 and 7 shows very little difference in evacuation flow rates. The 12-inch difference in exit height was under evaluation in this test.

“C” stewardess directed 20 passengers to the rear exit who had initially started toward Exit 2 from the center area of the cabin. The escape-time plot in Figure 8 shows similar rates for the two exits. Table V gives the variations in flow rates of groups of 20 passengers at intervals throughout the evacuation. Table VI lists the overall evacuation flow rates tabulated from the three points in the evacuation.

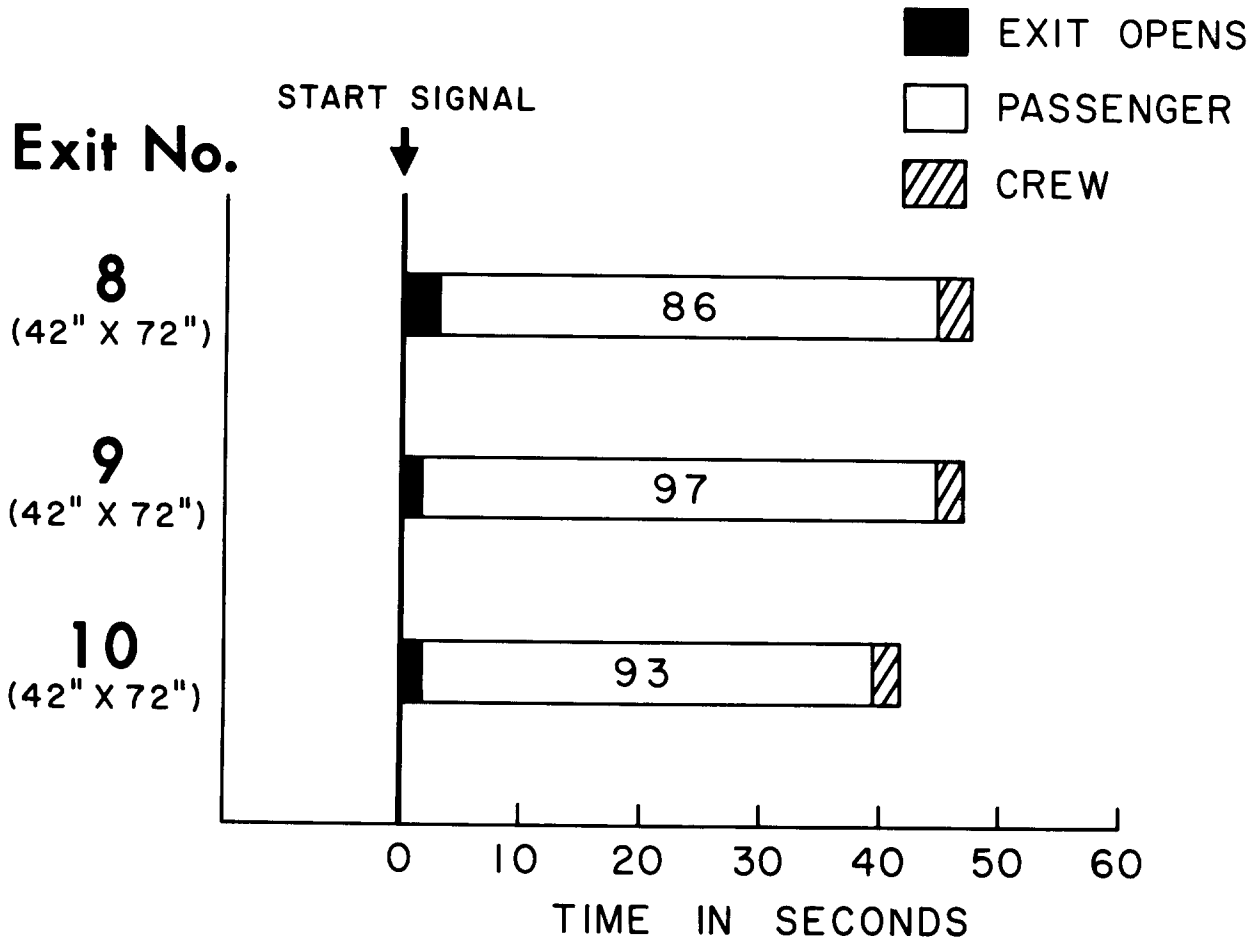
TEST 2 ESCAPE TIMES

FIGURE 9. The comparative total evacuation times with numbers of passengers through each Type A double-door exit.

evacuation times for Exits 8, 9 and 10 were 47.4, 46.9 and 41.3 seconds. The last passengers (excluding crew) cleared each exit at 44.4, 44.6 and 40.1 seconds, respectively (Figure 9).

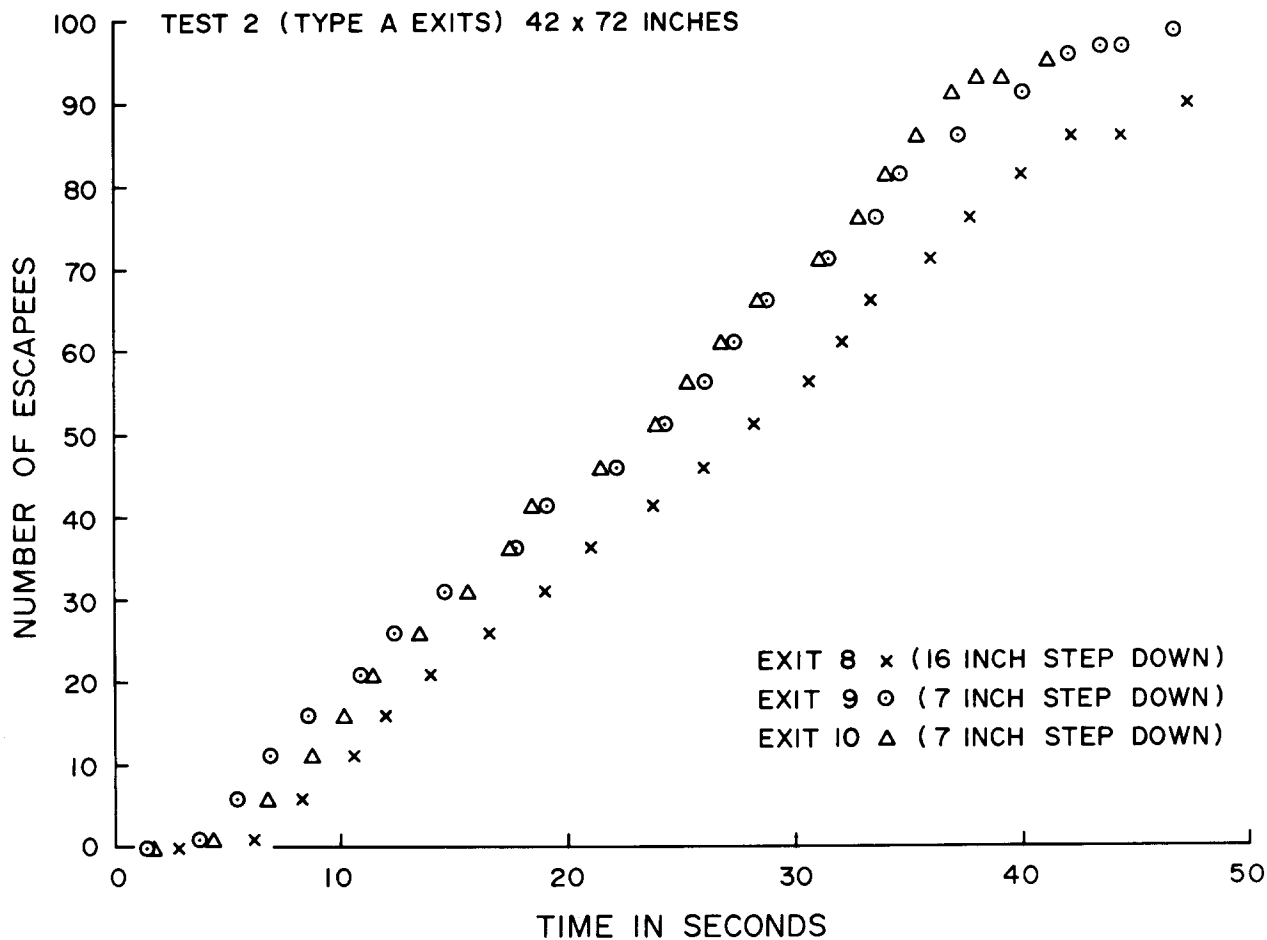
FIGURE 10. The number of escapee-time plot of Test 2 through three Type A door exits shows comparative efficiencies. The lag in evacuation rate of Exit 8 is apparently due to the highest step-down distance (16 inches) of the three exits and a slight passageway restriction by the forward stewardesses.

Flow Patterns. Under the conditions of the test, without escape chutes and in an ideal environment, the flow rates were 113.9, 126.7 and 138 passengers per minute (Table VII). The escapee-time chart (Figure 10) shows Exits 9 and 10 to have similar rates, each with a 7-inch step-down onto the wing surface. Exit 8, with a 16-inch step-down, had a slower flow rate, with approximately 14 fewer passengers evacuating per minute throughout the evacuation. Table VIII depicts variations in flow rate by timing groups of 20 passengers during the evacuation.

Passengers at Exit 9, with only one stewardess at the double door, evacuated at a rate comparable to that at the other two Type A doors (Figure 10). However, an evacuation from a normal landing emergency with escape chutes in use was not conducted. Conclusions on the effectiveness of just one cabin attendant at a double-door in this condition would require further testing.

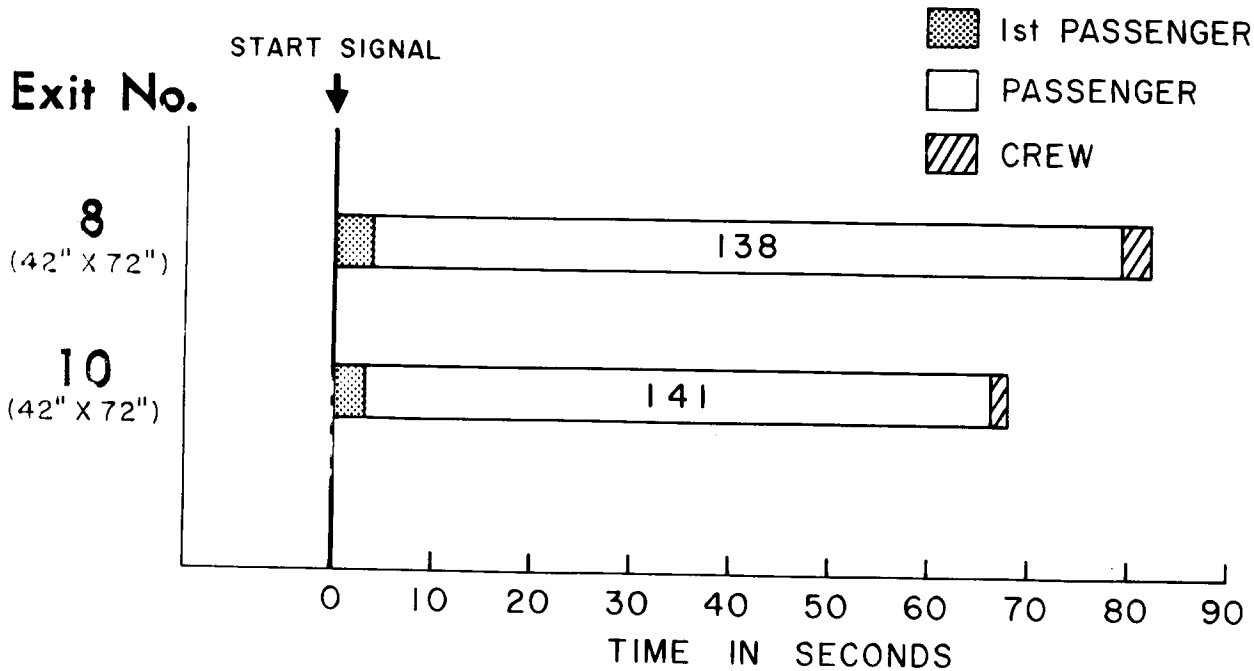
TEST 2A ESCAPE TIMES

FIGURE 12. Total evacuation times of Test 2A are shown with numbers of passengers using each exit. Exit 8 had a 16-inch step-down; Exit 10 had a 7-inch step-down distance. The door plugs were left out for this test and time was taken when the first passenger appeared in the doorway from the start signal.

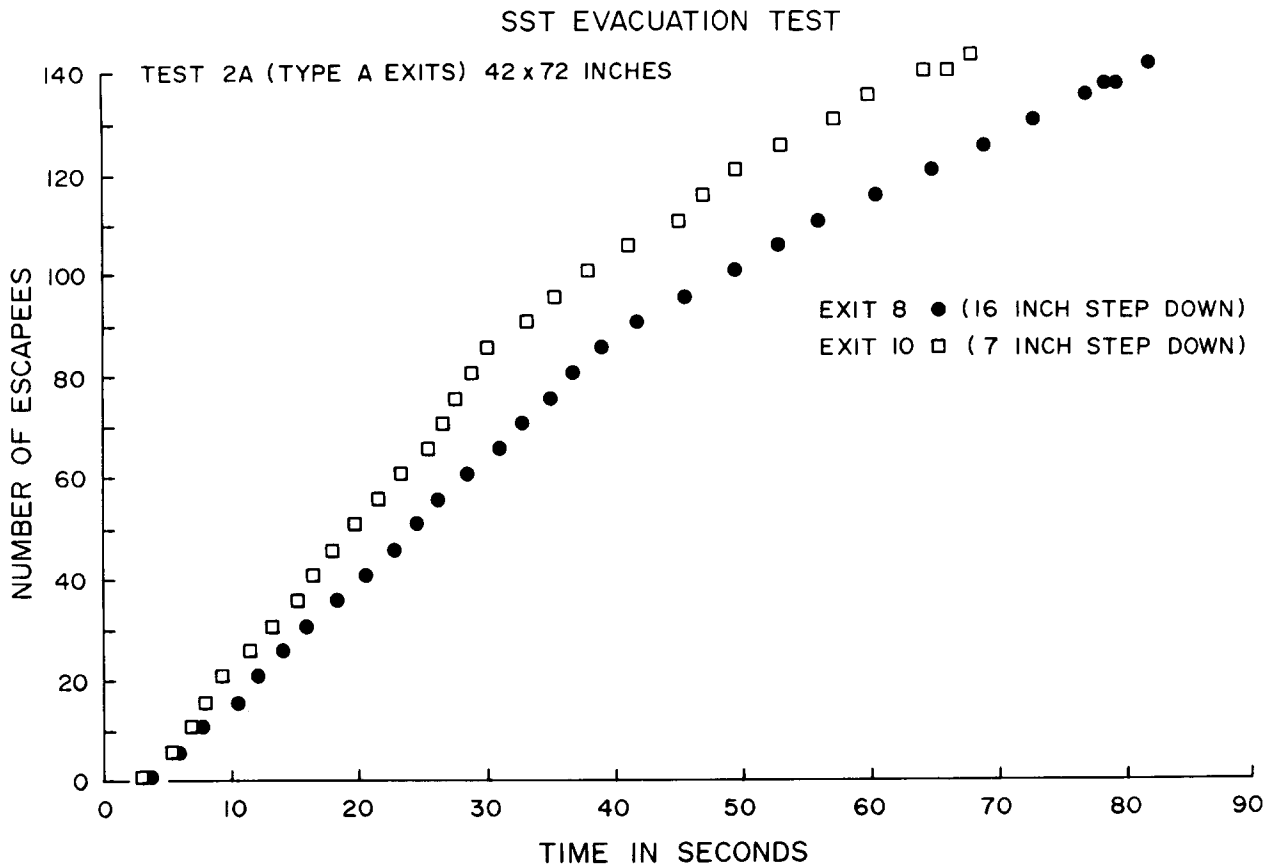
FIGURE 13. The escapee-time plot on Test 2A shows effects of the 16-inch step-down at Exit 8 and where the exits began to be fed with evacuees from only one aisle at approximately the halfway point during the evacuation.

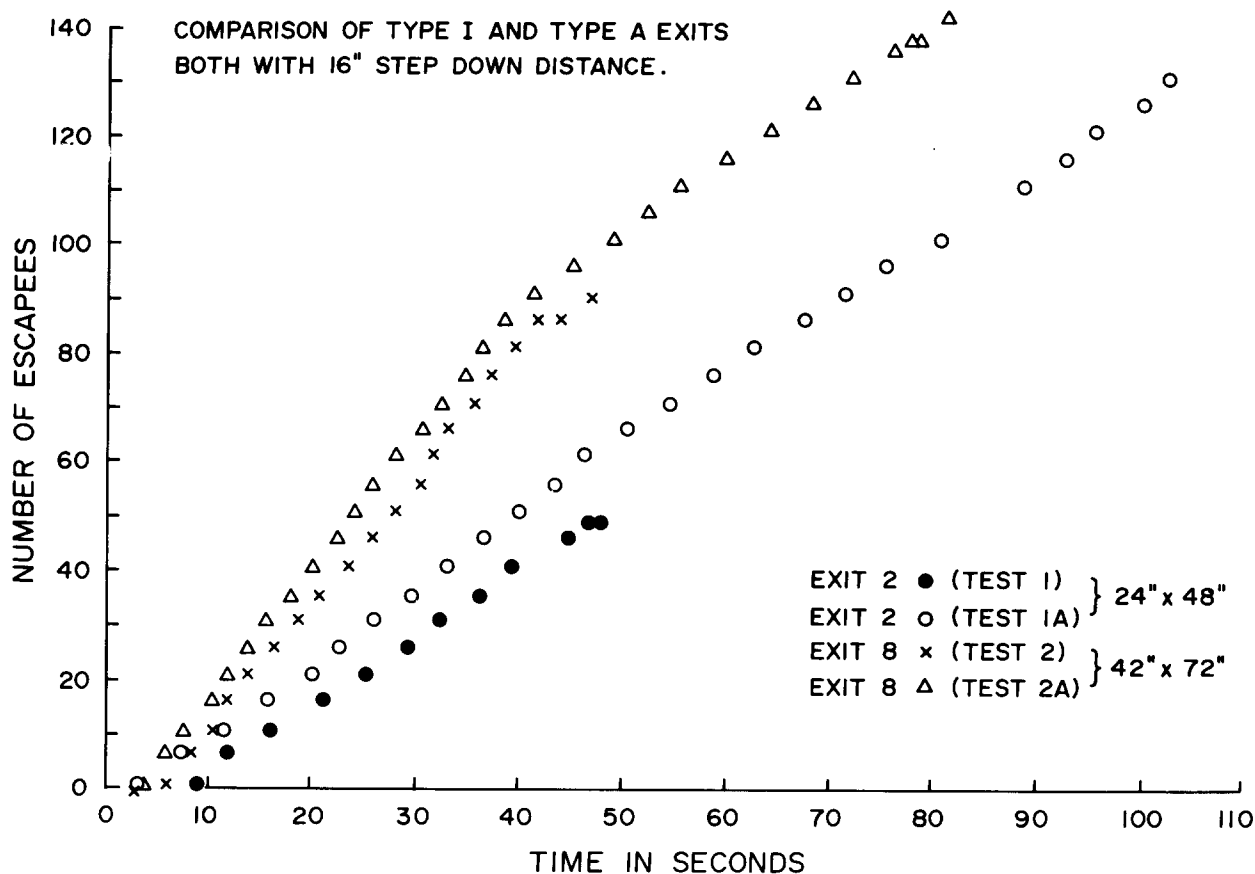
FIGURE 15. A Type I (Exit 2) and a Type A (Exit 8) door from all four tests are plotted together for direct comparison of flow rates during evacuations. Step-down distance was 16 inches.
