**REPRODUCTIVE SUCCESS OF OSPREY
(PANDION HALIAETUS) NESTING IN THE
VICINITY OF THE CHALK POINT OIL SPILL**

**Final Report
November, 2001**

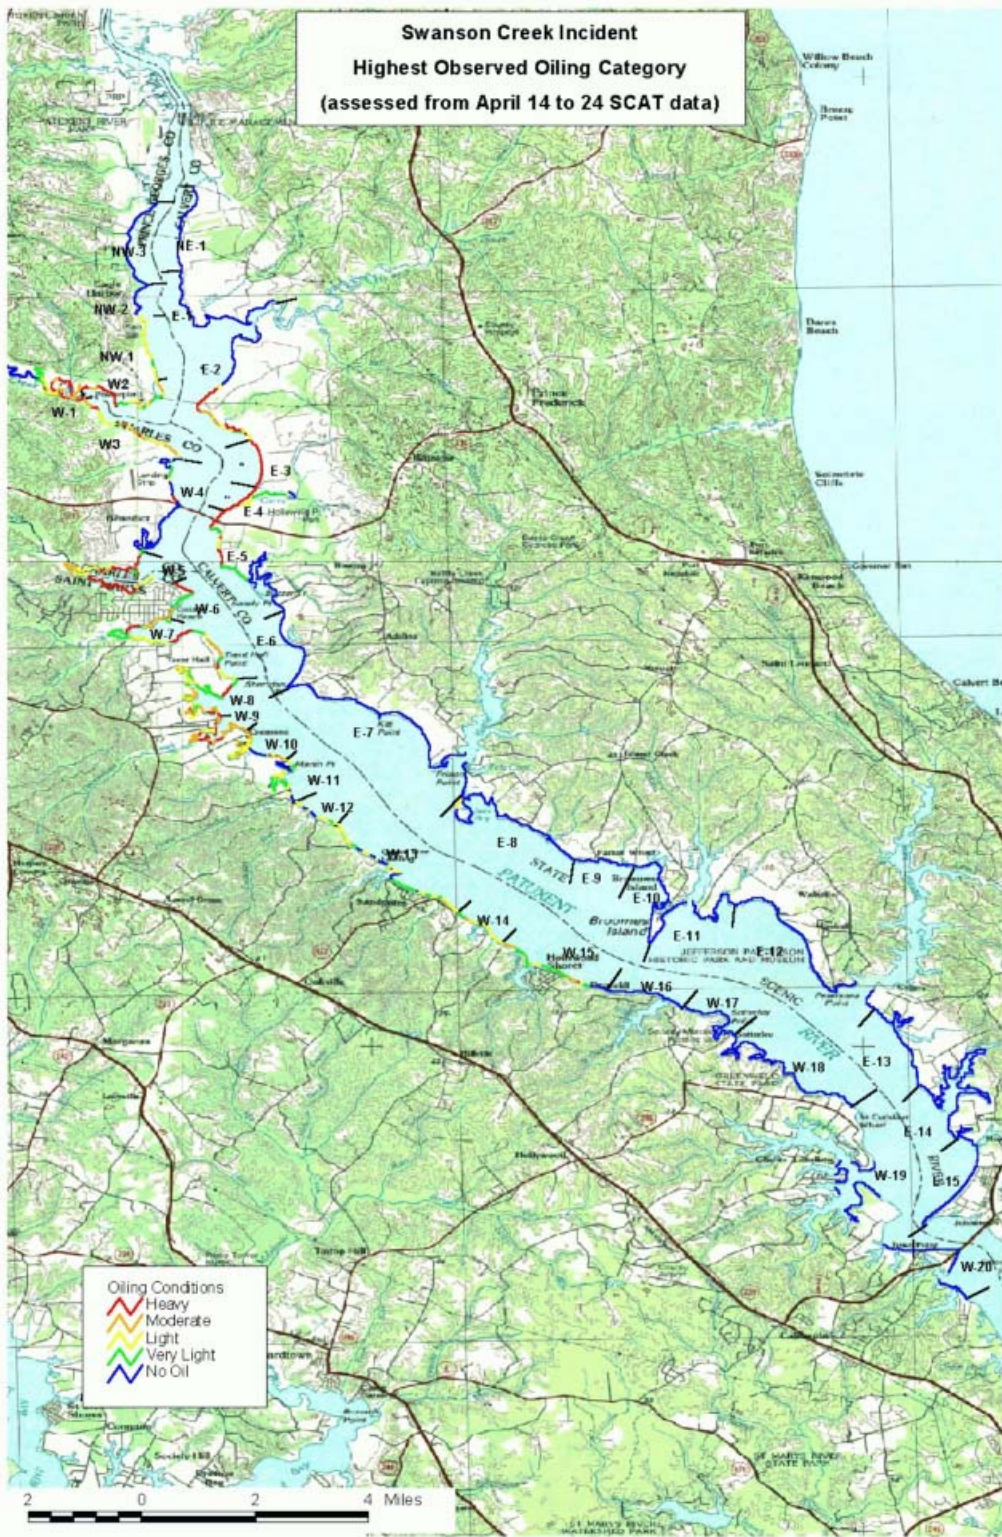
Figure 1. Extent of shoreline oiling resulting from the Chalk Point Oil spill.

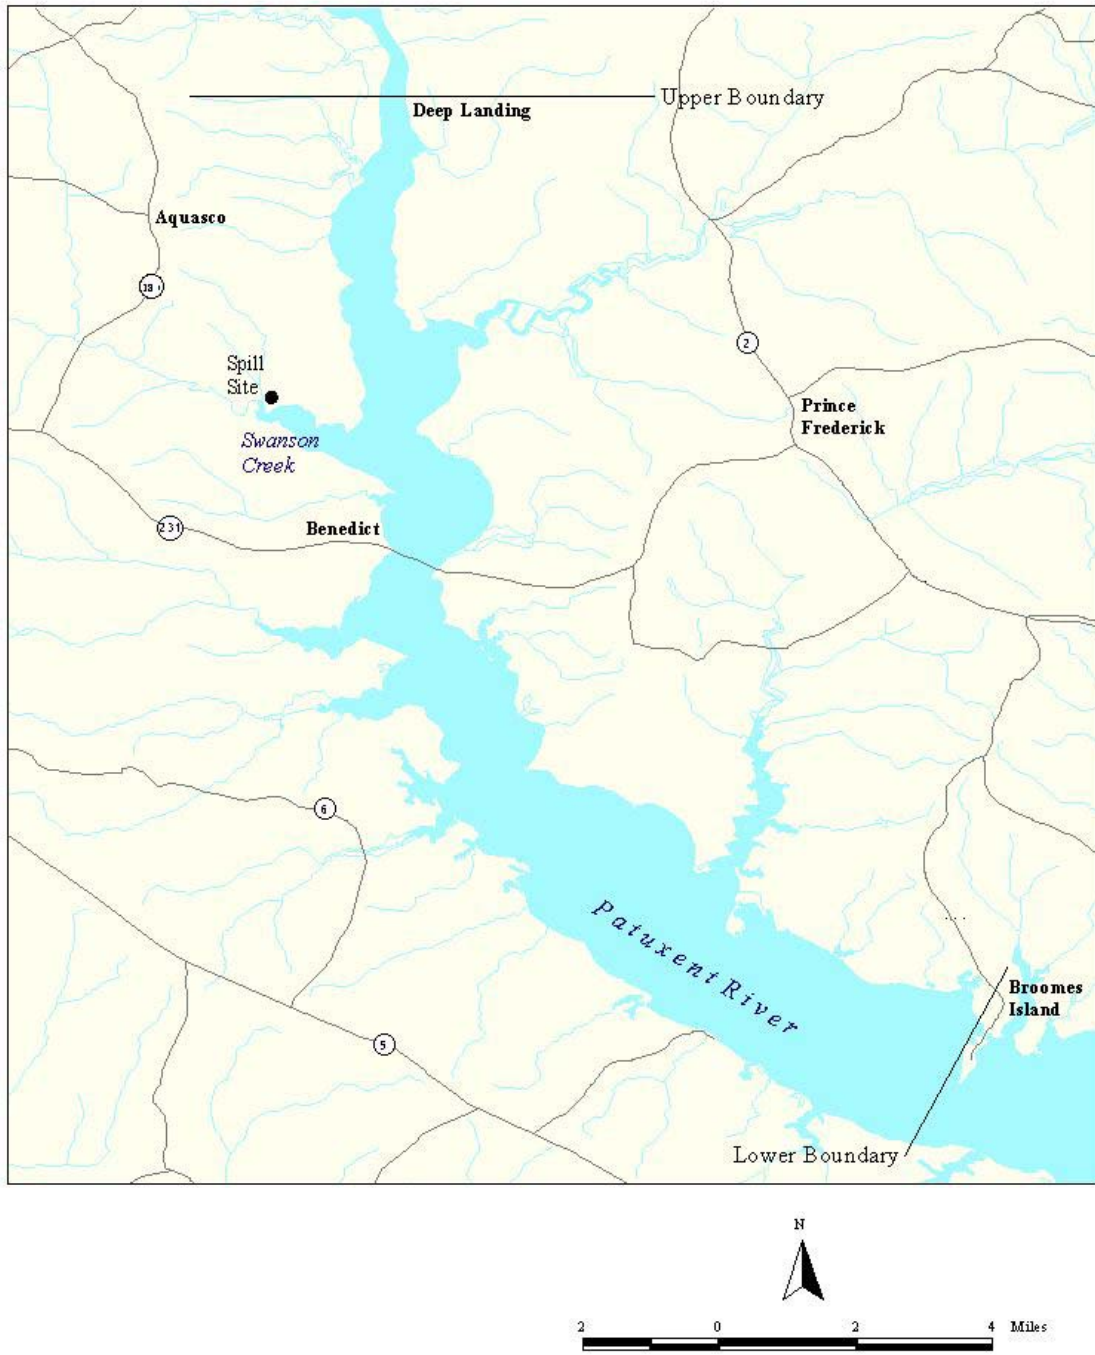
Figure 2b. Map of middle Patuxent River region in which active osprey nests (n=58) were monitored for reproductive success during the PEPCO-Chalk Point oil spill in April, 2000.

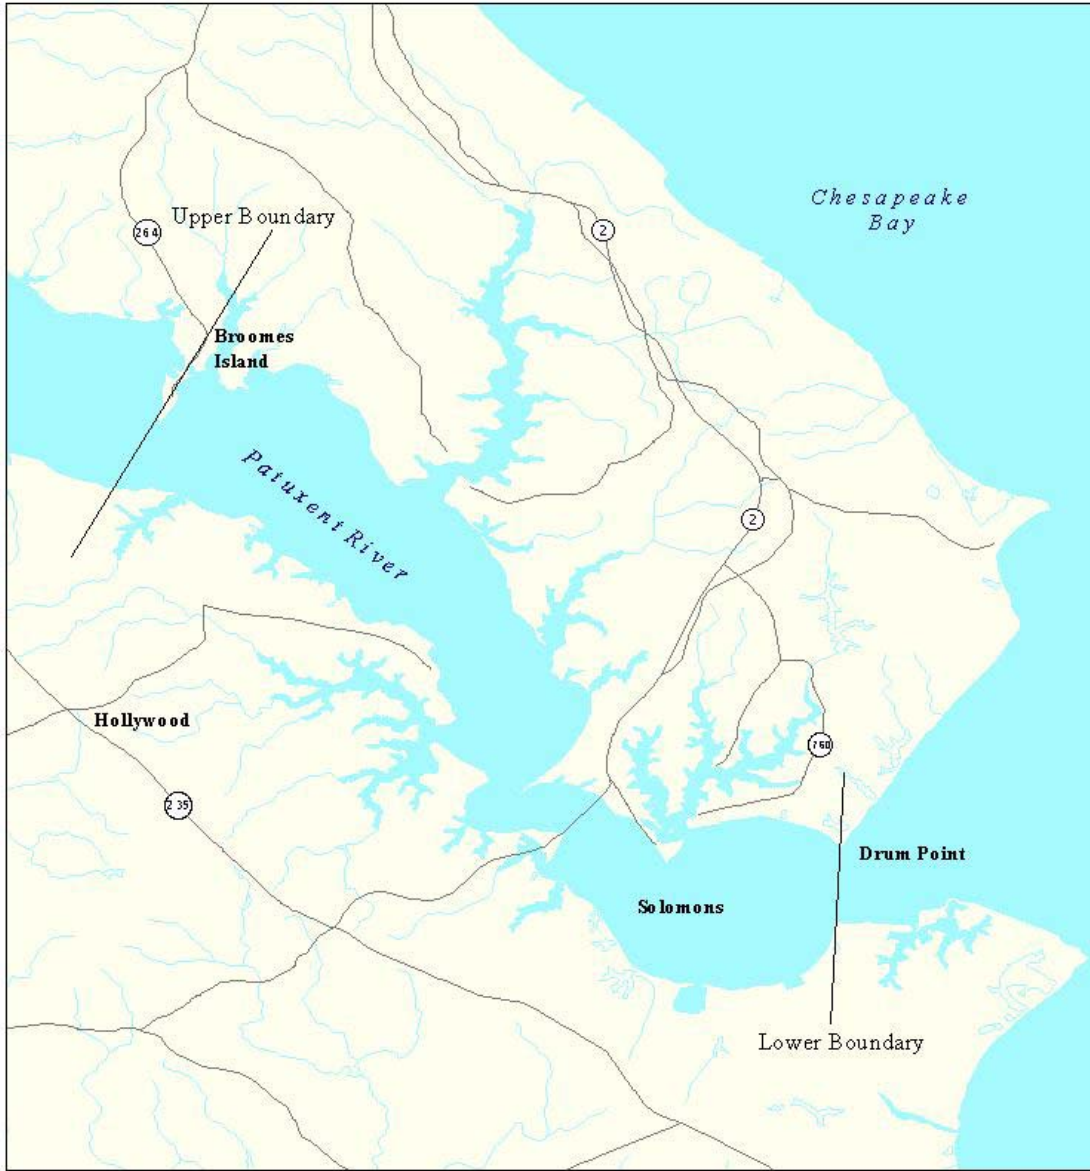
Figure 2c. Map of lower Patuxent River region in which active osprey nests (n=41) were monitored for reproductive success during the PEPCO-Chalk Point oil spill in April, 2000.

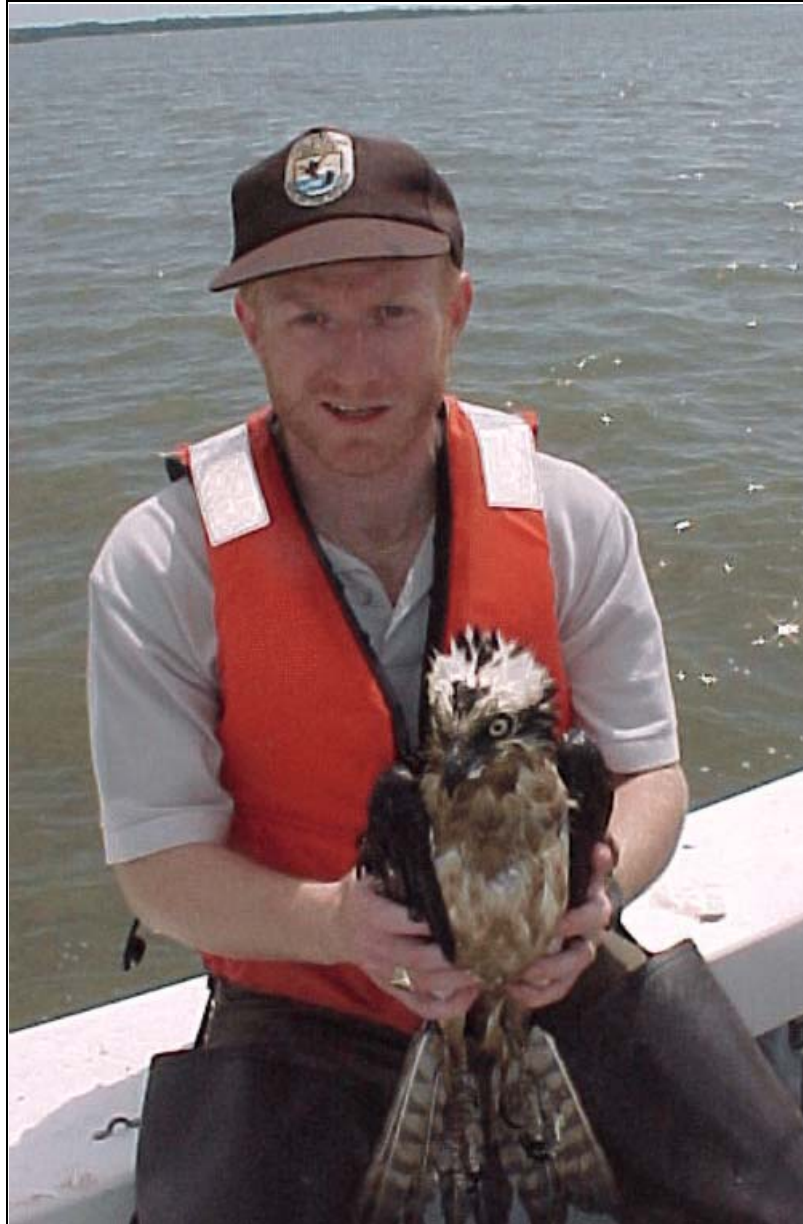
Figure 3. Moderately oiled male adult osprey captured for cleaning and rehabilitation during the PEPCO, Chalk Point oil spill in April 2000.

After being captured, the osprey (Figure 3) were transferred to waiting wildlife rehabilitation personnel for cleanup and release. If a female was captured, the male would return to the nest to assume incubating duties. In the case that both ospreys needed to be caught, the male was caught in the same manner as the female. The eggs from nests in which both adults were captured were either placed in foster nests or given to wildlife rehabilitation personnel and placed in incubators. Collected eggs were replaced on the nest just prior to the release of the adults. In an effort to minimize stress to oiled adult ospreys, all trapping occurred when the wind was calm and clear skies and mild temperatures prevented the chilling of exposed eggs. Where possible, oiled sticks and vegetation found in nests were removed.

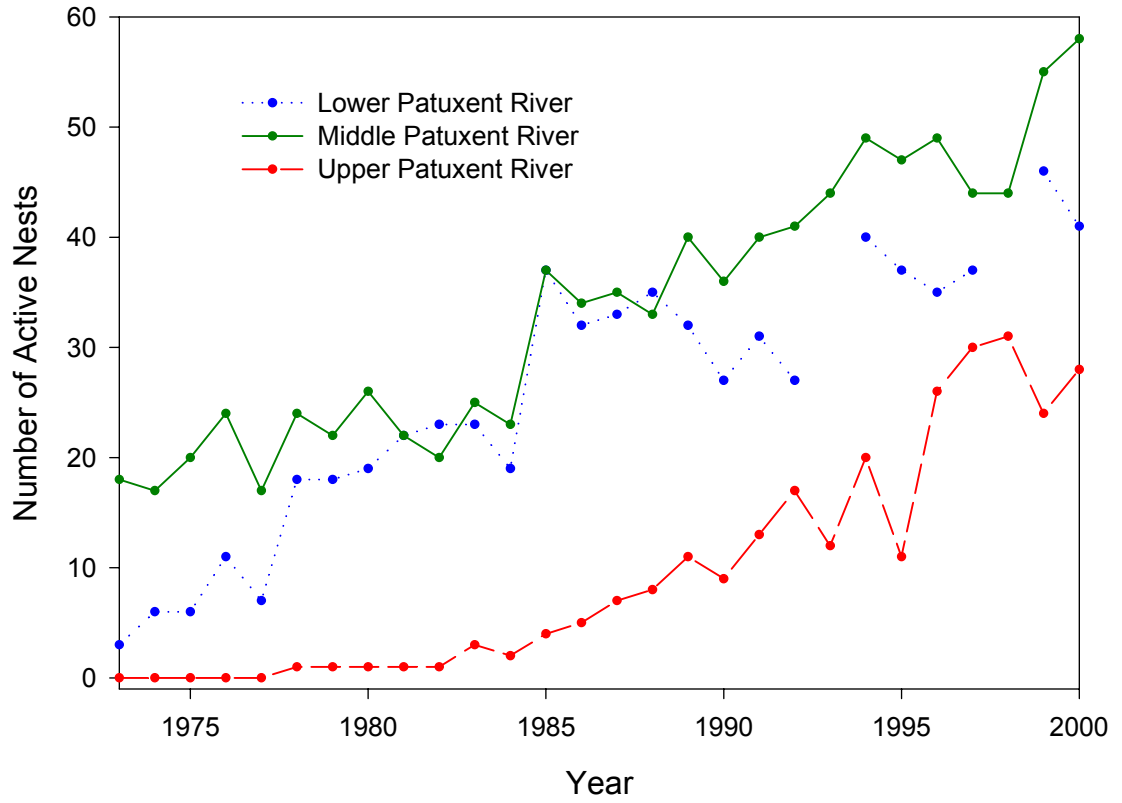
Figure 4. Number of active osprey nests in the three sections of the Patuxent River, 1973 - 2000.

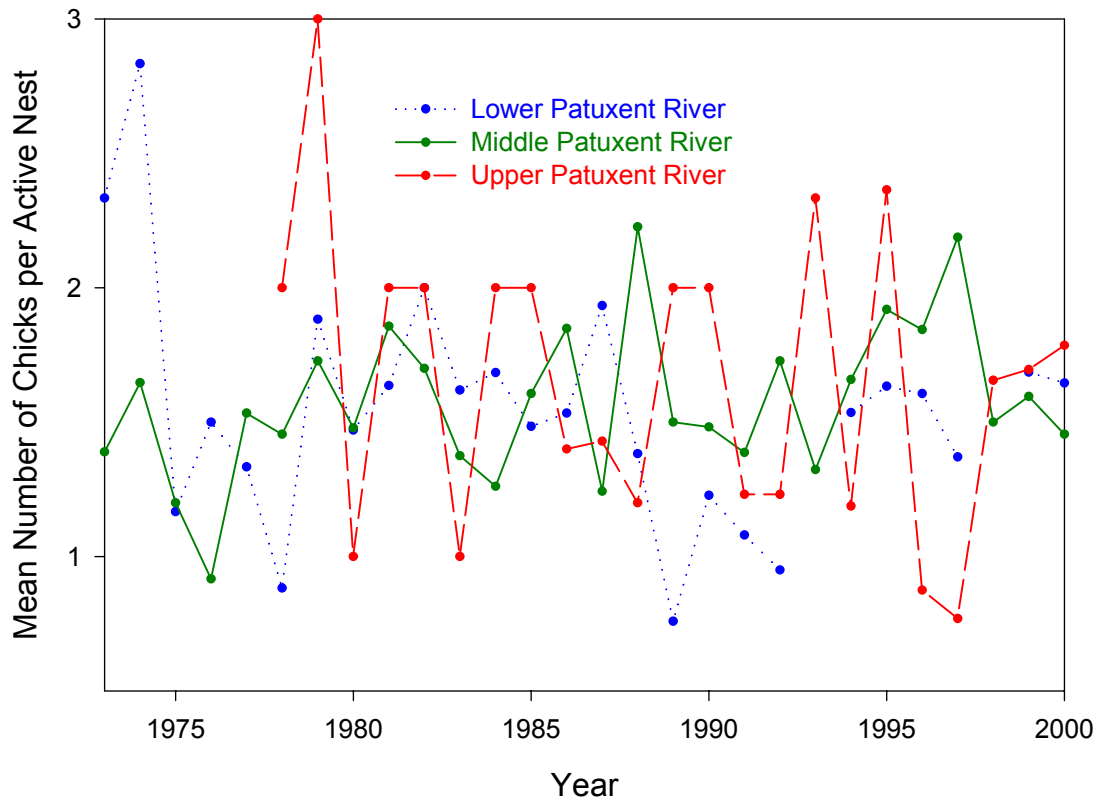
Figure 5. Mean productivity of active osprey nests in the upper, middle, and lower sections of the Patuxent River, 1973-2000.

Results of the monitoring study suggested that there were no detectable population-level impacts on the reproductive success of the ospreys nesting in the Patuxent River as a result of the April 7, 2000 Chalk Point oil spill. The mean of 1.50 young fledged per active nest in the middle section was similar to the 25 year average of 1.51 for the river (Cardano, unpublished data) and exceeded values determined to maintain a stable population. Henny and Wight (1969) determined that 0.95-1.30 young were required to fledge per nest in order to maintain a stable breeding population. In 2000, and most other years of the Patuxent study (except 1976, 1978, and 1989), ospreys have met or exceeded this average (Figure 5).
