# FEMA-1551-DR, Florida

## Imagery Derived Assessment - Escambia, FL / Baldwin, AL as of 09/18/2004

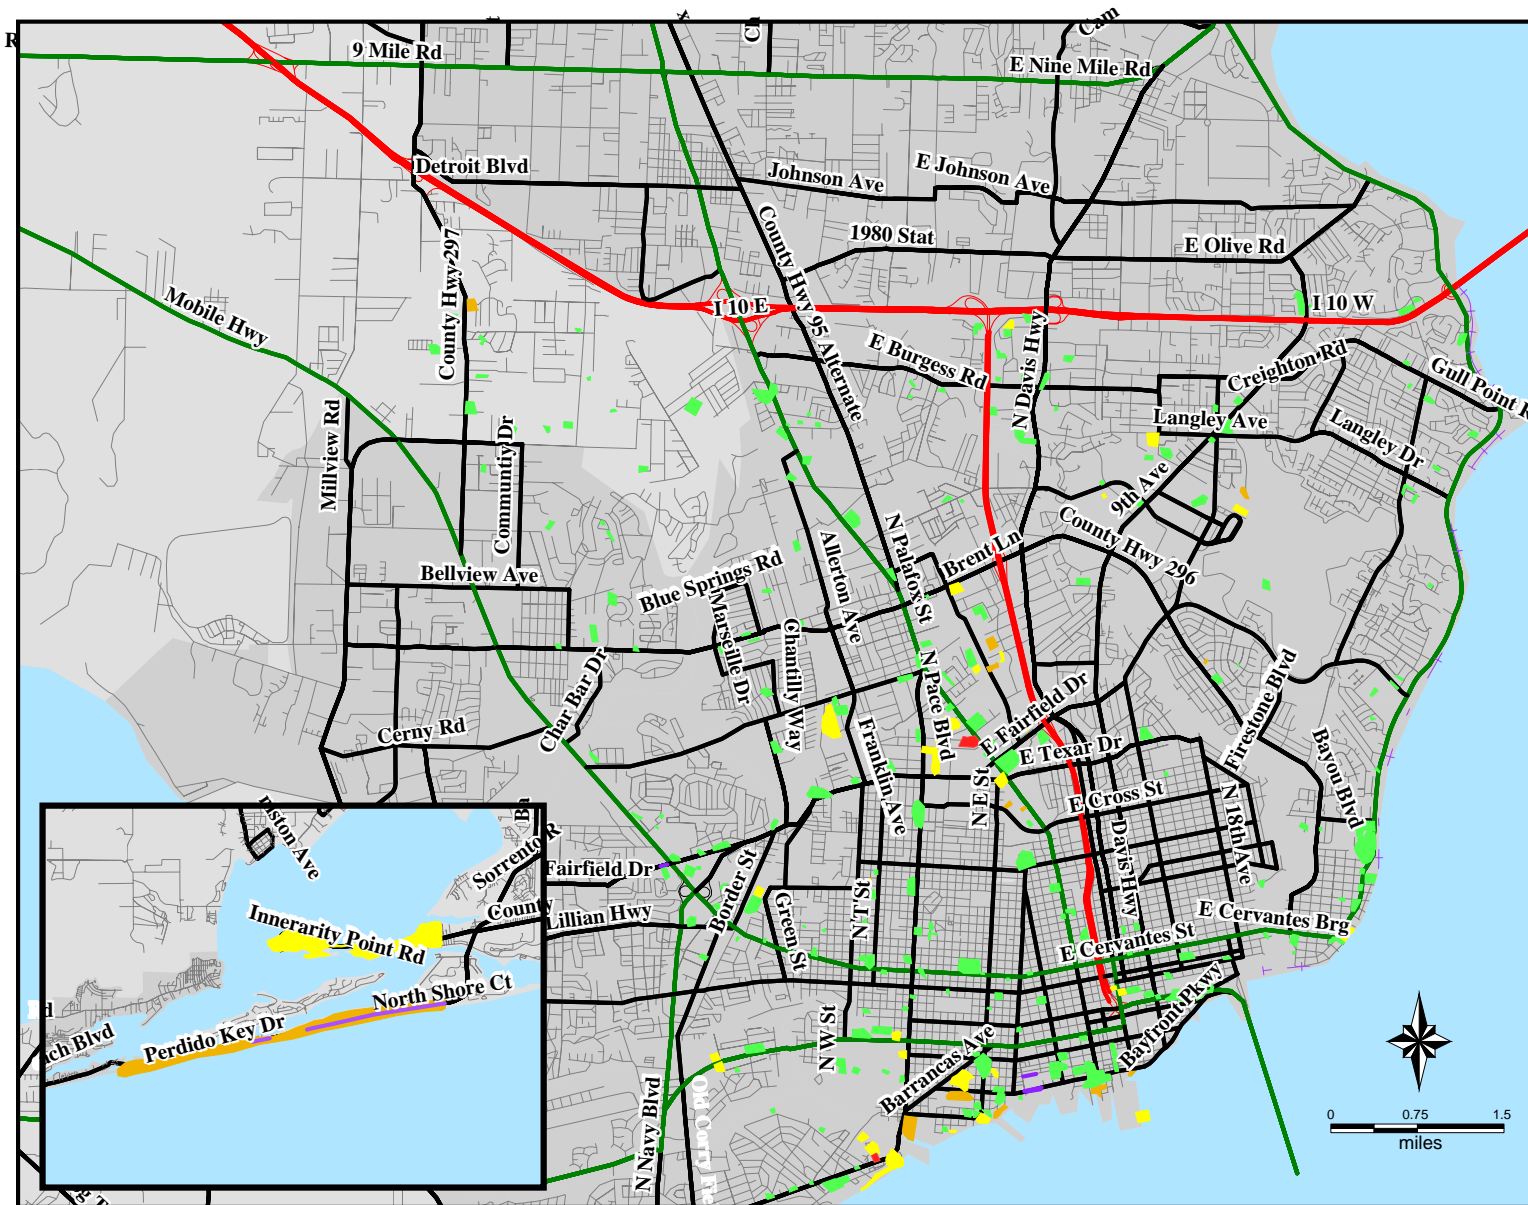
**Baldwin, AL Estimated Number in Damage Area:**

Population:	Housing Units:
<b>ED: 168</b>	<b>ED: 441</b>

**Escambia, FL Estimated Number in Damage Area:**

Population:	Housing Units:
<b>LD: 2227</b>	<b>LD: 1008</b>
<b>MD: 2731</b>	<b>MD: 1161</b>
<b>ED: 2062</b>	<b>ED: 854</b>
<b>CD: 37</b>	<b>CD: 20</b>

**LIMITED DAMAGE:** Generally superficial damage to solid structures (e.g., loss of tiles or roof shingles); some mobile homes and light structures are damaged or displaced.

**MODERATE DAMAGE:** Solid structures sustain exterior damage (e.g., missing roofs or roof segments); some mobile homes and light structures are destroyed, many are damaged or displaced.

**EXTENSIVE DAMAGE:** Some solid structures are destroyed; most sustain exterior and interior damage (e.g., roofs missing, interior walls exposed), most mobile homes and light structures are destroyed.

**CATASTROPHIC DAMAGE:** Most solid and all light or mobile structures destroyed.
