U.S. Army Corps of Engineers Omaha District Monthly Drought Report April 2006

CURRENT CONDITIONS

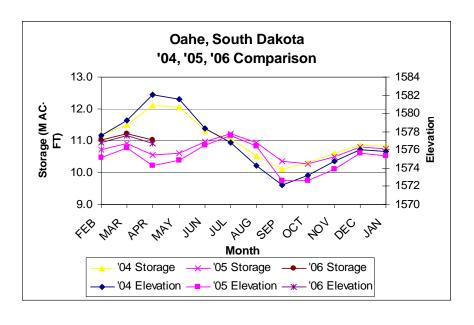
Oahe, SD

Water Year 2004 (FEB 2004 – JAN 2005)			Water Year 2005 (FEB 2005 – JAN 2006)			Water Year 2006 (FEB 2006 – JAN 2007)		
Date	Elevation	Storage (MAC-Ft.)	Date	Elevation	Storage (MAC-Ft.)	Date	Elevation	Storage (MAC-Ft.)
FEB	1577.6	11.204	2/1/2005	1575.2	10.715	2/1/2006	1576.8	11.037
MAR	1579.2	11.504	3/1/2005	1576.2	10.924	3/1/2006	1577.6	11.209
APR	1582.1	12.110	4/1/2005	1574.29	10.568	4/1/2006	1576.7	11.024
MAY	1581.6	12.056	5/1/2005	1574.82	10.608	5/1/2006		
JUN	1578.4	11.338	6/1/2005	1576.47	10.980	6/1/2006		
JUL	1576.8	11.045	7/1/2005	1577.6	11.214	7/1/2006		
AUG	1574.3	10.540	8/1/2005	1576.38	10.958	8/1/2006		
SEP	1572.1	10.112	9/1/2005	1572.64	10.363	9/1/2006		
ОСТ	1573.2	10.316	10/1/2005	1572.63	10.267	10/1/2006		
NOV	1574.8	10.608	11/1/2005	1573.90	10.501	11/1/2006		
DEC	1576	10.866	12/1/2005	1575.6	10.814	12/1/2006		
JAN	1575.8	10.824	1/1/2006	1575.6	10.778	1/1/2007
