**U.S. Army Corps of Engineers  
Omaha District  
Monthly Drought Report  
December 2005**

**US Army Corps  
of Engineers  
Omaha District**

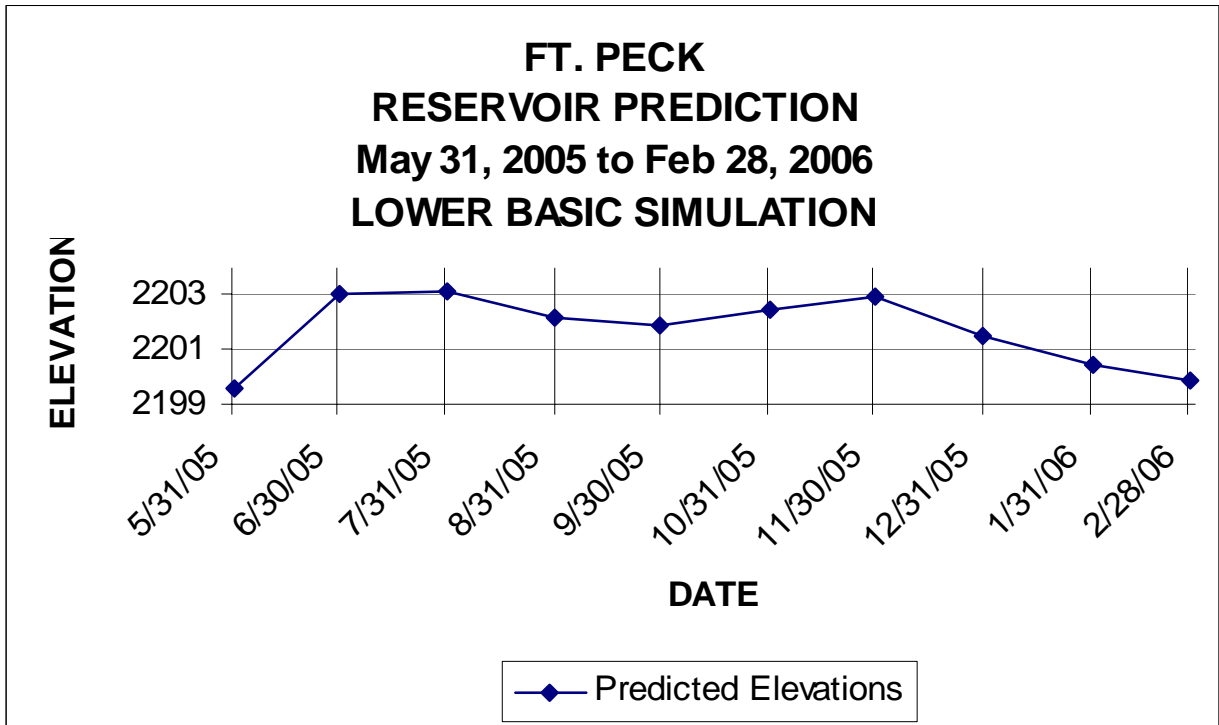
Lake Elevation 7/01/2005 (ft. msl)	Current Lake Elevation 11/30/2005 (ft. msl)	30-Day Projected Elevation* (12/31/2005) (ft. msl)	60-Day Projected Elevation* (1/31/2006) (ft. msl)	90-Day** Projected Elevation* (2/28/2006) (ft. msl)
2203.0	2202.9	2201.5	2200.4	2199.9

1. Current reservoir elevation is 31.5-feet below the top of conservation pool (elevation 2234.0 ft. msl).
2. \*Projections provided are based upon the Lower Basic Simulation prepared by the Reservoir Control Center.
3. Current elevation is 2.7-ft. higher than elevation on 10/31/2004 (2199.8).
4. \*\*90-day projection used in lieu of 180-day due to 2/28/06 being the end of the water year.

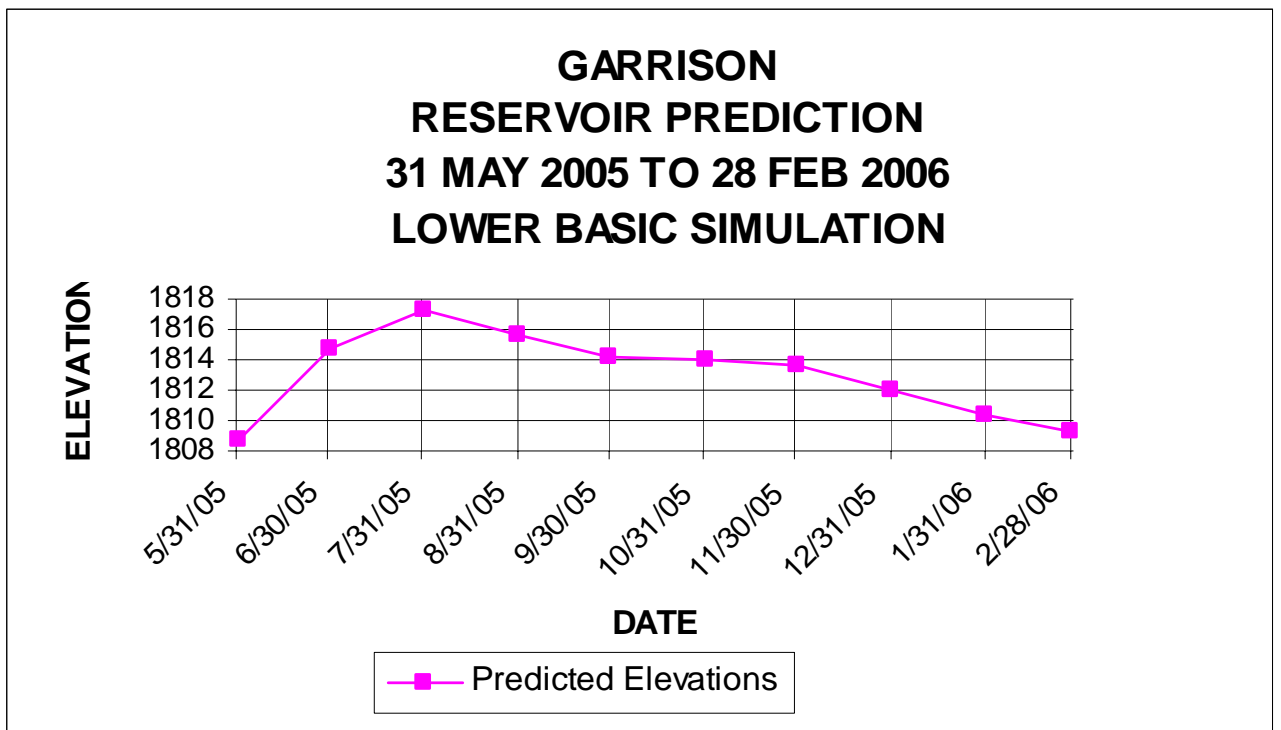
Lake Elevation 5/31/2005 (ft. msl)	Current Lake Elevation (11/30/2005) (ft. msl)	30-Day Projected Elevation* (12/31/2005) (ft. msl)	60-Day Projected Elevation* (1/31/2006) (ft. msl)	90-Day** Projected Elevation* (2/28/2006) (ft. msl)
1808.8	1813.6	1812.0	1810.3	1809.2

1. Current reservoir elevation is 23.5-feet below the top of conservation pool (elevation 1837.5 ft. msl).
2. \*Projections provided are based upon the Lower Basic Simulation prepared by the Reservoir Control Center.
3. Current reservoir elevation is 1.1 ft. higher than elevation on 10/31/04.
4. \*\*90-day projection used in lieu of 180-day due to 2/28/06 being the end of the water year.

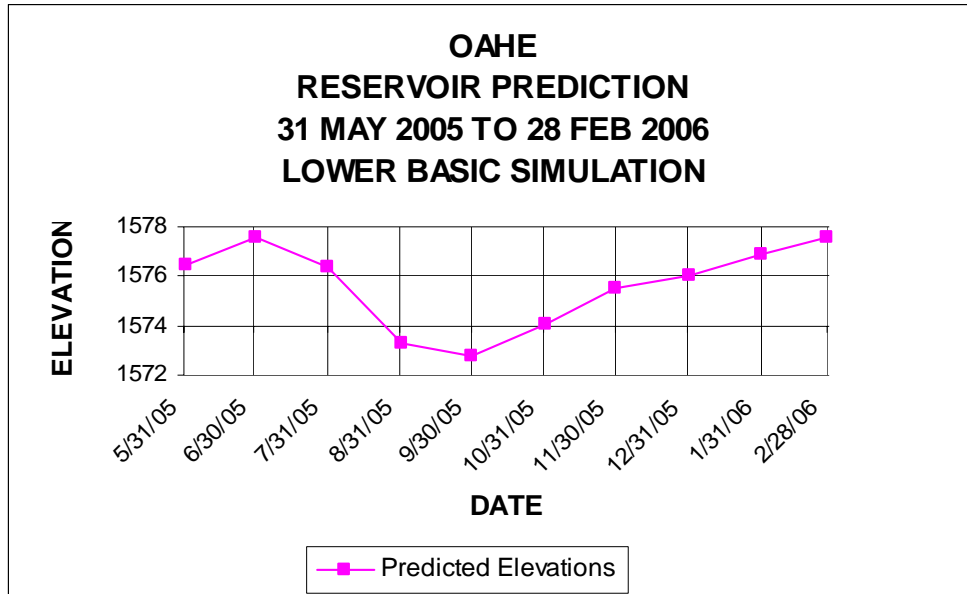
Lake Elevation 5/31/2005 (ft. msl)	Current Lake Elevation (11/30/2005) (ft. msl)	30-Day Projected Elevation* (12/31/2005) (ft. msl)	60-Day Projected Elevation* (1/31/2006) (ft. msl)	90-Day** Projected Elevation* (2/28/2006) (ft. msl)
1576.5	1575.5	1576.0	1576.9	1577.6

1. Current reservoir elevation is 33.4-feet below the top of conservation pool (elevation 1607.5 ft. msl).
2. \*Projections provided are based upon the Lower Basic Simulation prepared by the Reservoir Control Center.

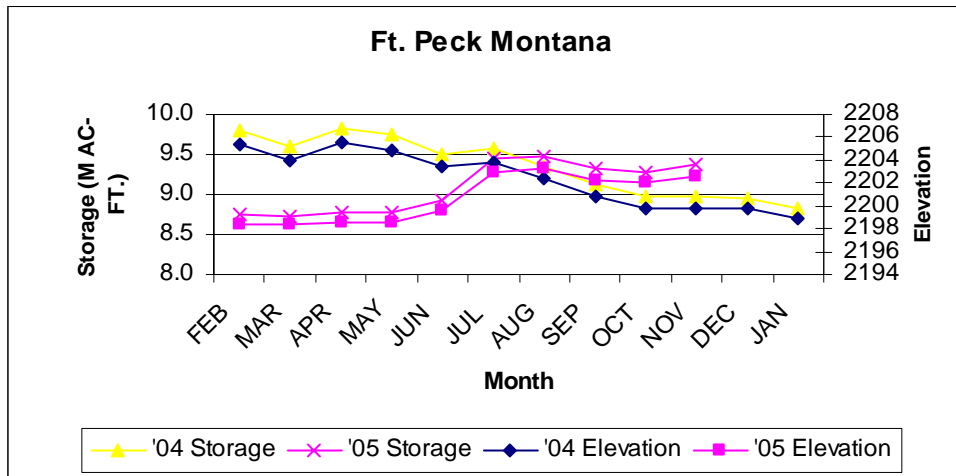
**Fort Peck, Montana**

Water Year 2004 (FEB 2004 - JAN 2005)			Water Year 2005 (FEB 2005 - JAN 2006)		
Date	Elevation	Storage (MAC- Ft.)	Date	Elevation	Storage (MAC- Ft.)
FEB	2205.3	9.806	2/1/2005	2198.4	8.749
MAR	2204	9.603	3/1/2005	2198.3	8.732
APR	2205.5	9.837	4/1/2005	2198.5	8.773
MAY	2204.9	9.740	5/1/2005	2198.5	8.773
JUN	2203.4	9.507	6/1/2005	2199.6	8.935
JUL	2203.8	9.565	7/1/2005	2203.0	9.448
AUG	2202.4	9.357	8/1/2005	2203.2	9.472
SEP	2200.9	9.121	9/1/2005	2202.2	9.325
OCT	2199.8	8.969	10/1/2005	2202.0	9.286
NOV	2199.8	8.963	11/1/2005	2202.6	9.371
DEC	2199.8	8.961	12/1/2005	2202.9	9.432
JAN	2198.9	8.829	1/1/2006

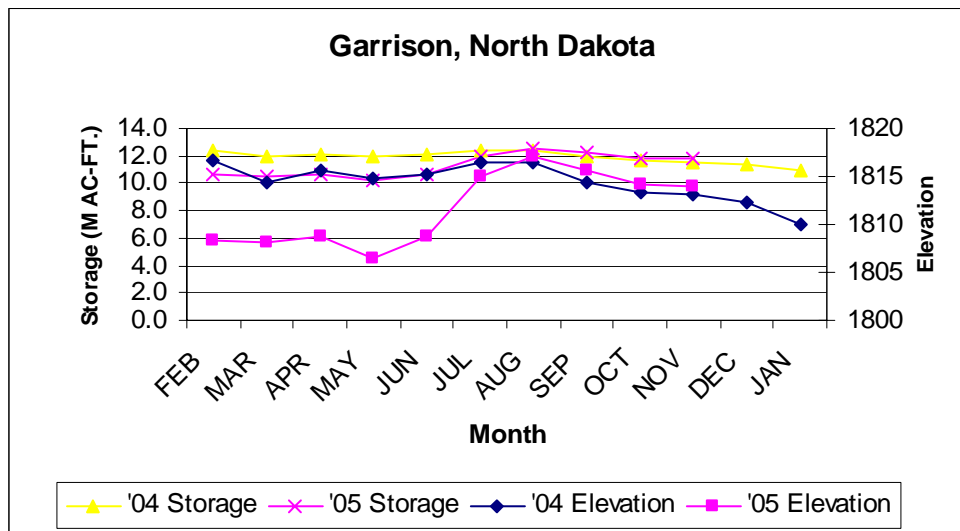
**Garrison, ND**

Water Year 2004 (FEB 2004 – JAN 2005)			2005 (FEB 2005 – JAN 2006)		
Date	Elevation	Storage (MAC-Ft.)	Date	Elevation	Storage (MAC-Ft.)
FEB	1816.7	12.446	2/1/2005	1808.4	10.574
MAR	1814.3	11.891	3/1/2005	1808.2	10.537
APR	1815.6	12.110	4/1/2005	1808.65	10.632
MAY	1814.7	11.989	5/1/2005	1806.47	10.189
JUN	1815.3	12.121	6/1/2005	1808.8	10.665
JUL	1816.5	12.426	7/1/2005	1814.9	12.026
AUG	1816.5	12.401	8/1/2005	1817.17	12.591
SEP	1814.3	11.914	9/1/2005	1815.56	12.216
OCT	1813.3	11.645	10/1/2005	1814.11	11.861
NOV	1813.1	11.589	11/1/2005	1814.00	11.837
DEC	1812.3	11.422	12/1/2005	1813.50	11.707
JAN	1810	10.936	1/1/2006

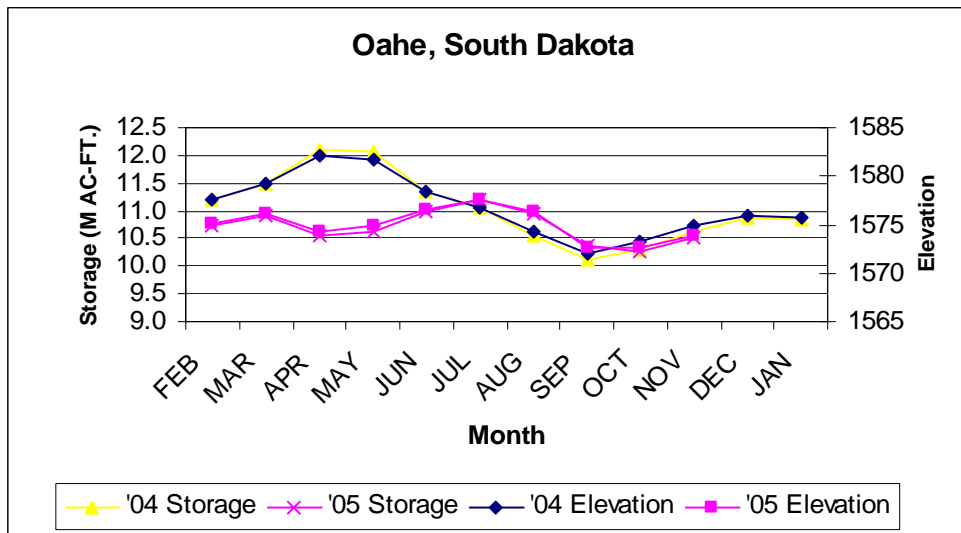
## Oahe, SD

Water Year 2004 (FEB 2004 - JAN 2005)			2005 (FEB 2005 - JAN 2006)		
Date	Elevation	Storage (MAC-Ft.)	Date	Elevation	Storage (MAC-Ft.)
FEB	1577.6	11.204	2/1/2005	1575.2	10.715
MAR	1579.2	11.504	3/1/2005	1576.2	10.924
APR	1582.1	12.110	4/1/2005	1574.29	10.568
MAY	1581.6	12.056	5/1/2005	1574.82	10.608
JUN	1578.4	11.338	6/1/2005	1576.47	10.980
JUL	1576.8	11.045	7/1/2005	1577.6	11.214
AUG	1574.3	10.540	8/1/2005	1576.38	10.958
SEP	1572.1	10.112	9/1/2005	1572.64	10.363
OCT	1573.2	10.316	10/1/2005	1572.63	10.267
NOV	1574.8	10.608	11/1/2005	1573.90	10.501
DEC	1576	10.866	12/1/2005	1575.6	10.814
JAN	1575.8	10.824	1/1/2006
