**U.S. Army Corps of Engineers  
Omaha District  
Monthly Drought Report  
December 2006**

**US Army Corps  
of Engineers  
Omaha District**

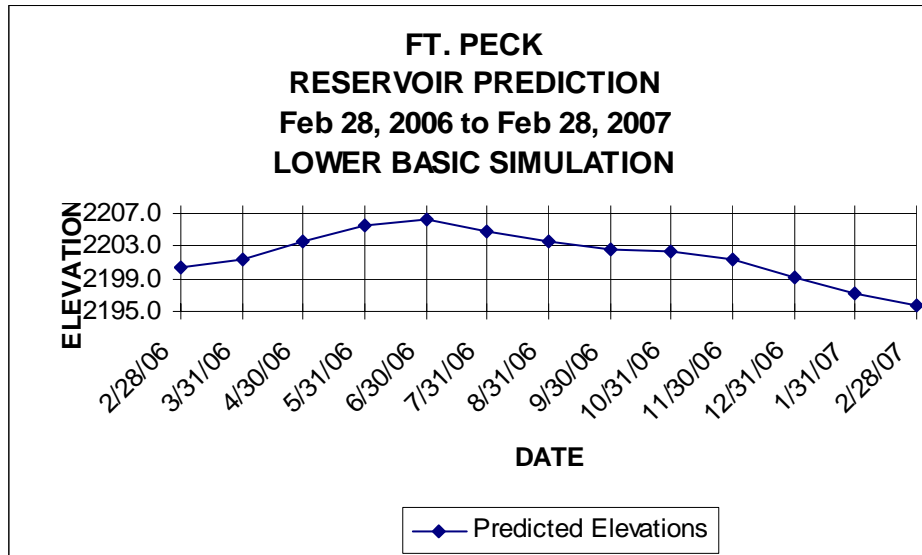
Lake Elevation 11/30/2005 (ft. msl)	Current Lake Elevation 11/30/2006 (ft. msl)	30-Day Projected Elevation* (12/31/2006) (ft. msl)	90-Day Projected Elevation* (2/28/2007) (ft. msl)
2202.9	2201.3	2199.1	2195.7

1. Current reservoir elevation is 32.7-feet below the top of conservation pool (elevation 2234.0 ft. msl).
  2. Projections provided are based upon the Lower Basic Simulation prepared by the Reservoir Control Center.
  3. Current elevation 1.6-feet lower than 11/30/05 (2202.9) and trending downward. The reservoir is predicted to hit a new record low this winter.
- \* Normally use 180-day projections; however, since the water year ends Feb. 28, the end of water year projection is used.

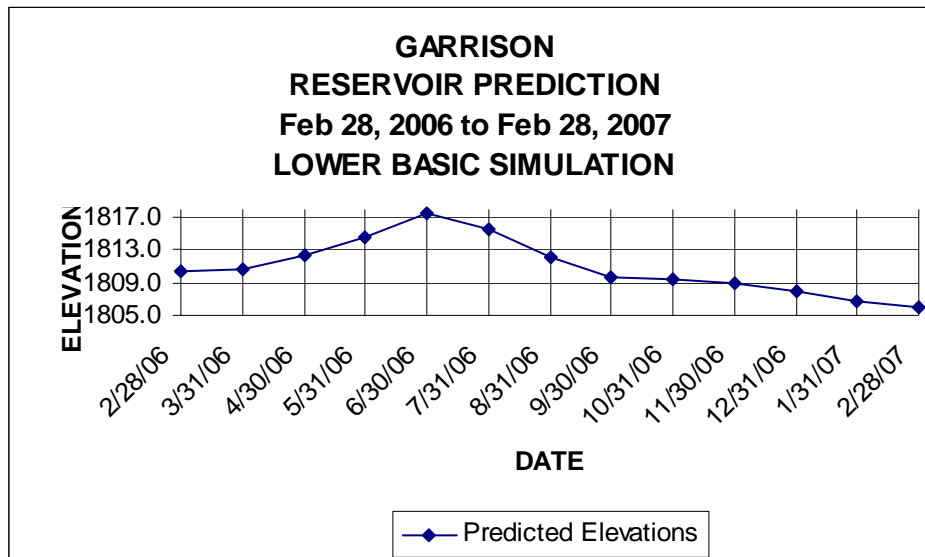
Lake Elevation 11/30/2005 (ft. msl)	Current Lake Elevation (11/30/2006) (ft. msl)	30-Day Projected Elevation (12/31/2006) (ft. msl)	90-Day Projected Elevation* (2/28/2007) (ft. msl)
1813.6	1809.0	1807.9	1805.9

1. Current reservoir elevation is 28.5-feet below the top of conservation pool (elevation 1837.5 ft. msl).
2. Projections provided are based upon the Lower Basic Simulation prepared by the Reservoir Control Center.
3. Current reservoir elevation is 4.6-feet lower than elevation on 11/30/05 (1813.6).

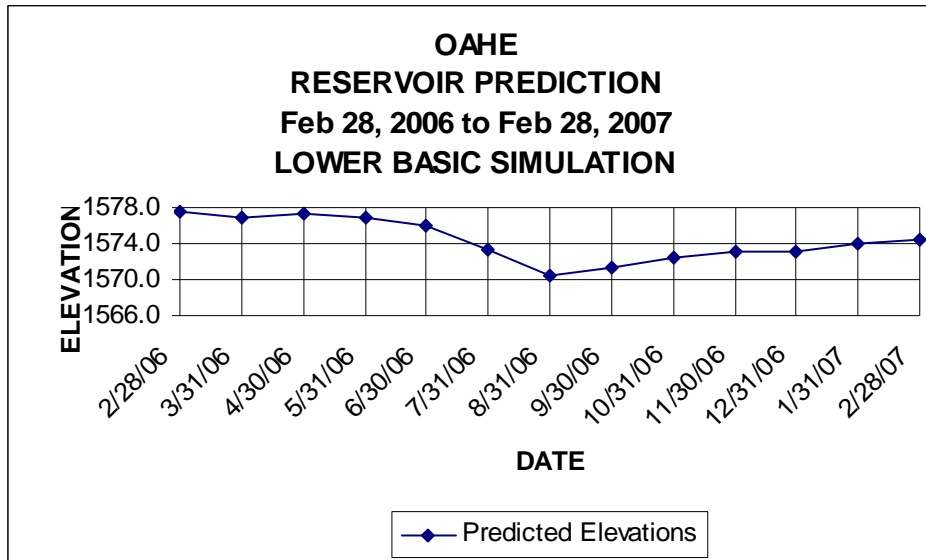
Lake Elevation 11/30/2005 (ft. msl)	Current Lake Elevation (11/30/2006) (ft. msl)	30-Day Projected Elevation (12/31/2006) (ft. msl)	90-Day Projected Elevation* (2/28/2007) (ft. msl)
1575.5	1573.2	1573.1	1574.4

1. Current reservoir elevation is 34.3-feet below the top of conservation pool (elevation 1607.5 ft. msl).
  2. Projections provided are based upon the Lower Basic Simulation prepared by the Reservoir Control Center.
  3. Current reservoir elevation is 2.3-feet lower than 11/30/05 (1575.5).
- \* Normally use 180-day projections; however, since the water year ends Feb. 28, the end of water year projection is used.

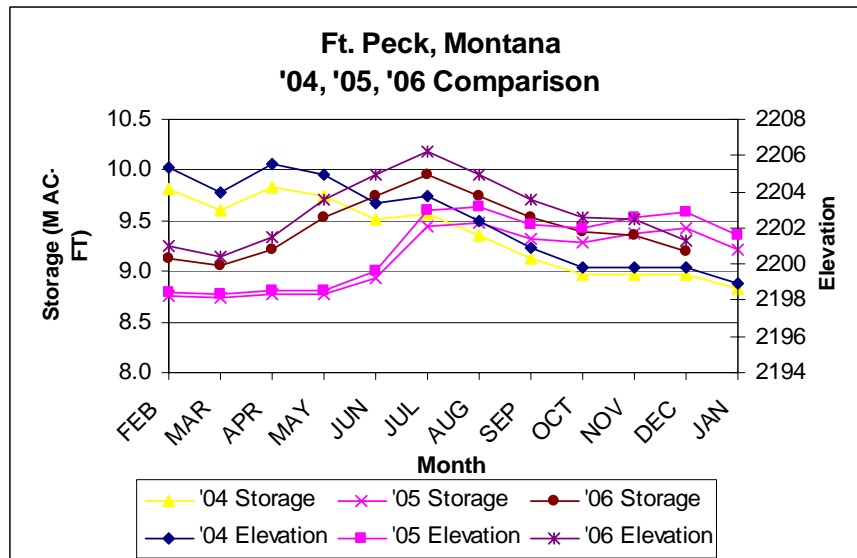
### Fort Peck, Montana

Water Year 2004 (FEB 2004 – JAN 2005)			Water Year 2005 (FEB 2005 – JAN 2006)			Water Year 2006 (FEB 2006 – JAN 2007)		
Date	Elevation	Storage (MAC-Ft.)	Date	Elevation	Storage (MAC-Ft.)	Date	Elevation	Storage (MAC-Ft.)
2/1/2004	2205.3	9.806	2/1/2005	2198.4	8.749	2/1/2006	2201.0	9.134
3/1/2004	2204	9.603	3/1/2005	2198.3	8.732	3/1/2006	2200.4	9.048
4/1/2004	2205.5	9.837	4/1/2005	2198.5	8.773	4/1/2006	2201.5	9.222
5/1/2004	2204.9	9.740	5/1/2005	2198.5	8.773	5/1/2006	2203.6	9.540
6/1/2004	2203.4	9.507	6/1/2005	2199.6	8.935	6/1/2006	2204.9	9.741
7/1/2004	2203.8	9.565	7/1/2005	2203.0	9.448	7/1/2006	2206.2	9.958
8/1/2004	2202.4	9.357	8/1/2005	2203.2	9.472	8/1/2006	2204.9	9.750
9/1/2004	2200.9	9.121	9/1/2005	2202.2	9.325	9/1/2006	2203.6	9.525
10/1/2004	2199.8	8.969	10/1/2005	2202.0	9.286	10/1/2006	2202.6	9.383
11/1/2004	2199.8	8.963	11/1/2005	2202.6	9.371	11/1/2006	2202.5	9.359
12/1/2004	2199.8	8.961	12/1/2005	2202.9	9.432	12/1/2006	2201.3	9.192

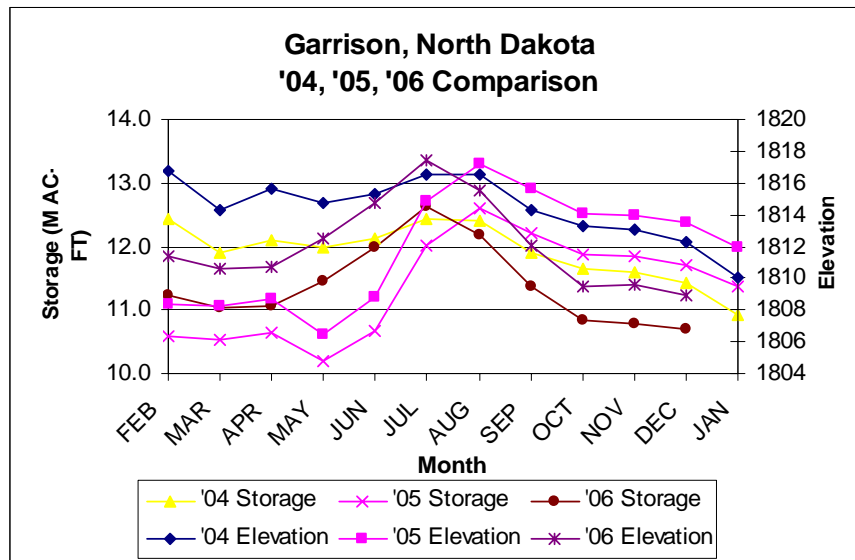
## Garrison, ND

Water Year 2004 (FEB 2004 – JAN 2005)			Water Year 2005 (FEB 2005 – JAN 2006)			Water Year 2006 (FEB 2006 – JAN 2007)		
Date	Elevation	Storage (MAC-Ft.)	Date	Elevation	Storage (MAC-Ft.)	Date	Elevation	Storage (MAC-Ft.)
2/1/2004	1816.7	12.446	2/1/2005	1808.4	10.574	2/1/2006	1811.4	11.230
3/1/2004	1814.3	11.891	3/1/2005	1808.2	10.537	3/1/2006	1810.6	11.040
4/1/2004	1815.6	12.110	4/1/2005	1808.65	10.632	4/1/2006	1810.7	11.076
5/1/2004	1814.7	11.989	5/1/2005	1806.47	10.189	5/1/2006	1812.5	11.460
6/1/2004	1815.3	12.121	6/1/2005	1808.8	10.665	6/1/2006	1814.7	11.992
7/1/2004	1816.5	12.426	7/1/2005	1814.9	12.026	7/1/2006	1817.4	12.629
8/1/2004	1816.5	12.401	8/1/2005	1817.17	12.591	8/1/2006	1815.5	12.172
9/1/2004	1814.3	11.914	9/1/2005	1815.56	12.216	9/1/2006	1812.1	11.372
10/1/2004	1813.3	11.645	10/1/2005	1814.11	11.861	10/1/2006	1809.5	10.838
11/1/2004	1813.1	11.589	11/1/2005	1814.00	11.837	11/1/2006	1809.6	10.772

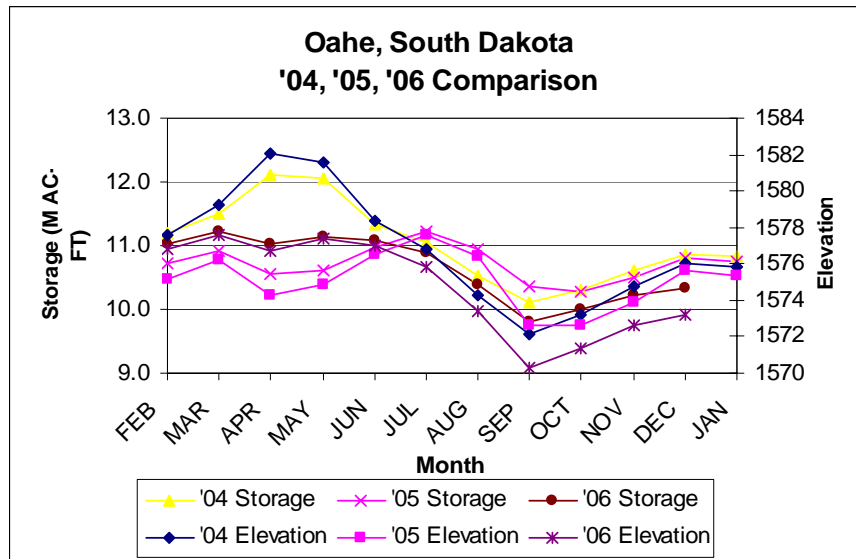
## Oahe, SD

Water Year 2004 (FEB 2004 – JAN 2005)			Water Year 2005 (FEB 2005 – JAN 2006)			Water Year 2006 (FEB 2006 – JAN 2007)		
Date	Elevation	Storage (MAC-Ft.)	Date	Elevation	Storage (MAC-Ft.)	Date	Elevation	Storage (MAC-Ft.)
2/1/2004	1577.6	11.204	2/1/2005	1575.2	10.715	2/1/2006	1576.8	11.037
3/1/2004	1579.2	11.504	3/1/2005	1576.2	10.924	3/1/2006	1577.6	11.209
4/1/2004	1582.1	12.110	4/1/2005	1574.29	10.568	4/1/2006	1576.7	11.024
5/1/2004	1581.6	12.056	5/1/2005	1574.82	10.608	5/1/2006	1577.4	11.150
6/1/2004	1578.4	11.338	6/1/2005	1576.47	10.980	6/1/2006	1577.0	11.088
7/1/2004	1576.8	11.045	7/1/2005	1577.6	11.214	7/1/2006	1575.8	10.880
8/1/2004	1574.3	10.540	8/1/2005	1576.38	10.958	8/1/2006	1573.4	10.378
9/1/2004	1572.1	10.112	9/1/2005	1572.64	10.363	9/1/2006	1570.3	9.807
10/1/2004	1573.2	10.316	10/1/2005	1572.63	10.267	10/1/2006	1571.4	9.998
11/1/2004	1574.8	10.608	11/1/2005	1573.90	10.501	11/1/2006	1572.6	10.214
