U.S. Army Corps of Engineers
Omaha District
Monthly Drought Report
February 2007

**US Army Corps
of Engineers
Omaha District**

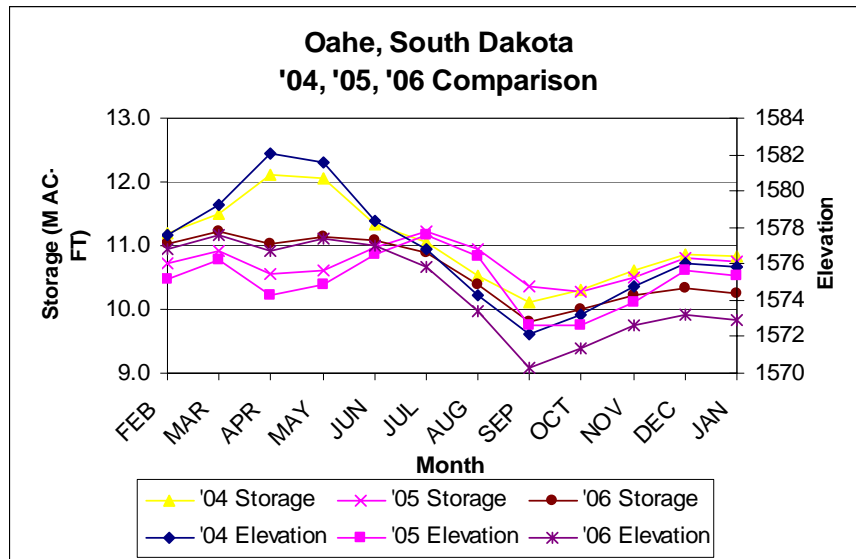
Oahe, SD

Water Year 2004 (FEB 2004 – JAN 2005)			Water Year 2005 (FEB 2005 – JAN 2006)			Water Year 2006 (FEB 2006 – JAN 2007)		
Date	Elevation	Storage (MAC-Ft.)	Date	Elevation	Storage (MAC-Ft.)	Date	Elevation	Storage (MAC-Ft.)
2/1/2004	1577.6	11.204	2/1/2005	1575.2	10.715	2/1/2006	1576.8	11.037
3/1/2004	1579.2	11.504	3/1/2005	1576.2	10.924	3/1/2006	1577.6	11.209
4/1/2004	1582.1	12.110	4/1/2005	1574.29	10.568	4/1/2006	1576.7	11.024
5/1/2004	1581.6	12.056	5/1/2005	1574.82	10.608	5/1/2006	1577.4	11.150
6/1/2004	1578.4	11.338	6/1/2005	1576.47	10.980	6/1/2006	1577.0	11.088
7/1/2004	1576.8	11.045	7/1/2005	1577.6	11.214	7/1/2006	1575.8	10.880
8/1/2004	1574.3	10.540	8/1/2005	1576.38	10.958	8/1/2006	1573.4	10.378
9/1/2004	1572.1	10.112	9/1/2005	1572.64	10.363	9/1/2006	1570.3	9.807
10/1/2004	1573.2	10.316	10/1/2005	1572.63	10.267	10/1/2006	1571.4	9.998
11/1/2004	1574.8	10.608	11/1/2005	1573.90	10.501	11/1/2006	1572.6	10.214

12/1/2004	1576	10.866	12/1/2005	1575.6	10.814	12/1/2006	1573.2	10.339
1/1/2005	1575.8	10.824	1/1/2006	1575.6	10.778	1/1/2007	1572.9	10.263
