U.S. Army Corps of Engineers Omaha District Monthly Drought Report January 2006

CURRENT CONDITIONS

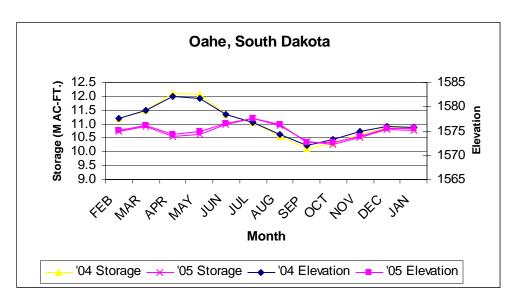
Oahe, SD

Water Year 2004			2005		
(F1	(FEB 2004 - JAN 2005) Storage		(FEB 2005 - JAN 2006) Stora		Storage
Date	Elevation	(MAC-Ft.)	Date	Elevation	(MAC- Ft.)
FEB	1577.6	11.204	2/1/2005	1575.2	10.715
MAR	1579.2	11.504	3/1/2005	1576.2	10.924
APR	1582.1	12.110	4/1/2005	1574.29	10.568
MAY	1581.6	12.056	5/1/2005	1574.82	10.608
JUN	1578.4	11.338	6/1/2005	1576.47	10.980
JUL	1576.8	11.045	7/1/2005	1577.6	11.214
AUG	1574.3	10.540	8/1/2005	1576.38	10.958
SEP	1572.1	10.112	9/1/2005	1572.64	10.363
ОСТ	1573.2	10.316	10/1/2005	1572.63	10.267
NOV	1574.8	10.608	11/1/2005	1573.90	10.501
DEC	1576	10.866	12/1/2005	1575.6	10.814
JAN	1575.8	10.824	1/1/2006	1575.6	10.778
