U.S. Army Corps of Engineers Omaha District Monthly Drought Report June 2007

Table of Contents

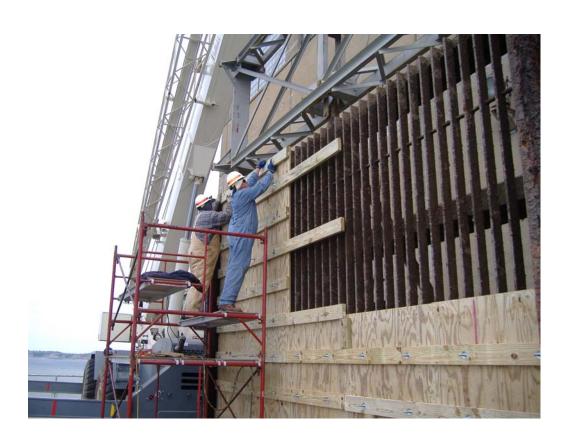
Cover Photo: Modification to intake trash rack on power intake tunnel no. 1 at Garrison Dam to conserve cold water for the fishery (May 17, 2007).

- 3. Garrison Cold Water Fishery The lower portion of the intake for Unit 1 was blocked during the week of May 14, 2007. The underwater inspection of the existing plywood barriers, utilizing a remote operated camera, and the removal of one of the trash racks to perform a physical inspection to ensure integrity of the plywood, j-bolts, etc. showed that the materials were in excellent condition.

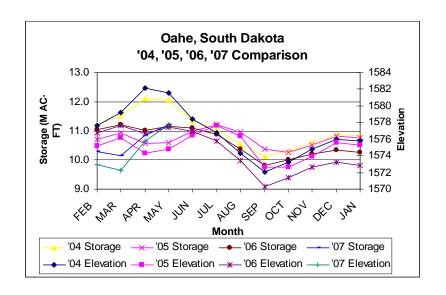
Oahe, SD

Water Year 2004		Water Year 2005		Water Year 2006		Water Year 2007	
(FEB 2004 - JAN 2005)		(FEB 2005 - JAN 2006)		(FEB 2006 - JAN 2007)		(FEB 2007 - JAN 2008)	
	Storage		Storage		Storage		Storage
Elevation	(MAC-Ft.)	Elevation	(MAC-Ft.)	Elevation	(MAC-Ft.)	Elevation	(MAC-Ft.)
1577.6	11.204	1575.2	10.715	1576.8	11.037	1572.9	10.287
1579.2	11.504	1576.2	10.924	1577.6	11.209	1572.3	10.151
1582.1	12.110	1574.29	10.568	1576.7	11.024	1575.8	10.839
1581.6	12.056	1574.82	10.608	1577.4	11.150	1577.7	11.221
1578.4	11.338	1576.47	10.980	1577.0	11.088	1580.5	11.826
1576.8	11.045	1577.6	11.214	1575.8	10.881		
1574.3	10.540	1576.38	10.958	1573.4	10.378		
1572.1	10.112	1572.6	10.363	1570.3	9.807		
1573.2	10.316	1572.63	10.267	1571.4	9.998		
1574.8	10.608	1573.9	10.501	1572.6	10.214		
1576	10.866	1575.6	10.814	1572.9	10.263		
1575.8	10.824	1575.3	10.75	1572.8	10.260
