# U.S. Army Corps of Engineers Omaha District Monthly Drought Report November 2006

# **CURRENT CONDITIONS**

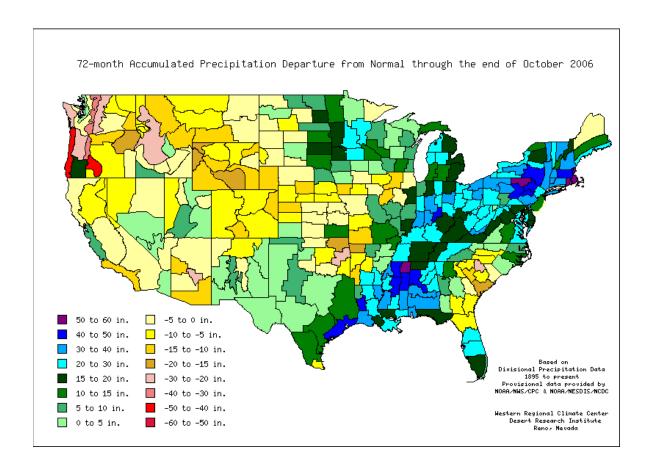
Figure 1 – 72 month Precipitation Departure From Normal <a href="http://www.wrcc.dri.edu/cgi-bin/spiFmap.pl?dep72">http://www.wrcc.dri.edu/cgi-bin/spiFmap.pl?dep72</a>

Precipitation departures from normal during the last 72 months for the United States are shown in Figure 1. In Montana, accumulated precipitation ranges from near normal to nearly a 15-inch deficit. Wyoming's accumulated precipitation varies widely from near normal to a 20-inch deficit. Nebraska ranges from near normal to a 10-inch surplus. The Dakotas generally range from near normal to a 30-inch surplus. The South Platte River Basin in Colorado still shows precipitation deficits of 5 to 15 inches during a majority of the 72-month period.

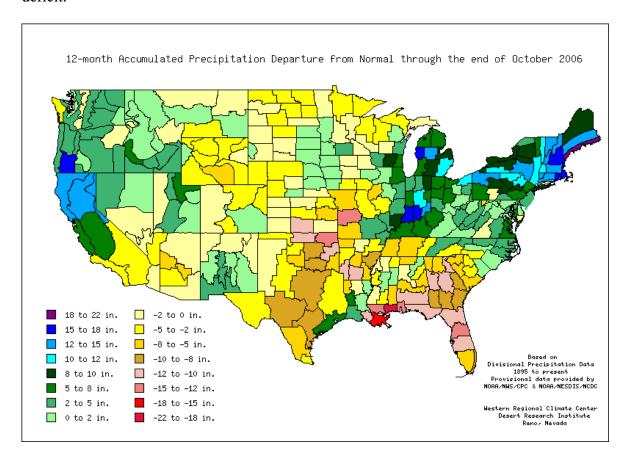
Figure 2 – 12 month Precipitation Departure From Normal <a href="http://www.wrcc.dri.edu/cgi-bin/spiFmap.pl?dep12">http://www.wrcc.dri.edu/cgi-bin/spiFmap.pl?dep12</a>

The 12-month precipitation accumulation in Figure 2 indicates that precipitation throughout much of the western and northwestern District is from normal to a three-inch deficit.

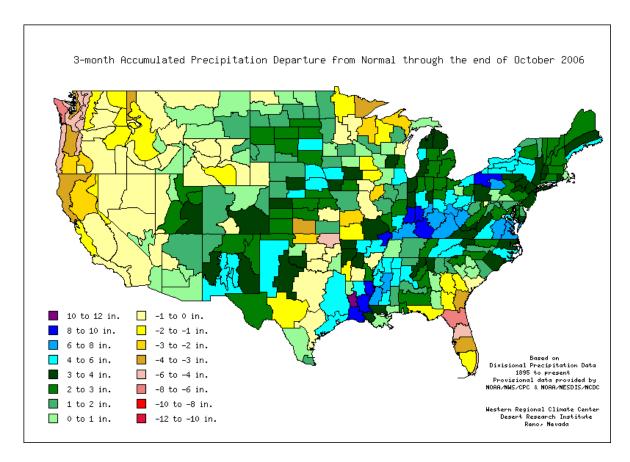
$Figure \ 3-3 \ month \ Precipitation \ Departure \ From \ Normal \ \underline{http://www.wrcc.dri.edu/cgi-bin/spiFmap.pl?dep03}$

The three-month period (Figure 3) shows that much of the basin continues to receive an adequate supply of precipitation to move away from deficits.

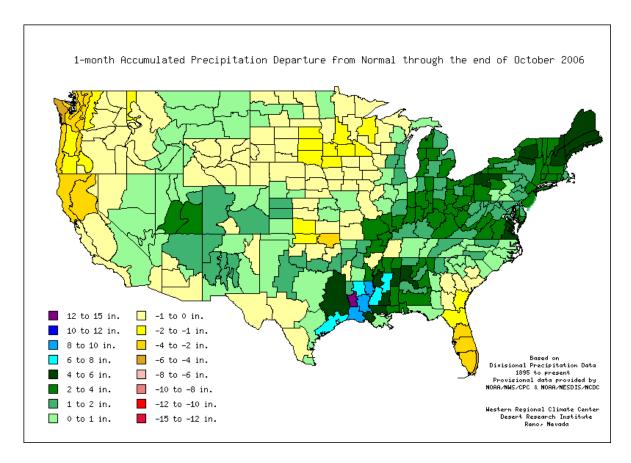
Figure 4 – 1 month Precipitation Departure From Normal <a href="http://www.wrcc.dri.edu/cgi-bin/spiFmap.pl?dep01">http://www.wrcc.dri.edu/cgi-bin/spiFmap.pl?dep01</a>

For the month of November, the majority of the basin received normal precipitation. The exception is eastern South Dakota, which saw a deficit of 1 to 2 inches (Figure 4).

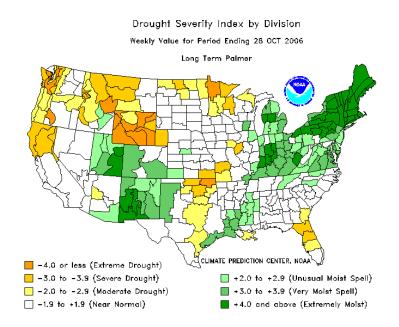
Figure 5 – Long-Term Palmer Drought Indicator Ending 28 OCT 2006 <a href="http://www.cpc.ncep.noaa.gov/products/analysis\_monitoring/regional\_monitoring/palmer.gif">http://www.cpc.ncep.noaa.gov/products/analysis\_monitoring/regional\_monitoring/palmer.gif</a>

Changes to the PDSI are more immediate in response to heavy precipitation over short periods. The PDSI shown in Figure 5 reflects near normal conditions in a large area of the basin and moderate to extreme drought conditions in others.

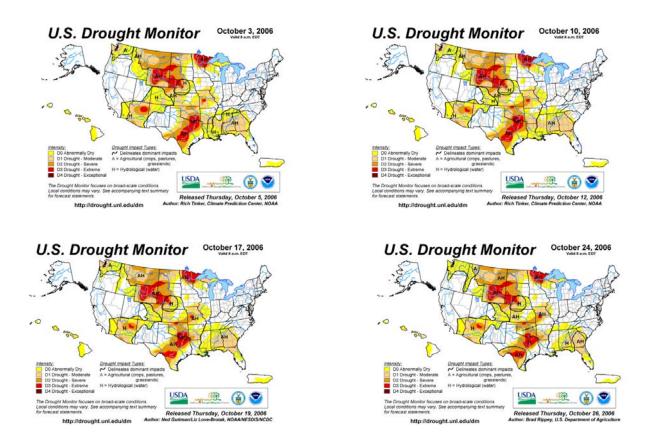
Figure 6 – U.S. Drought Monitor – October 3, 2006 through October 24, 2006 <a href="http://www.drought.unl.edu/dm/monitor.html">http://www.drought.unl.edu/dm/monitor.html</a>

As is indicative of the figures below, large portions of the basin are still experiencing the effects of the drought.

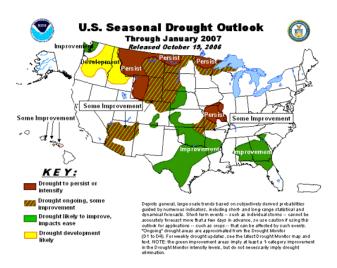
Figure 7 – Three-Month Seasonal Drought Outlook through January 2007 <a href="http://www.cpc.ncep.noaa.gov/products/expert\_assessment/seasonal\_drought.html">http://www.cpc.ncep.noaa.gov/products/expert\_assessment/seasonal\_drought.html</a>

The basin drought outlook uses several expert products that indicate precipitation needs necessary to reduce the Palmer Drought to normal conditions, a one- and three-month climate outlook, and the impacts that future climate predictions could have on the current drought situation. The three-month Drought Outlook (Figure 7) indicates that large portions of the basin will continue to experience detrimental effects.

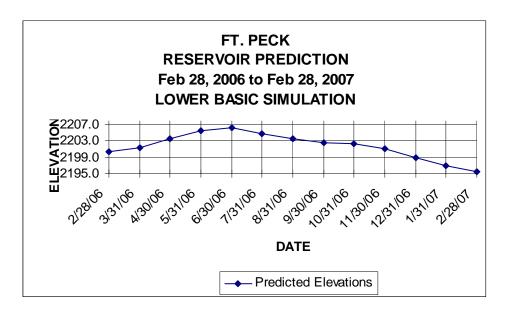
- 1. Current reservoir elevation is 31.6-feet below the top of conservation pool (elevation 2234.0 ft. msl).
- 2. Projections provided are based upon the Lower Basic Simulation prepared by the Reservoir Control Center.
- 3. Current elevation is the same elevation as on 10/31/05 (2202.4) and trending downward. The reservoir is predicted to hit a new record low this winter.
- \* Normally use 180-day projections; however, since the water year ends Feb. 28, the end of water year projection is used.

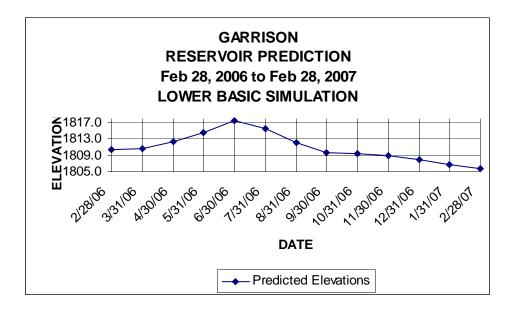
- 1. Current reservoir elevation is 27.9-feet below the top of conservation pool (elevation 1837.5 ft. msl).
- 2. Projections provided are based upon the Lower Basic Simulation prepared by the Reservoir Control Center.
- 3. Current reservoir elevation is 4.5 ft. lower than elevation on 10/31/05 (1814.1).
- \* Normally use 180-day projections; however, since the water year ends Feb. 28, the end of water year projection is used.

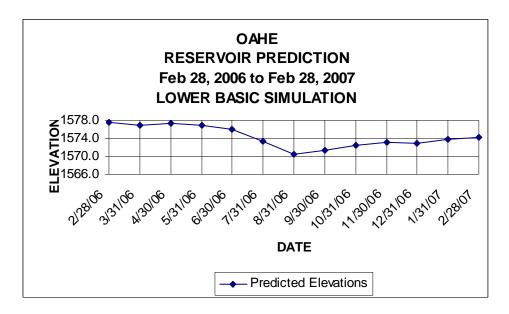
- 1. Current reservoir elevation is 35.0-feet below the top of conservation pool (elevation 1607.5 ft. msl).
- 2. Projections provided are based upon the Lower Basic Simulation prepared by the Reservoir Control Center.
- 3. Current reservoir elevation is 1.5 feet lower than 10/31/05 (1574.0).
- \* Normally use 180-day projections; however, since the water year ends Feb. 28, the end of water year projection is used.
