# U.S. Army Corps of Engineers Omaha District Monthly Drought Report October 2005

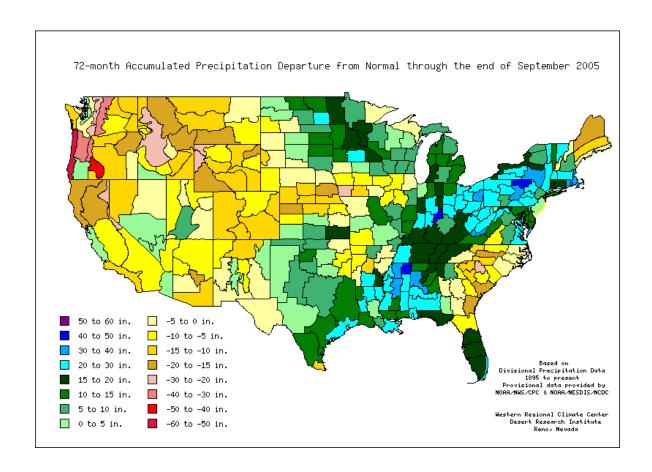
Figure 1 – 72 month Precipitation Departure From Normal <a href="http://www.wrcc.dri.edu/cgi-bin/spiFmap.pl?dep72">http://www.wrcc.dri.edu/cgi-bin/spiFmap.pl?dep72</a>

Precipitation accumulations in the Western U.S. have largely affected the severity and extent of the drought since 2000. Precipitation departures from normal during the last 72-months for the United States are shown in Figure 1. Precipitation departures or deficits in the Western U.S. have shown significant improvement due to Spring and Summer moisture. In much of western and southwestern Montana, accumulated precipitation during the last 72 months had been 15 to 20 inches below normal, compared to the current departure of 5 to 10 inches below normal. Wyoming accumulated precipitation remains 10 to 15 inches below normal during the observation period. Southeast Nebraska and southwest Iowa have received 5 to 10 inches less than normal precipitation. The Dakotas have largely received a surplus (10 to 15 inches) of precipitation in the central and eastern regions, while western regions are normal to 5 inches below normal. The South Platte River Basin in Colorado shows precipitation deficits of 5 to 10 inches during a majority of the 72-month period.

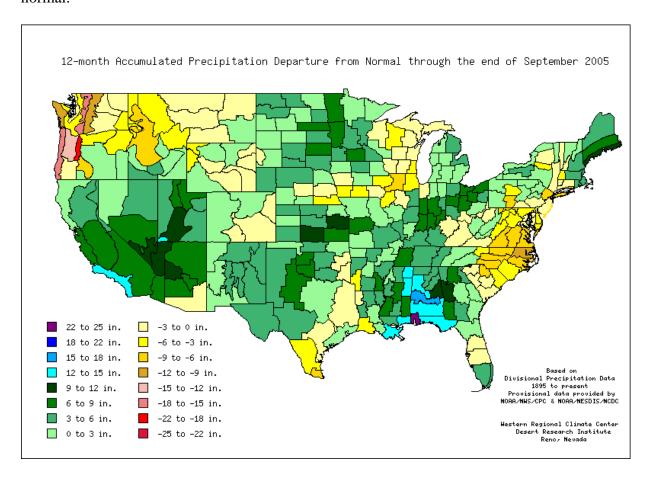
Figure 2 – 12 month Precipitation Departure From Normal <a href="http://www.wrcc.dri.edu/cgi-bin/spiFmap.pl?dep12">http://www.wrcc.dri.edu/cgi-bin/spiFmap.pl?dep12</a>

The 12-month precipitation accumulation in Figure 2 indicates that precipitation throughout much of the western and northwestern District is three-inches above or below normal.

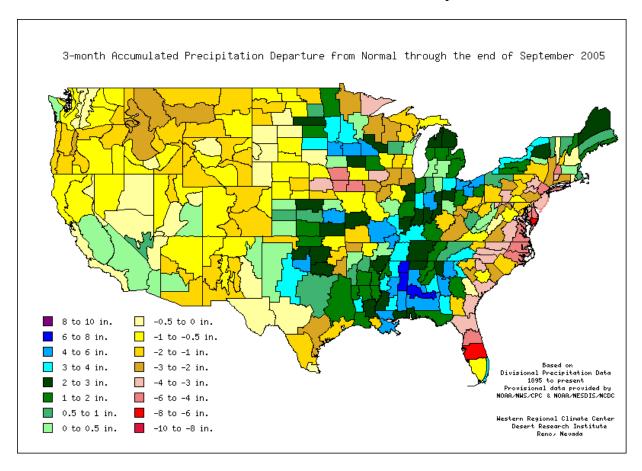
Figure 3 – 3 month Precipitation Departure From Normal <a href="http://www.wrcc.dri.edu/cgi-bin/spiFmap.pl?dep03">http://www.wrcc.dri.edu/cgi-bin/spiFmap.pl?dep03</a>

The three-month period (Figure 3) shows precipitation ranges from 3 inch deficits in Montana to 1 to 2 inch deficits in the Dakotas. Elsewhere in the District precipitation accumulations reflect zero to two inch deficits for the three-month period.

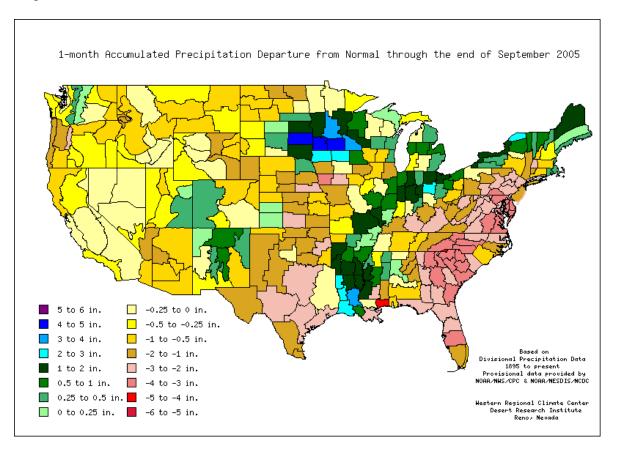
Figure 4 – 1 month Precipitation Departure From Normal <a href="http://www.wrcc.dri.edu/cgi-bin/spiFmap.pl?dep01">http://www.wrcc.dri.edu/cgi-bin/spiFmap.pl?dep01</a>

During August, the majority of the basin received normal to 2 inch rainfall deficits (Figure 4).

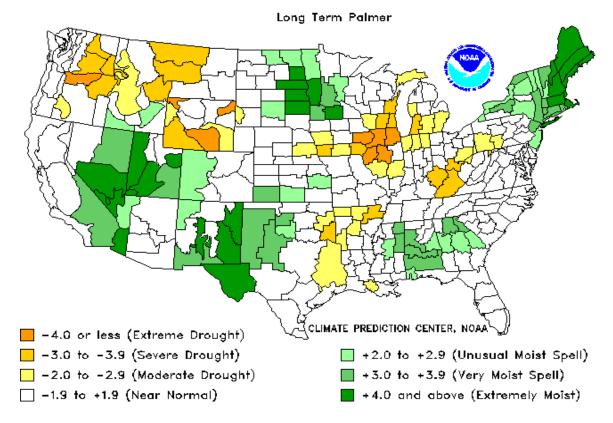
Figure 5 – Long-Term Palmer Drought Indicator Ending 3 SEP 2005 http://www.cpc.ncep.noaa.gov/products/analysis\_monitoring/regional\_monitoring/palmer.gif

Changes to the PDSI are more immediate in response to heavy precipitation over short periods. The PDSI shown in Figure 5 reflects near normal to very moist spells in South Dakota and North Dakota. Large portions of both Montana and Wyoming are still being affected by Severe and Extreme Palmer droughts.

Figure 8 is the weekly precipitation needed to reduce the current Palmer Drought Severity Index value to -0.5 or near normal conditions. According to the PDSI (Figure 5) drought currently is affecting portions of Montana, Wyoming, western South Dakota, and northern North Dakota

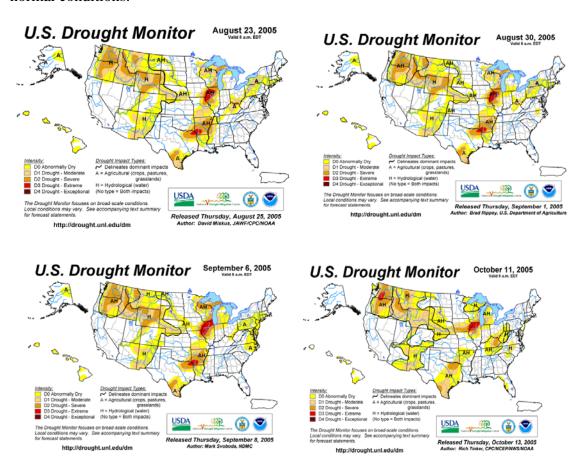
Figure 6 – U.S. Drought Monitor Through October 2005 http://drought.unl.edu/dm/monitor.html

Omaha District drought has steadily improved throughout the spring and summer. Above-normal rainfall and increased pool levels in Oahe Reservoir, Lake Sakakawea, and Ft. Peck reservoir have helped reduce the drought. Portions of Nebraska, South Dakota, Montana and Wyoming are currently classified as Severe (D2). However, the vast majority of North and South Dakota currently exhibit Abnormally Dry (D0) or normal conditions.

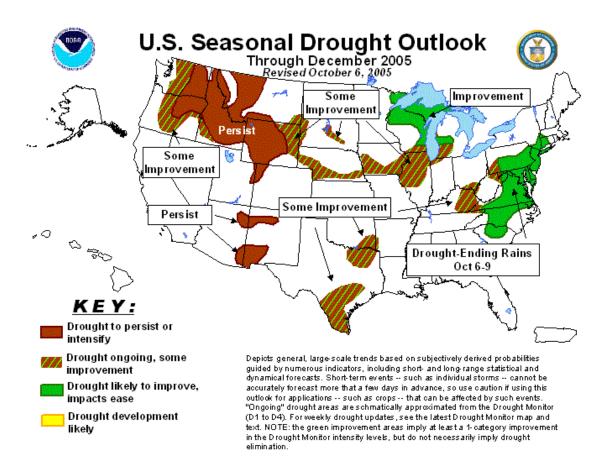
Figure 7 – Three-Month Seasonal Drought Outlook Through December 2005 http://www.cpc.ncep.noaa.gov/products/expert\_assessment/seasonal\_drought.html

The basin drought outlook uses several expert products that indicate precipitation needs to reduce the Palmer Drought to normal conditions, a one- and three-month climate outlook, and the impacts that future climate predictions could have on the current drought situation. The three-month Drought Outlook (Figure 7) indicates that the majority of the basin is returning to normal moisture conditions with the exception south-central and western Nebraska, western Montana, and Wyoming.

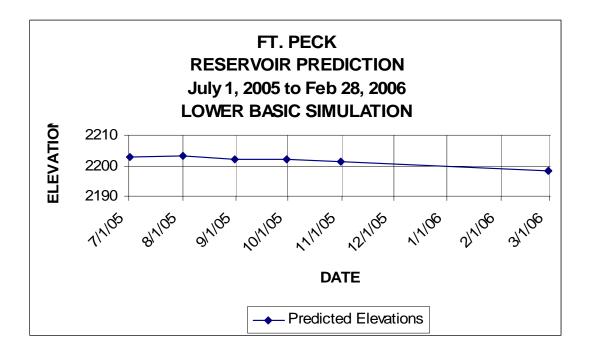
30-Day	60-Day	150-Day
	Current Lake	Projected	Projected	Projected
Lake Elevation	Elevation	Elevation*	Elevation*	Elevation*
7/01/2005	9/30/2005	(10/31/2005)	(11/30/2005)	(2/28/2006)
(ft. msl)	(ft. msl)	(ft. msl)	(ft. msl)	(ft. msl)
2203.0	2201.9	2201.2	2200.7	2198.2

- 1. Current reservoir elevation is 32.1-feet below the top of conservation pool (elevation 2234.0 ft. msl).
- 2. \*Projections provided are based upon the Lower Basic Simulation prepared by the Reservoir Control Center.
- 3. Current elevation is 2.1-ft. higher than elevation on 9/1/2004 (2199.8).

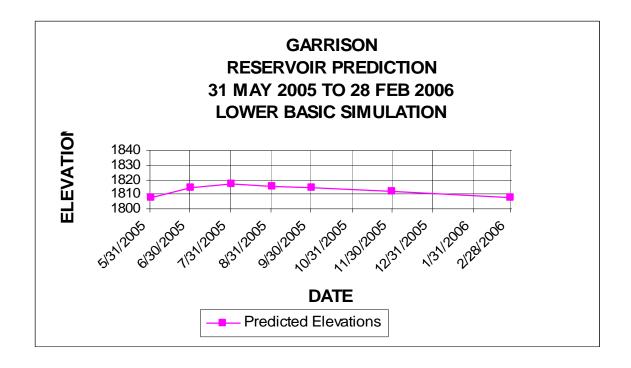
30-Day	60-Day	150-Day
	Current Lake	Projected	Projected	Projected
Lake Elevation	Elevation	Elevation*	Elevation*	Elevation*
5/31/2005	(9/30/2005)	(10/31/2005)	(11/30/2005)	(2/28/2006)
(ft. msl)	(ft. msl)	(ft. msl)	(ft. msl)	(ft. msl)
1808.08	1814.1	1812.4	1811.9	1808.0

- 1. Current reservoir elevation is 23.4-feet below the top of conservation pool (elevation 1837.5 ft. msl).
- 2. \*Projections provided are based upon the Lower Basic Simulation prepared by the Reservoir Control Center.
- 3. Current reservoir elevation is 0.8 ft. higher than elevation on 10/1/04.

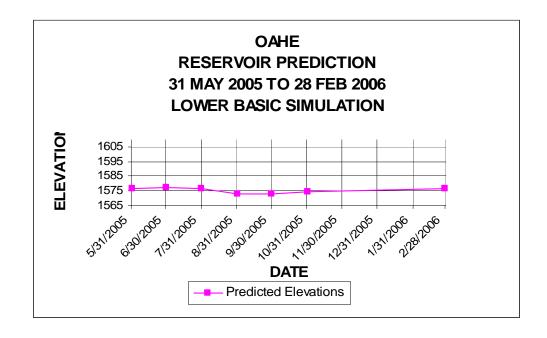
30-Day	60-Day	150-Day
	Current Lake	Projected	Projected	Projected
Lake Elevation	Elevation	Elevation*	Elevation*	Elevation*
5/31/2005	(9/30/2005)	(10/31/2005)	(11/30/2005)	(2/28/2006)
(ft. msl)	(ft. msl)	(ft. msl)	(ft. msl)	(ft. msl)
1576.5	1572.8	1574.6	1575.8	1576.6

- 1. Current reservoir elevation is 34.7-feet below the top of conservation pool (elevation 1607.5 ft. msl).
- 2. \*Projections provided are based upon the Lower Basic Simulation prepared by the Reservoir Control Center.

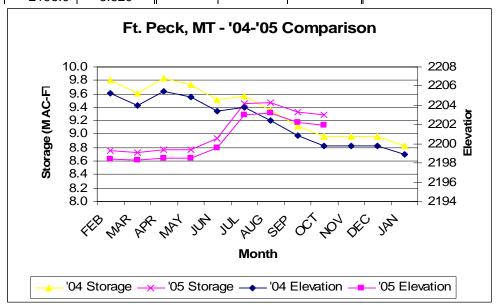
Ft. Peck, MT

/ater Year 2	005			
Water Year 2004 (FEB 2004 - JAN 2005)			(FEB 2005 - JAN 2006)		
		Storage	,		Storage
Date	Elevation	(MAC-Ft.)	Date	Elevation	(MAC-Ft.)
FEB	2205.3	9.806	2/1/05	2198.4	8.749
MAR	2204	9.603	3/1/05	2198.3	8.732
APR	2205.5	9.837	4/1/05	2198.52	8.773
MAY	2204.9	9.740	5/1/05	2198.53	8.773
JUN	2203.4	9.507	6/1/05	2199.61	8.935
JUL	2203.8	9.565	7/1/05	2203	9.448
AUG	2202.4	9.357	8/1/05	2203.2	9.472
SEP	2200.9	9.121	9/1/05	2202.2	9.325
ОСТ	2199.8	8.969	9/30/05	2201.9	9.286
NOV	2199.8	8.963			
DEC	2199.8	8.961			
JAN	2198.9	8.829

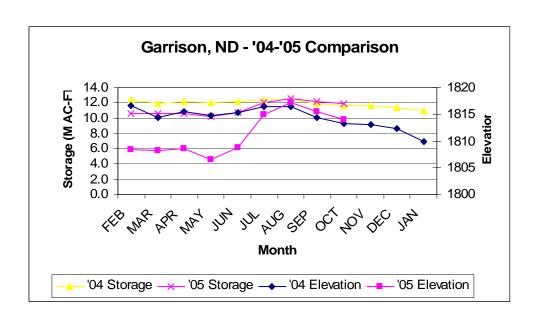
# Garrison, ND

Water Year 2004			2005		
(FEB 2004 - JAN 2005)			(FEB 2005 - JAN 2006)		
		Storage			Storage
Date	Elevation	(MAC-Ft.)	Date	Elevation	(MAC-Ft.)
FEB	1816.7	12.446	2/1/05	1808.4	10.574
MAR	1814.3	11.891	3/1/05	1808.2	10.537
APR	1815.6	12.110	4/1/05	1808.65	10.632
MAY	1814.7	11.989	5/1/05	1806.47	10.189
JUN	1815.3	12.121	6/1/05	1808.8	10.665
JUL	1816.5	12.426	7/1/05	1814.9	12.026
AUG	1816.5	12.401	8/1/05	1817.17	12.591
SEP	1814.3	11.914	9/1/05	1815.6	12.216
ОСТ	1813.3	11.645	9/30/05	1814.1	11.861
NOV	1813.1	11.589			
DEC	1812.3	11.422			
JAN	1810	10.936

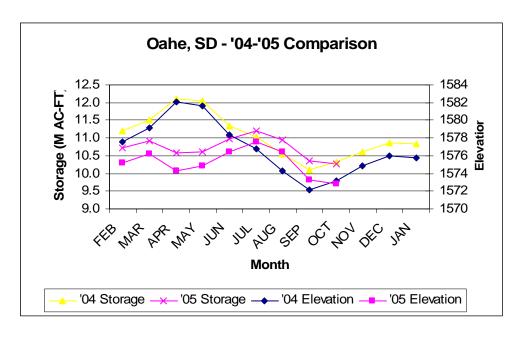
Oahe, SD

Water Year 2004		2005			
(FEB 2004 - JAN 2005)			(FEB 2005 - JAN 2006)		
		Storage			Storage
Date	Elevation	(MAC-Ft.)	Date	Elevation	(MAC-Ft.)
FEB	1577.6	11.204	2/1/05	1575.2	10.715
MAR	1579.2	11.504	3/1/05	1576.2	10.924
APR	1582.1	12.110	4/1/05	1574.29	10.568
MAY	1581.6	12.056	5/1/05	1574.82	10.608
JUN	1578.4	11.338	6/1/05	1576.47	10.980
JUL	1576.8	11.045	7/1/05	1577.6	11.214
AUG	1574.3	10.540	8/1/05	1576.38	10.958
SEP	1572.1	10.112	9/1/05	1573.3	10.363
ОСТ	1573.2	10.316	9/30/05	1572.8	10.267
NOV	1574.8	10.608			
DEC	1576	10.866			
JAN	1575.8	10.824
