**U.S. Army Corps of Engineers
Omaha District
Monthly Drought Report
September 2006**

**US Army Corps
of Engineers
Omaha District**

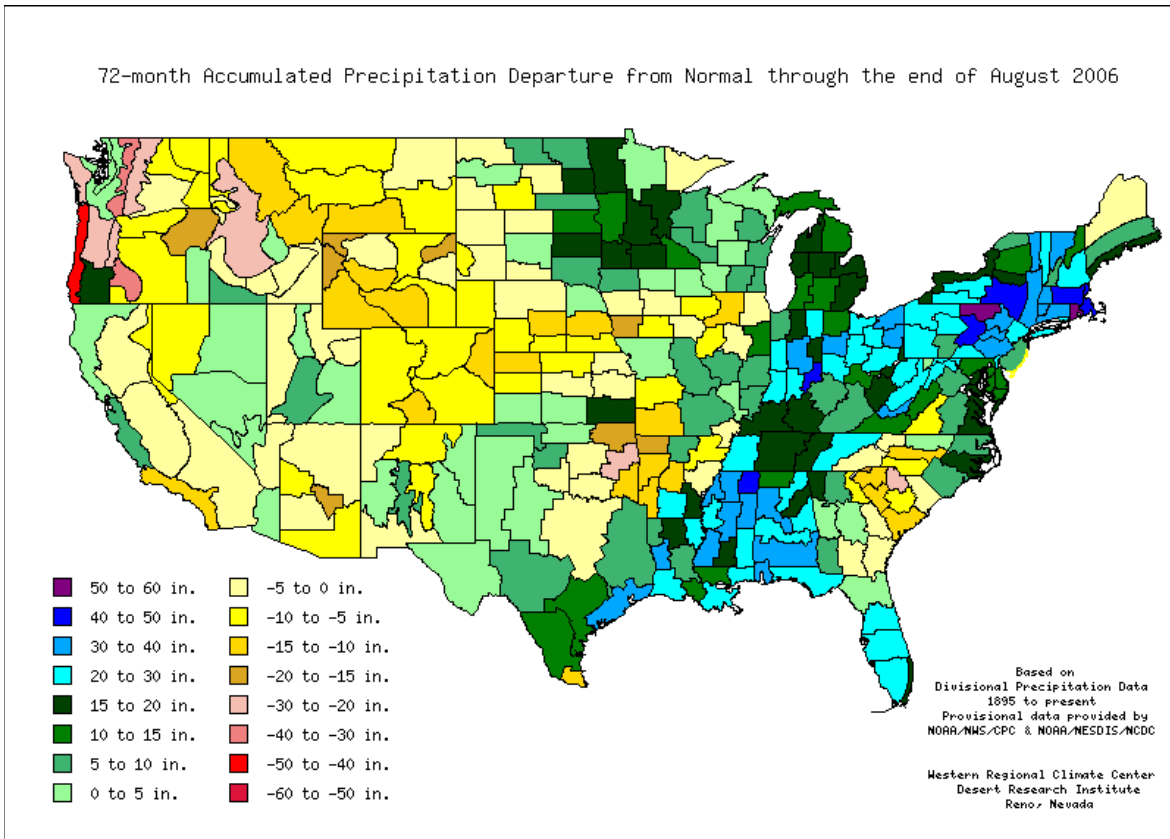
Figure 1 – 72 month Precipitation Departure From Normal

Precipitation departures from normal during the last 72 months for the United States are shown in Figure 1. In Montana, accumulated precipitation ranges from near normal to nearly a 15-inch deficit. Wyoming's accumulated precipitation varies widely from near normal to a 20-inch deficit. Nebraska ranges from near normal to a 15-inch deficit. The Dakotas generally range from near normal to a 30-inch deficit. The South Platte River Basin in Colorado still shows precipitation deficits of 5 to 15 inches during a majority of the 72-month period.

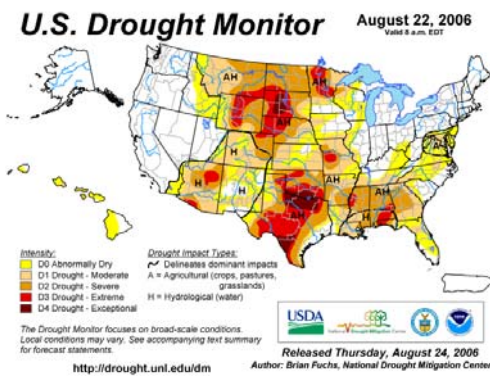
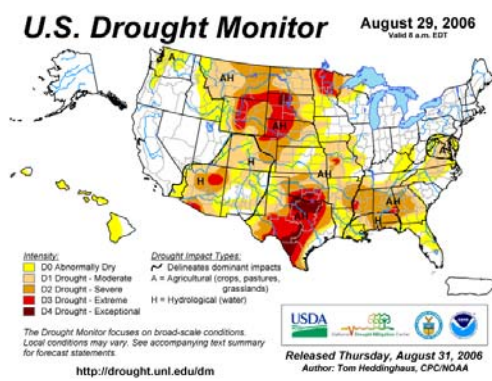
Figure 6 – U.S. Drought Monitor – August 1, 2006 through August 29, 2006
<http://www.drought.unl.edu/dm/monitor.html>

Similar to July, the basin has large areas suffering from "severe" to "exceptional" drought conditions. The figures below illustrate the extent and severity of the drought.

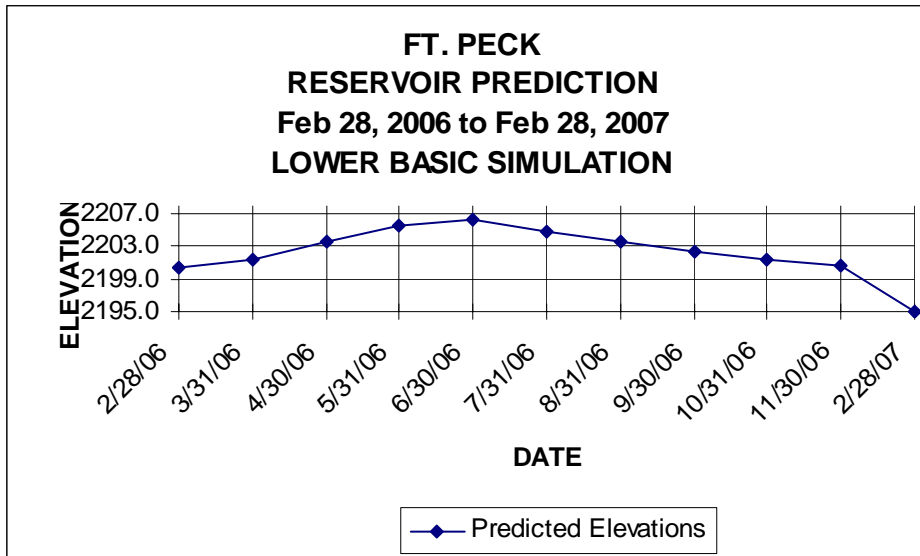
Lake Elevation 8/31/2005 (ft. msl)	Current Lake Elevation 8/31/2006 (ft. msl)	30-Day Projected Elevation* (9/30/2006) (ft. msl)	150-Day Projected Elevation* (01/31/2007) (ft. msl)
2202.3	2203.5	2202.3	2196.5

1. Current reservoir elevation is 30.5-feet below the top of conservation pool (elevation 2234.0 ft. msl).
 2. Projections provided are based upon the Lower Basic Simulation prepared by the Reservoir Control Center.
 3. Current elevation is 1.2-ft. higher than elevation on 7/31/05 (2203.2).
- * Normally use 180-day projections; however, since the water year ends Jan. 31, the end of water year projection is used.

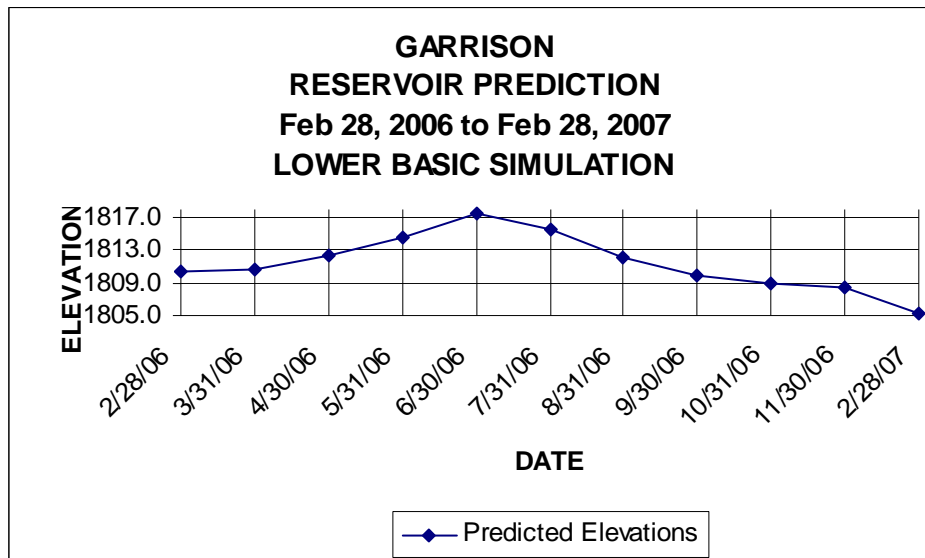
Lake Elevation 8/31/2005 (ft. msl)	Current Lake Elevation (8/31/2006) (ft. msl)	30-Day Projected Elevation (9/30/2006) (ft. msl)	150-Day Projected Elevation* (1/31/2007) (ft. msl)
1816.5	1812.0	1809.8	1806.0

1. Current reservoir elevation is 25.5-feet below the top of conservation pool (elevation 1837.5 ft. msl).
 2. Projections provided are based upon the Lower Basic Simulation prepared by the Reservoir Control Center.
 3. Current reservoir elevation is 4.5 ft. lower than elevation on 8/31/05 (1816.5).
- * Normally use 180-day projections; however, since the water year ends Jan. 31, the end of water year projection is used.

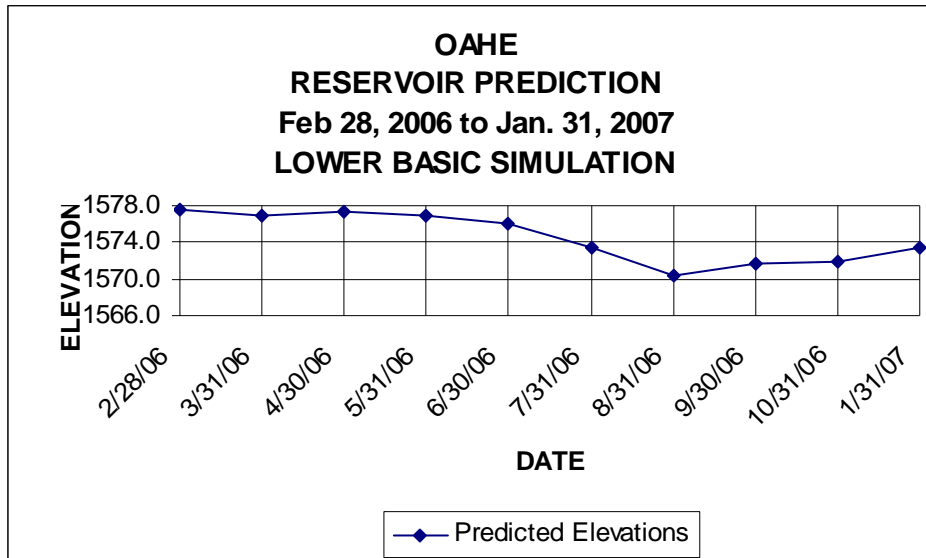
Lake Elevation 8/31/2005 (ft. msl)	Current Lake Elevation (8/31/2006) (ft. msl)	30-Day Projected Elevation (9/30/2006) (ft. msl)	150-Day Projected Elevation* (1/31/2007) (ft. msl)
1573.9	1570.4	1572.9	1573.8

1. Current reservoir elevation is 37.1-feet below the top of conservation pool (elevation 1607.5 ft. msl).
 2. Projections provided are based upon the Lower Basic Simulation prepared by the Reservoir Control Center.
 3. Current reservoir elevation is 3.5 feet lower than 8/31/05 (1573.9).
- * Normally use 180-day projections; however, since the water year ends Jan. 31, the end of water year projection is used.

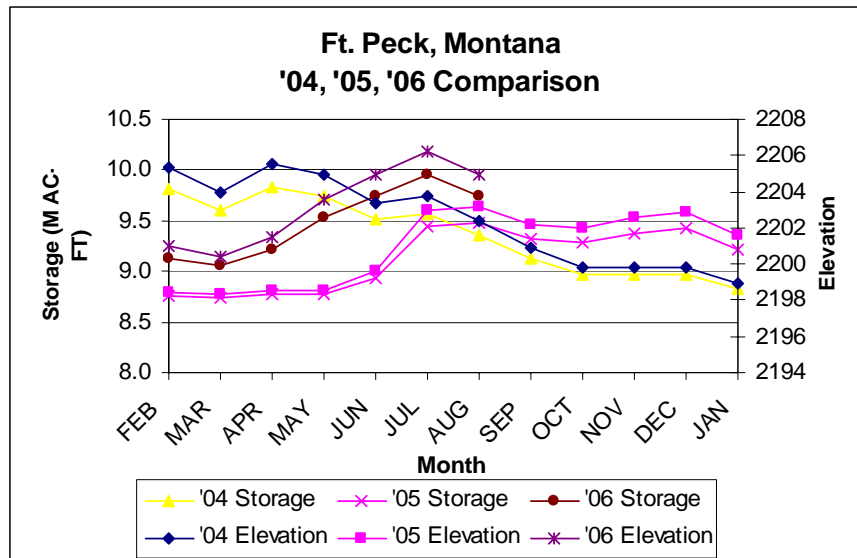
Fort Peck, Montana

Water Year 2004 (FEB 2004 – JAN 2005)			Water Year 2005 (FEB 2005 – JAN 2006)			Water Year 2006 (FEB 2006 – JAN 2007)		
Date	Elevation	Storage (MAC-Ft.)	Date	Elevation	Storage (MAC-Ft.)	Date	Elevation	Storage (MAC-Ft.)
2/1/2004	2205.3	9.806	2/1/2005	2198.4	8.749	2/1/2006	2201.0	9.134
3/1/2004	2204	9.603	3/1/2005	2198.3	8.732	3/1/2006	2200.4	9.048
4/1/2004	2205.5	9.837	4/1/2005	2198.5	8.773	4/1/2006	2201.5	9.222
5/1/2004	2204.9	9.740	5/1/2005	2198.5	8.773	5/1/2006	2203.6	9.540
6/1/2004	2203.4	9.507	6/1/2005	2199.6	8.935	6/1/2006	2204.9	9.741
7/1/2004	2203.8	9.565	7/1/2005	2203.0	9.448	7/1/2006	2206.2	9.958
8/1/2004	2202.4	9.357	8/1/2005	2203.2	9.472	8/1/2006	2204.9	9.750
9/1/2004	2200.9	9.121	9/1/2005	2202.2	9.325	9/1/2006		
10/1/2004	2199.8	8.969	10/1/2005	2202.0	9.286	10/1/2006		
11/1/2004	2199.8	8.963	11/1/2005	2202.6	9.371	11/1/2006		
12/1/2004	2199.8	8.961	12/1/2005	2202.9	9.432	12/1/2006		
1/1/2005	2198.9	8.829	1/1/2006	2201.5	9.222	1/1/2007

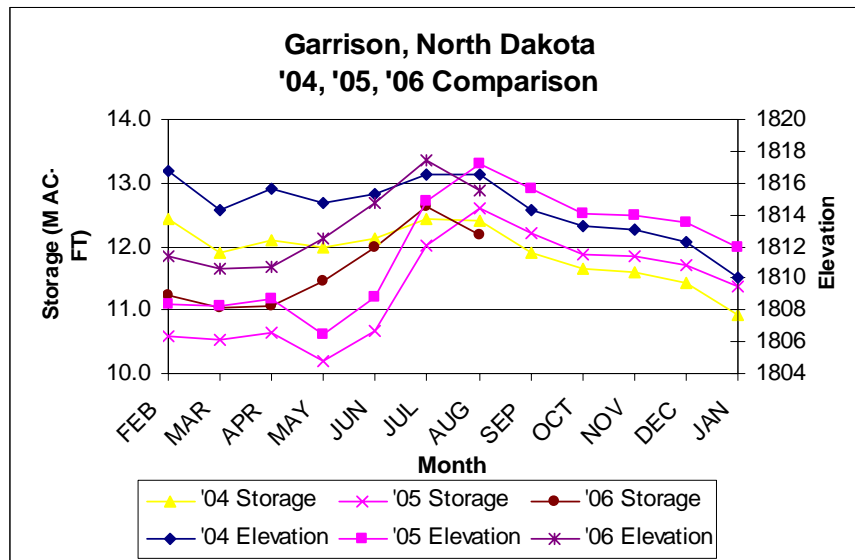
Garrison, ND

Water Year 2004 (FEB 2004 – JAN 2005)			Water Year 2005 (FEB 2005 – JAN 2006)			Water Year 2006 (FEB 2006 – JAN 2007)		
Date	Elevation	Storage (MAC-Ft.)	Date	Elevation	Storage (MAC-Ft.)	Date	Elevation	Storage (MAC-Ft.)
2/1/2004	1816.7	12.446	2/1/2005	1808.4	10.574	2/1/2006	1811.4	11.230
3/1/2004	1814.3	11.891	3/1/2005	1808.2	10.537	3/1/2006	1810.6	11.040
4/1/2004	1815.6	12.110	4/1/2005	1808.65	10.632	4/1/2006	1810.7	11.076
5/1/2004	1814.7	11.989	5/1/2005	1806.47	10.189	5/1/2006	1812.5	11.460
6/1/2004	1815.3	12.121	6/1/2005	1808.8	10.665	6/1/2006	1814.7	11.992
7/1/2004	1816.5	12.426	7/1/2005	1814.9	12.026	7/1/2006	1817.4	12.629
8/1/2004	1816.5	12.401	8/1/2005	1817.17	12.591	8/1/2006	1815.5	12.172
9/1/2004	1814.3	11.914	9/1/2005	1815.56	12.216	9/1/2006		
10/1/2004	1813.3	11.645	10/1/2005	1814.11	11.861	10/1/2006		
11/1/2004	1813.1	11.589	11/1/2005	1814.00	11.837	11/1/2006		
12/1/2004	1812.3	11.422	12/1/2005	1813.50	11.707	12/1/2006

1/1/2005	1810	10.936	1/1/2006	1812.0	11.371	1/1/2007

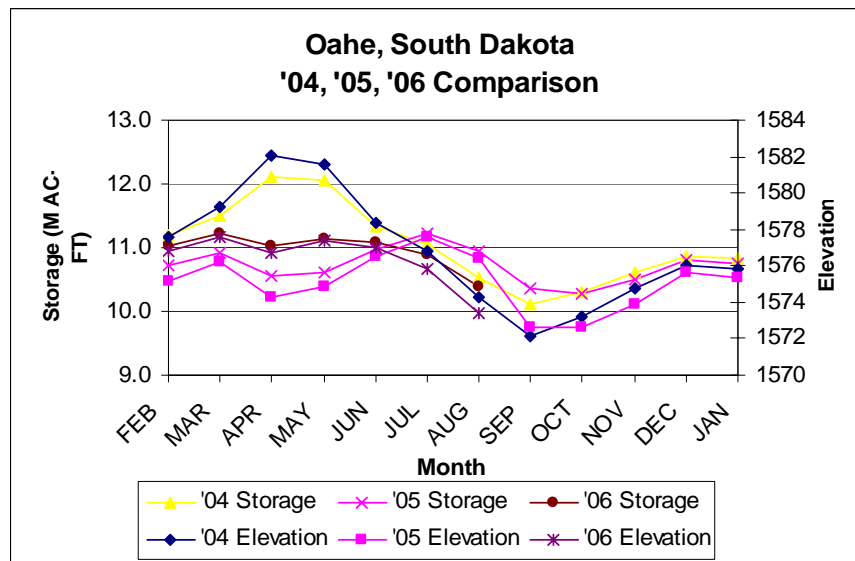
Oahe, SD

Water Year 2004 (FEB 2004 – JAN 2005)			Water Year 2005 (FEB 2005 – JAN 2006)			Water Year 2006 (FEB 2006 – JAN 2007)		
Date	Elevation	Storage (MAC-Ft.)	Date	Elevation	Storage (MAC-Ft.)	Date	Elevation	Storage (MAC-Ft.)
2/1/2004	1577.6	11.204	2/1/2005	1575.2	10.715	2/1/2006	1576.8	11.037
3/1/2004	1579.2	11.504	3/1/2005	1576.2	10.924	3/1/2006	1577.6	11.209
4/1/2004	1582.1	12.110	4/1/2005	1574.29	10.568	4/1/2006	1576.7	11.024
5/1/2004	1581.6	12.056	5/1/2005	1574.82	10.608	5/1/2006	1577.4	11.150
6/1/2004	1578.4	11.338	6/1/2005	1576.47	10.980	6/1/2006	1577.0	11.088
7/1/2004	1576.8	11.045	7/1/2005	1577.6	11.214	7/1/2006	1575.8	10.880
8/1/2004	1574.3	10.540	8/1/2005	1576.38	10.958	8/1/2006	1573.4	10.378
9/1/2004	1572.1	10.112	9/1/2005	1572.64	10.363	9/1/2006		
10/1/2004	1573.2	10.316	10/1/2005	1572.63	10.267	10/1/2006		
11/1/2004	1574.8	10.608	11/1/2005	1573.90	10.501	11/1/2006		
12/1/2004	1576	10.866	12/1/2005	1575.6	10.814	12/1/2006

1/1/2005	1575.8	10.824	1/1/2006	1575.6	10.778	1/1/2007
