WATER CONTROL MANUAL

**MATHEWS CANYON DAM & RESERVOIR
CLOVER CREEK, LINCOLN COUNTY, NEVADA**

SEPTEMBER 2000

**U.S. ARMY CORPS OF ENGINEERS
LOS ANGELES DISTRICT**

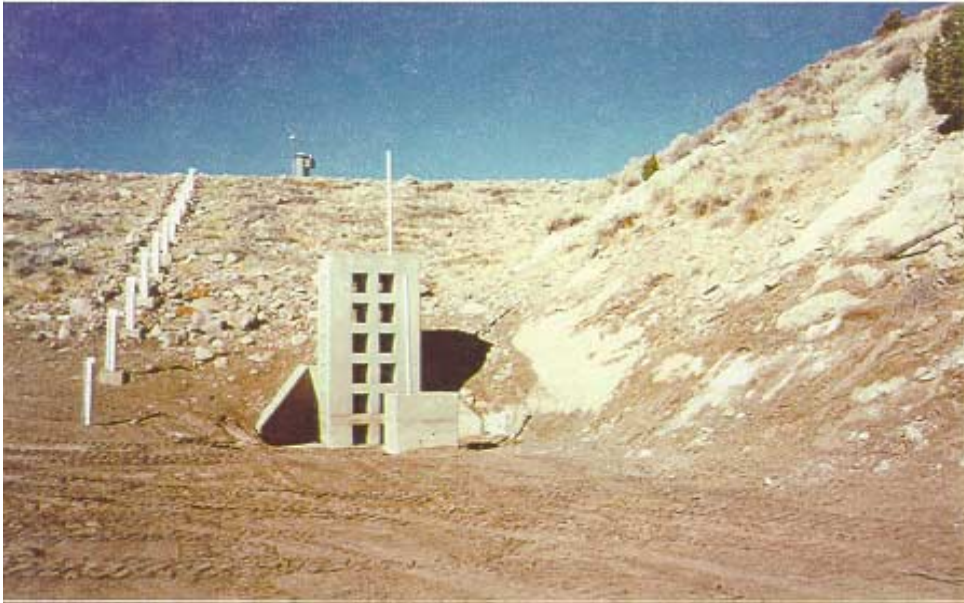
Photo 2-3. Intake structure and staff boards at right abutment.

abutment (looking downstream) and consists of an intake structure, an ungated conduit and a stilling basin. The plan, profile and sections of the outlet works are shown on Plate 2-04 and 2-05. Studies were conducted to determine the type of conduit to be constructed as part of the outlet works. Consideration was given to the following: 1) ease of construction, 2) accessibility for inspection and maintenance, and 3) desirability of providing sufficient capacity to drain the reservoir in a reasonable length of time (estimated to be about 2 weeks). From these studies, it was found that the smallest practicable conduit that would meet these requirements was a 3.5 feet diameter conduit. The outlet discharge curve for the 3.5 feet diameter conduit is shown on Plate 2-06. A general description of the outlet works is contained in the following paragraphs.

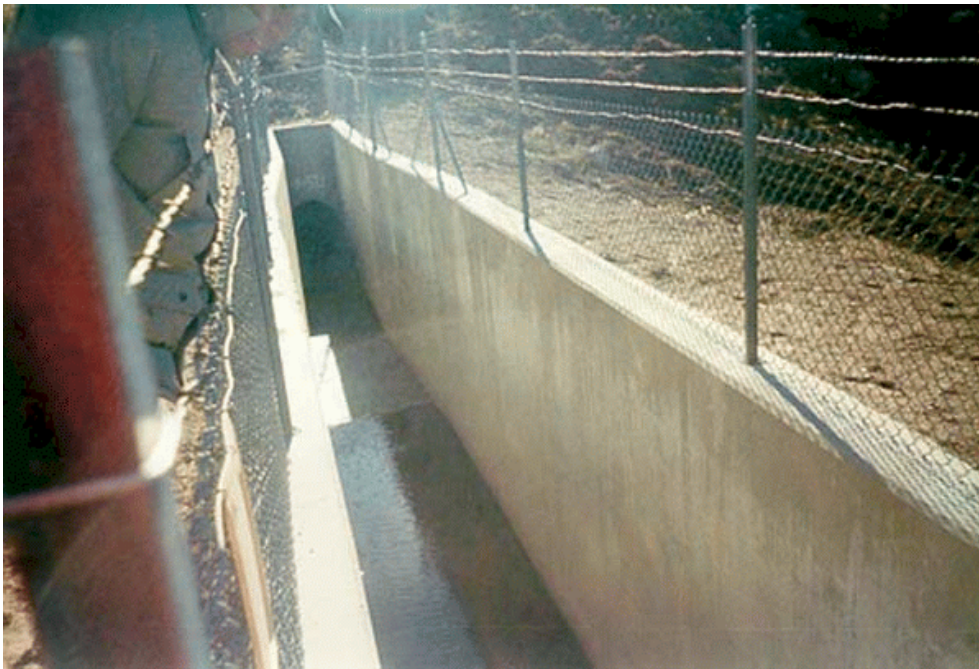
Photo 2-4. Looking upstream at outlet tunnel and stilling basin.

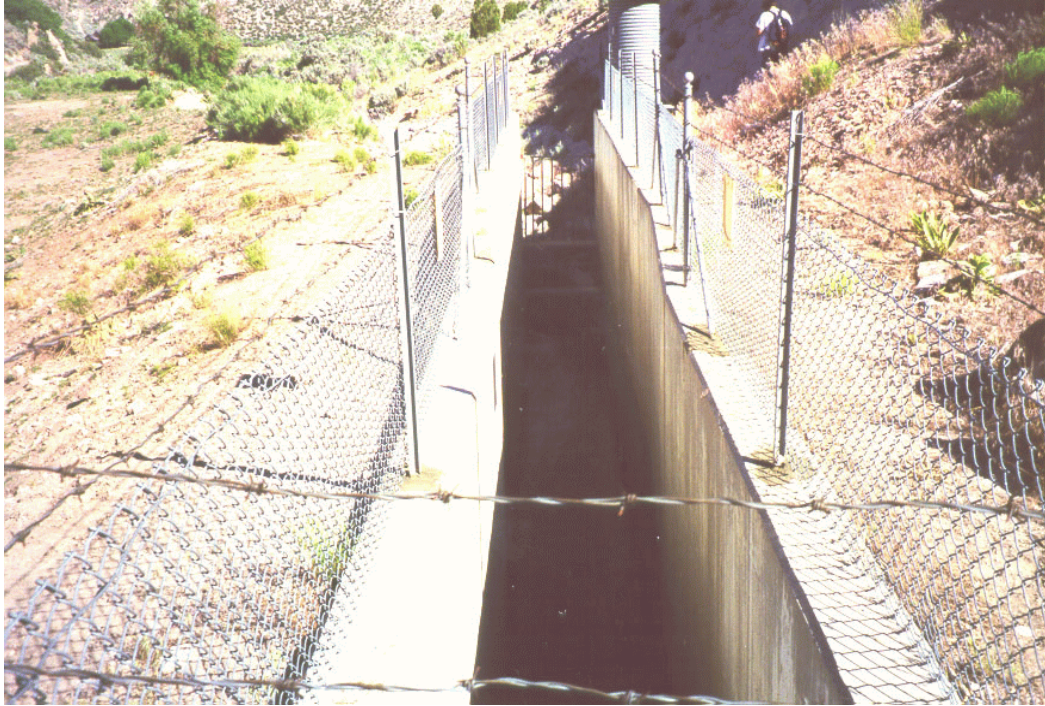
Photo 2-5. Looking downstream at stilling basin.

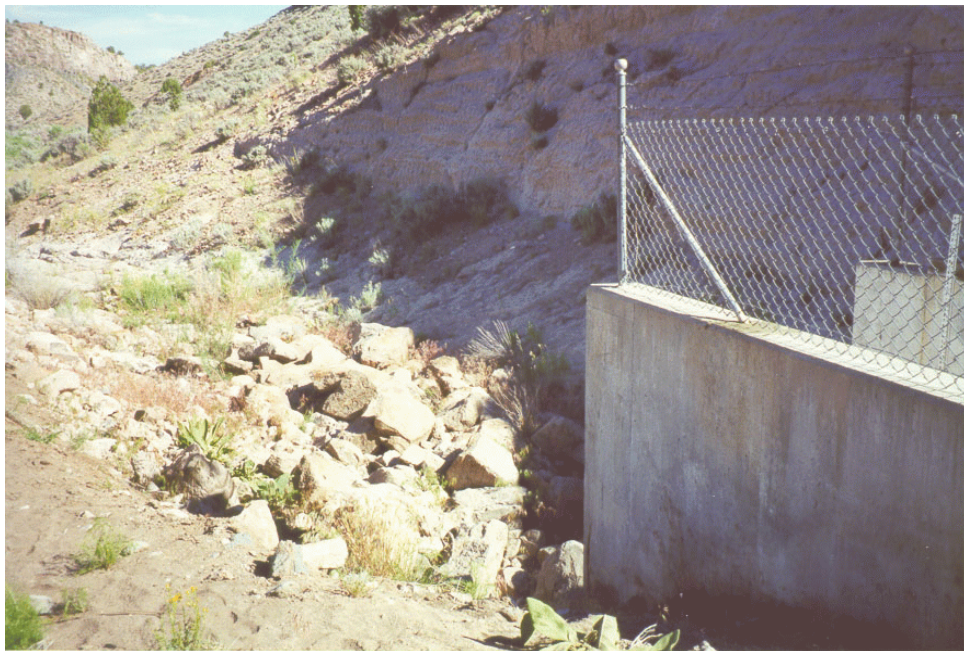
Photo 2-6. Riprap at the Transition from Stilling Basin to Outlet Channel

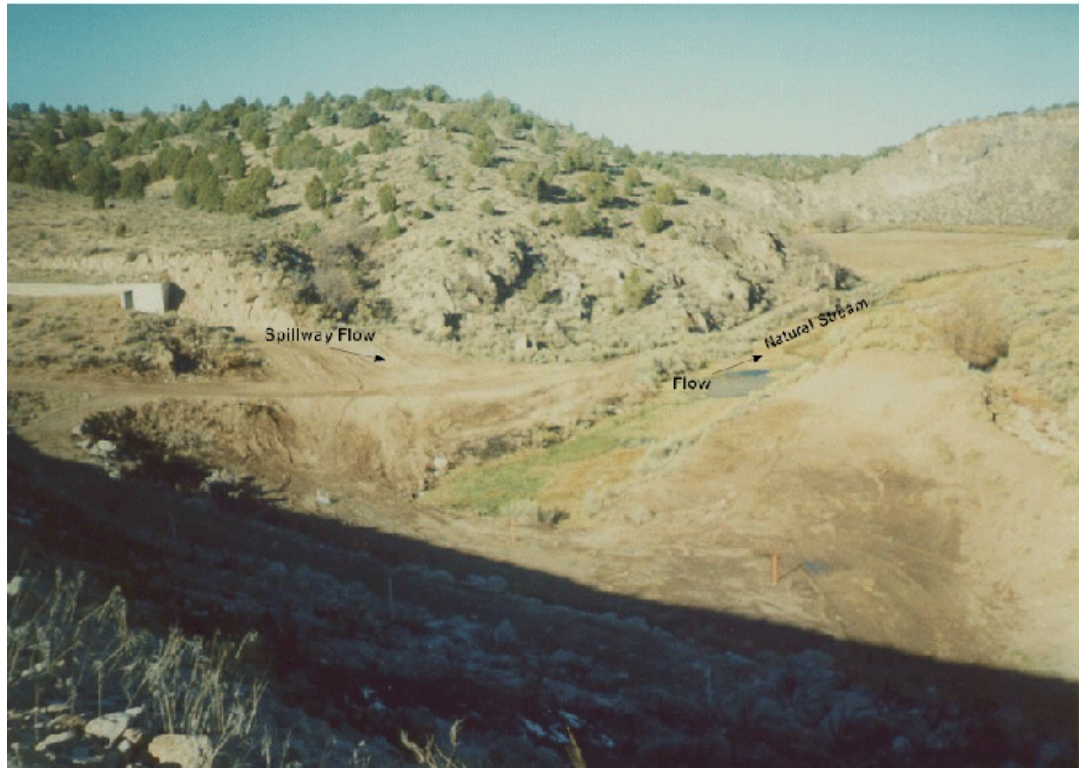
Photo 4-1. Looking downstream below spillway

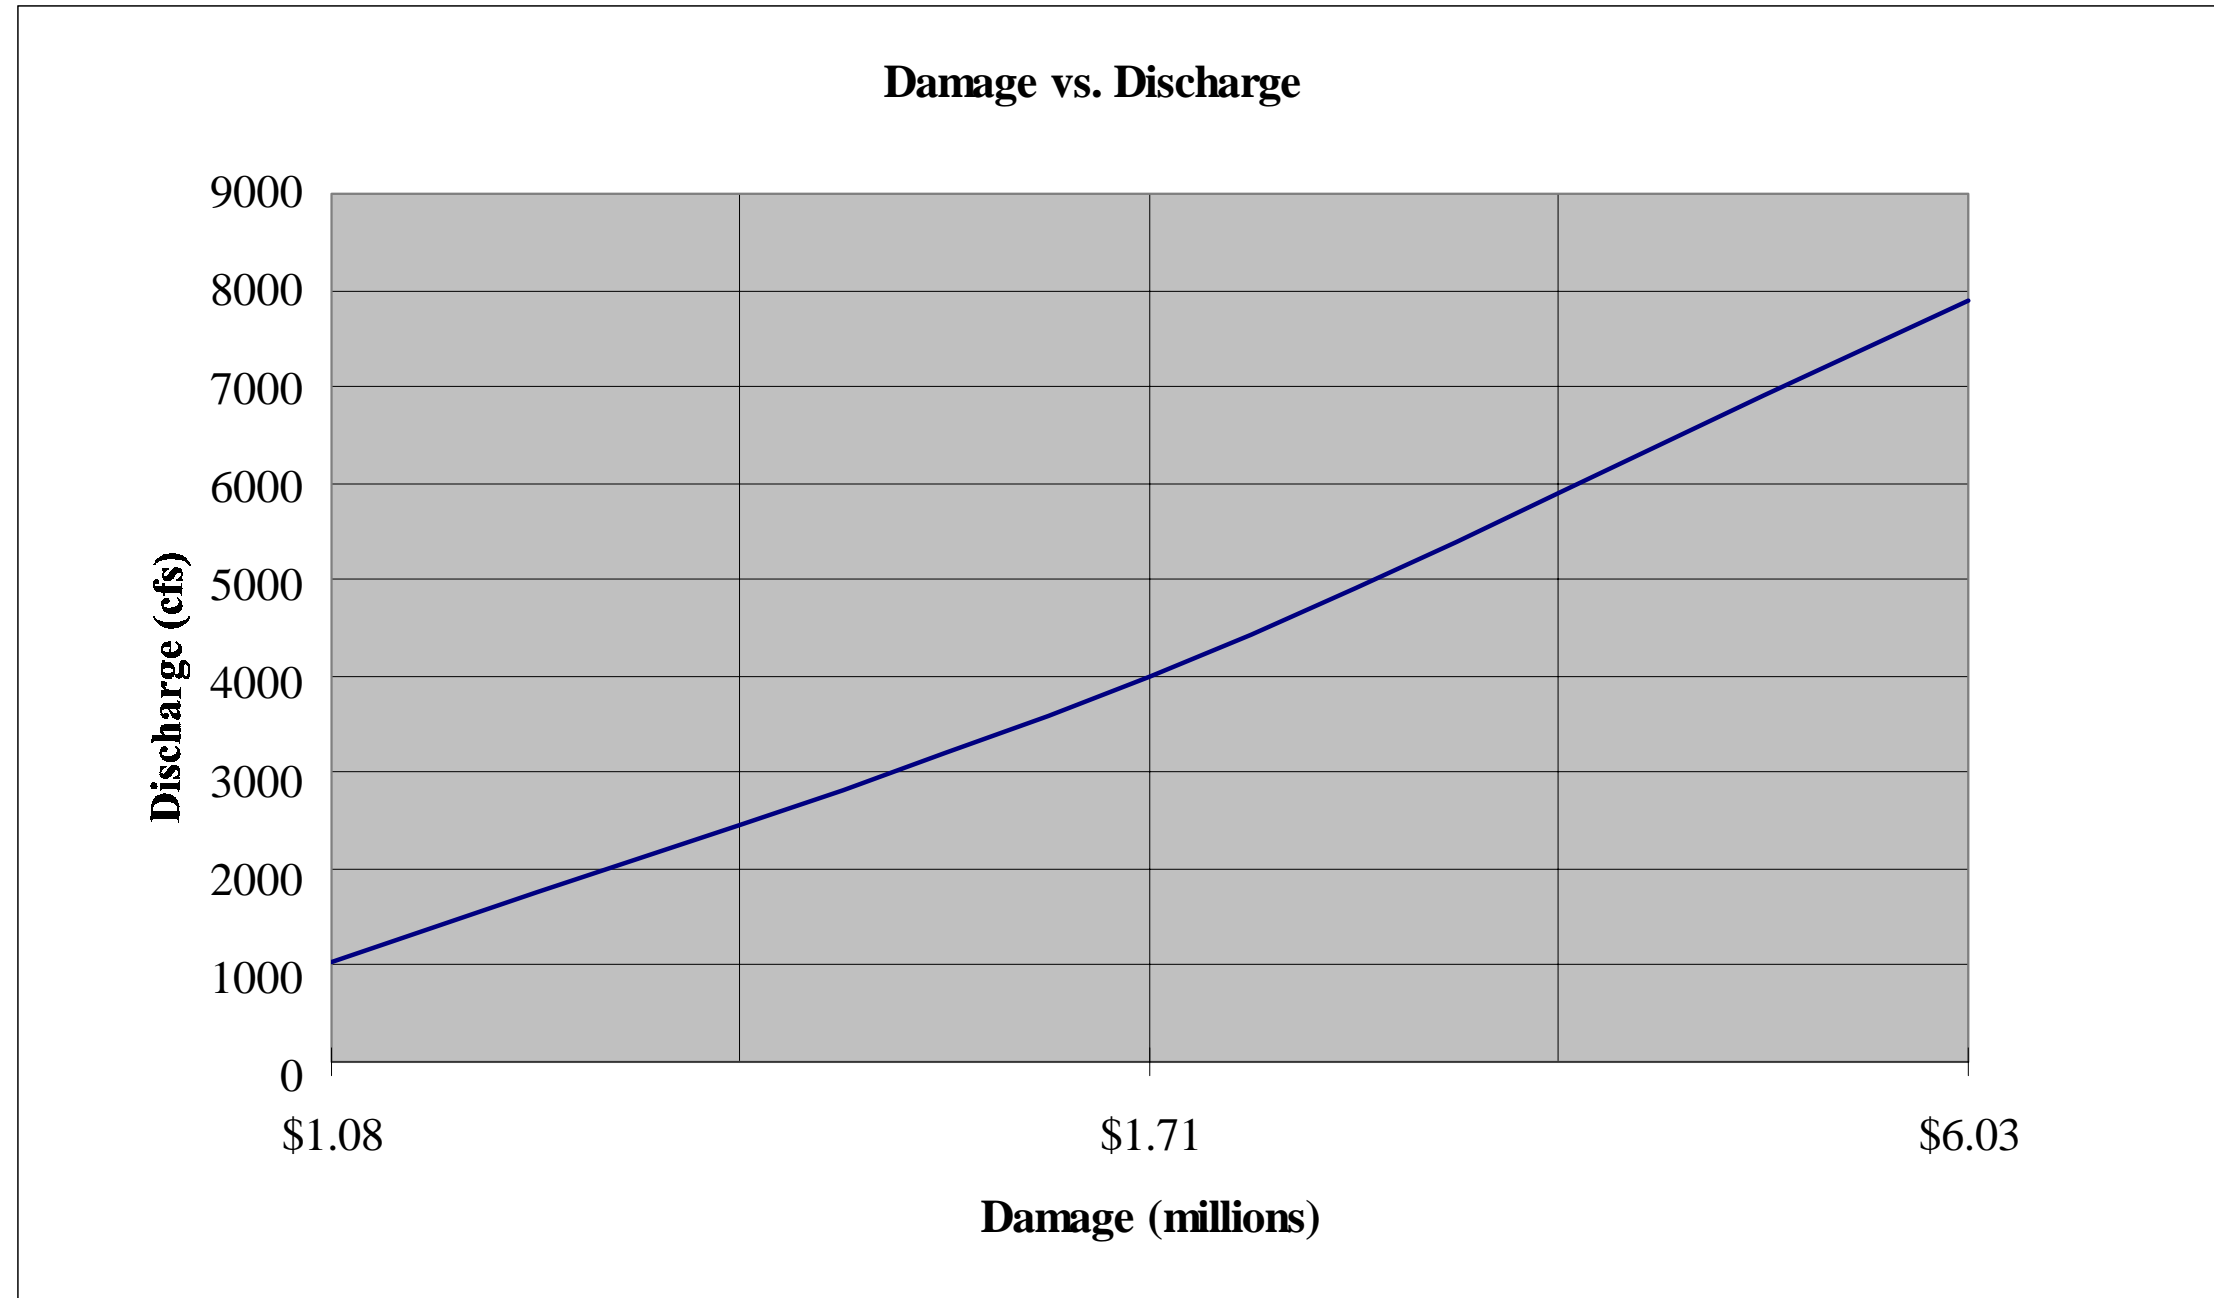
1. The damage reach considered for the economic analysis were four overflow areas, namely Clover Creek, Caliente, Lower Meadow Valley Wash from Caliente to Muddy River, and Lower Muddy River from Meadow Valley Wash to Lake Mead. The damages prevented are discussed in Section 4-12.d.
2. The damage-discharge curve was based on Mathews Canyon and Pine Canyon Dams and Reservoirs as an interdependent unit.

DAMAGE - DISCHARGE CURVE

performed. The economic analysis was performed by the Los Angeles District's Economic Section, and the numeric estimate of flood damages prevented was based on their Damage-Discharge curve. The damage reach considered in this analysis were four overflow areas, namely Clover Creek, Caliente, Lower Meadow Valley Wash from Caliente to Muddy River, and Lower Muddy River from Meadow Valley Wash to Lake Mead. The Damage-Discharge curve is shown on Plate 4-09.

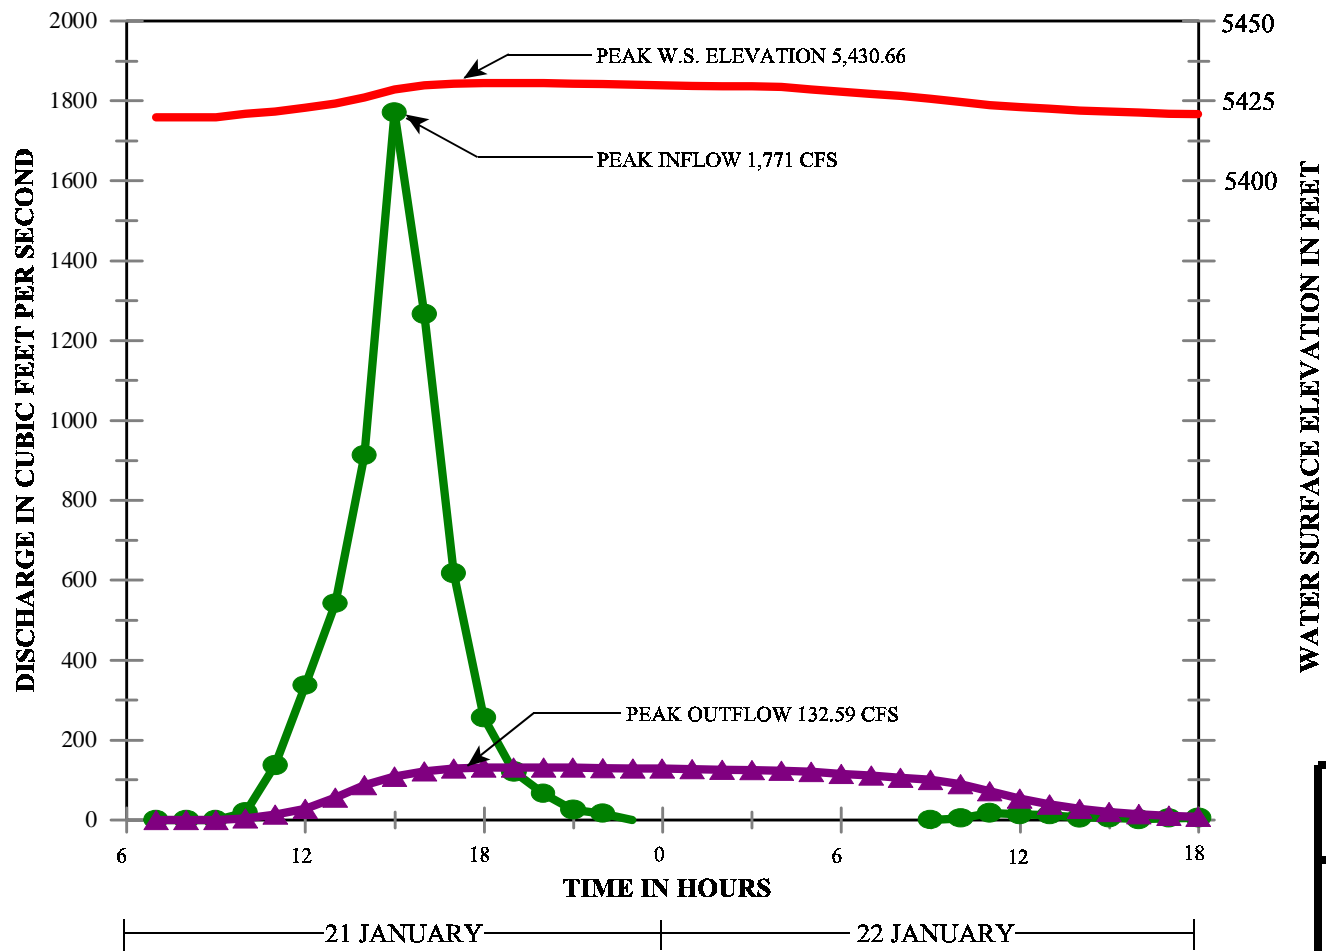
OPERATION HYDROGRAPHS
 21 JANUARY - 22 JANUARY 1969

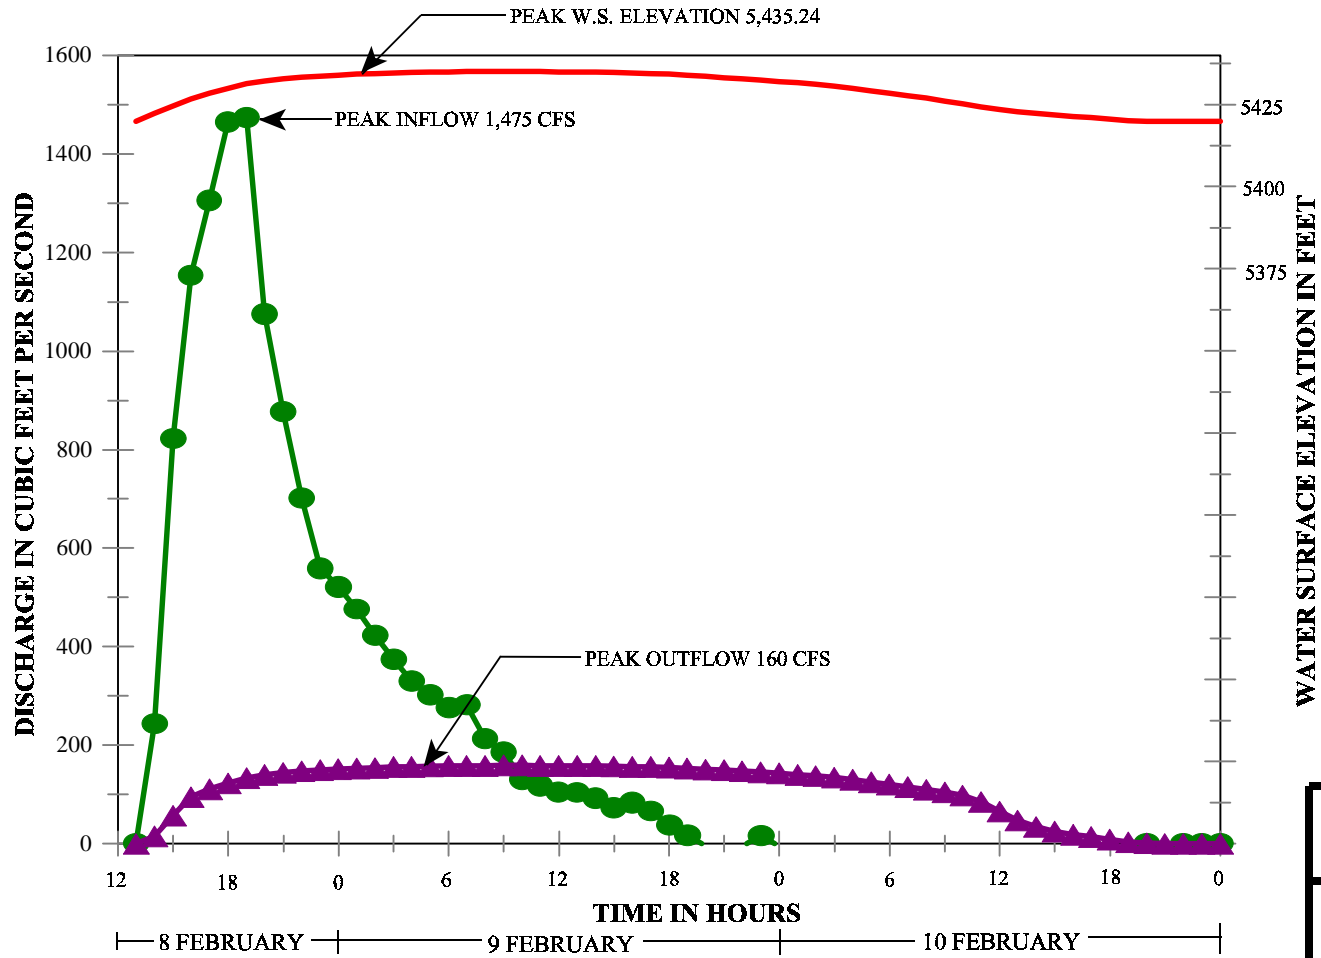
OPERATION HYDROGRAPH
 8 FEBRUARY - 10 FEBRUARY 1993
