## Moving a Lighthouse...Saving a Landmark

The 208-foot-high Cape Hatteras Lighthouse is being relocated 2,900 feet southwest of its present location and 1,600 feet inland from the ocean. This move is underway to save this Landmark structure, built in 1870, from destruction due to the rapidly eroding beach along Hatteras Island. The lighthouse should reach its new site in July. Watch for a full account of this amazing preservation effort in a fall issue of *CRM*.

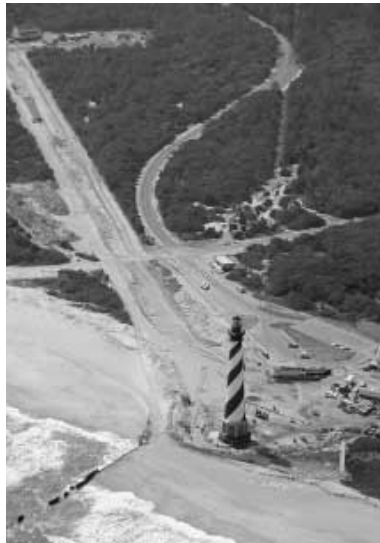
Cape Hatteras Lighthouse, showing the move corridor. Photo by Mike Booher.

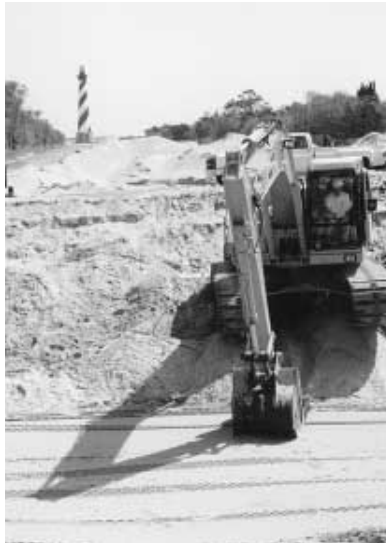
Preparing the new site to receive the tower. Photo by Steve Kozosky.

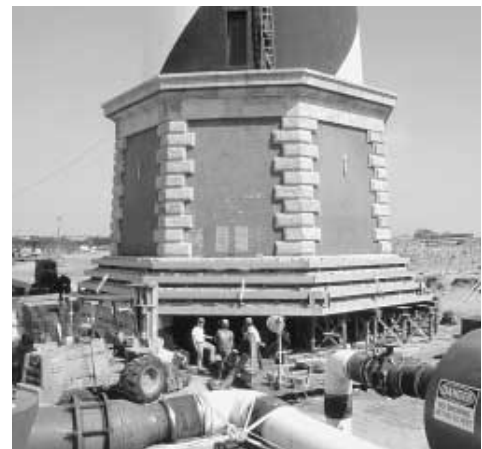
The lighthouse tower on a temporary support system. Note one of a series of sensors (at right on tower base) which will be connected to a central monitor to direct the operator to adjust the hydraulic jacks that will support the tower during the move. Photo by Steve Kozosky.

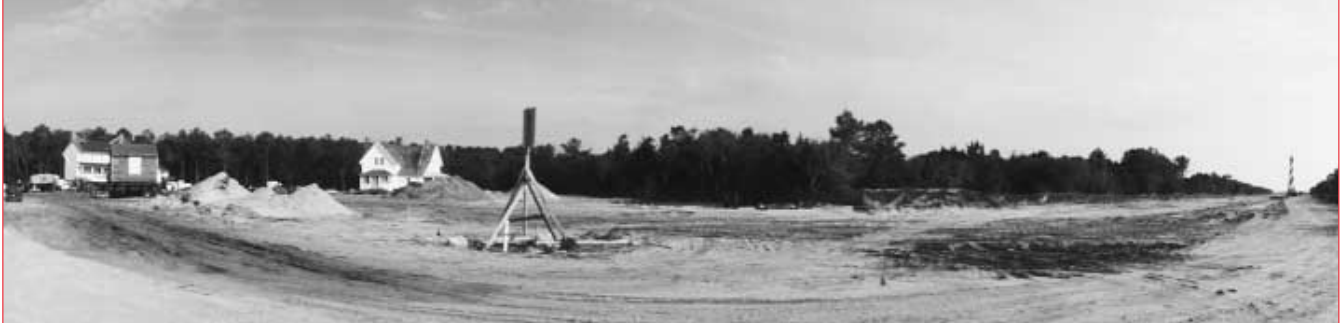
The move corridor. The lighthouse is at the original location on the far right. The keeper's quarters are positioned in their new site on the left. Photo by Mike Booher.

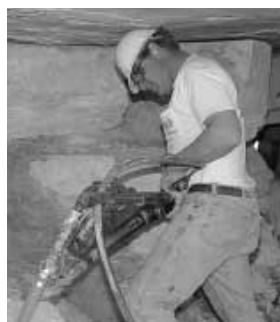
Mike Vakanti removes foundation stones before the lighthouse can be lifted from its present foundation. Photo by Mike Booher.

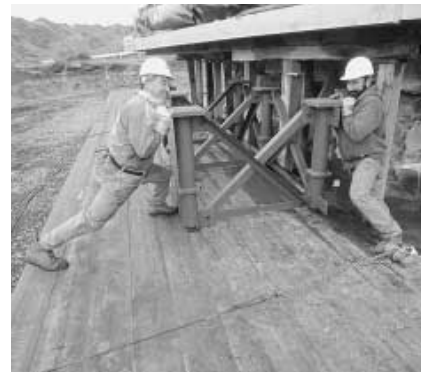
Jim Matyiko and Richie Meekins of Expert House Movers install temporary support system. Photo by Mike Booher.
