John Enright

## American Samoa Prepares its Historic District for Centennial

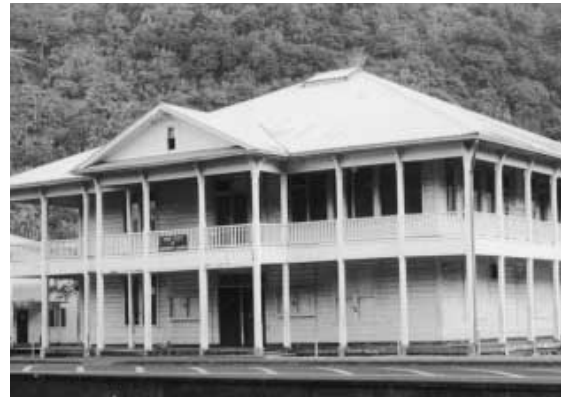
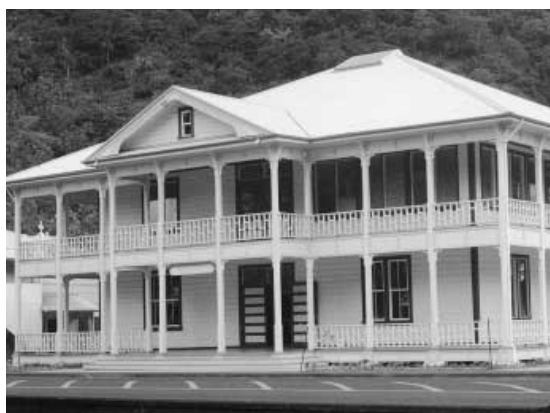
patchwork repair. Over the years, as the function of the building changed, much of the once spacious interior had been haphazardly turned into warrens of offices. There was extensive termite and rot damage, especially to the ancillary additions.

*American Samoa High Court Building before and after restoration. Photos courtesy American Samoa Historic Preservation Office.*

Working closely with the American Samoa Historic Preservation Office, the architect, contractor, and project manager carefully deconstructed the building’s interior, salvaging for reuse all possible original material. The building was then lifted four feet off the ground so that new footings and foundation structural units could be emplaced and the building lowered again. The entire building was structurally hardened to meet modern standards of hurricane resistance.

Work on the building’s exterior included the removal of decades of paint and the matching and replacement of damaged pillars, windows, and veranda railings and flooring. Pains were taken to identify and match the original paint colors of the walls and trim. Working from old photographs supplied by the Historic Preservation Office, the ornate woodwork that had originally embellished the porch pillars and railings were replicated.
