Videomonitoring Performance of the St. Marys River Ice Islands and Ice Boom

Abstract: In 1997, six islands were constructed to stabilize the ice cover at the entrance to the Little Rapids Cut on the St. Marys River at Sault Ste. Marie, Michigan. It was hoped that the artificial islands would eliminate the need for an ice retention boom installed annually since 1974 by the Corps of Engineers. The U.S. Army Cold Regions Research and Engineering Laboratory

Technical Report
ERDC/CRREL TR-02-8

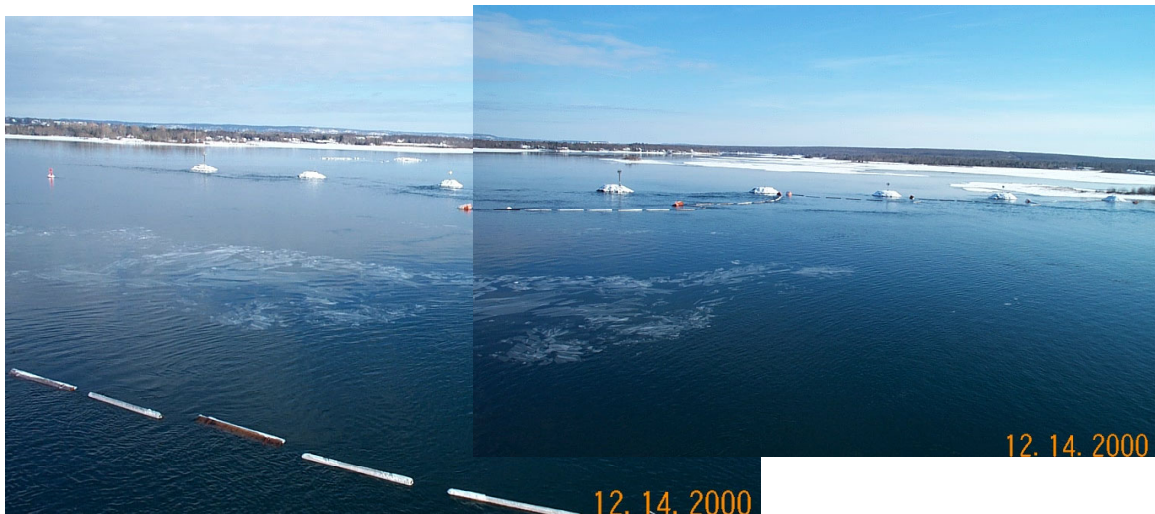
Figure 4. Completed ice stabilization islands and east arm of ice boom, December 2000.

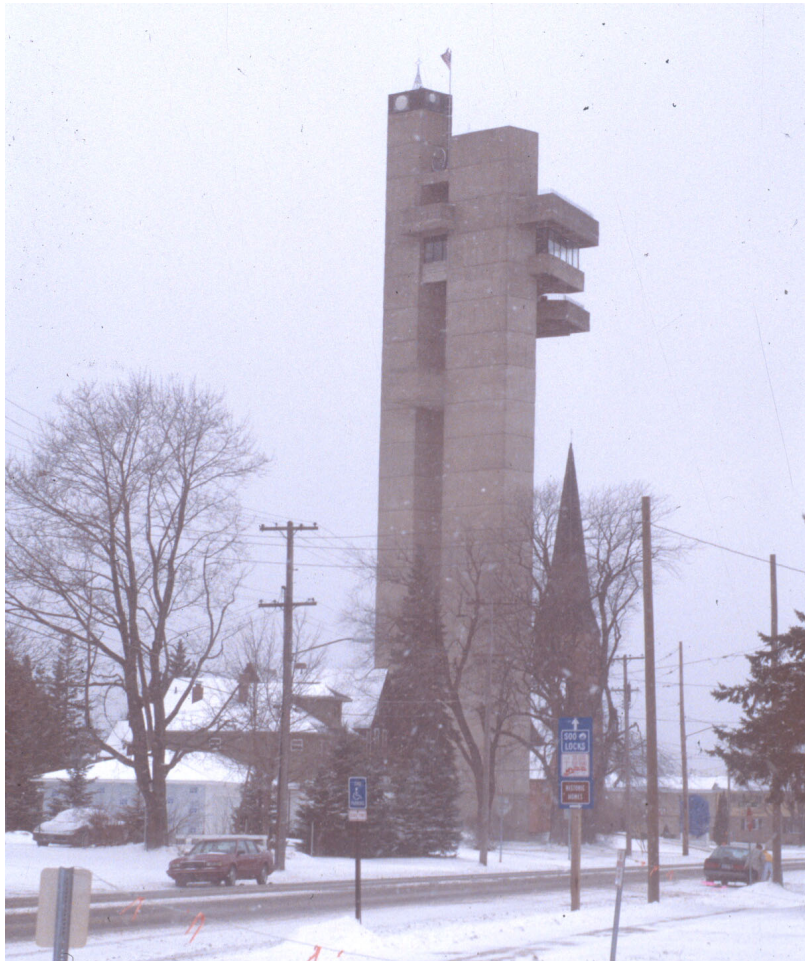
Figure 6. Sault Ste. Marie's 210-ft-high Tower of History, site of Webcam 1.

Two Web cameras were installed by CRREL in December 1999: the first near the top of the 210-ft-high Tower of History two miles northwest of the site in Sault Ste. Marie (Fig. 6) and the second on the U.S. Coast Guard tower at Mission Point, located on the west side of the Little Rapids Cut (Fig. 7). The Tower of History camera was connected to the Internet via direct phone line. During the 1999–2000 winter, the Mission Point camera was connected to the Web via modem and cellular phone.

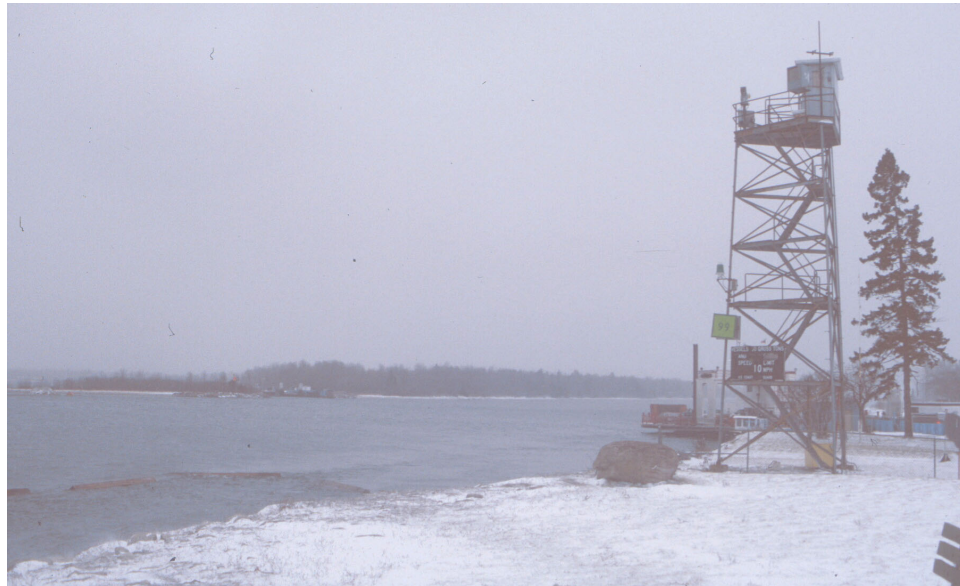
Figure 7. Tower at Mission Point, site of second Webcam and U.S. Coast Guard video camera. The west arm of the boom is on the left and the Sugar Island Ferry slip appears in the background.

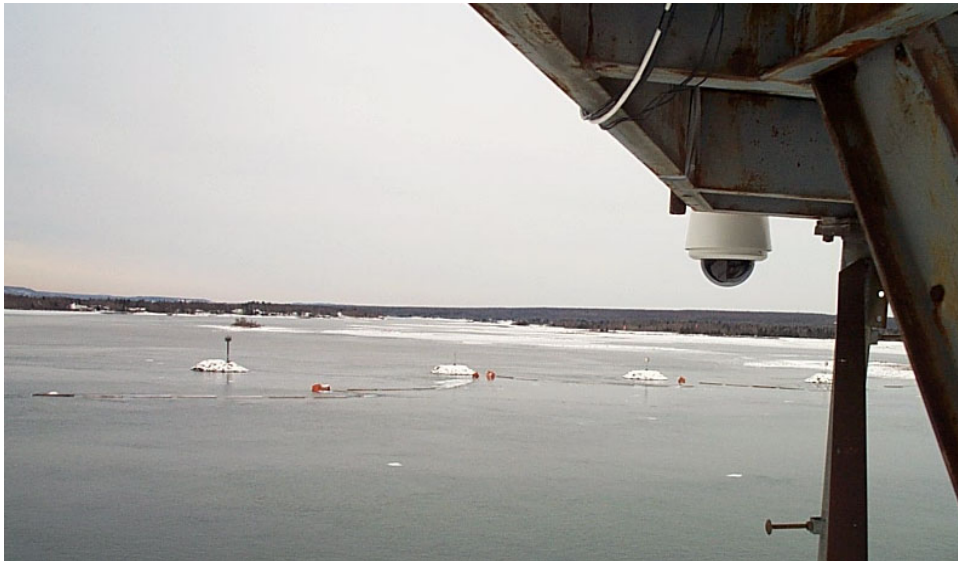
In December 2000, a pan-tilt-zoom camera replaced the fixed camera at Mission Point (Fig. 8) and three additional cameras were added to provide a 100° field of view extending from the ferry slip to the most upstream island. Instead of relying on a cellular phone, a wireless Ethernet radio modem sent image data to a Web server located two miles away at the Soo Locks. Figure 9 shows the camera locations and fields of view. The Tower of History camera gave a good overall view of the islands and the area to the east while the Mission Point cameras provided detailed images of the ice stabilization islands and boom spans. In addition to the Web cameras, during the 1999–2000 winter, the U.S. Coast Guard agreed to record video of any interesting ice conditions or significant changes in the ice conditions at the Little Rapids Cut using their pan-tilt-zoom video camera at Mission Point. The Coast Guard video data proved invaluable because of its wide field of view and particularly after the cellular phone system connected to the Mission Point Web camera failed after 11 January 2000.

Figure 8. Pan-tilt-zoom Web camera mounted on the U.S. Coast Guard tower at Mission Point in December 2000.

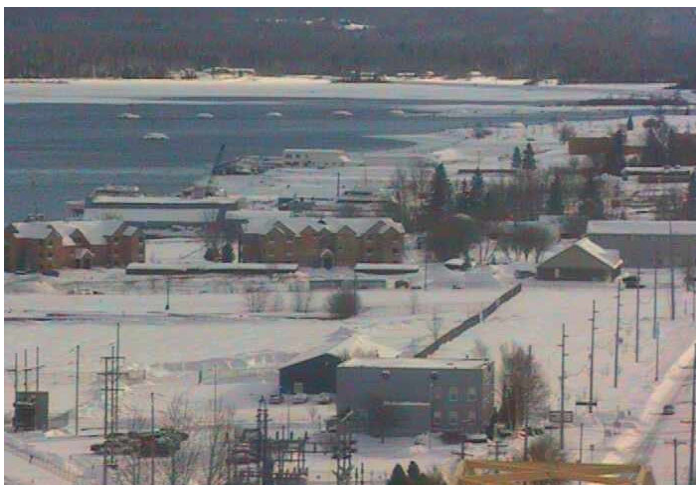
By 4 January 2000, the sheet ice area to the north of Sugar Island extended to within several hundred yards of the islands (Fig. 16 and 17), and boom spans 1, 2, and 3 were retaining small fields of unconsolidated frazil. Open water still existed behind the eastern islands and Mouse Island, and a narrow band of shore ice lined the west bank upstream of Mission Point. Average air temperature for 4 January was relatively mild (20°F) and strong northerly winds were pushing floes and frazil slush under boom spans 4 and 5 (Fig. 17). Disperse floes up to 15 ft in diameter could be seen drifting down both margins of the navigation channel and into the cut.

Figure 16. Sheet ice growing from the eastern shore towards the structures, 4 January 2000.

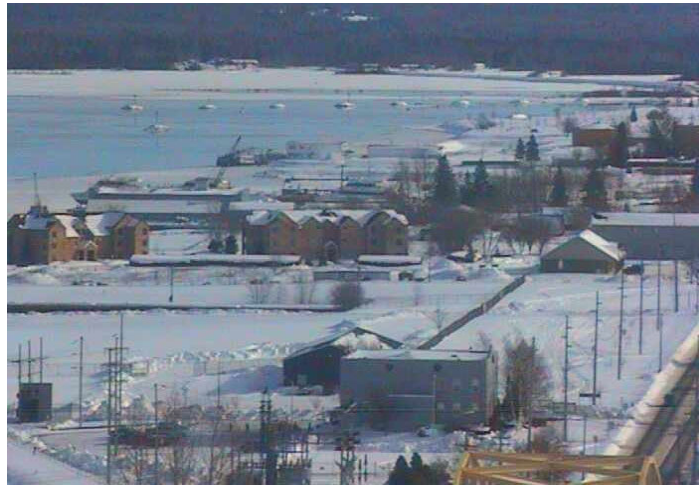
Between 4 and 14 January 2000, daily average air temperature had decreased significantly (Fig. 14a) and Soo Harbor water temperature had reached the freezing point. The sheet ice to the north of Sugar Island extended nearly to the line of islands with a narrow lead interrupting the cover behind and to the north of Mouse Island (Fig. 18 and 19). Average air temperature for 14 January was 11°F, winds were relatively calm, and large fields of frazil slush the width of the navigation channel were drifting into the cut. Stable ice existed behind boom spans 1, 2, and 3 and the eastern portion of span 4. Island 4, which is upstream of span 4, appeared to be helping stabilize the ice. The Sugar Island Ferry was moving easily through the moving ice fields, indicating that the frazil was thin

Figure 18. Sheet ice cover to the east, 14 January 2000. This cover extends nearly to the islands.

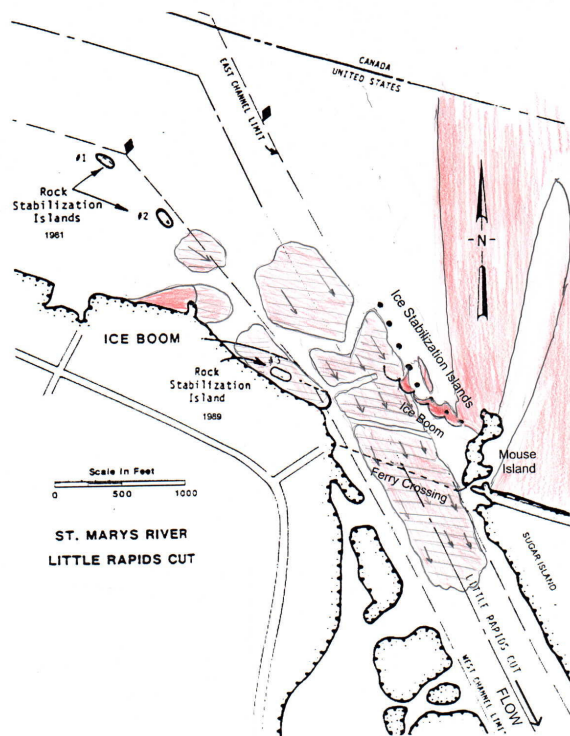
Figure 19. Ice conditions, 14 January 2000, with ice forming behind boom spans 1–4, and large frazil floes drifting into cut.

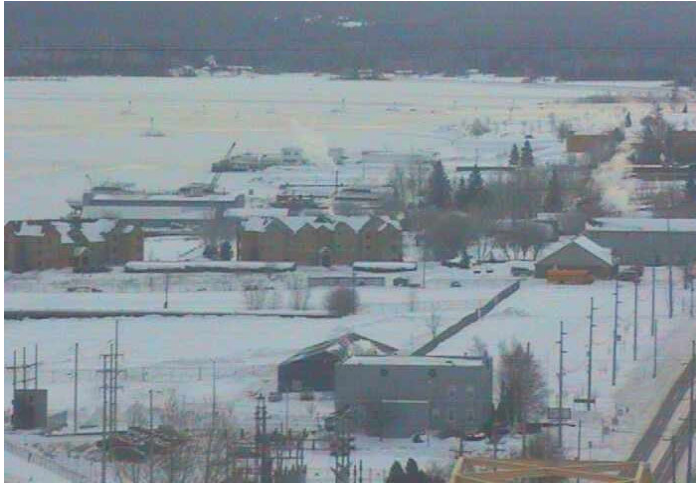
By 17 January 2000, a stable ice sheet covered the entire area from the north end of Sugar Island to the edge of the navigation channel, surrounding the islands (Fig. 20 and 21). Sheet ice also extended out from the west shore to the edge of the navigation channel, surrounding the three west-side ice stabilization islands. 17 January was extremely cold (-7°F). Massive frazil slush floes were moving into the cut, nearly arching across the gap. The ferry was able to easily negotiate the floes, indicating that they were relatively thin and unconsolidated.

Figure 20. Eastern sheet ice, 17 January 2000. This sheet ice extended beyond the islands to the edge of the navigation channel.

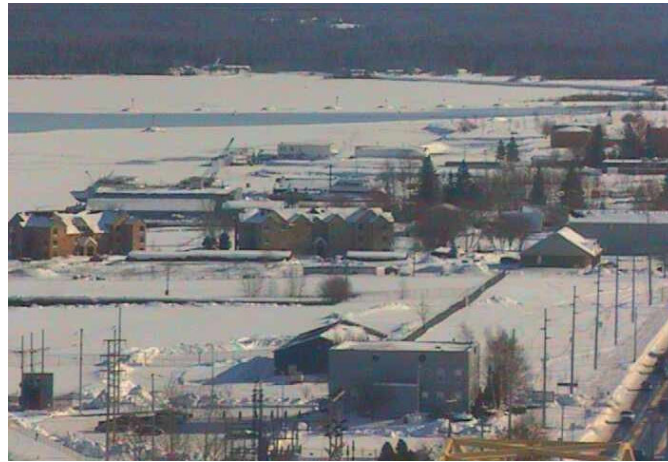
By 20 January 2000, a stable ice arch had formed across the navigation channel about 4000 ft upstream of the boom. Although 20 January was extremely cold (0°F), the upstream ice arch prevented all but minor ice floes from drifting into the cut (Fig. 22 and 23).

Figure 22. 20 January 2000. By this date, an ice arch had formed upstream of the Little Rapids Cut.

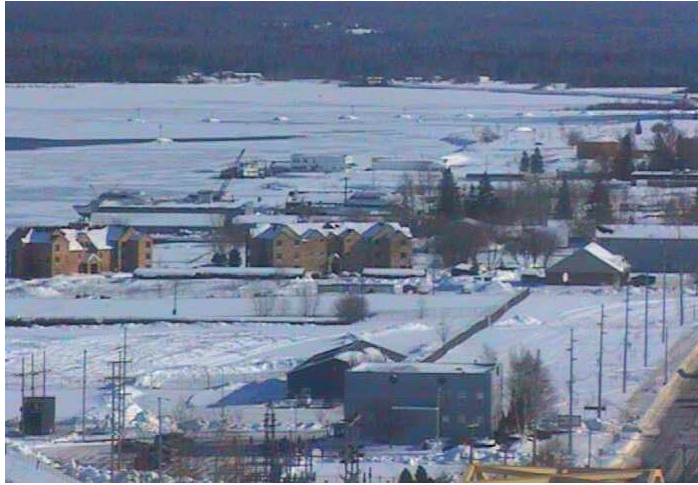
Between 20 and 27 January 2000 daily average air temperatures warmed to the teens for three days, then cooled back to 1°F. Wind action on 26 January caused large floes to break from the sheet ice arch and lodge in the channel constriction adjacent to the boom spans and islands by 27 January (Fig. 24 and 25). Ice rubble between the floes and the stationary ice on the west side of the channel indicated that shearing had occurred.

Figure 24. 27 January 2000. By this date, large floes had broken from the upstream sheet ice cover and lodged in the entrance to the cut.

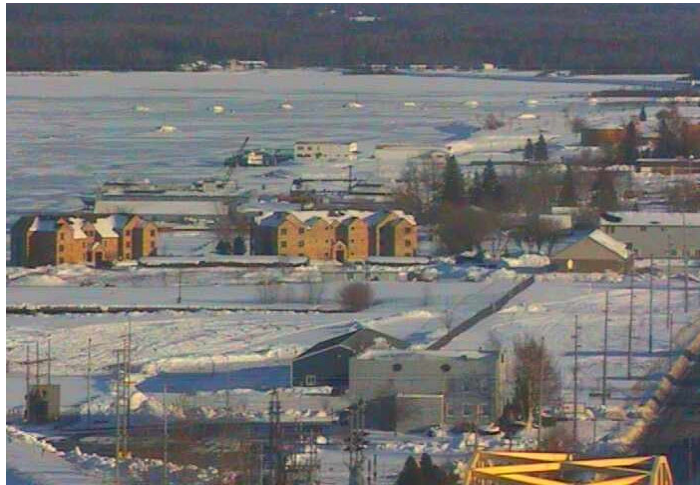
By 29 January 2000, the open leads between the floes and the upstream arch had frozen over. Air temperature had moderated (20°F) and the sheet ice had a slightly gray, decayed appearance (Fig. 26). Much broken ice and ice rubble was interspersed between the floes lodged in the entrance to the cut (Fig. 27). Ice rubble zones were visible between the floes, especially where the floes had sheared along the stationary ice bordering the navigation channel.

Figure 26. 29 January 2000. Many of the leads upstream of the boom had closed in.

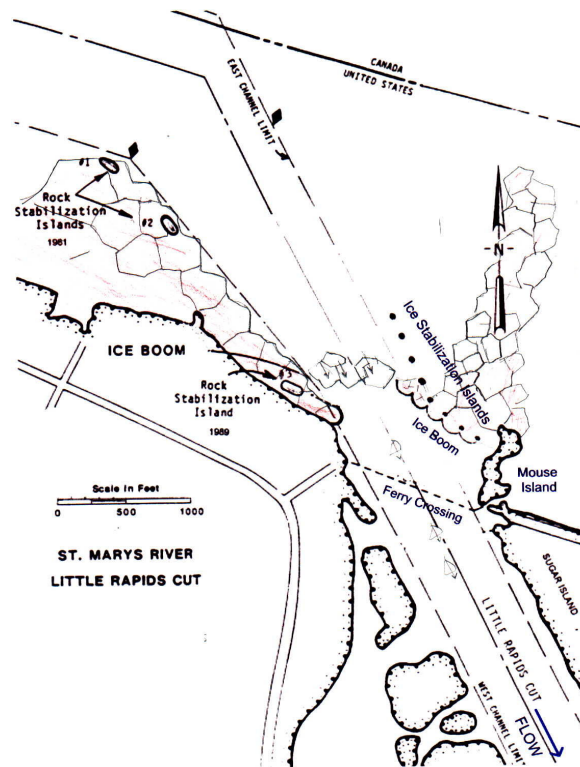
By 24 February 2000, the ice cover upstream of the Little Rapids Cut had broken up. The Coast Guard video from that day shows nearly all the ice gone, with accumulations of broken sheet ice and floes extending several thousand ft upstream of Mouse Island and boom spans 1, 2, 3, and 4. Floes and broken sheets also lined the western side of the navigation channel, and a loose arch had formed between the two arms of the boom (Fig. 29).

Figure 29. 24 February 2000. Most of the ice upstream of Little Rapids Cut had gone out. Ice floes were retained behind Islands 1, 2, 3, and 4.

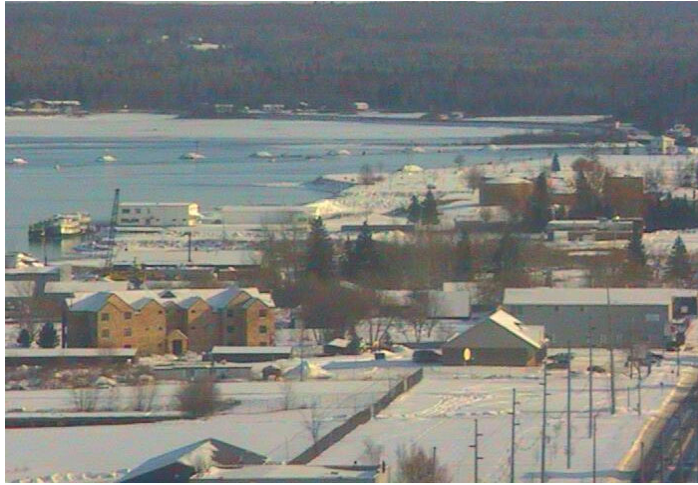
By 14 December 2000, following a week of subfreezing air temperature, a sheet ice cover extended about 3000 ft out from the northwest shore of Sugar Island. An ice cover was building on the northern end of Mouse Island and a spit of ice had formed upstream, running parallel to the sheet ice edge to the east (Fig. 30 and 31).

Figure 30. 14 December 2000. On this date, the ice cover extended well out from the north shore of Sugar Island.

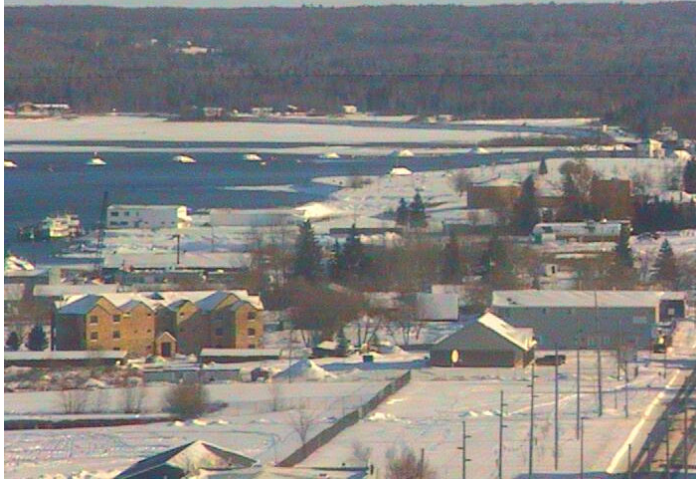
By 24 December 2000, the ice cover extended to within several hundred ft of the ice control islands (Fig. 32). The ice spit, visible on 14 December, had widened and connected with Mouse Island. Minor amounts of ice were collecting behind boom spans 1 and 2, indicating that the faster moving water in the channel had cooled nearly to the freezing point (Fig. 33).

Figure 32. 24 December 2000. The ice cover extended to within several hundred feet of the ice control islands.

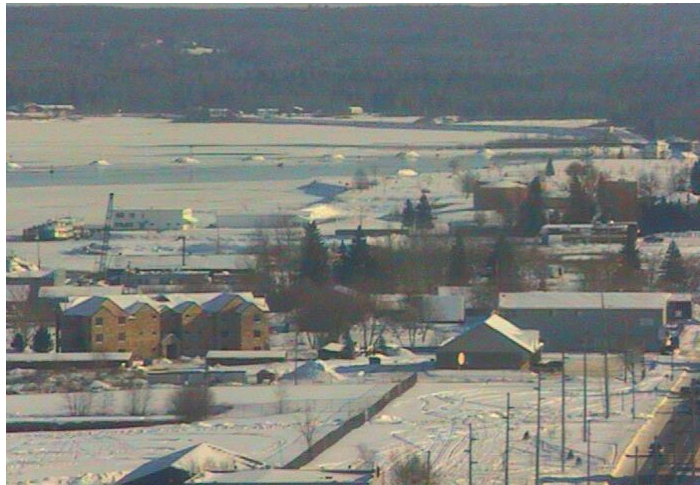
By 28 December 2000, following four days of cold air temperatures, stable ice sheets covered both sides of the navigation channel, the east-side cover extending from the boom spans upstream past Islands 1–5 (Fig. 34 and 35). Two parallel leads to the east of the islands were visible, a small one passing between Islands 2 and 3 and a larger one extending upstream from the tip of Mouse Island.

Figure 34. 28 December 2000. Stable ice extended from the boom spans upstream beyond Islands 1–5.

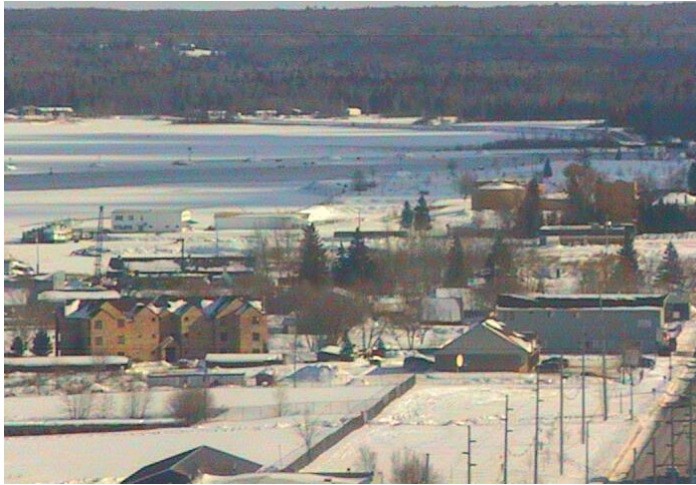
Between 24 January and 18 March 2001, the ice cover was at its maximum extent, with the ice edges close to the 600-ft-wide navigation channel limits (Fig. 36 and 37). The boom spans and ice control islands delineated the eastern edge of the ice cover and a narrow lead was visible behind Islands 3, 4, and 5.

Figure 36. 24 January–18 March 2001. The ice cover was at its maximum during this time.

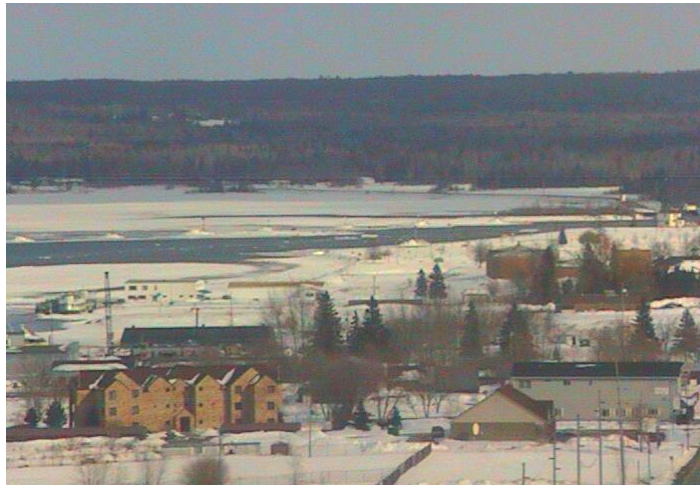
By 26 March 2001, the ice cover had begun to deteriorate. The ice edges had receded on both sides of the navigation channel and open water was visible behind Islands 3–8. Boom spans 2–5 retained broken floes (Fig. 38 and 39).

Figure 38. 26 March 2001. The ice cover had begun to deteriorate.

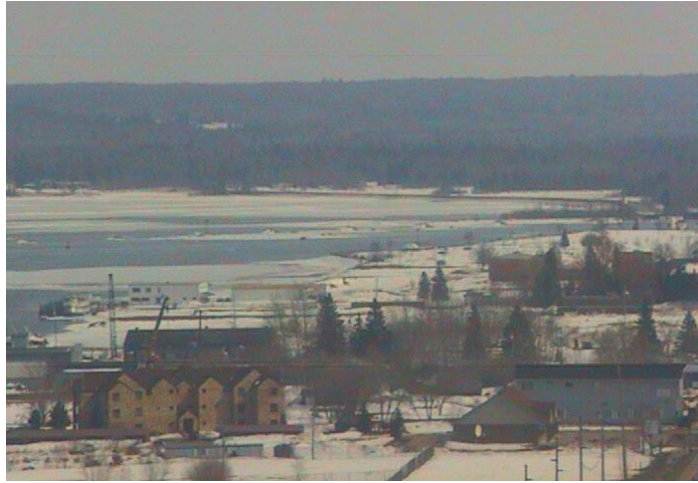
Through 31 March 2001, the open channel continued to widen until most of the ice on the west side had disappeared, and a lead was visible upstream of Mouse Island. Boom spans 2, 3, and 4 retained broken floes (Fig. 40 and 41).

Figure 40. 31 March 2000. The channel continued to widen.

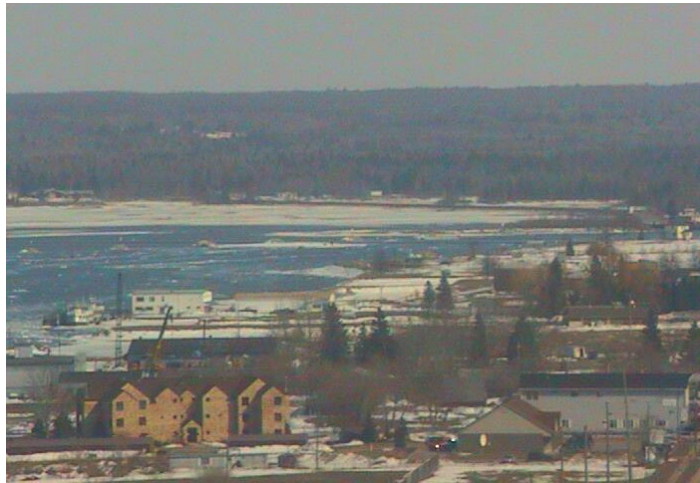
The ice cover deterioration continued through 4 April 2001, at which time most of the area upstream of the Little Rapids Cut was ice-free (Fig. 42).

Figure 42. 4 April 2001. By this date, most of the area upstream of the Little Rapids Cut was ice-free.
