Grating size needed to protect adult Pacific lamprey in the Columbia River Basin

Report of research to

Portland District
U.S. Army Corps of Engineers
P.O. Box 2946, Portland OR 97020
Contract E96950021

July 2007

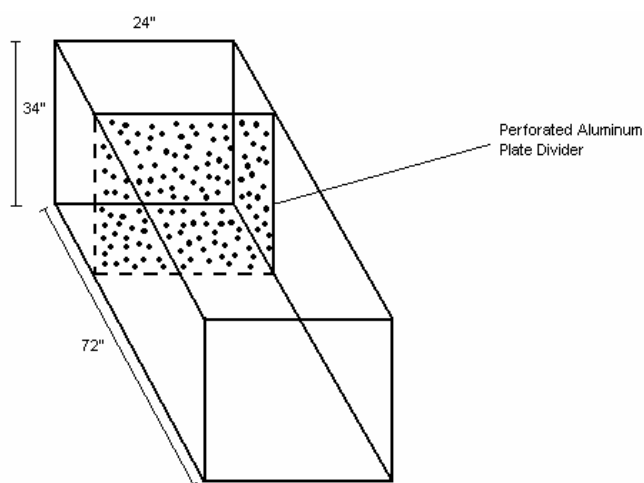
Figure 1. Experimental apparatus used to test lamprey ability to pass through a vertical gap. A vertical gap of 2.5, 2.2, 1.9, 1.6, or 1.3 cm was created by placing a spacer of the appropriate size under the perforated partition.

filled with ambient Columbia River water. This tank was divided into two unequal compartments with a divider made of perforated aluminum plate (0.6 cm perforations), which slid snugly along guides in the tank wall (Figure 1). A vertical gap (2.5, 2.2, 1.9, 1.6, or 1.3 cm in height) was produced at the bottom of the divider by placing an appropriately sized spacer under the bottom edge of the plate.

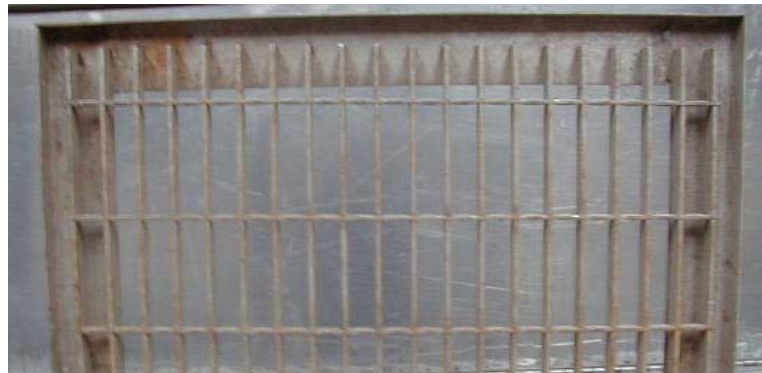
Figure 2. Photograph of traditional 2.5-cm diffuser grating material.

These experiments simulated conditions that lamprey would experience during dewatering operations for fishway maintenance. As water in the fishways is drained, lamprey can pass through diffuser grates in the floor of the fishways and enter areas below the grating. Traditional diffuser grating material used at Columbia River hydropower dams is a rectangular metal grid that is 4.4 cm deep and has 2.5×9.2 cm openings (Figure 2). We tested this material (2.5 cm grating) and another commercially-available diffuser grating that had 1.9×9.2 cm openings (1.9 cm grating).

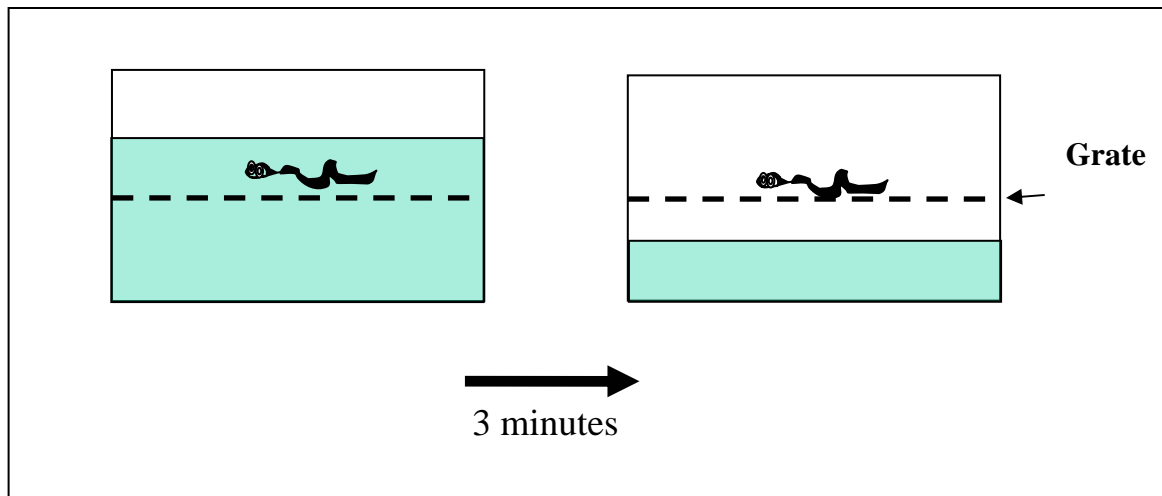
Figure 3. Cartoon of horizontal dewatering simulation as viewed from the side. A grate (either 2.5- or 1.9-cm bar spacing) was installed in a tank at a depth of 15 cm and 10 lamprey were released above it. The water level was then dropped by 30 cm over the course of 3 min, so that the lamprey were stranded on the grate for 2 min and induced to pass vertically through it.

For these tests, a large ($1.8 \times 0.9 \times 0.6$ m) flow-through tank was filled with ambient Columbia River water. A horizontal grate was installed at a depth of 15 cm to completely separate the tank into upper and lower compartments

(Figure 3). The choice of grating size was random. Ten lamprey were placed in the tank above the grate and allowed to acclimate for 5 min. Water in the tank was then lowered 30 cm in 3 min, so that lamprey were stranded on the grate for a maximum of approximately 2 min and induced to pass down into the lower compartment (Figure 4).

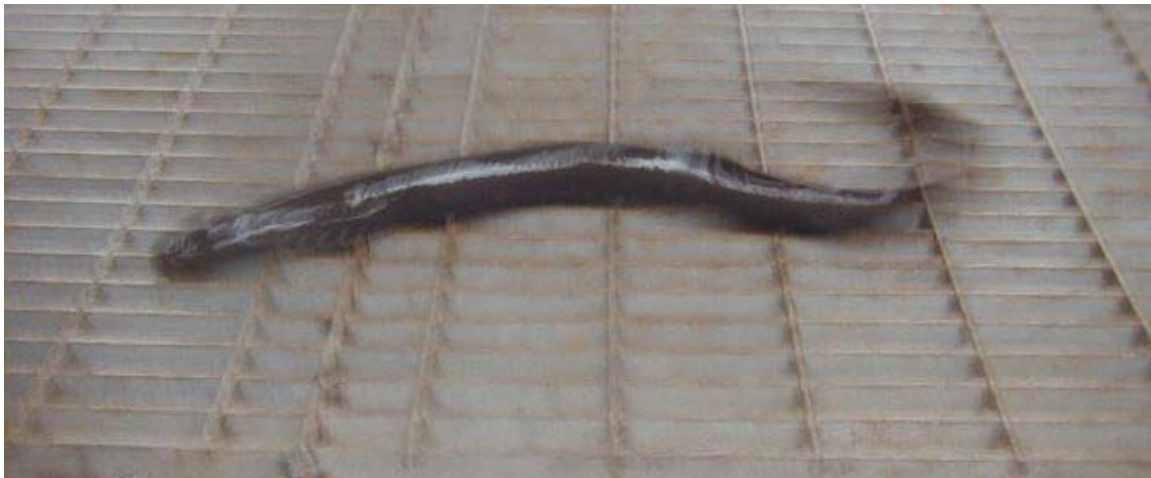
Figure 4. Adult Pacific lamprey stranded on diffuser grating during horizontal dewatering simulation.

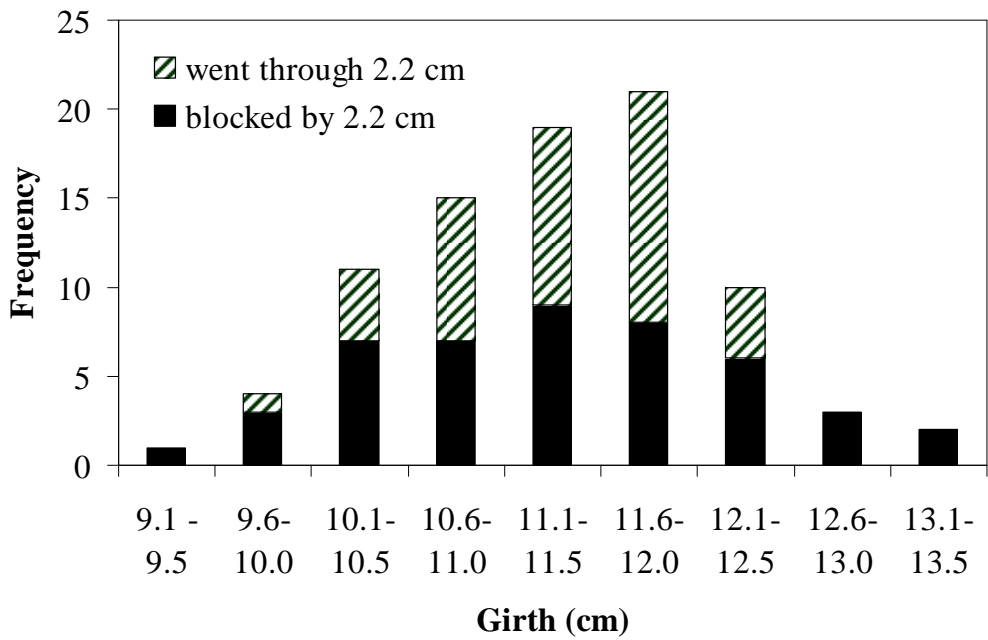
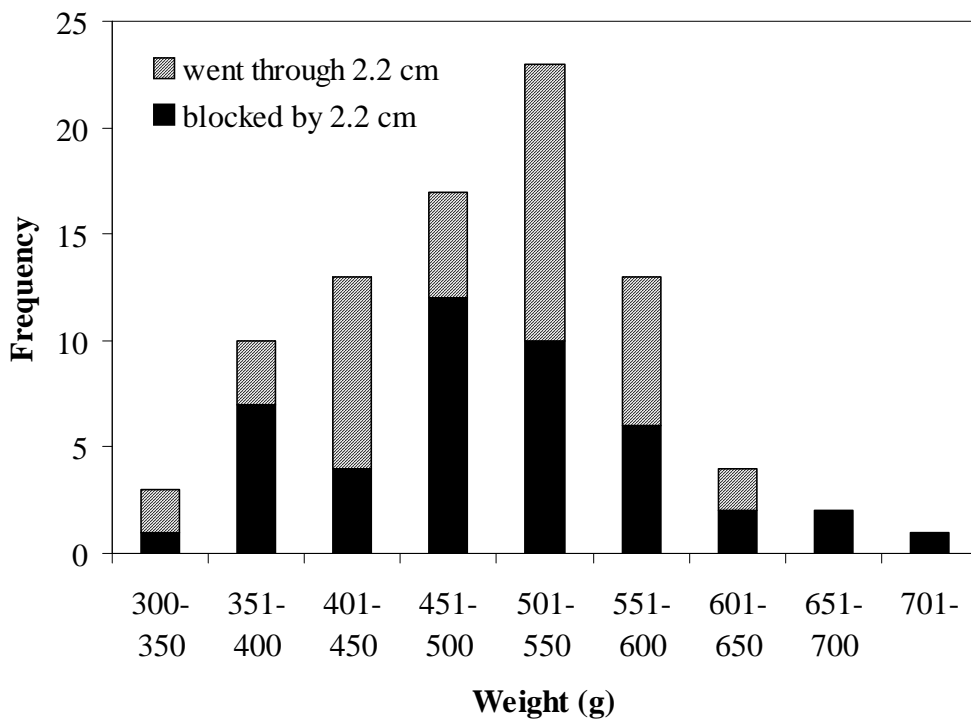
Figure 5. Size frequencies (girth in top panel and weight in bottom panel) of adult Pacific lamprey that were able to pass through a 2.2-cm vertical gap (hatched bars) and those that were blocked by a gap of this size (solid bars).

All lamprey were able to pass through the 2.5-cm gap, 47% were able to pass through the 2.2-cm gap, and no lamprey were able to pass through gap sizes of 1.9-cm or less (Table 1). For the 2.2-cm treatment group, there was no significant difference in length ($t = 0.49$, $df = 85$, $P = 0.62$), weight ($t = 0.44$, $df = 85$, $P = 0.66$), or girth ($t = 0.52$, $df = 85$, $P = 0.60$) between fish that passed through and those that did not, and size frequency distributions of the two groups were similar (Figure 5).

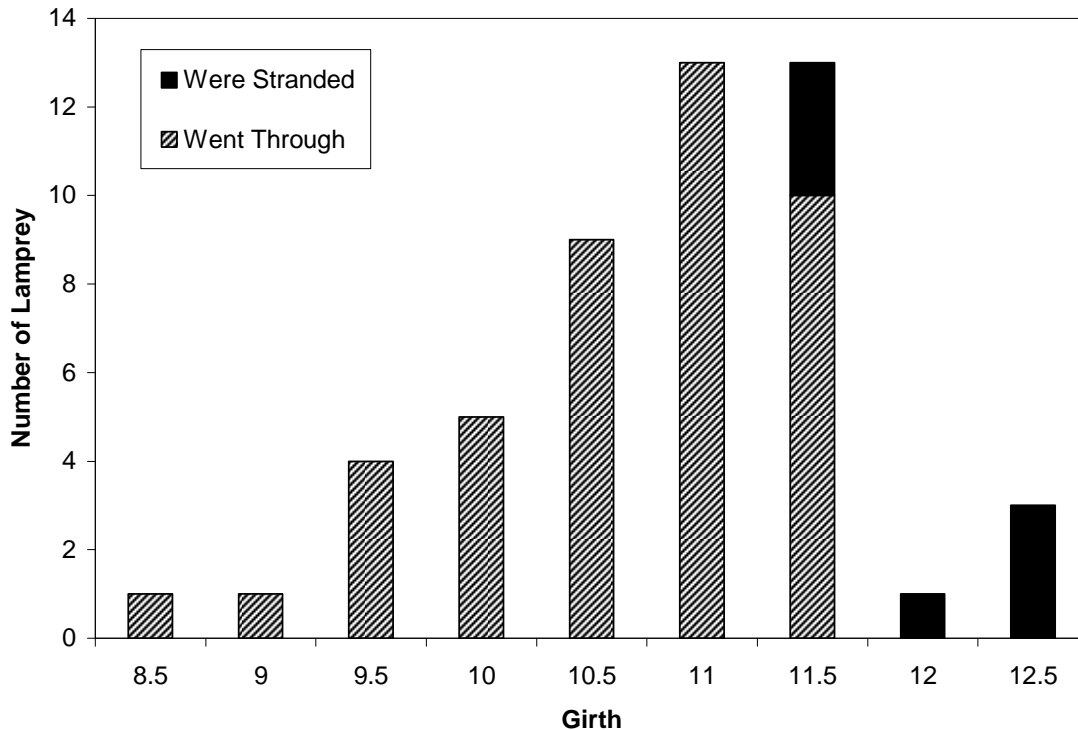
Figure 6. Frequency histogram of the lamprey girth (cm) recorded for fish that passed through the 2.5-cm bar spacing (hatched bars) and those that were stranded on it (solid bars) during horizontal dewatering simulations.

The 50 lamprey used in these experiments were comparable in size to those used in the vertical gap experiments: mean length was 67.5 cm (SD = 4.7, range = 56.0-77.0), mean weight 481 g (SD = 88, range 284-684), and mean girth 11.0 cm (SD = 0.9, range = 8.9-12.9). None of these lamprey were able to pass down through the 1.9-cm grating. In contrast, all but 7 (86%) were able to pass down through the 2.5-cm grating. The 7 lamprey that were stranded on the 2.5-cm grating were at the upper end of the size distribution (Figure 6) and were significantly larger than those that passed through in terms of length ($t = 2.42$, $df = 48$, $P = 0.02$), weight ($t = 4.38$, $df = 48$, $P < 0.0001$), and girth ($t = 4.50$, $df = 48$, $P < 0.0001$).
