COLUMBIA

ACCIDENT INVESTIGATION BOARD

REPORT VOLUME I
AUGUST 2003

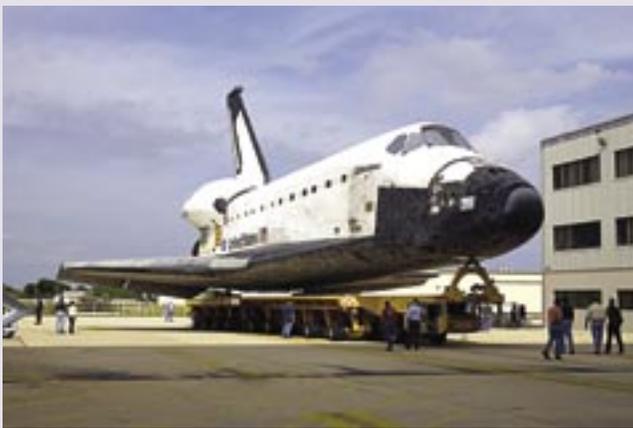
Different parts of the Orbiter are subjected to dramatically different temperatures during re-entry. The nose and leading edges of the wings are exposed to superheated air temperatures of 2,800 to 3,000 degrees Fahrenheit, depending upon re-entry profile. Other portions of the wing and fuselage can reach 2,300 degrees Fahrenheit. Still other areas on top of the fuselage are sufficiently shielded from superheated air that ice sometimes survives through landing.

To protect its thin aluminum structure during re-entry, the Orbiter is covered with various materials collectively referred to as the Thermal Protection System. The three major components of the system are various types of heat-resistant tiles, blankets, and the Reinforced Carbon-Carbon (RCC) panels on the leading edge of the wing and nose cap. The RCC panels most closely resemble a hi-tech fiberglass – layers of special graphite cloth that are molded

to the desired shape at very high temperatures. The tiles, which protect most other areas of the Orbiter exposed to medium and high heating, are 90 percent air and 10 percent silica (similar to common sand). One-tenth the weight of ablative heat shields, which are designed to erode during re-entry and therefore can only be used once, the Shuttle’s tiles are reusable. They come in varying strengths and sizes, depending on which area of the Orbiter they protect, and are designed to withstand either 1,200 or 2,300 degrees Fahrenheit. In a dramatic demonstration of how little heat the tiles transfer, one can place a blowtorch on one side of a tile and a bare hand on the other. The blankets, capable of withstanding either 700 or 1,200 degrees Fahrenheit, cover regions of the Orbiter that experience only moderate heating.

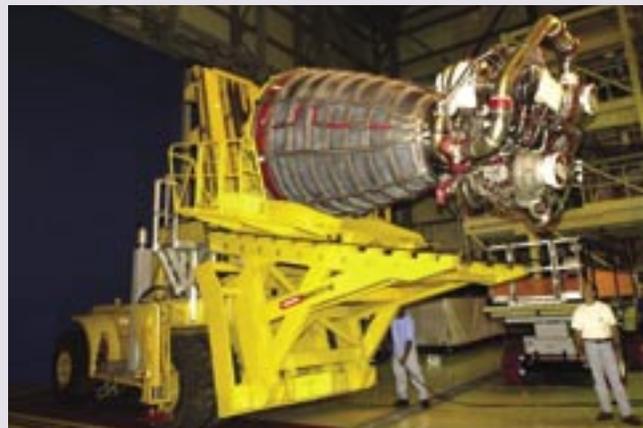
SPACE SHUTTLE MAIN ENGINES

Each Orbiter has three main engines mounted at the aft fuselage. These engines use the most efficient propellants in the world – oxygen and hydrogen – at a rate of half a ton per second. At 100 percent power, each engine produces 375,000 pounds of thrust, four times that of the largest engine on commercial jets. The large bell-shaped nozzle on each engine can swivel 10.5 degrees up and down and 8.5 degrees left and right to provide steering control during ascent.

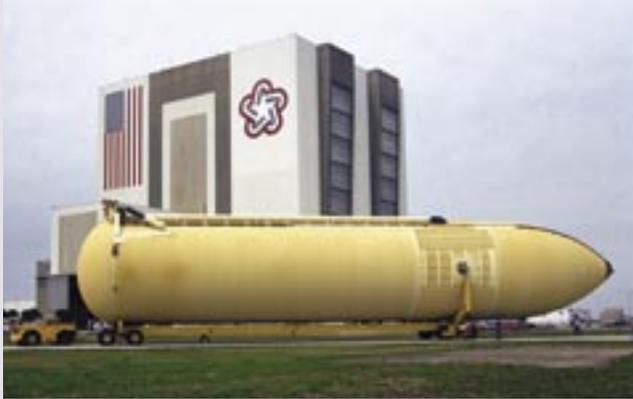
EXTERNAL TANK

The three main engines burn propellant at a rate that would drain an average-size swimming pool in 20 seconds. The External Tank accommodates up to 143,351 gallons of liquid oxygen and 385,265 gallons of liquid hydrogen. In order to keep the super-cold propellants from boiling and to prevent ice from forming on the outside of the tank while it is sitting on the launch pad, the External Tank is covered with a one-inch-thick coating of insulating foam. This insulation is so effective that the surface of the External Tank feels only slightly cool to the touch, even though the liquid oxygen is stored at minus 297 degrees Fahrenheit and liquid hydrogen at minus 423 degrees Fahrenheit. This insulating foam also protects the tank’s aluminum structure from aerodynamic heating during ascent. Although generally considered the least complex of the Shuttle’s main components, in fact the External Tank is a remarkable engineering achievement. In addition to holding over 1.5 million pounds of cryogenic propellants, the 153.8-foot long tank must support the weight of the Orbiter while on the launch pad and absorb the 7.3 million pounds of thrust generated by the Solid Rocket Boosters and Space Shuttle Main Engines during launch and ascent. The External Tanks are manufactured in a plant near New

Orleans and are transported by barge to the Kennedy Space Center in Florida. Unlike the Solid Rocket Boosters, which are reused, the External Tank is discarded during each mission, burning up in the Earth's atmosphere after being jettisoned from the Orbiter.

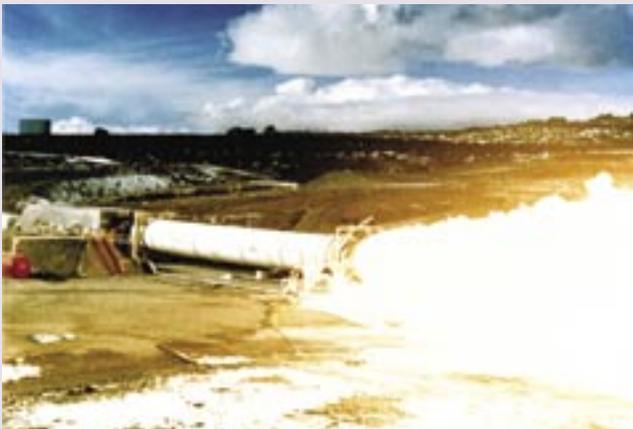
A Solid Rocket Booster (SRB) Demonstration Motor being tested near Brigham City, Utah.

Each of the Solid Rocket Boosters consists of 11 separate segments joined together. The joints between the segments were extensively redesigned after the *Challenger* accident, which occurred when hot gases burned through an O-ring and seal in the aft joint on the left Solid Rocket Booster. The motor segments are shipped from their manufacturer in Utah and assembled at the Kennedy Space Center. Once assembled, each Solid Rocket Booster is connected to the External Tank by bolts weighing 65 pounds each. After the Solid Rocket Boosters burn for just over two minutes, these bolts are separated by pyrotechnic charges and small rockets then push the Solid Rocket Boosters safely away from the rest of the vehicle. As the boosters fall back to Earth, parachutes in their nosecones deploy. After splashing down into the ocean 120 miles downrange from the launch pad, they are recovered for refurbishment and reuse.
