# Evolution of the Sensor Fish Device for Measuring Physical Conditions in Severe Hydraulic Environments

March 2003

Pacific Northwest National Laboratory  
Richland, Washington 99352

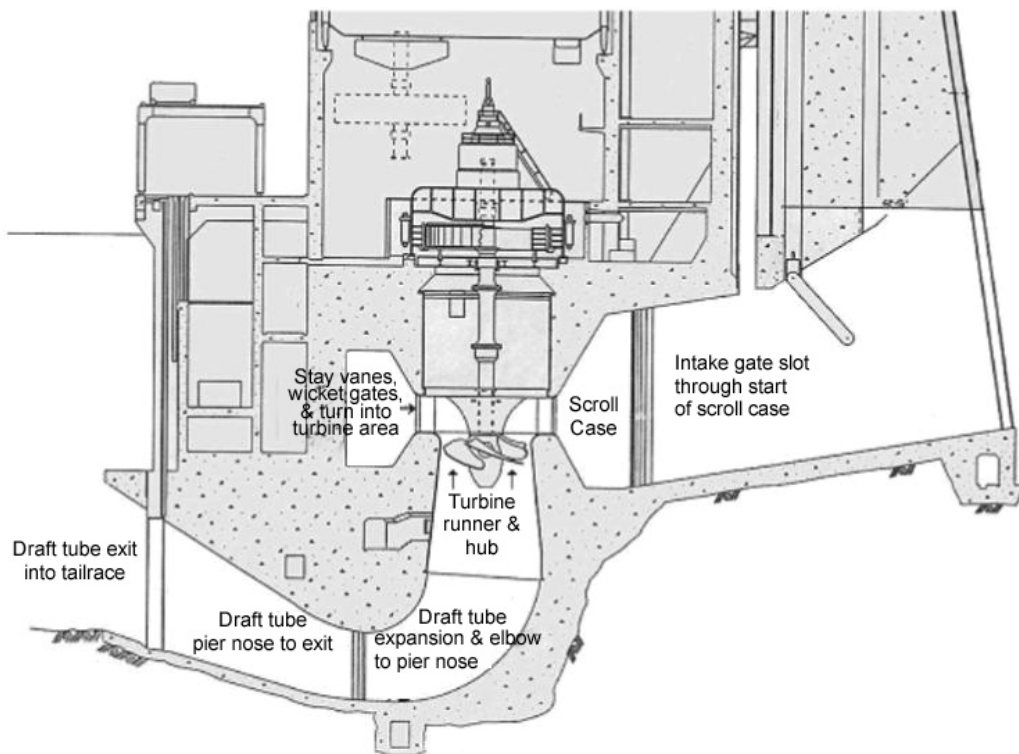
**Figure 1.1. Cross-Section of a Typical Columbia River Federal Hydropower System Kaplan Turbine**

When fish pass dams, particularly through turbines (Figure 1.1) or in spill (Figure 1.2), they are exposed to severe hydraulic conditions and may be injured or killed (Bell and DeLacy 1972; Bell 1981; Čada et al. 1997; McEwen and Scobie 1992; Monten 1985; Pavlov et al. 1999; Ruggles and Murray 1983; R2 Resource Consultants 1998; Turnpenny et al. 1992; Turnpenny 1998). Injury mechanisms include striking or scraping stationary structures such as turbine wicket gates or spillway stilling basin baffle blocks; being struck by moving elements such as the blades of turbine runners; and getting pinched in

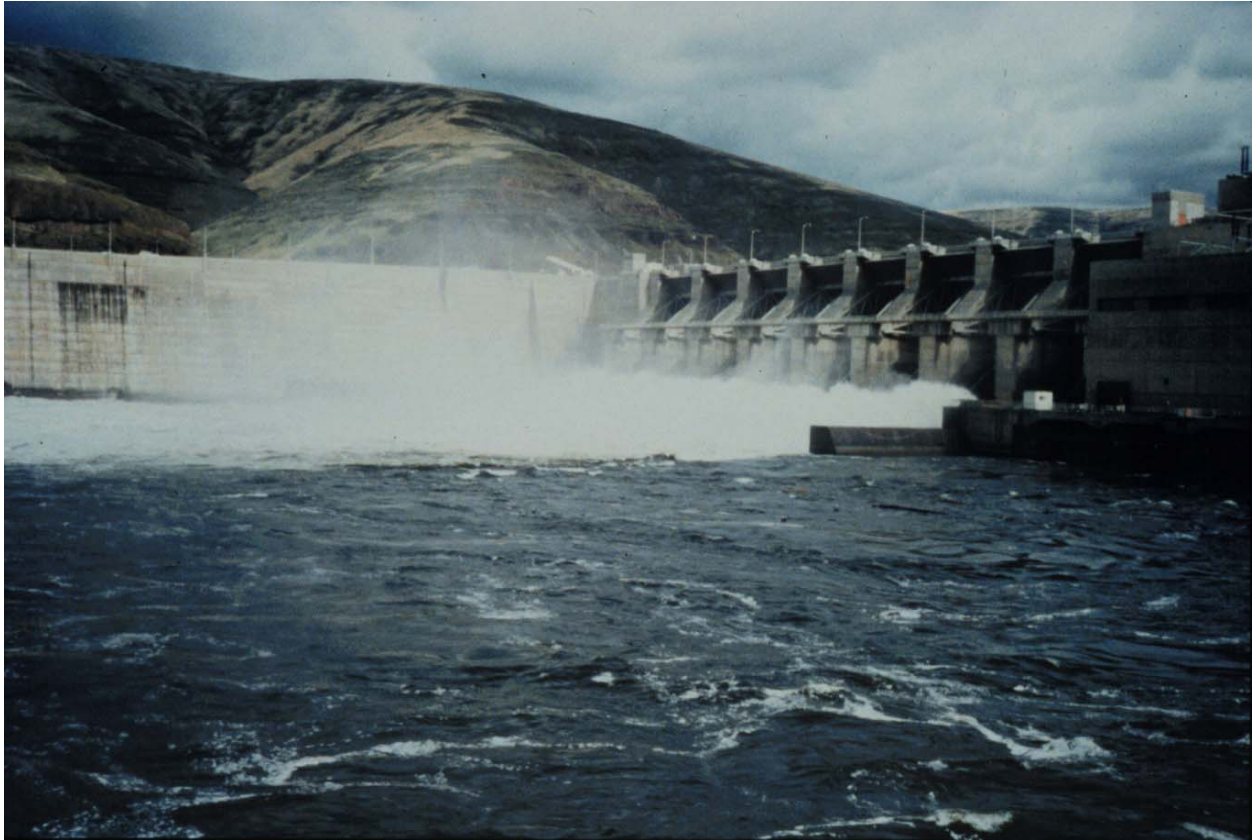
**Figure 1.2. Tailrace Environment of Lower Granite Dam on the Snake River During Spill Operations**

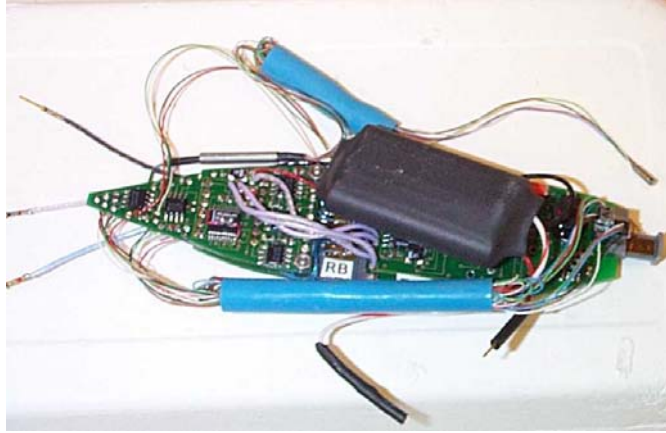
**Figure 2.1. Pressure Transducer, Accelerometer, and Strain Gages in Sensor Fish Device**

**Microsensor transducers to analyze turbine conditions.** PNNL researchers defined three types of forces (stress-strain relationships) a fish might experience during turbine passage: tensile force,

compression, and shear strain (Johnson et al. 1998). To measure these forces, researchers selected six strain gages from MicroMeasurement's Division of Measurement Group, Inc. Two strain gages were positioned in the nose area of the fish, one on the right side and one on the left side. Four strain gages were placed in the middle body area of the surrogate fish, two on the right side (top and bottom) and two on the left side (Johnson et al. 1998). The circuit boards were pieced so that shear, tensile, and compression forces would be more accurate.

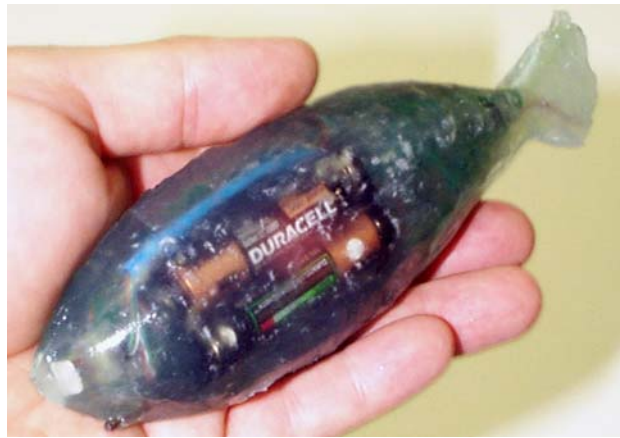
**Figure 2.2. Initial Sensor Fish Device**

**Size and shape.** The size and shape factors for the initial design were obtained by making a plaster cast of a juvenile chinook salmon smolt. Microsensors were placed on a specially designed printed circuit card (Figure 2.1) and covered with a state-of-the-art polymer (Dow Corning 3-4207 Dielectric Tough Gel) designed to give the electronic assembly a fish shape while remaining flexible enough for the forces to activate the internal sensors. A foam layer was imbedded in the tough gel to aid in achieving neutral buoyancy. The overall dimensions of the prototype were approximately 16 cm long and 5.7 cm wide (Figures 2.1 and 2.2). It was nicknamed “flubber fish.” Without foam “flubber” had a density of  $1.2 \text{ gm/cm}^3$  and a specific gravity of 1.2.

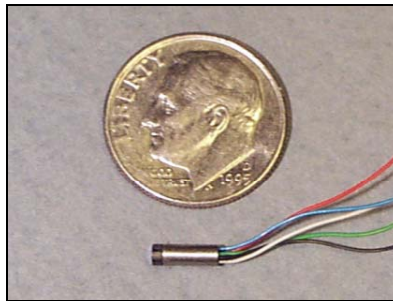
**Figure 2.4. Pressure Transducer Contained in Prototype Sensor Fish Device**

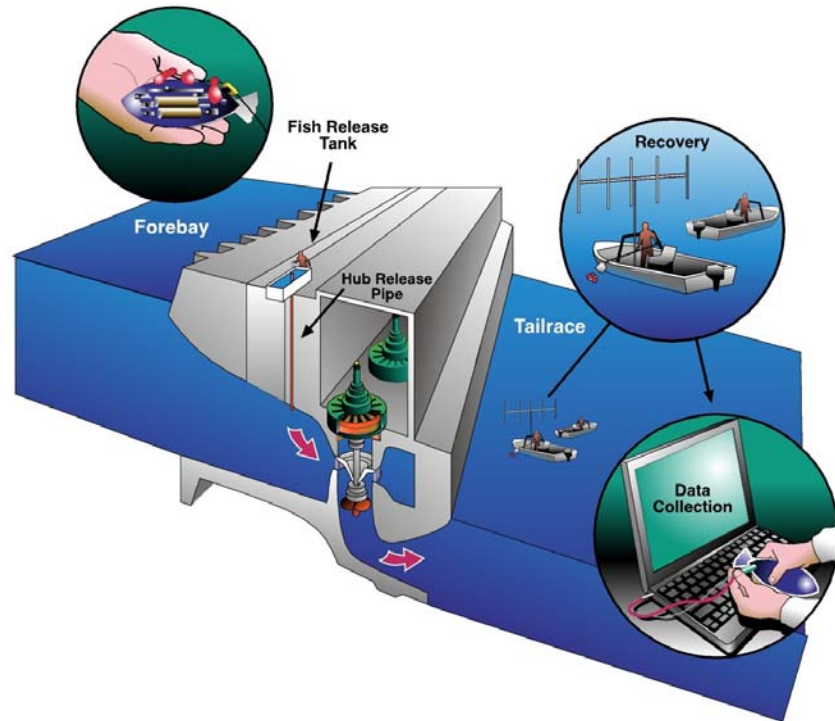
**Figure 2.5. Sensor Fish Data Acquisition Process**

Initial testing in the field environment used non-instrumented fish to assess physical damage caused by turbine passage and determine the retrievability of the sensor fish from the tailrace. Figure 2.5 shows the process used to acquire data with the Sensor Fish. The device is released from the intake (forebay) deck on the forebay side of the dam into the inlet of an induction system consisting of a head tank, pipe, and control valves (Carlson 2000). The pipe extended from the intake deck to the test turbine stay vanes immediately upstream of the turbine runner blades. In preparation for deployment, Hi-Z tags, specially designed balloons containing a gas-producing chemical, were attached to the Sensor Fish, along with a

micro-radio transmitter. A few seconds before the sensor was released into the induction system, a small amount of hot water is injected into the balloons. The hot water immediately begins to dissolve a capsule surrounding a gas-producing chemical. No gas is produced during the few seconds required for the sensor to pass through the turbine. The balloons inflated within a few minutes of release and brought the non-instrumented fish to the tailrace surface.

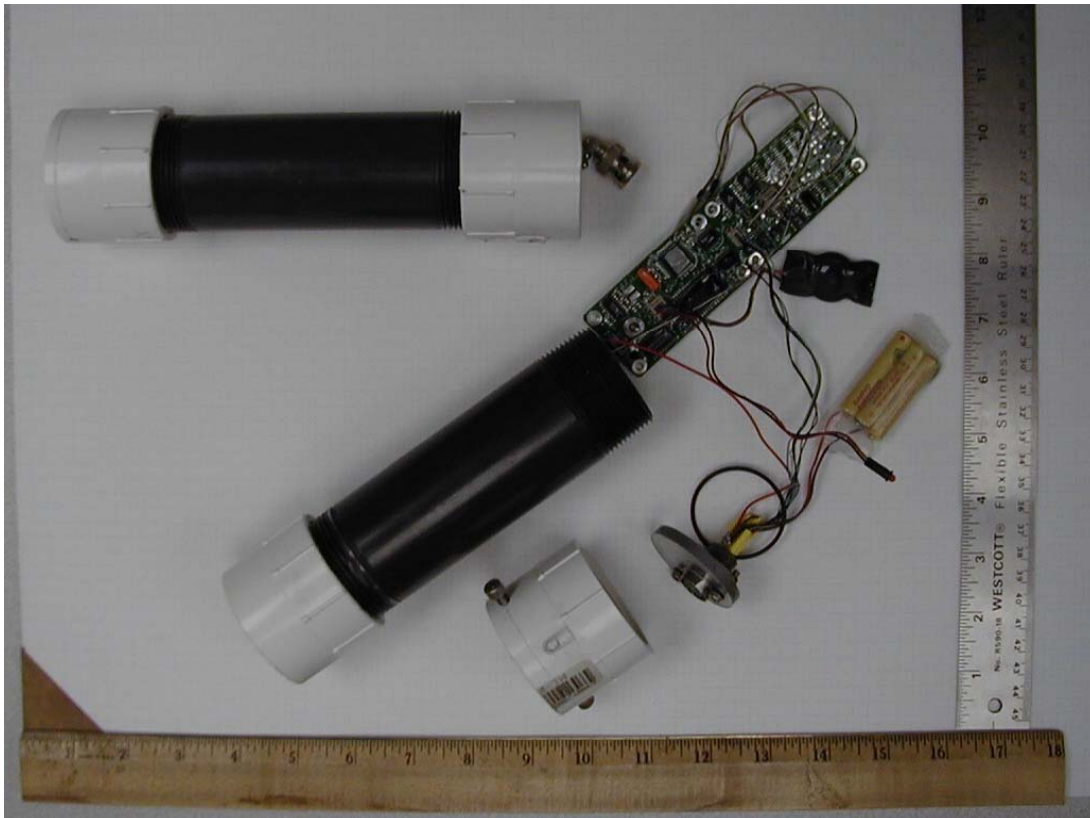
**Figure 2.6. Redesigned Sensor Fish Device: PVC Pipe**

The original design was of PVC pipe with the batteries protruding from one end and the download leads and pressure transducer protruding from the opposite end. Wire was wrapped around the exterior length of the pipe for weight to make the sensor package neutrally buoyant. The sensors used in the design were pressure gages and x-, y-, and z-accelerometers.

Field testing of the first PVC prototype units demonstrated that leakage occurred through the threads of the endcaps, shorting the sensors. In early January 2000, O-rings were added to seal the endcaps. The battery wires were replaced with a twist-on through hole connector that powered the batteries when coupled. On the opposite end of the pipe, the download wires were replaced with another through-hole connector that served to download the data and recharge the batteries. This was sealed under a watertight

To obtain neutral buoyancy, rigid plastic tubing was wrapped around the unit. This representation of the sensor fish was adequate for use in the Bonneville Dam turbine testing, but some units cracked and subsequently leaked when striking the turbine blade or other turbine structures, so further redesign was warranted.

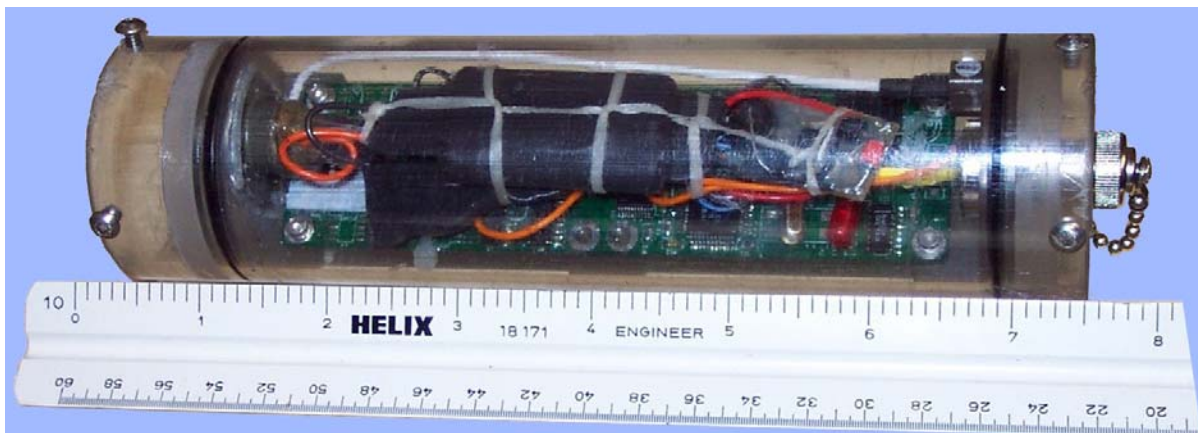
Figure 2.7. Redesigned Sensor Fish II: Polycarbonate Plastic Tube

In May 2000, following the Bonneville MGR test, PNNL scientists designed and built a new cylindrical sensor fish package using polycarbonate plastic (Figure 2.7). The electronics within the unit were coated with RTV (a waterproof coating for electronic components) for waterproofing in the event of O-ring failure.

The redesigned sensor housing is constructed of clear polycarbonate plastic. The device is 7.4 in. long (~188 mm) and 2 in. (~51 mm) in diameter. In addition to the new packaging, the printed circuit cards for the sensor were redesigned to make manufacture and repair easier and less costly. Features were added to simplify use and provide feedback to the user about the Sensor Fish's status (i.e., standby, data acquisition, mode, etc.). The strain sensors were removed because of inconclusiveness in the data obtained and because the new packaging was not conducive for their use. The new design is also nearly neutrally buoyant in fresh water at a temperature of 14°C. Most importantly, a new accelerometer with shock protection (5,000 g overload rating) was specified and built into the polycarbonate sensor.

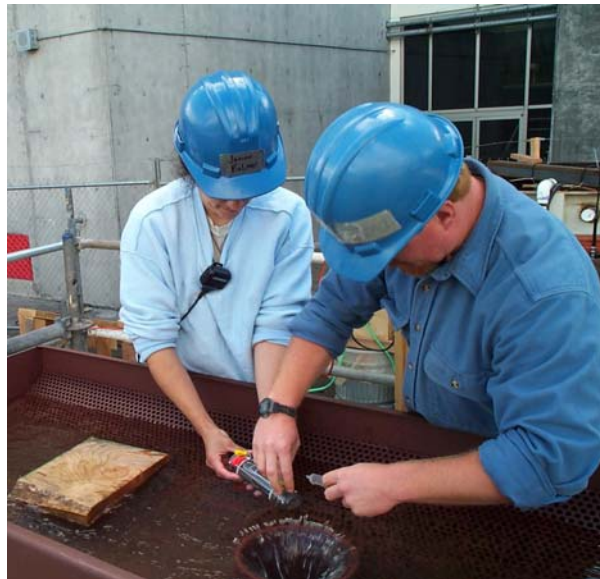
**Figure 3.1. Injection System Used to Deploy Sensor Fish**

Researchers standing on the deck of the dam drop the fish or Sensor Fish into the inlet of a water-filled pipe, which carries the fish to the desired release location in the flow field of a turbine intake or in a spill discharge jet (Figure 3.1). Simple injection systems use water flowing under the force of gravity to transport the fish into the flow field. More complex injection systems used for turbine passage route-specific studies of fish survival include a head tank and are designed so that the exit velocity of the fish and water closely match that of the ambient flow at the point of injection (Carlson 2000). This type of injection system, while providing the control of release location and conditions needed for some studies, requires specialized engineering and installation methods and is costly.

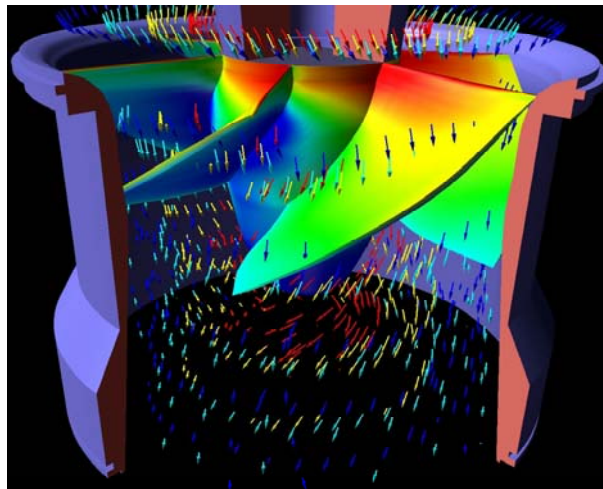
**Figure 4.1. Turbine Flow Visualization. Visualization by ETH Zurich (R. Peikert, M. Roth), CFD Simulation by Escher Wyss, Zurich, Switzerland**

Most injuries to fish appear to occur in the runner region of a dam's turbine (Čada et al. 1997; Monten 1985; Turnpenny 1998; McEwen and Scobie 1992). Figure 4.1 shows a visualization of the approach of the flow to the runner, water movement along the runner, and direction of flow immediately below the runner of a Kaplan turbine.

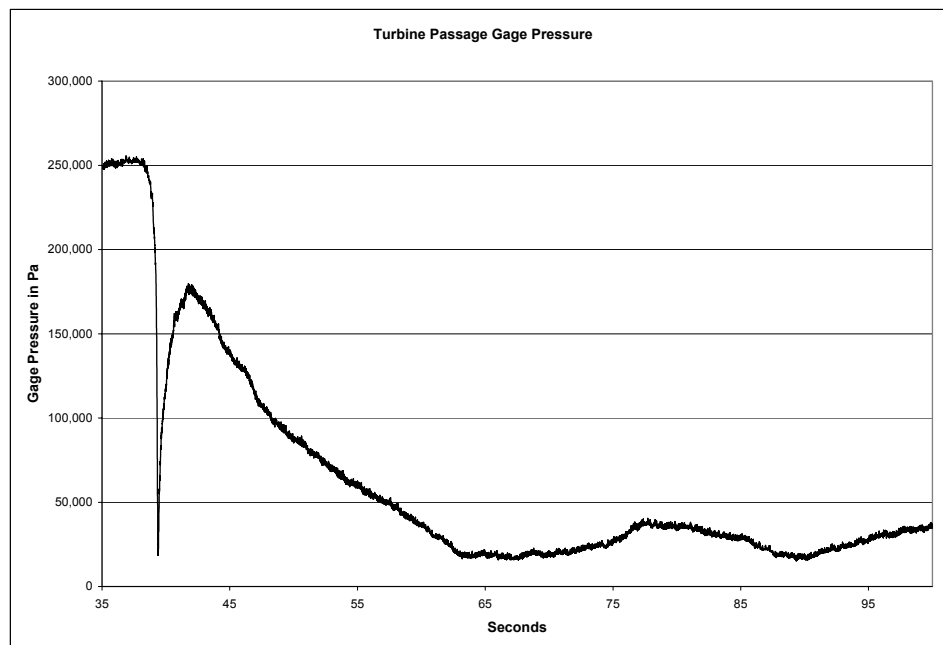
**Figure 4.2. Pressure Data for Sensor Fish Passing through Turbine Unit 9 at McNary Dam Showing Pressure Drop as Sensor Fish Drops through Turbine**

The acceleration magnitudes corresponding to this pressure time history are shown in Figure 4.3. These data indicate the greatest changes in velocity occurred as the Sensor Fish passed the turbine runner and again at the backroll upon exit from the draft tube (at approximately 44 seconds).

Because the Sensor Fish simultaneously samples pressure and acceleration, the time interval is the same for pressure and acceleration data. The acceleration magnitude maximum seen in Figure 4.3 corresponds to the pressure minimum shown in Figure 4.2 and occurs as the Sensor Fish drops through the runner. This unique feature in the pressure time history greatly aids identification of the location of the sensor at a particular time during turbine transit. This is expected because the pressure in the fluid should be lowest when the velocity of water is highest. The “bumps” in acceleration on the left side of the peak as the sensor approaches the runner can be seen clearly in Figure 4.3. The time interval between these peaks is approximately 0.145 seconds, which is roughly the period between passage of turbine blades past a point on the discharge ring. It appears that the flow through the runner is modulated by interplay between the movement of runner blades and the wicket gate openings. The result is the “pulsing” in the movement of the Sensor Fish as it is carried by the water.

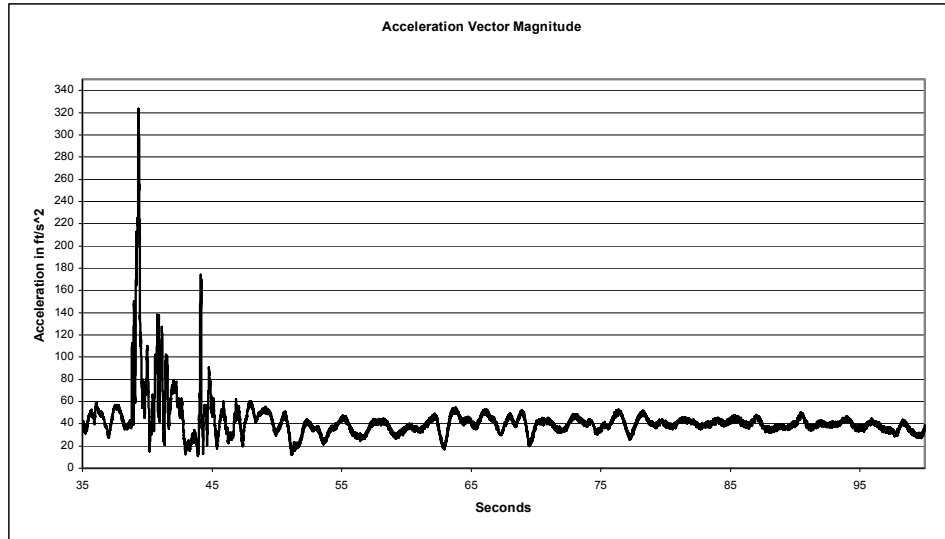
**Figure 4.3. Acceleration Data for Sensor Fish Passing through Turbine Unit 9 at McNary Dam**

This result demonstrates the detail about hydraulic conditions immediately above a turbine runner that can be observed using the Sensor Fish. In particular, it is clear that the acceleration of the water approaching the runner is not smooth, but rather, a “surging” flow with a number of distinctive acceleration and deceleration cycles of relatively high magnitude.

The intensity of exposure to turbulent stilling basin conditions was estimated by summing the magnitude of the acceleration vector computed using the time history of accelerations measured on each axis of the Sensor Fish's tri-axial accelerometer cluster. This would be proportional to the area under the curve in Figure 4.3.

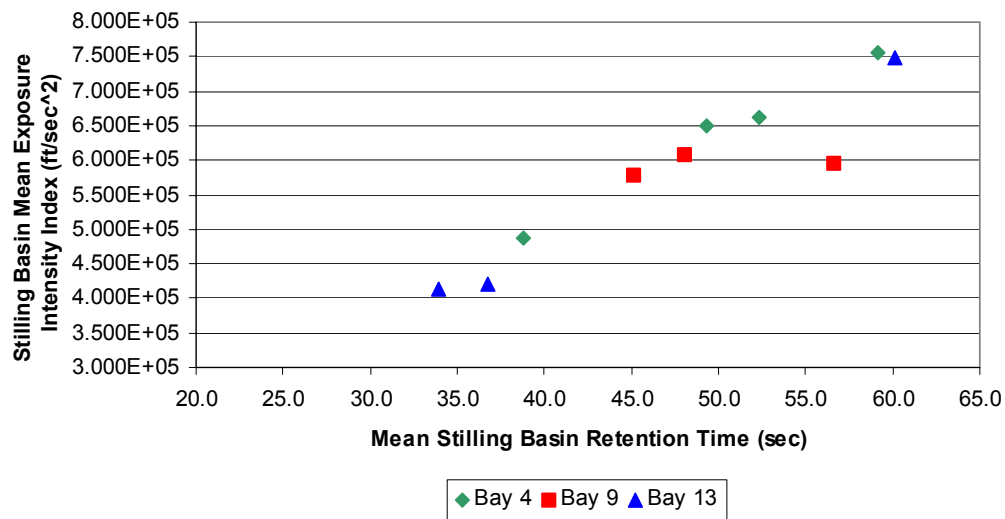
**Figure 4.4. Stilling Basin Mean Exposure Intensity Index for Spillbays by Mean Stilling Basin Retention Time**

The stilling basin retention duration estimates and exposure intensity index are plotted in Figure 4.4. There appears to be a fairly strong relationship between stilling basin retention time and exposure intensity index. This is not surprising since these variables are linked. The exposure index is the acceleration vector magnitude summed over the stilling basin duration. However, what was surprising was that, after we partially decoupled the exposure index from stilling basin duration by imposing a threshold on acceleration vector magnitude values before including them in the index, we found essentially the same relationship. The accelerations observed during passage through the stilling basin dominate the index. The higher exposure index values at lower discharge result from the additional turbulent cycles that the sensor fish experiences when it remains in the stilling basin an additional period of time. The time for a single additional cycles appears to be on the order of approximately 10 sec. An example of a sensor fish gage pressure time history is shown in Figure 4.5.

The range in the exposure intensity index is a factor of two from approximately  $4E+5$  to  $8E+5$  ft/sec<sup>2</sup>. Once CFD analyses have been done it will be possible to compare these data with estimates of stilling basin energy dissipation density and other factors. The highest exposure indices observed were for 3 kcfs

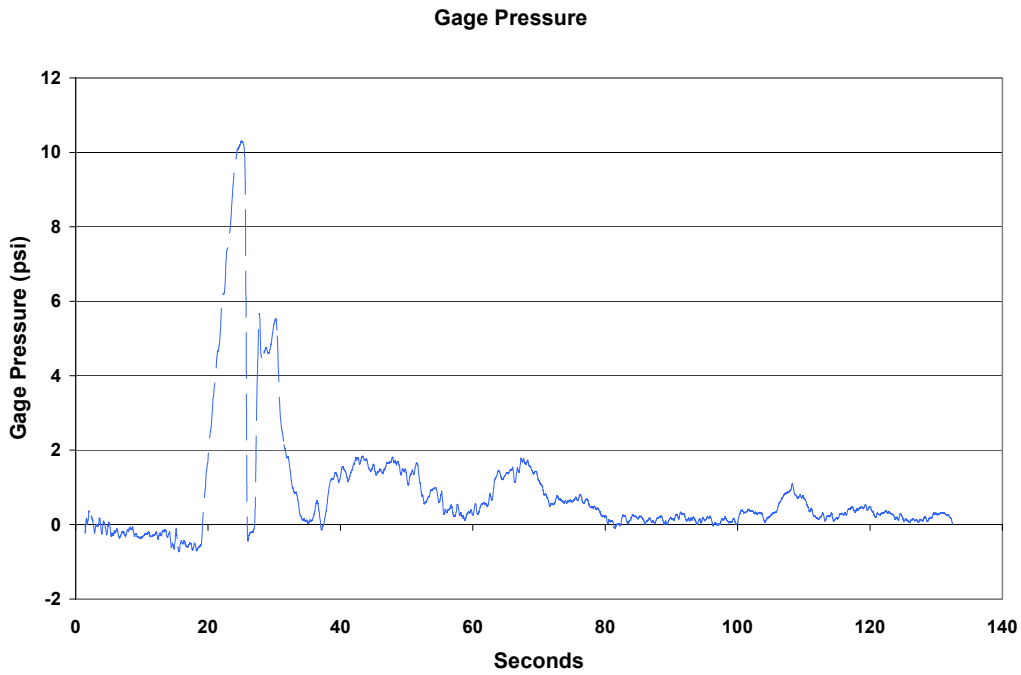
**Figure 4.5. Example of a Sensor Fish Gage Pressure Time History**

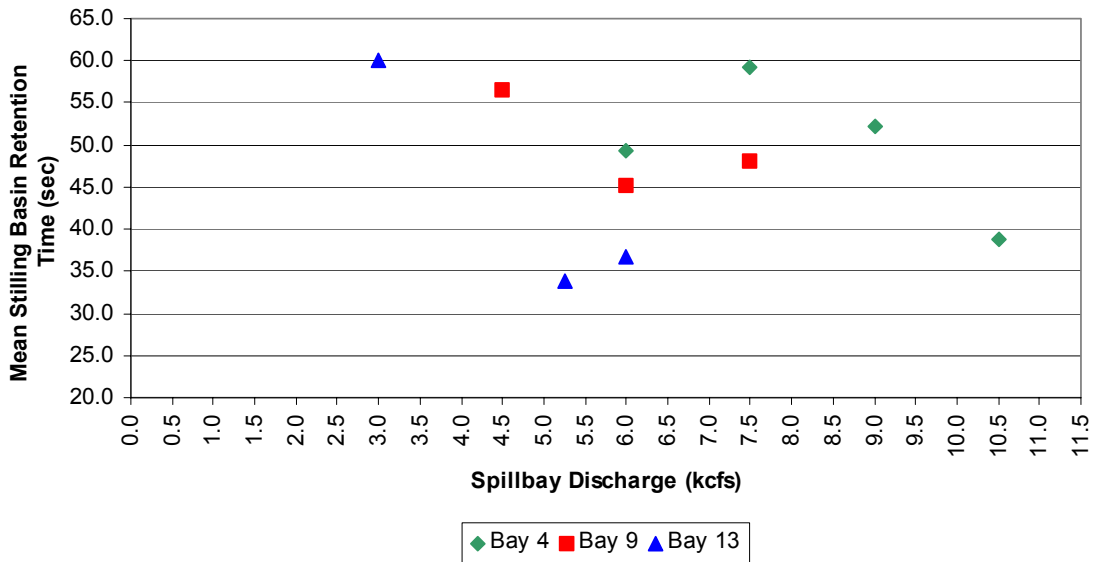
**Figure 4.6. Relationship Between Spillbay Discharge and Exposure Intensity Index**

Figure 4.6 shows the relationship between spillbay discharge and retention time for this data set. The relationship between stilling basin retention times and spillbay discharge shown is, in general, consistent with the patterns of stilling basin retention times observed using dye in tests with The Dalles Dam

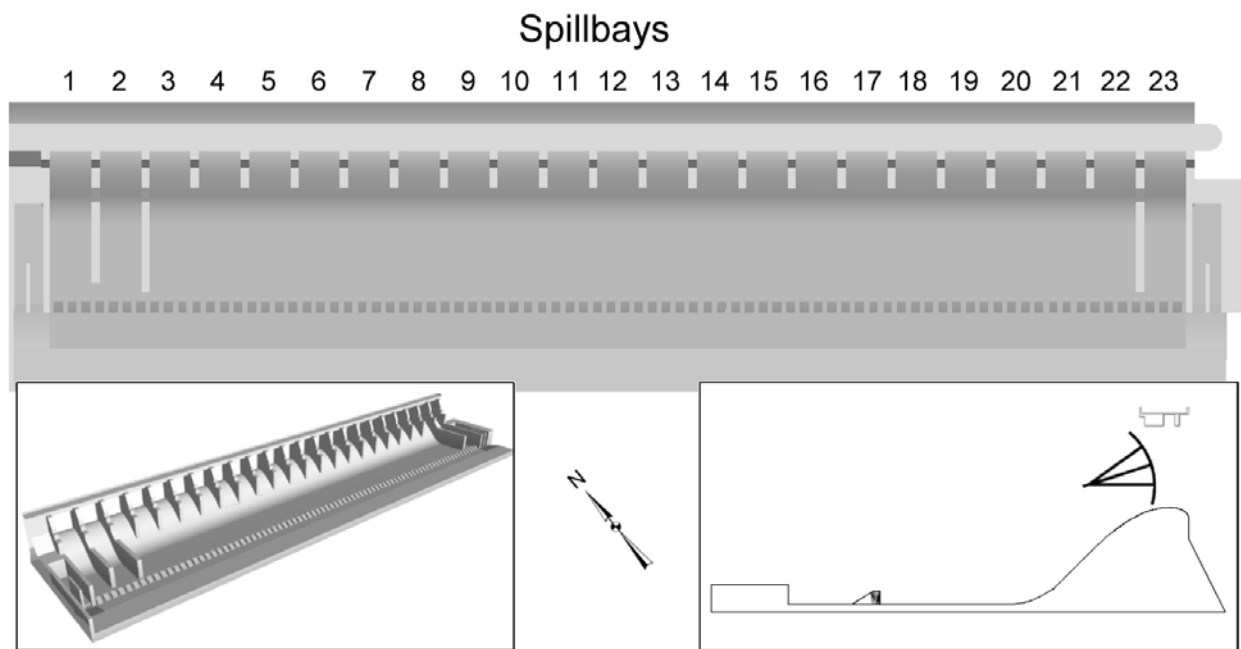
**Figure 4.7. Schematic of The Dalles Dam Spillbay Arrangement**

physical model. Figure 4.7 shows a plan view of The Dalles spillbay arrangement. Retention time decreased in the physical model when spillbay discharge was increased at a specific bay. In addition, retention time was higher for the end spillbays at lower discharge because of lateral flow from south to north. Somewhat unexpected were the relatively short stilling basin retention times for spillbay 13 at

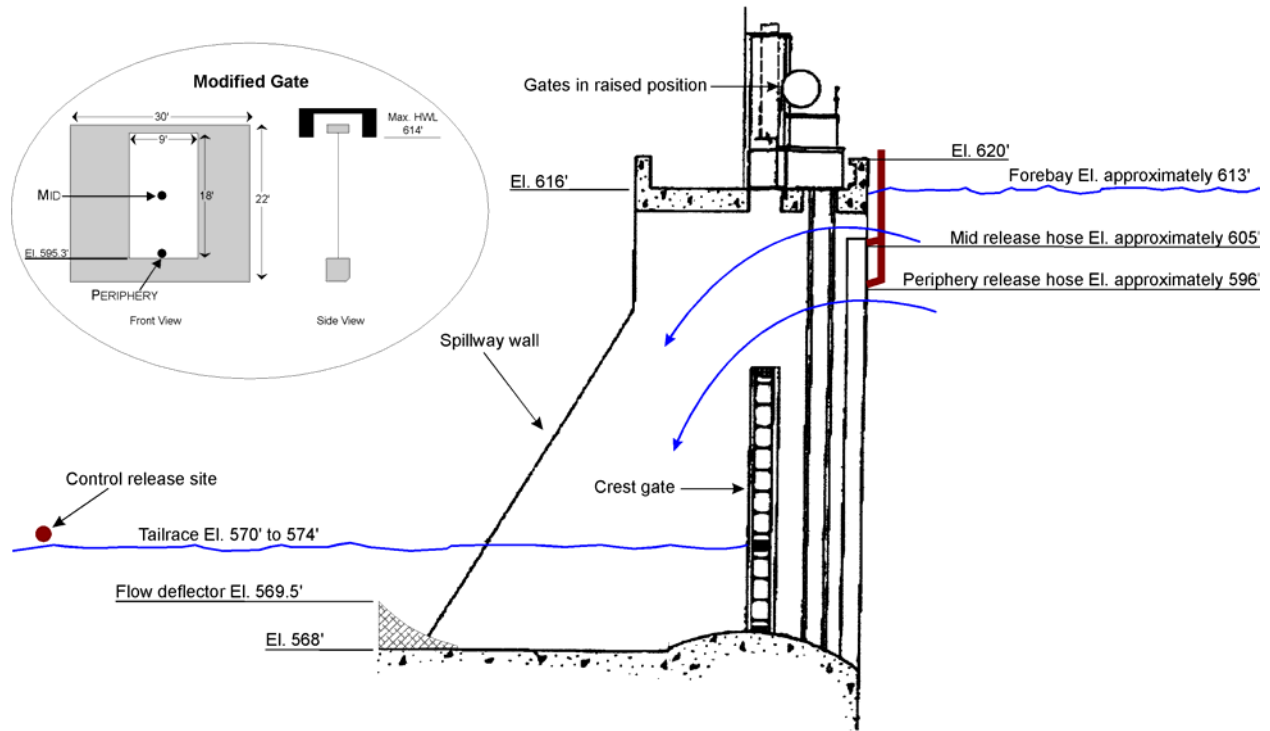
**Figure 4.8. Cross-Section of the Rock Island Dam Spillway Showing the Release Hose Positions and the Notched Spill Gate**

At Rock Island Dam, the Chelan County Public Utility District (PUD) has modified a spillbay by installing a bulkhead with an adjustable slot across the spillbay gate opening (Figure 4.8). The intent of this modification was to attract surface-oriented juvenile salmon to pass in spill rather than through turbines. The PUD also installed a deflector in the spill stilling basin to help control dissolved gas concentrations in the spill plume. The deflector was submerged approximately 4 ft.

A total of 31 Sensor Fish were released into a spill discharge of 2.5 kcfs from two locations immediately upstream of the spill opening: 14 were released at a mid-spill discharge release midway in the gate opening (at elevation 605 ft above mean sea level), 14 were released at a periphery release near the lower edge of the 18-ft-high gate opening, and 3 were released directly into the spill discharge downstream of the deflector in a “reference” release for comparison.

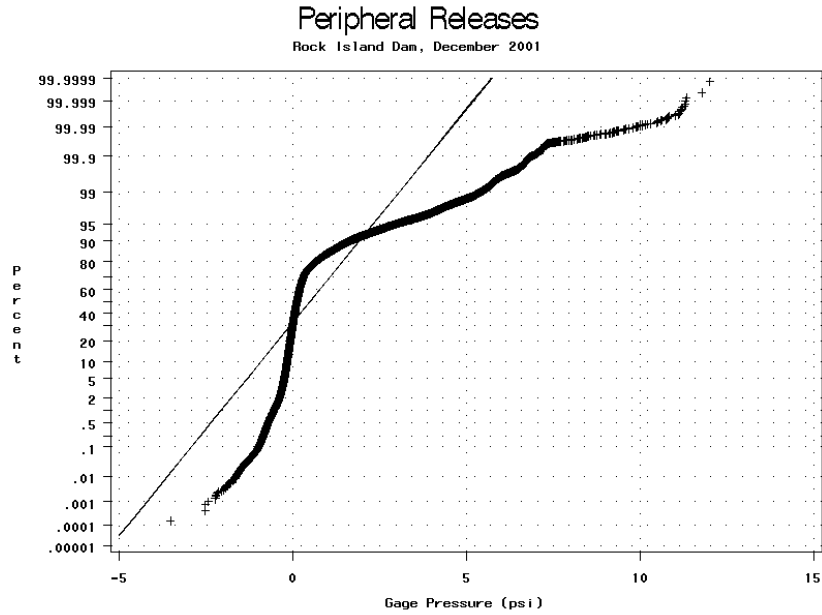
**Figure 4.9. Cumulative Distribution of Gage Pressure for all Peripheral Sensor Fish Releases (+ represents individual pressure readings taken every 0.005 seconds)**

Gage pressure (depth surrogate) and acceleration vector magnitude cumulative distributions for all peripheral releases combined were computed. Figure 4.9 shows the gage pressure cumulative distributions. Acceleration vector magnitude cumulative distributions are shown in Figure 4.10.

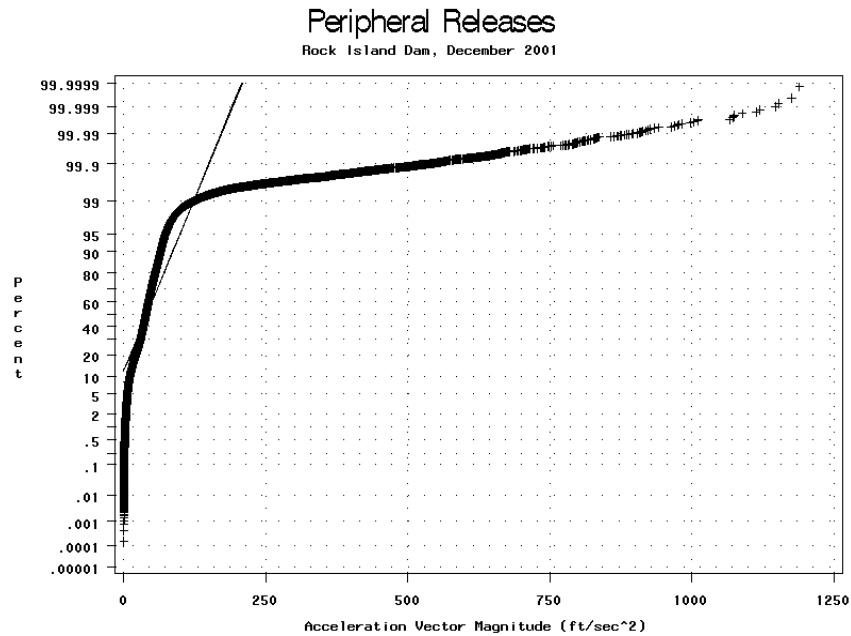
**Figure 4.10. Cumulative Distribution of Acceleration Vector Magnitude for all Peripheral Sensor Fish Releases**

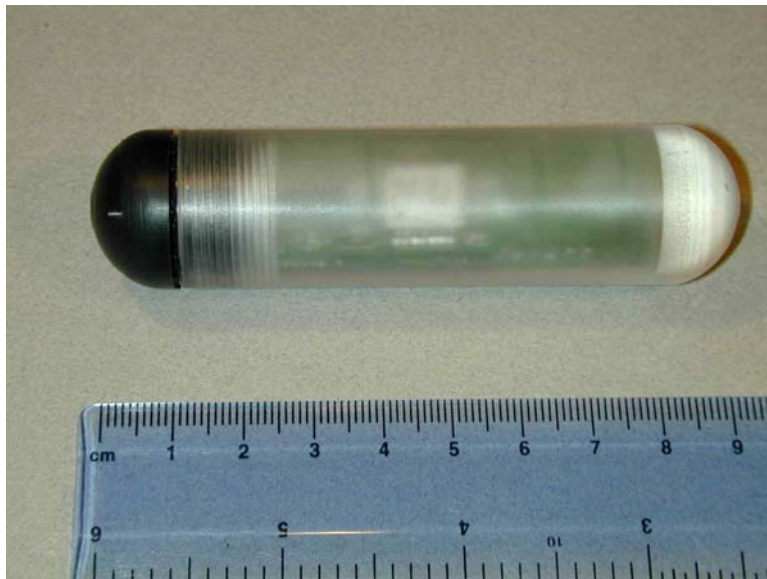
**Figure 5.1. New and Improved Sensor Fish Device**

Reducing the size of the electronics will allow us to create a Sensor Fish device that can be gastrically inserted into a live smolt. Because it will be a part of the fish, the new Sensor Fish could permit the most realistic view yet of the physical conditions fish are exposed to during dam passage. It could directly link environmental impacts encountered by an individual fish with its injuries. The first prototype insert is approximately 20 mm in diameter and 100 mm in length, which will limit it to be used as a gastric or surgical implant in larger smolt (Figure 5.1). However, an even smaller gastric insert device is being developed that would allow it to be used on smaller smolts. Both prototypes will be ready for testing by early 2003.
