OPERATING EXPERIENCE SUMMARY

U.S. Department of Energy
Office of Environment, Safety and Health
OE Summary 2005-08
May 12, 2005

Operating Experience Summary 2005-08

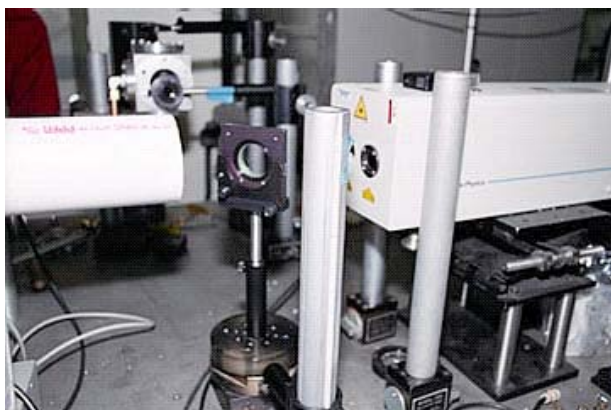
Figure 2-1. Laser experiment setup

The scientist and student had set up a laser experiment designed to suspend and analyze particles inside a vacuum target chamber, using a configuration that was not described or analyzed in work control documents. Figure 2-1 shows the setup for the experiment.

The experiment involved using a Particle Generating (PG) laser to suspend the particles and a Laser Induced Breakdown Spectroscopy (LIBS) laser to vaporize them. After the scientist had fired the laser, secured it, and observed the suspended particles, he told the student she could view the particles. As the student looked into the chamber, she saw a flash and noticed a reddish brown substance floating in her left eye. She was

later diagnosed with a retinal lesion and associated hemorrhage in the eye. Neither the student nor the scientist was wearing LEP because they needed to see the small amount of visible light from the laser while they were aligning the mirror.

Investigators determined that the laser exposure resulted from improper or no use of engineering controls and the lack of personal protection equipment. The work was poorly planned, hazards were not identified, controls were not put in place before work began, and the performance of workers was poorly monitored. In addition, the scientist did not adhere to documented requirements for Class 4 laser operations and failed to practice, model, and enforce safe behavior, which directly influenced the student's behavior in the laboratory.

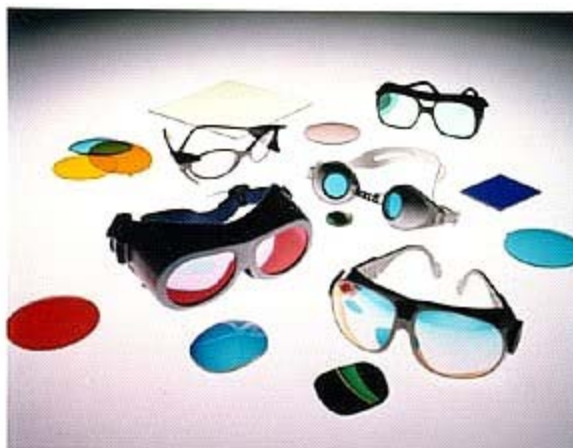
Figure 2-2. Protective eyewear

[OE Summary 2004-06](#) discusses a March 14, 2003, incident in which a graduate student at UC-Berkeley suffered a temporary eye injury while manipulating a power meter in the path of a pulsed infrared laser beam. The student believed the alignment task was completed and had already removed his LEP when a stray beam reflected into his eyes. The article includes a listing of techniques for performing laser alignments safely, as well as a figure (shown here as Figure 2-2) depicting various types of protective eyewear.

The unprotected human eye is extremely sensitive to laser radiation and can be permanently damaged from direct or reflected beams. Protective eyewear in the form of goggles, glasses, and shields must be worn at all times during laser operations. Each type of laser requires a specific type of protective eyewear that must be considered in the selection process. It is important to specifically check both the wavelength and the optical density imprinted on LEP before using a laser, especially in multi-wavelength facilities where more than one laser may be located in the same room. In addition, it is important to ensure that area lighting is adequate to allow sufficient visibility to observe instruments even while wearing LEP.

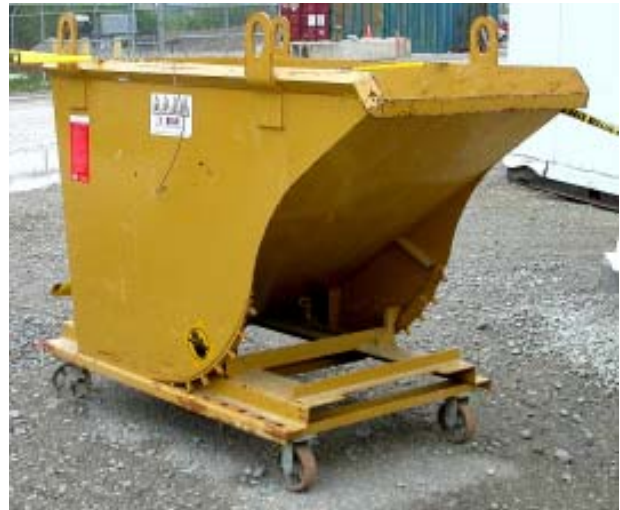
Figure 4-1. Waste hopper

On April 14, 2005, at the Fernald Closure Project, a DOE facility representative saw a radiological control technician (RCT) reach underneath a waste hopper supported on the tines of a forklift to swipe the bottom of the hopper. Concerned, the facility representative spoke to the RCT's supervisor and the project manager. The project manager suspended work. (ORPS Report OH-FN-FFI-FEMP-2005-0011)

The forklift operator had raised the hopper (Figure 4-1) about 12 inches from the ground and left the forklift's engine running. After swiping the sides of the hopper, the RCT reached under it and swiped the bottom of the hopper. The forklift operator did not maintain a clear view of the RCT while he was surveying the hopper, because he was waiting for the RCT's signal that the survey was complete and that the hopper could be transported away.

Fernald, like some other sites across the DOE Complex, trains its RCTs to use a standard long-handled mop with cloth affixed to the head when swiping the tops and sides of tall or large objects. Very large objects such as metal boxes or Sealand® containers are normally placed on blocks so that RCTs can survey the underside.

Good Practice: Use a long-handled mop to perform radiological swipes on inaccessible or potentially unstable objects.

Fernald is in the process of clarifying its procedures to prohibit RCTs from reaching under (or placing any body part under) a supported load unless it is absolutely necessary, in which case safety and health organization staff will first evaluate the situation.
