# OPERATING EXPERIENCE SUMMARY

**U.S. Department of Energy**  
**Office of Environment, Safety and Health**  
OE Summary 2004-20  
October 18, 2004

### 1. ***WORKER STRUCK IN FACE BY EJECTED DEWAR PLUG***

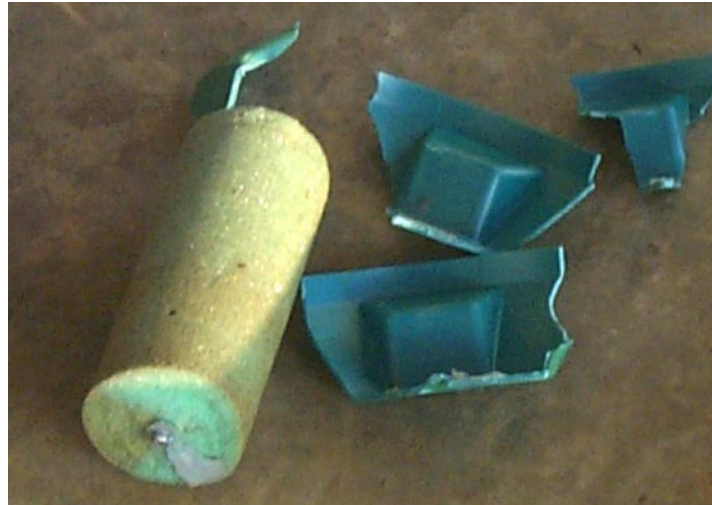
The worker picked up the 30-liter Dewar to determine if it was empty before he filled it with nitrogen. When he set the Dewar down, the plug popped out, hit him in the face, and shattered. The damaged plug is shown in Figure 1-2; an undamaged plug is shown in Figure 1-3.

of remaining nitrogen in the Dewar caused moisture in the air to condense around the mouth of the flask and freeze the plug in place. The plug is normally held by a friction fit that allows venting, but the ice effectively sealed the venting space normally provided by the plug, allowing a pressure buildup. When the worker set the flask down, the ice seal broke, and the plug was ejected.

The worker was not wearing personal protective equipment (PPE) that would normally be worn while filling the Dewar (gloves, apron, and full face shield). When the incident occurred, site workers were not required to wear PPE when working with empty Dewars.

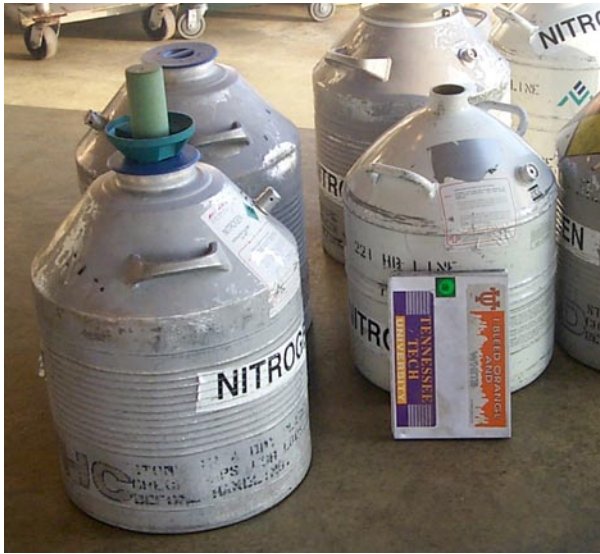
*Figure 1-1. Dewar involved in the event (next to clipboard)*

On September 8, 2004, at the Savannah River Site, a worker was struck on the side of the face by a plug that was ejected from a pressurized nitrogen Dewar (Figure 1-1). Doctors performed a medical evaluation on the worker, including x-rays. They released him after determining there was no injury other than a bruised cheek. The event was reported as a near miss. (ORPS Report SR--WSRC-FSSBU-2004-0005)

Corrective actions will include reviewing policies and procedures for accepting empty returned Dewars at the Gas Cylinder Building and determining whether self-venting lids that are less likely to freeze up are available for the 30-liter Dewars.

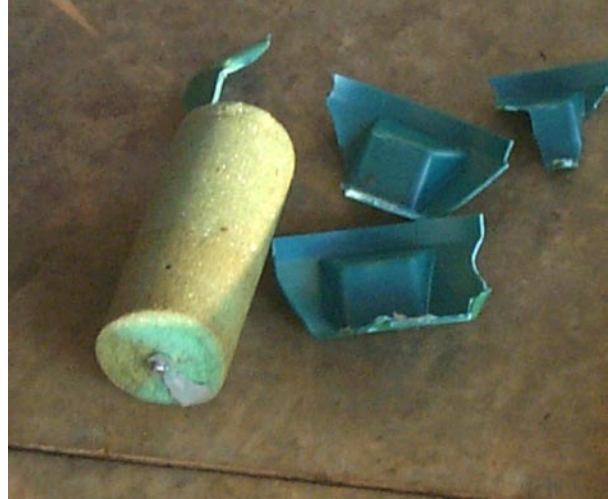
*Figure 1-2. Shattered Dewar plug*

When Dewars are returned for filling, a small amount of liquid nitrogen typically remains in the flask. Investigators believe that off-gassing
