**NATIONAL HISTORIC CONTEXT FOR
DEPARTMENT OF DEFENSE INSTALLATIONS, 1790 - 1940**

Volume II of IV

August 1995

FINAL REPORT

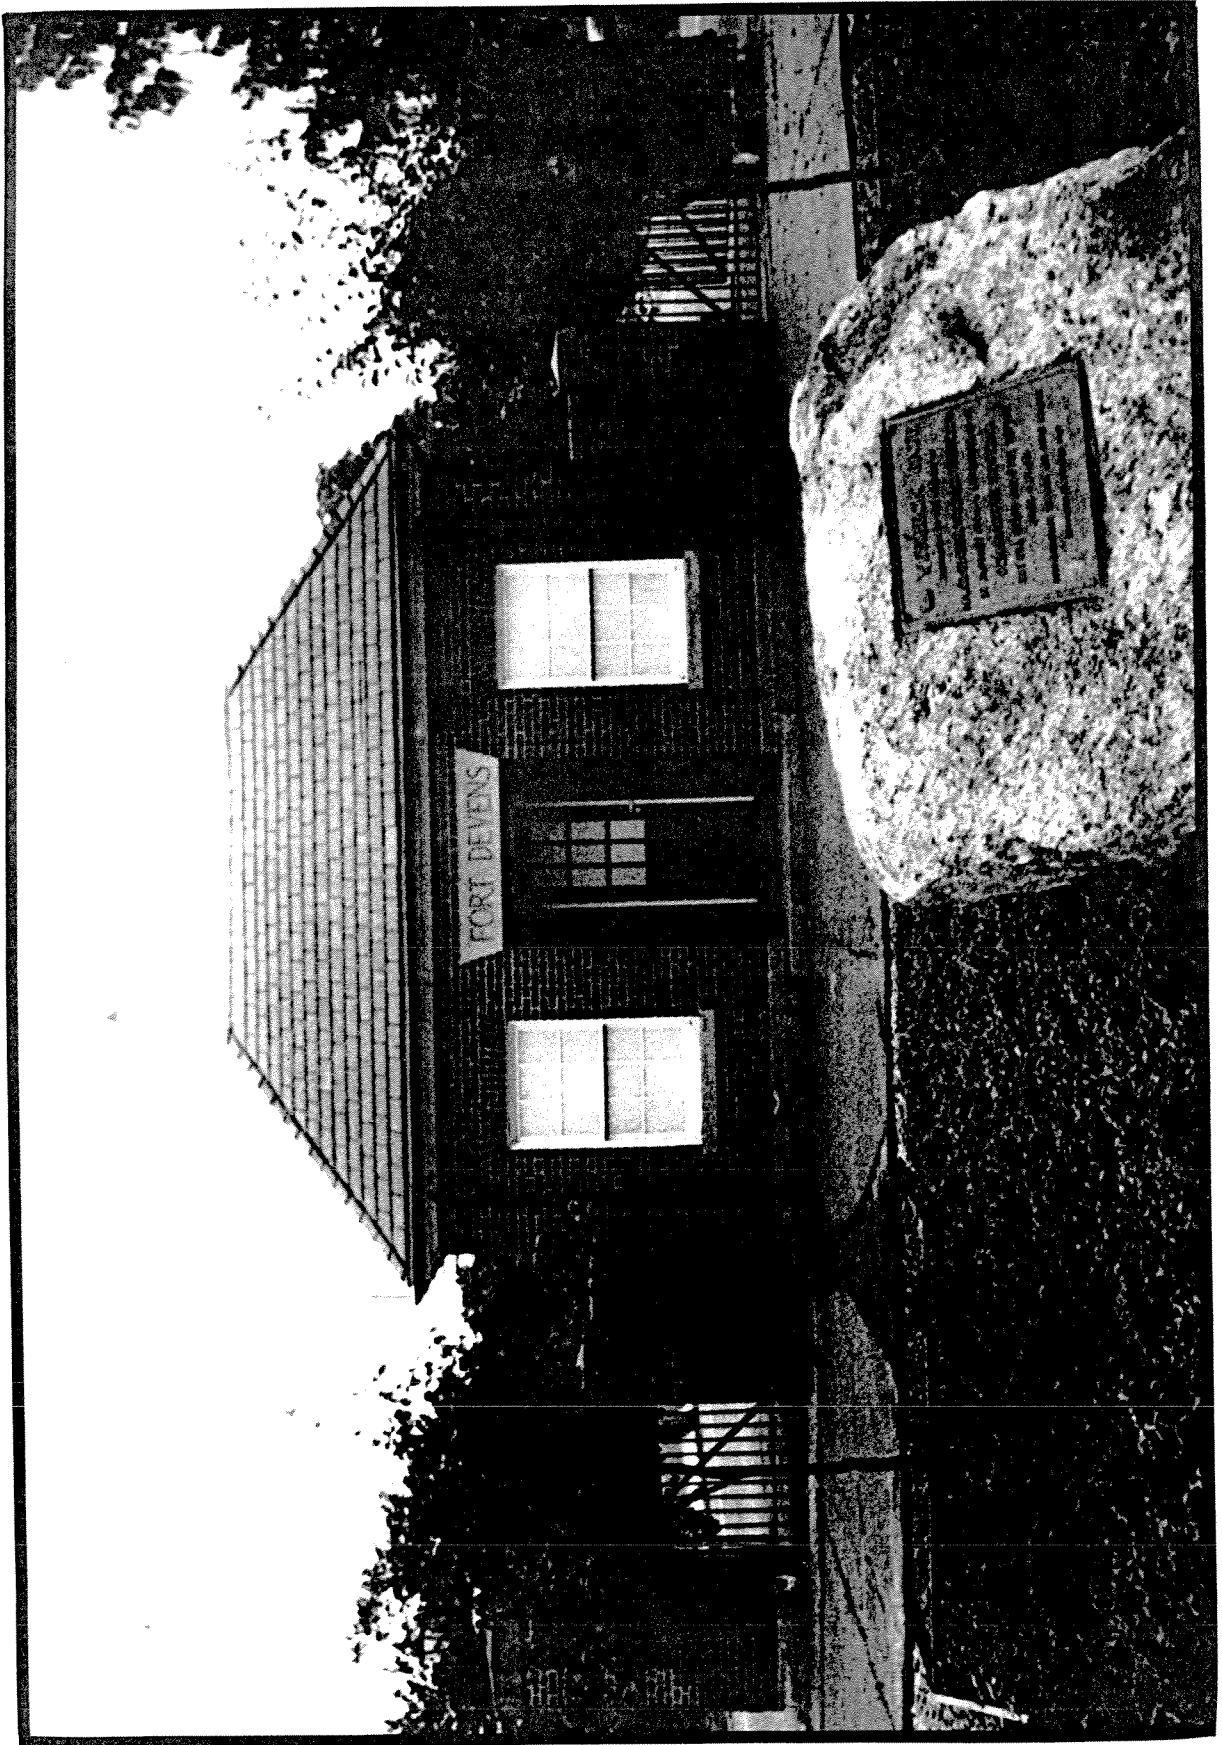
Figure III-6. 1909 Guardhouse, Quartermaster standardized plan no. 206 (Building 234, F.E. Warren AFB, [formerly Ft. D.A. Russell], Wyoming), *above*. 1932 French Colonial Revival combined fire station and guardhouse (Building 5676, Barksdale AFB, Louisiana), *below*

At the beginning of the twentieth century, the guardhouse retained the same basic shape as those of earlier times, but Colonial Revival details replaced the earlier Victorian-era details (Figure III-6). In general, the size of the building increased as the sizes of individual installations increased.⁶

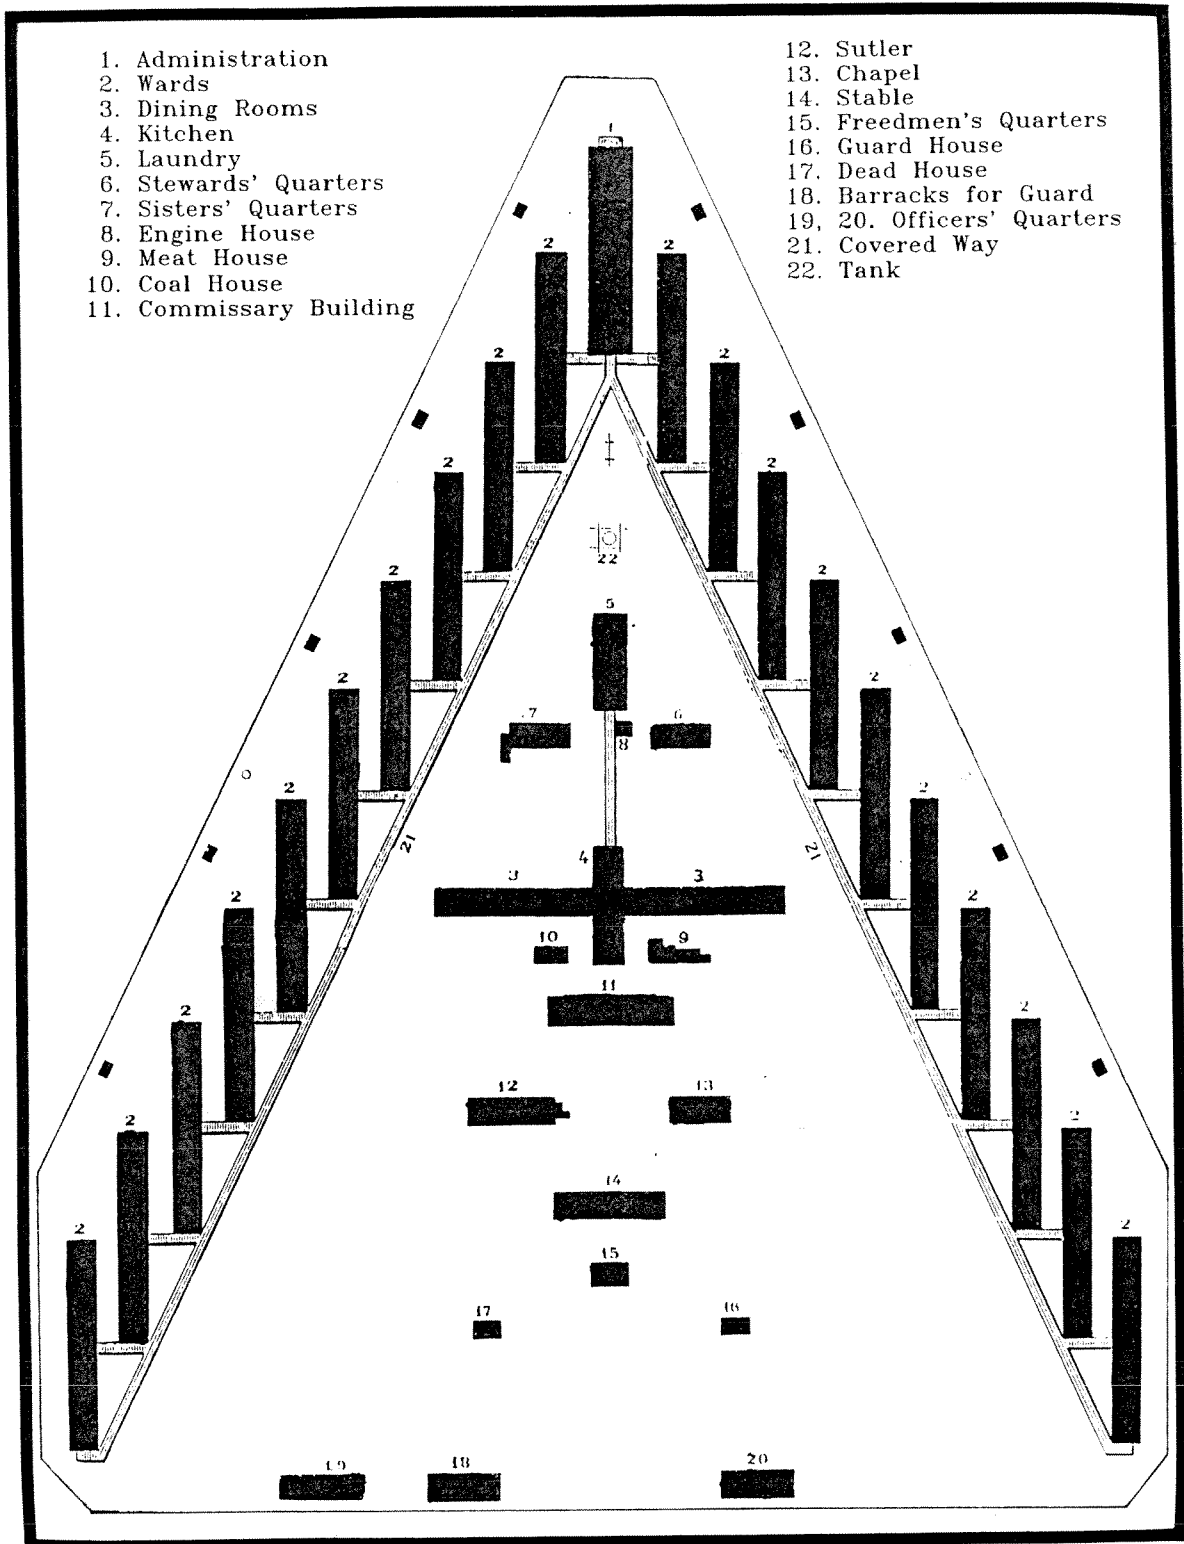
Figure III-39. 1932 Post hospital (Building 558, Langley AFB, Virginia), *above*. 1934 Medical detachment barracks (Building 566, Langley AFB, Virginia), *below*.

During the nationwide Army construction program initiated in 1926, the Army built many new, permanent posts and airfields. Hospitals were constructed at all new installations. The standard design still retained the characteristic central block with flanking wings, though the height was increased to three stories (Figure III-39). The long, open verandas characteristic of nineteenth- and early twentieth-century hospitals disappeared from the basic plan and sometimes were replaced with smaller sun porches. Medical Corps and Nurses Corps barracks often were constructed next to the hospital (Figure III-39).

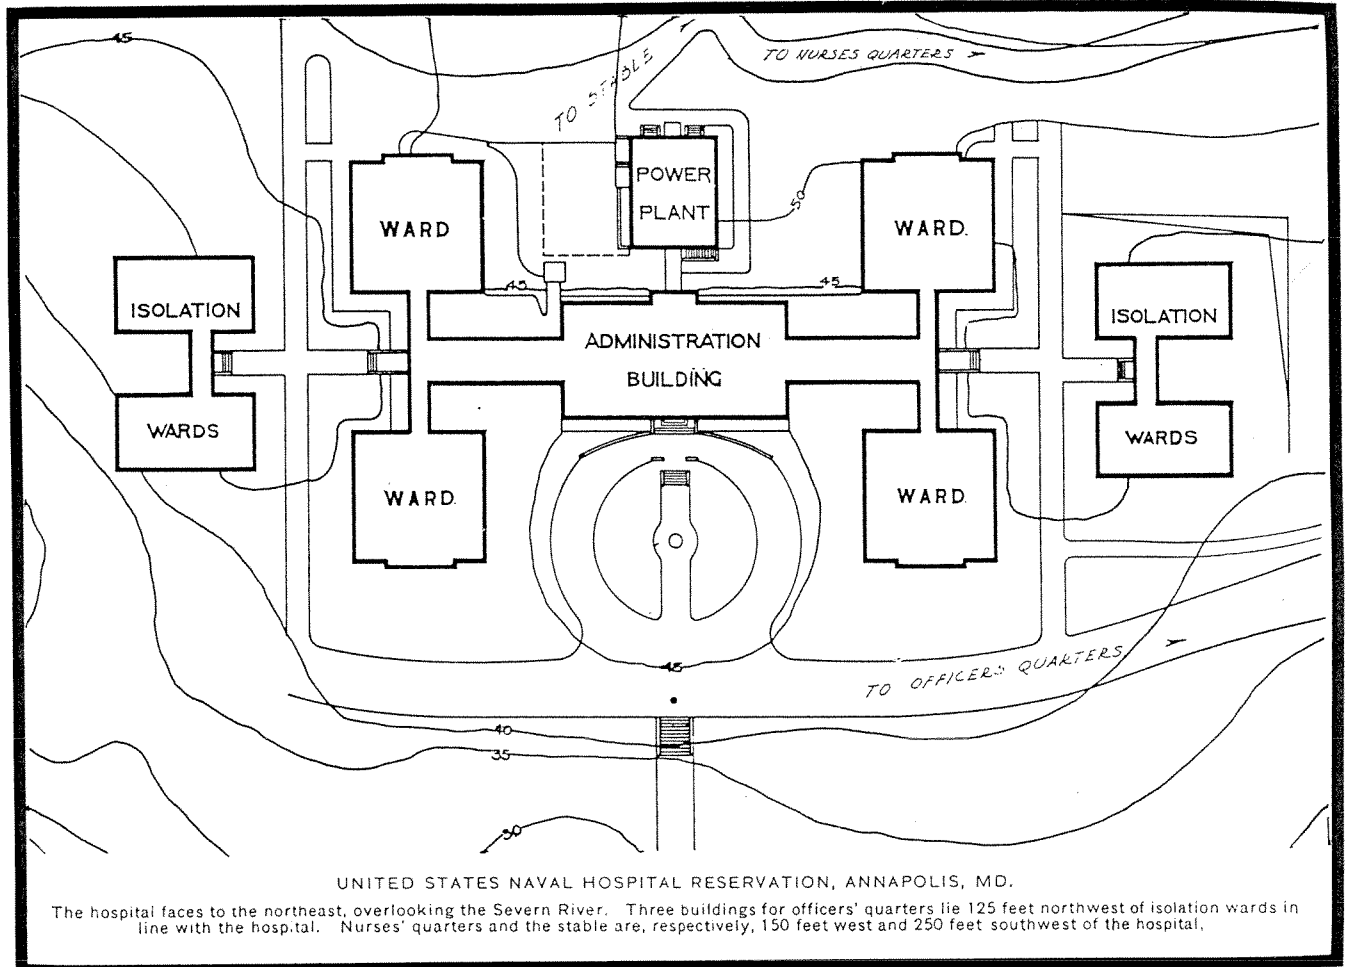
Figure III-47. Plan of pavilion-plan medical complex designed by Ernest Flagg and constructed in 1907 (U.S. Naval Academy, Annapolis, Maryland). (From A.W. Dunbar. *A Description of Recent Hospital Construction in the United States Navy.*)

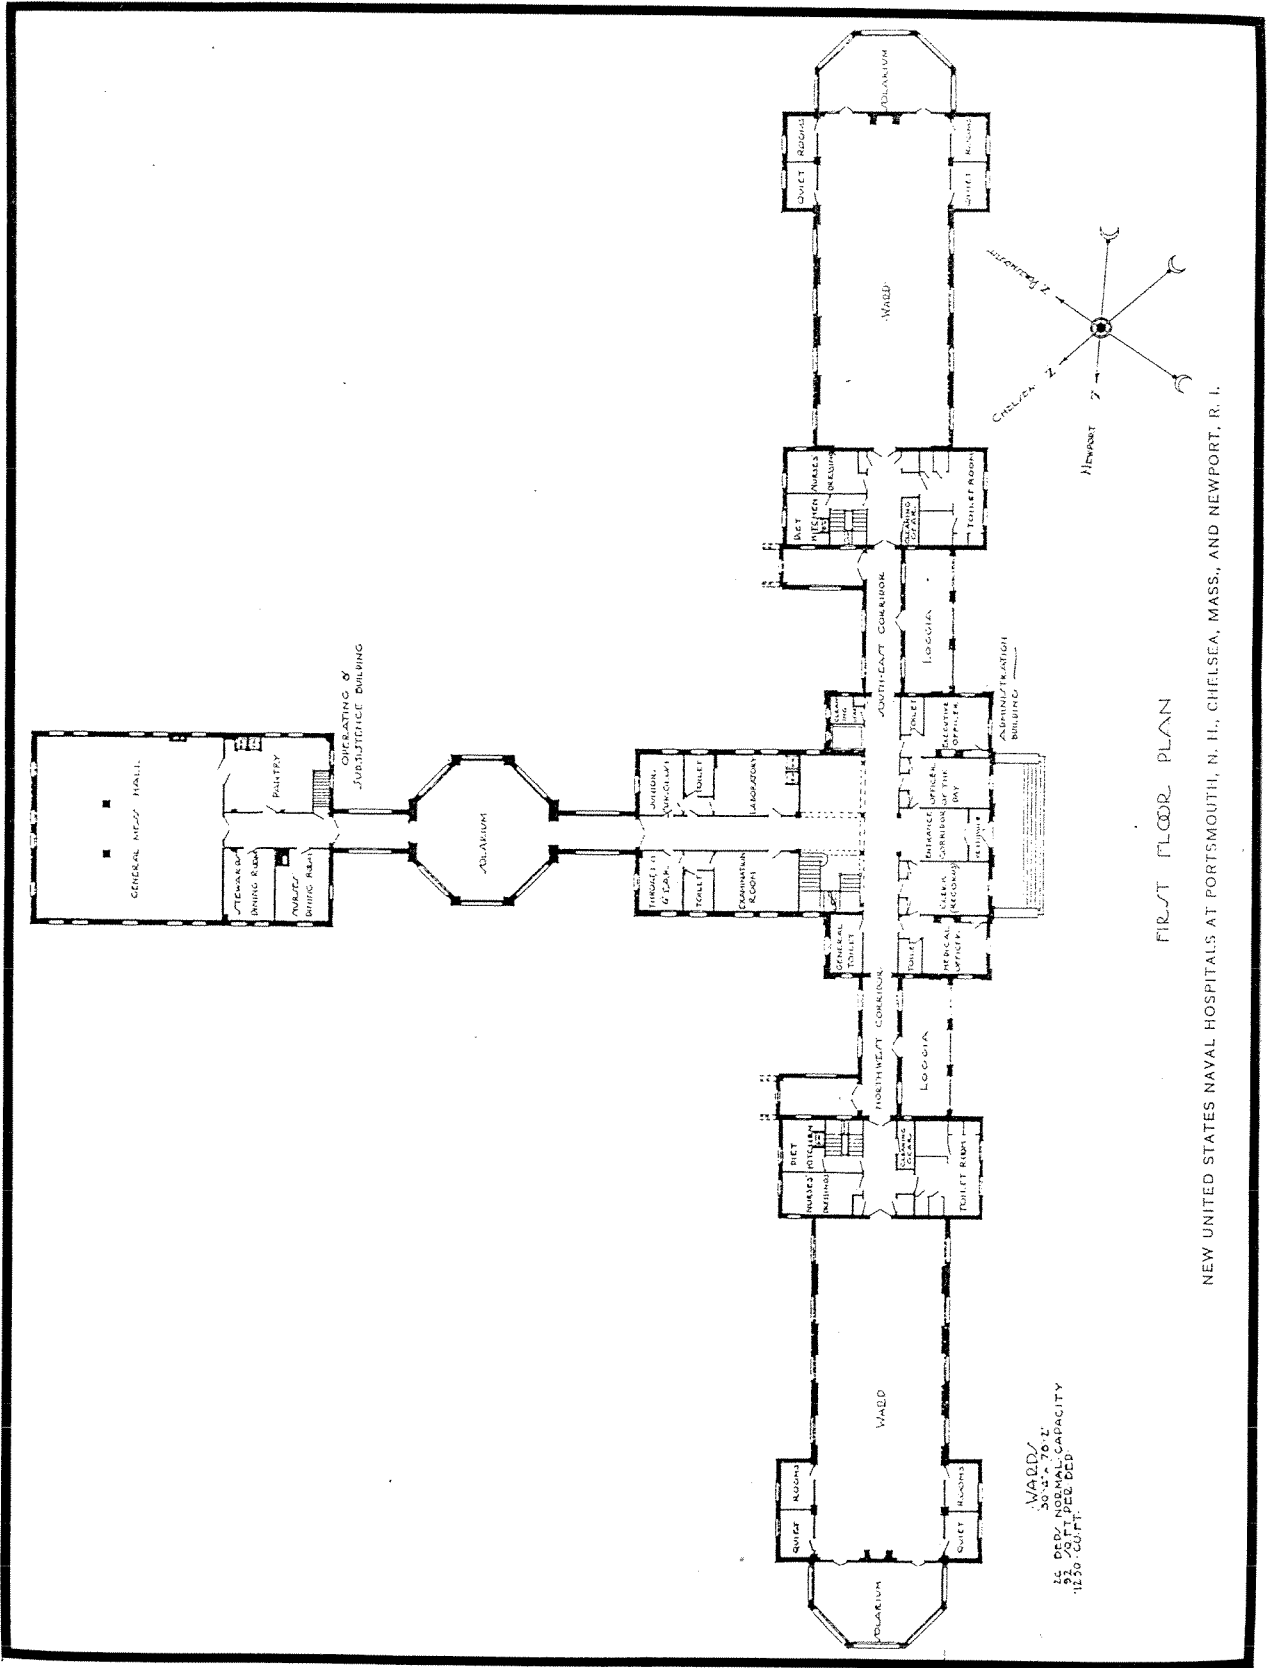
Figure III-48. Plan of naval hospitals constructed at Newport, Rhode Island; Portsmouth, New Hampshire; and, Chelsea, Massachusetts. (From A.W. Dunbar, *A Description of Recent Hospital Construction in the United States Navy.*)

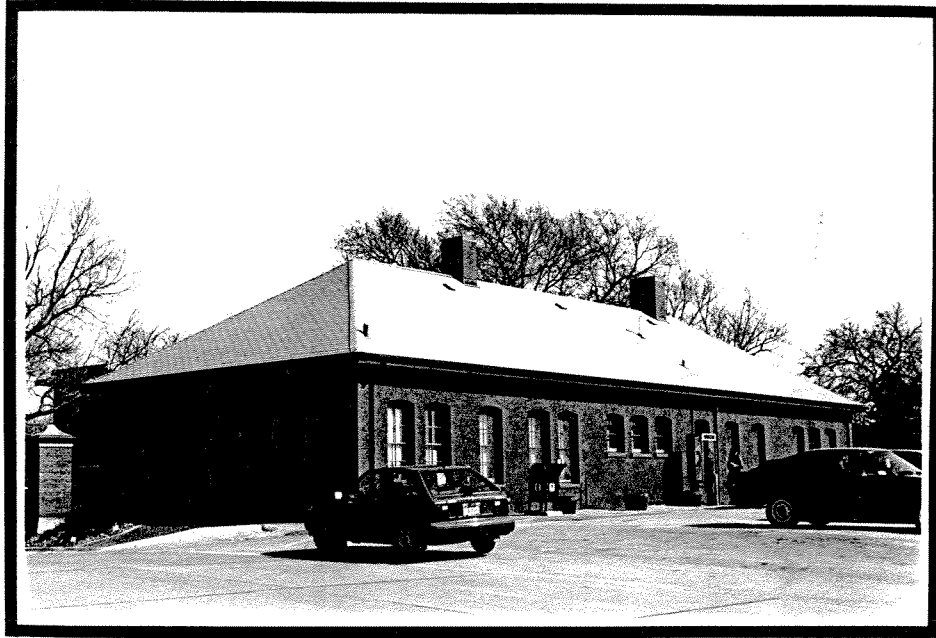
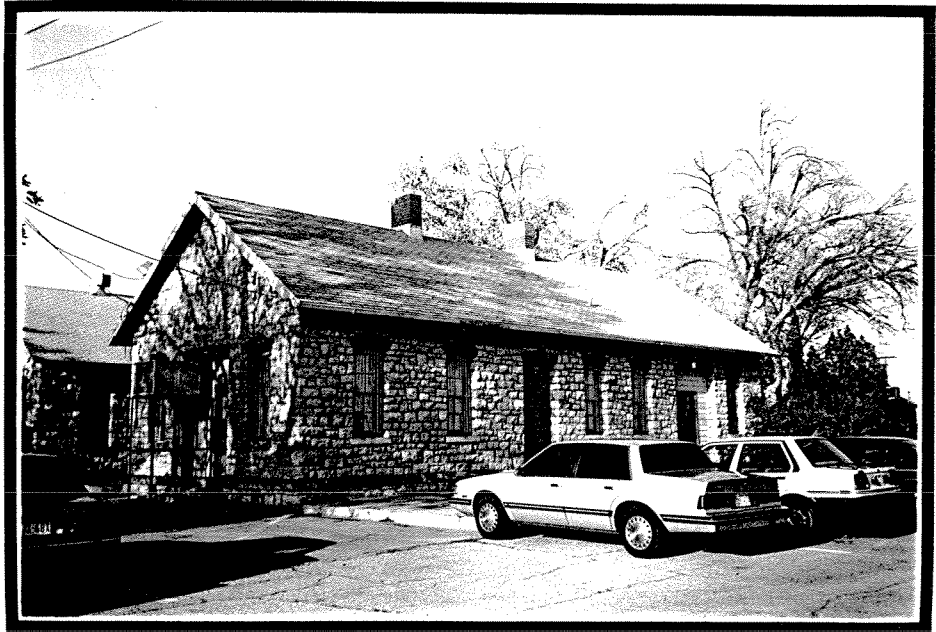
Figure III-49. Quartermaster shop constructed in 1893 to house blacksmith, tinsmith, plumber, paint, carpenter, and wheelwright shops (Building 44, Offutt AFB [formerly Ft. Crook], Nebraska), *above*. 1895 Quartermaster shop (Building 2009, Ft. Bliss, Texas), *below*.

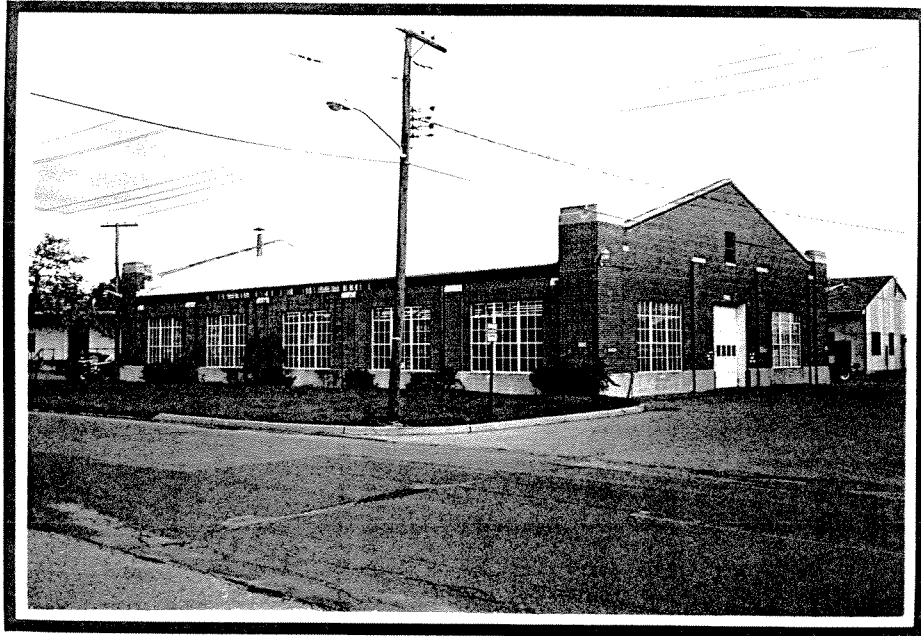
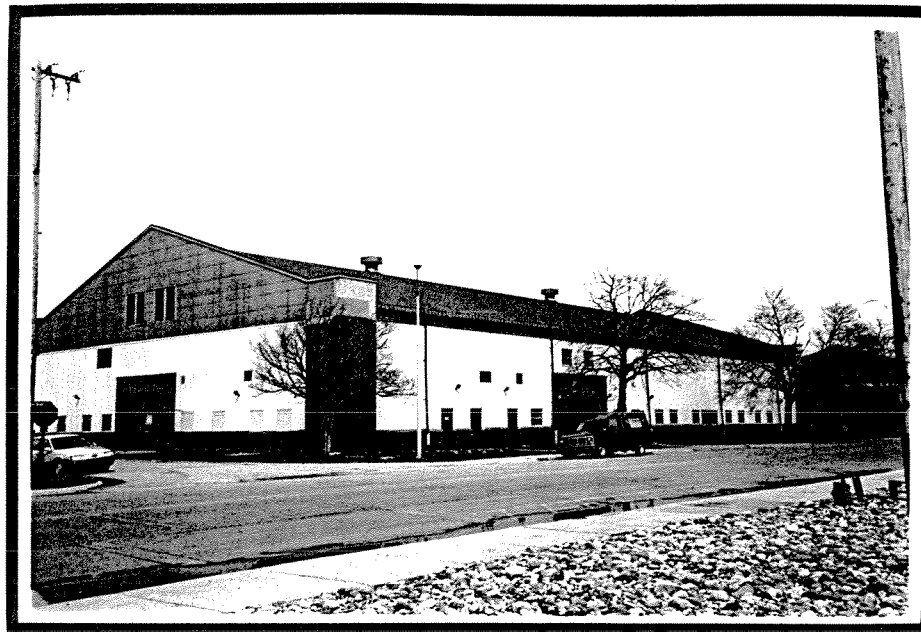
Figure III-51. 1934 Quatermaster garage (Building 279, Ft. Monmouth, New Jersey), *above*. 1932 Army Air Corps repair shop, with subsequent modifications covering original window openings (Building 117, Selfridge ANG, Michigan), *below*.

The functions of Quartermaster shops evolved between the late nineteenth century and the end of the 1930s. By the turn-of-the-century, railroads had replaced wagon trains and wheelwrights were no longer needed. During the inter-war period, the Army began to use trucks to transport supplies. The construction of blacksmith shops and quartermaster garages illustrates that both horses and motorized vehicles had roles on Army posts during the 1930s (Figures II-50 and III-51).

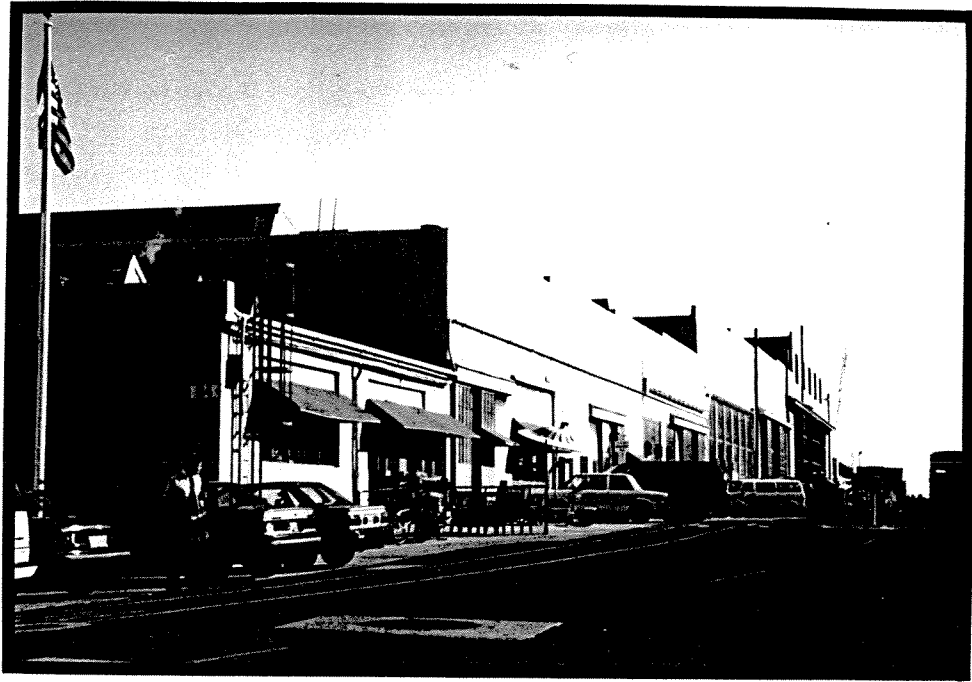
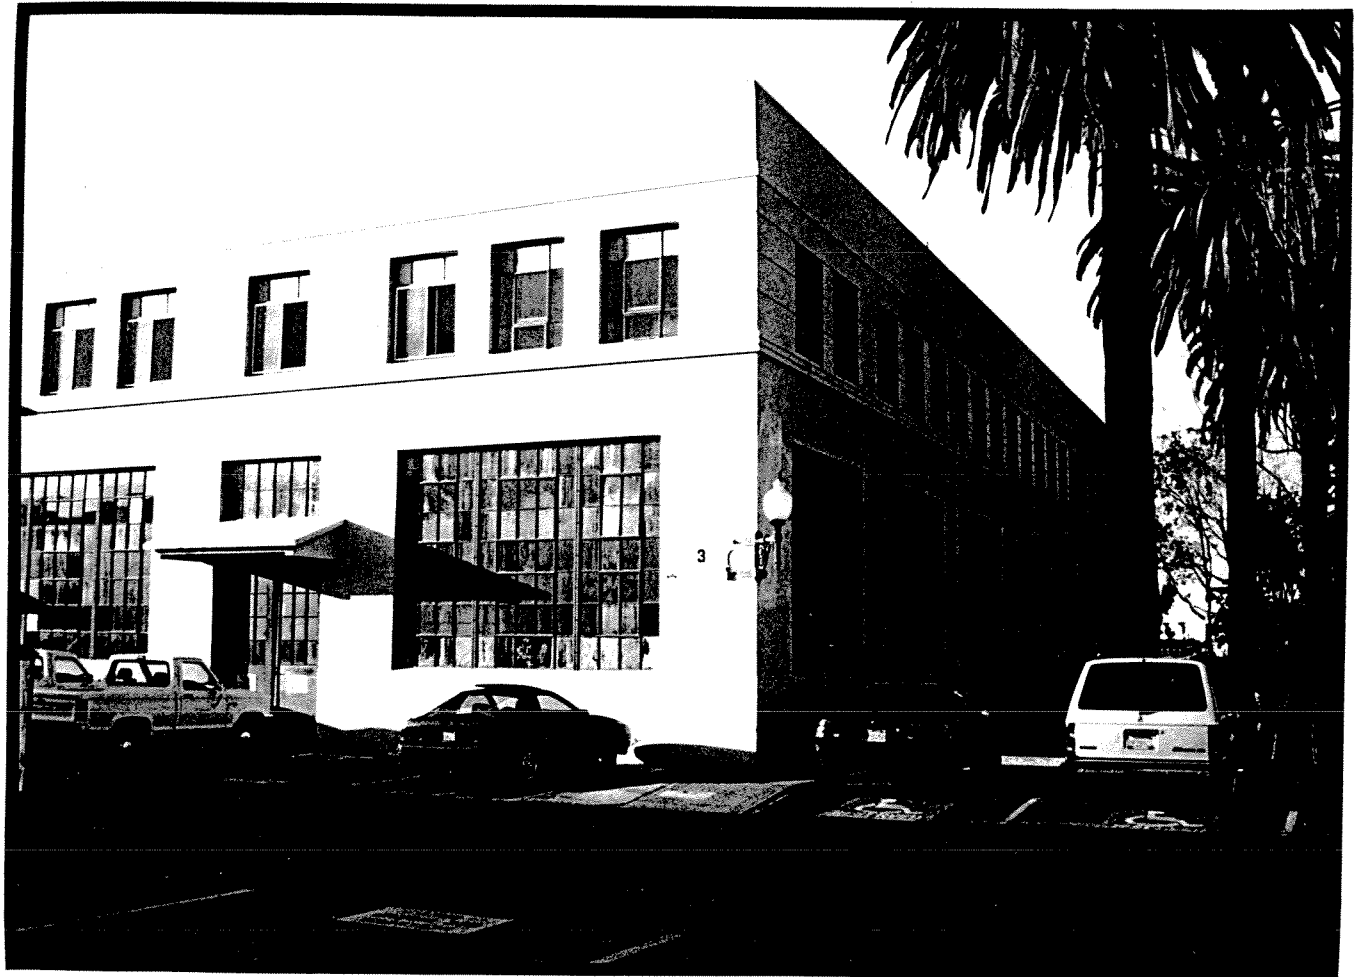
Figure III-52. ca. 1935 Final Engine Overhaul and Assembly Shop (Building 94, Naval Air Station North Island, California), *above*. 1919 Shops and Tool Room (Building 3, Naval Air Station North Island, California), *below*.

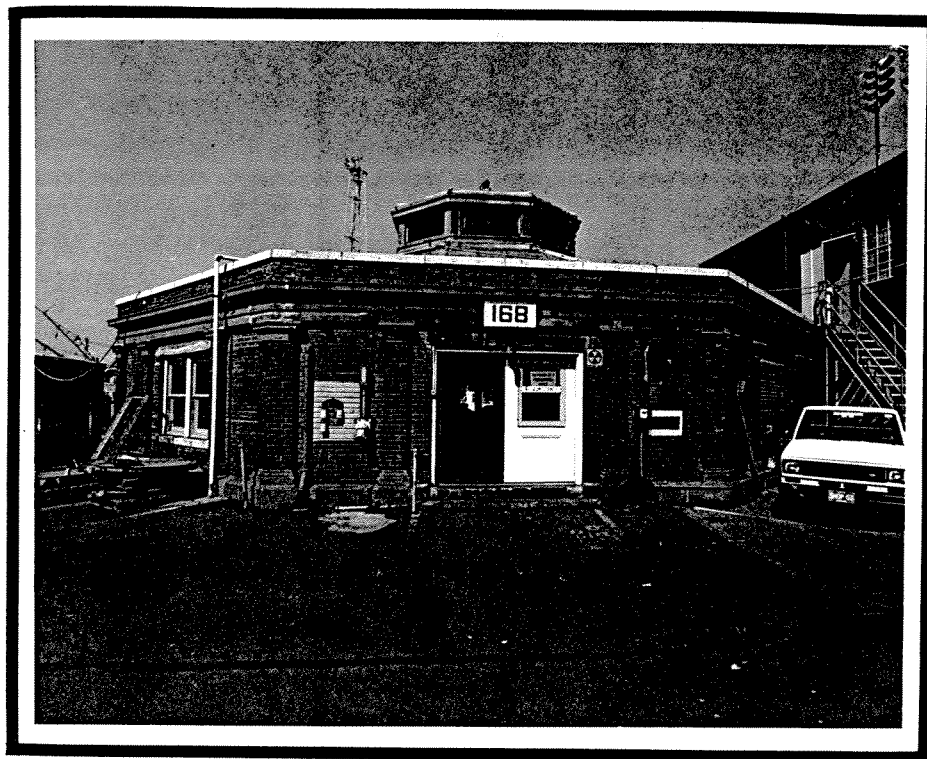
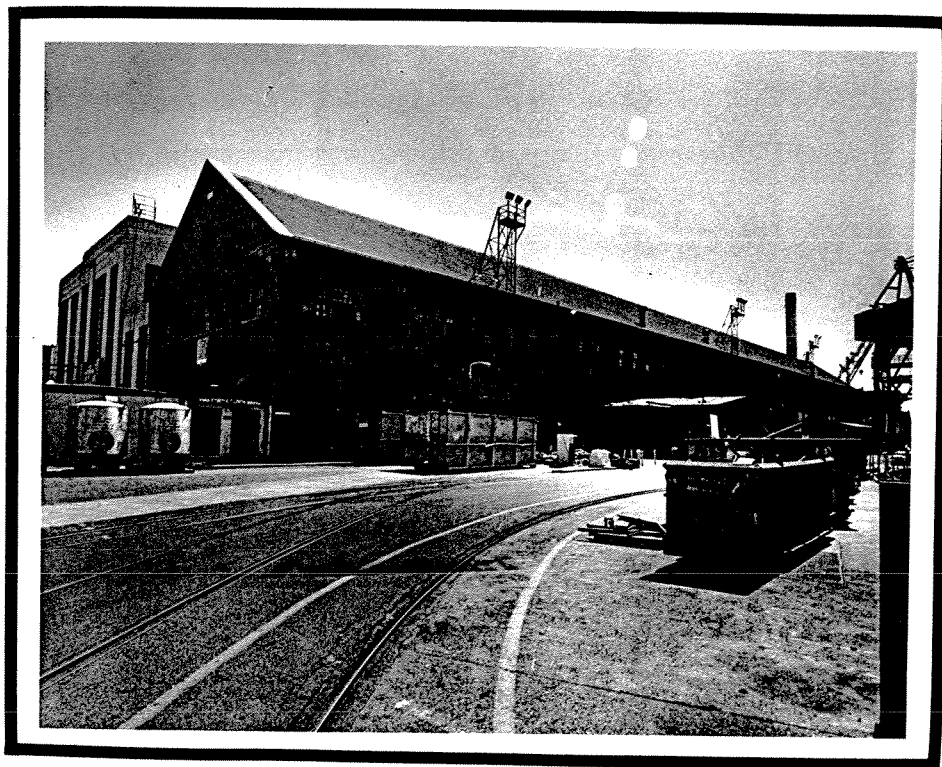
Figure III-58. 1908 Pumphouse (Building 168, Naval Shipyard Puget Sound, Bremerton, Washington), *above*. 1898 Machine shop, constructed of brick-encased steel frame (Building 58, Naval Shipyard Puget Sound, Bremerton, Washington), *below*. (Courtesy U.S. Navy)

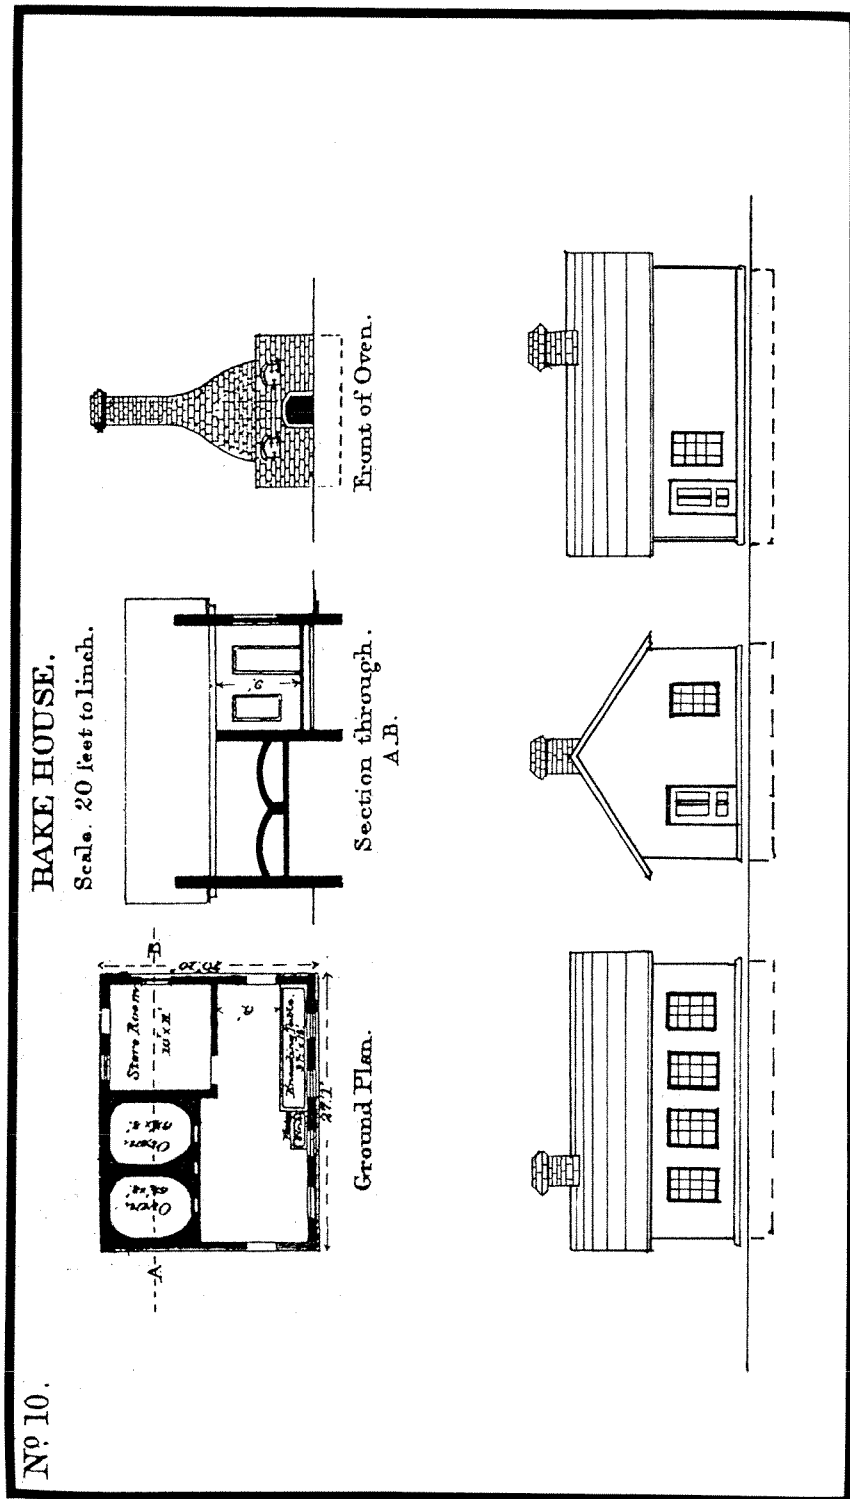
Figure III-62. 1872 Quartermaster bakery plan. (From War Department. *Annual Quartermaster Report*. Washington, D.C.: Government Printing Office, 1872.)

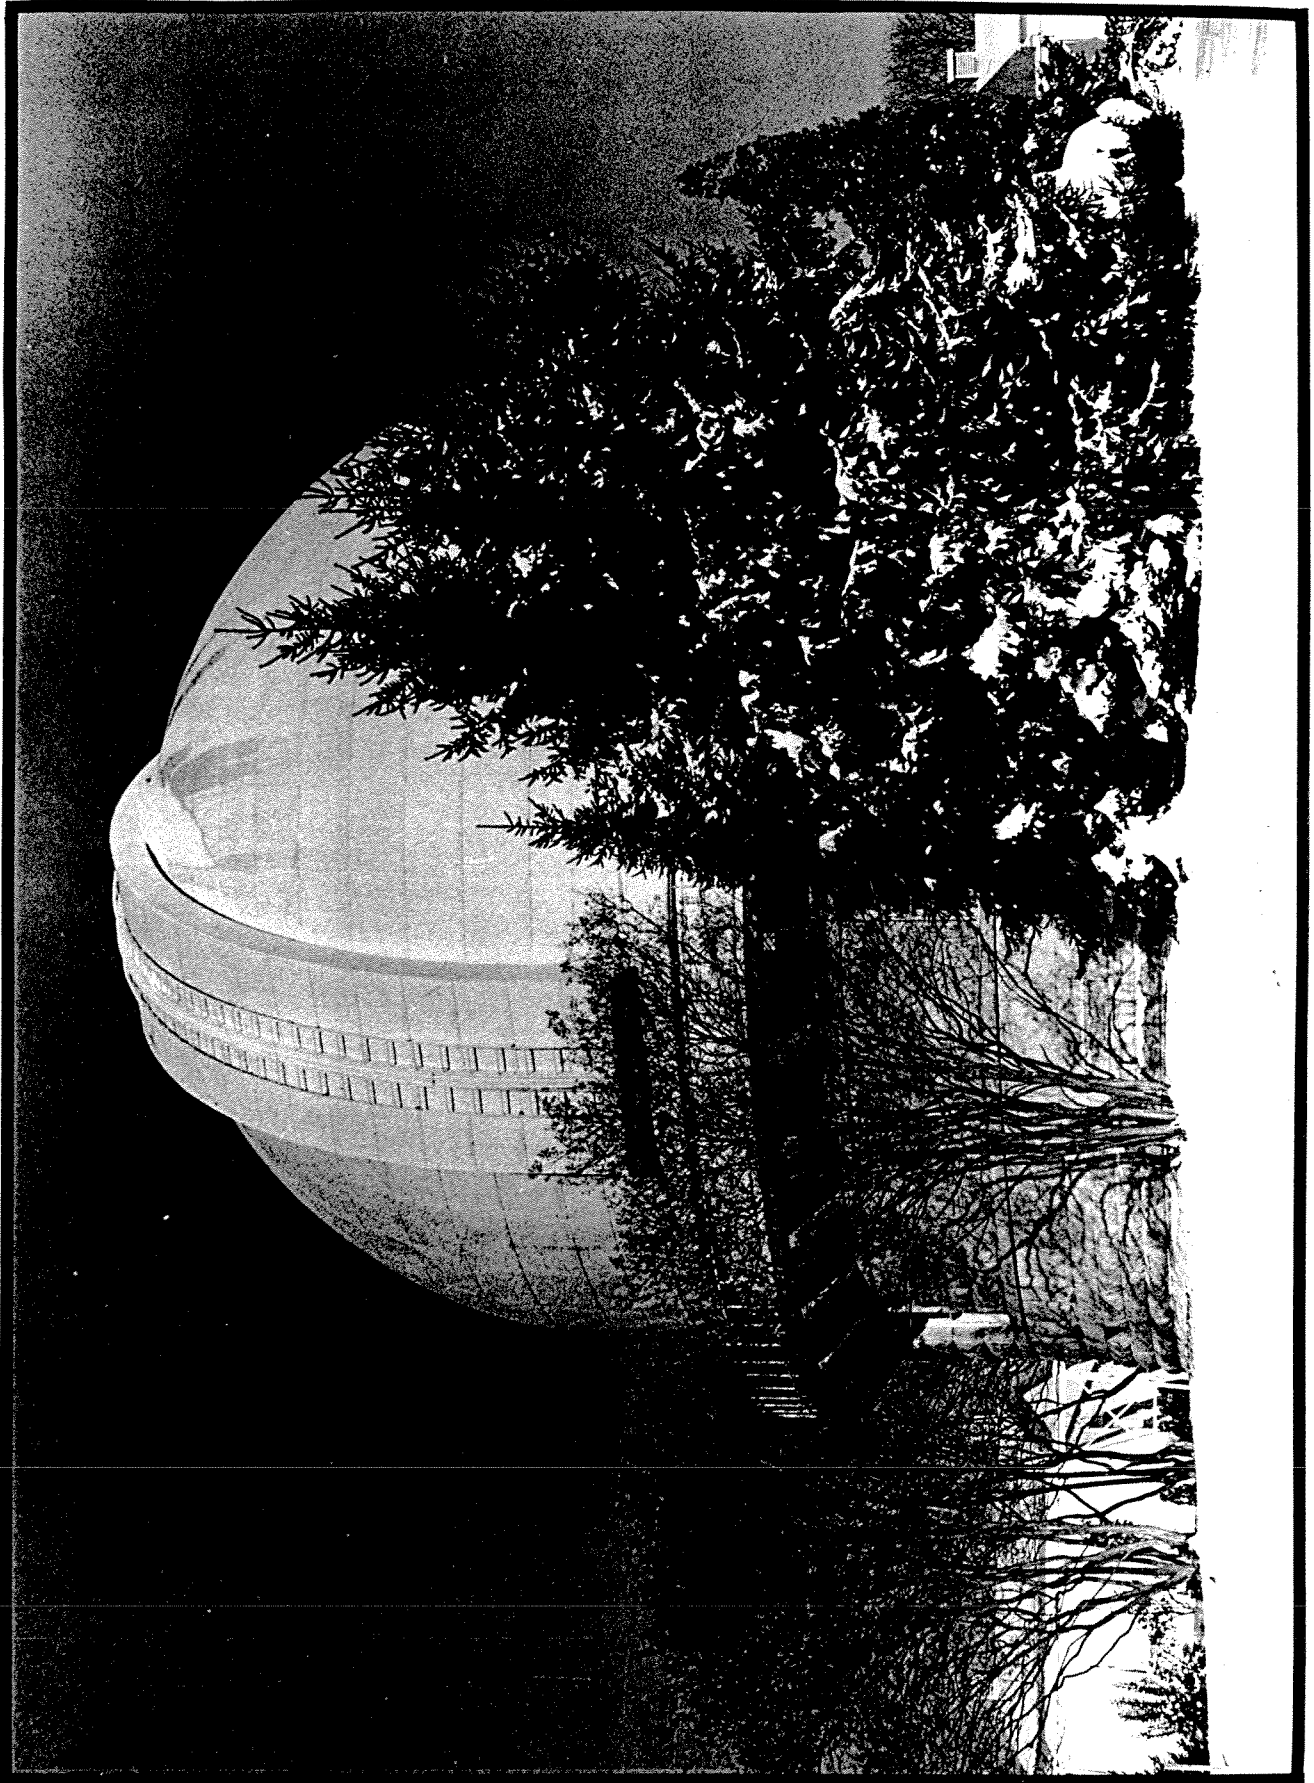
Figure III-103. 26-inch telescope dome constructed during 1890s (Naval Observatory, Washington, D.C.).

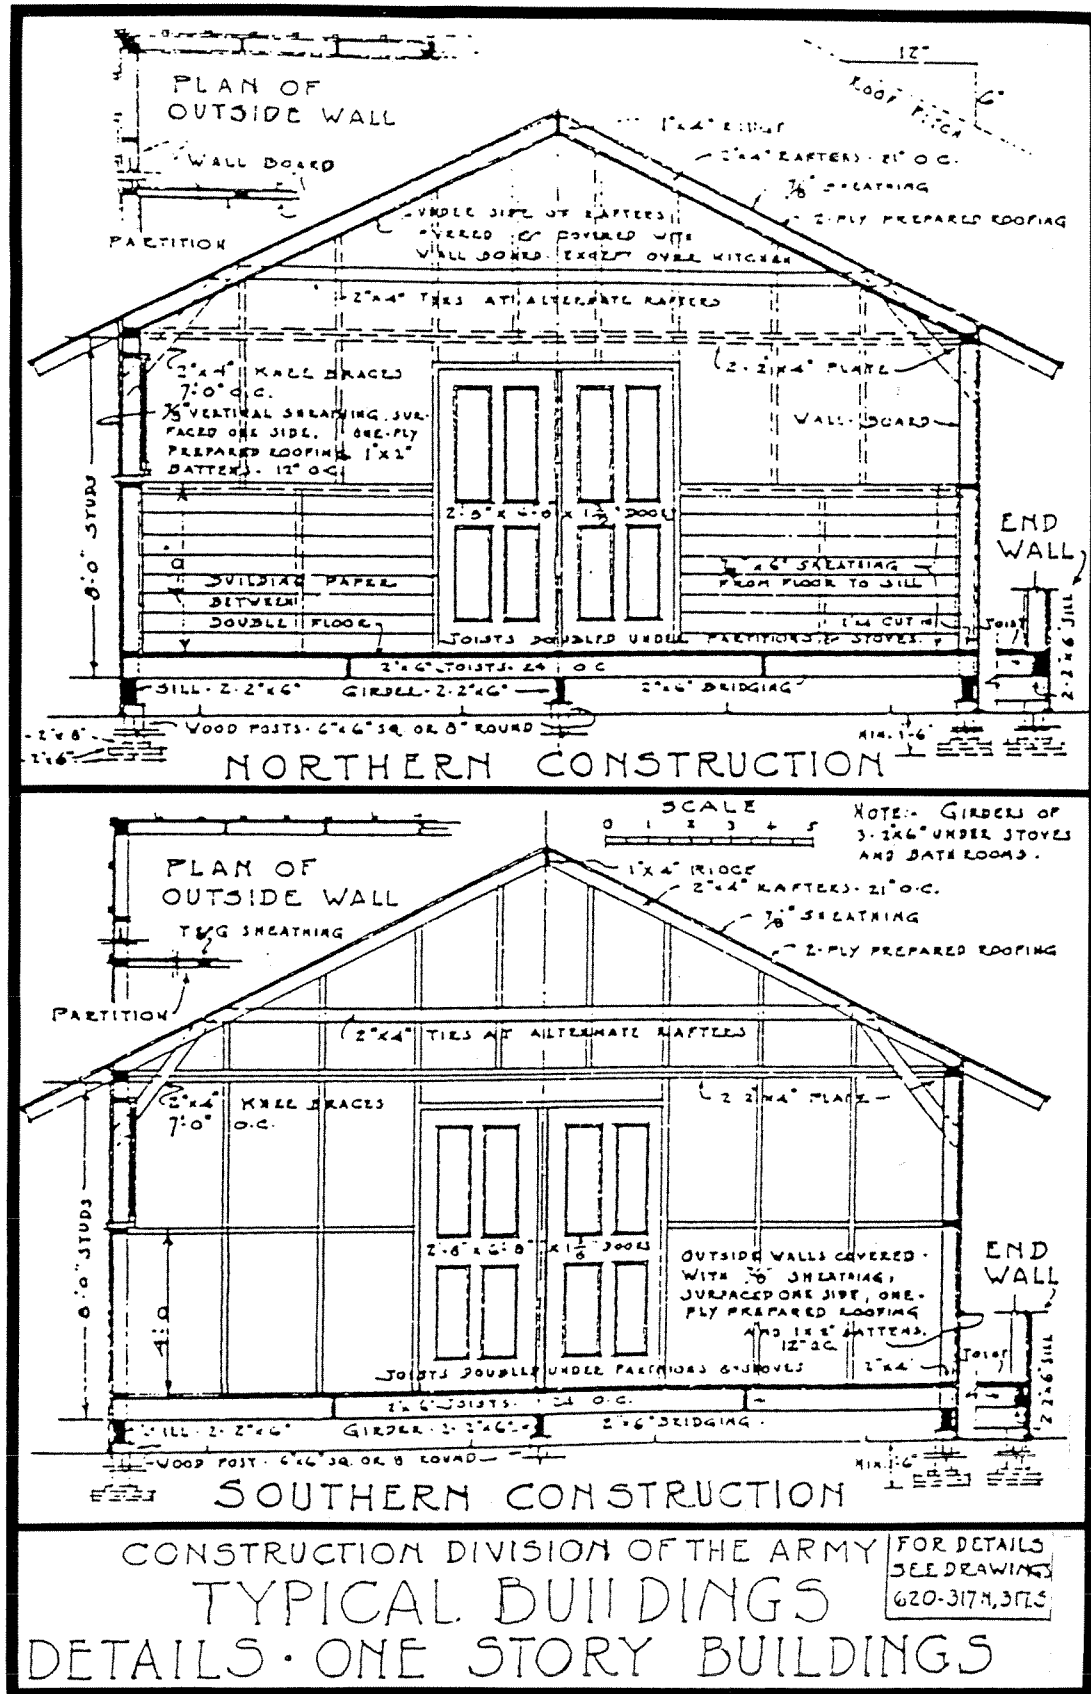
Figure III-111. 600 Series Mobilization Construction Plans (From John S. Garner. *World War II Temporary Military Buildings*. Champaign, Illinois: U.S. Army Construction Engineering Research Laboratory, 1993)

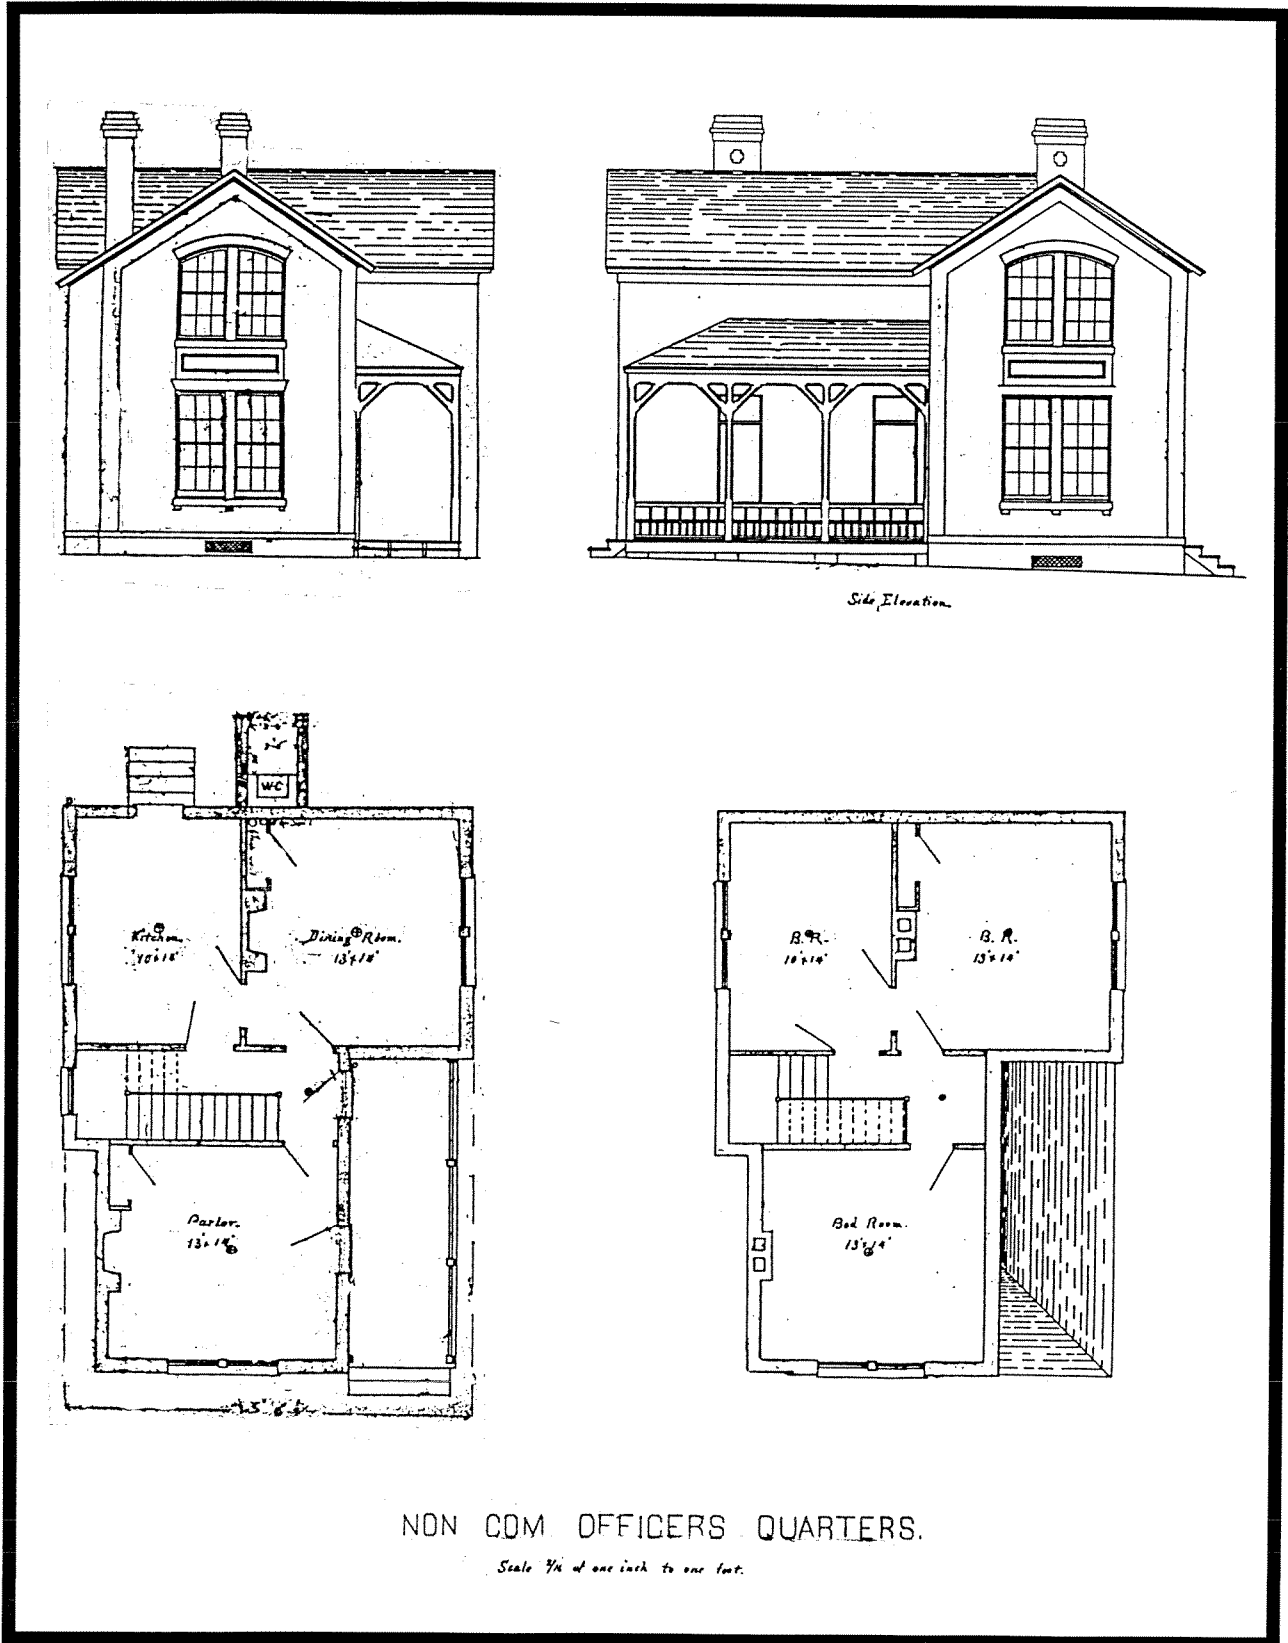
Figure III-123. 1887 plan for NCO housing issued by the Quartermaster Department. This plan was used both for hospital steward's quarters and for housing for other non-commissioned officers. (From National Archives, Record Group 77, Fortification Files, Ft. McPherson, Georgia)
