**NATIONAL HISTORIC CONTEXT FOR
DEPARTMENT OF DEFENSE INSTALLATIONS, 1790 - 1940**

Volume II of IV

August 1995

FINAL REPORT

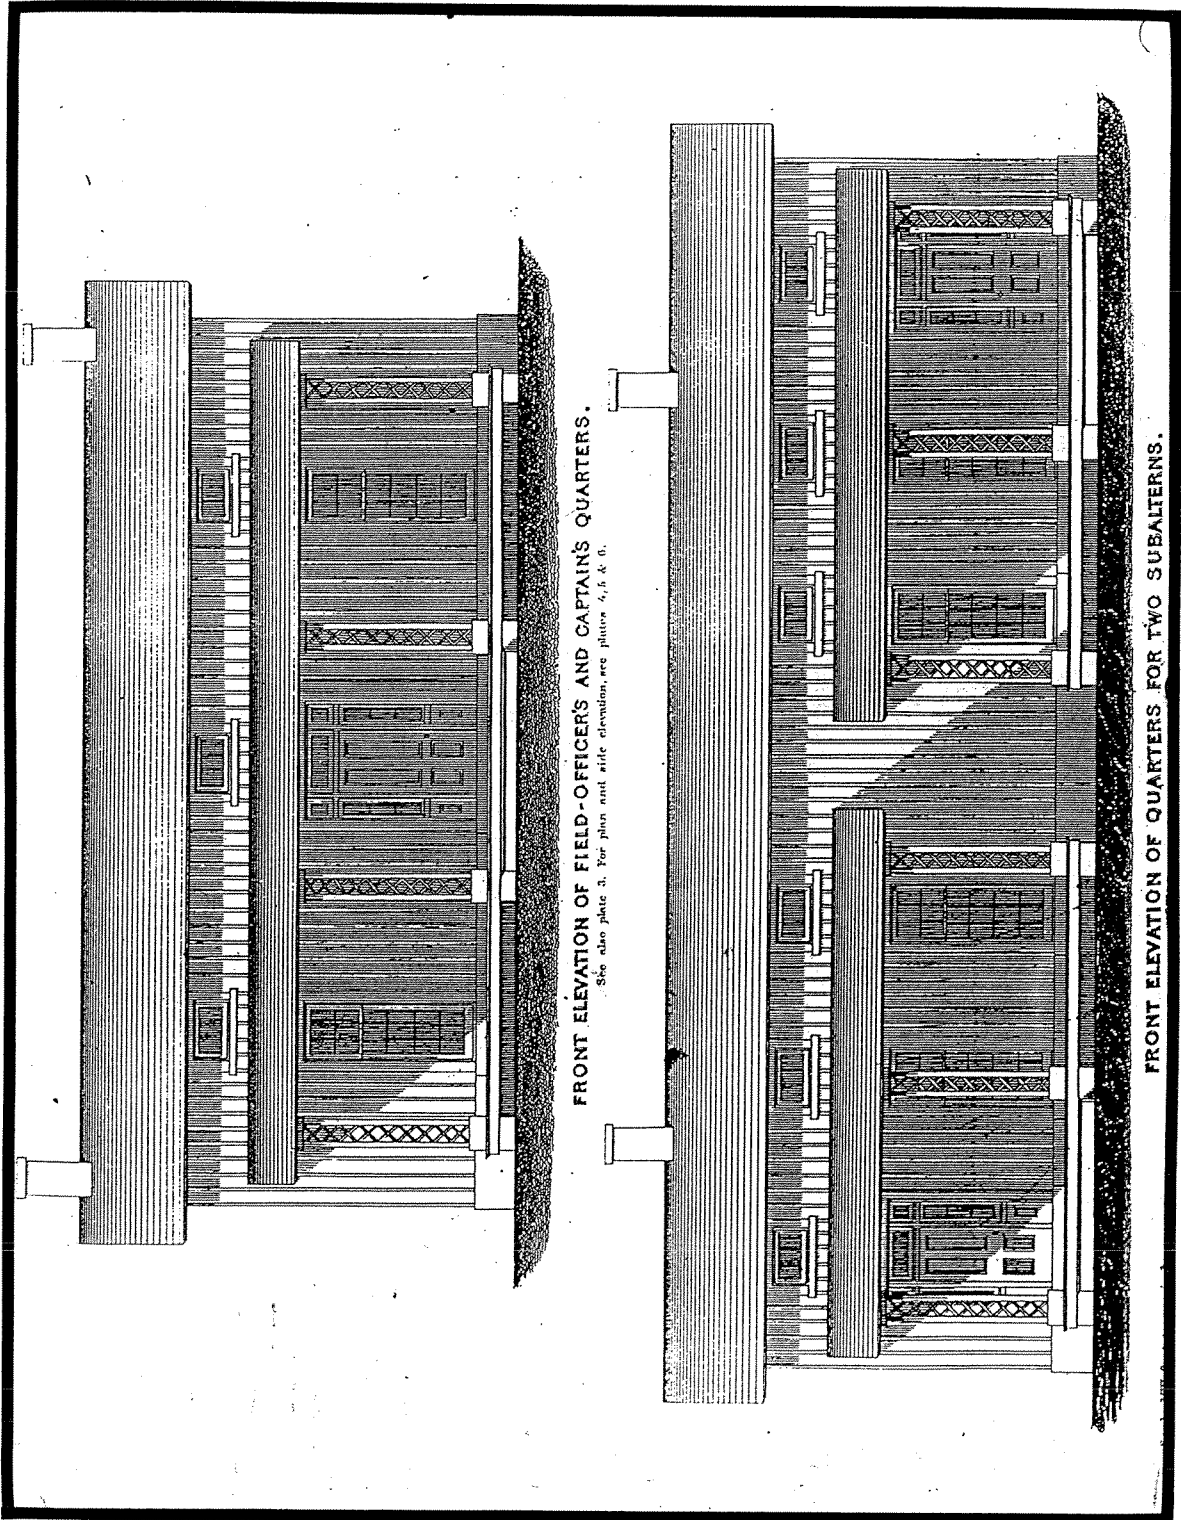
Figure III-130. Proposed 1860 plans for officers quarters. From *Regulations Concerning Barracks and Quarters for the Army of the United States 1860*. Washington, D.C.: George W. Bowman, 1861

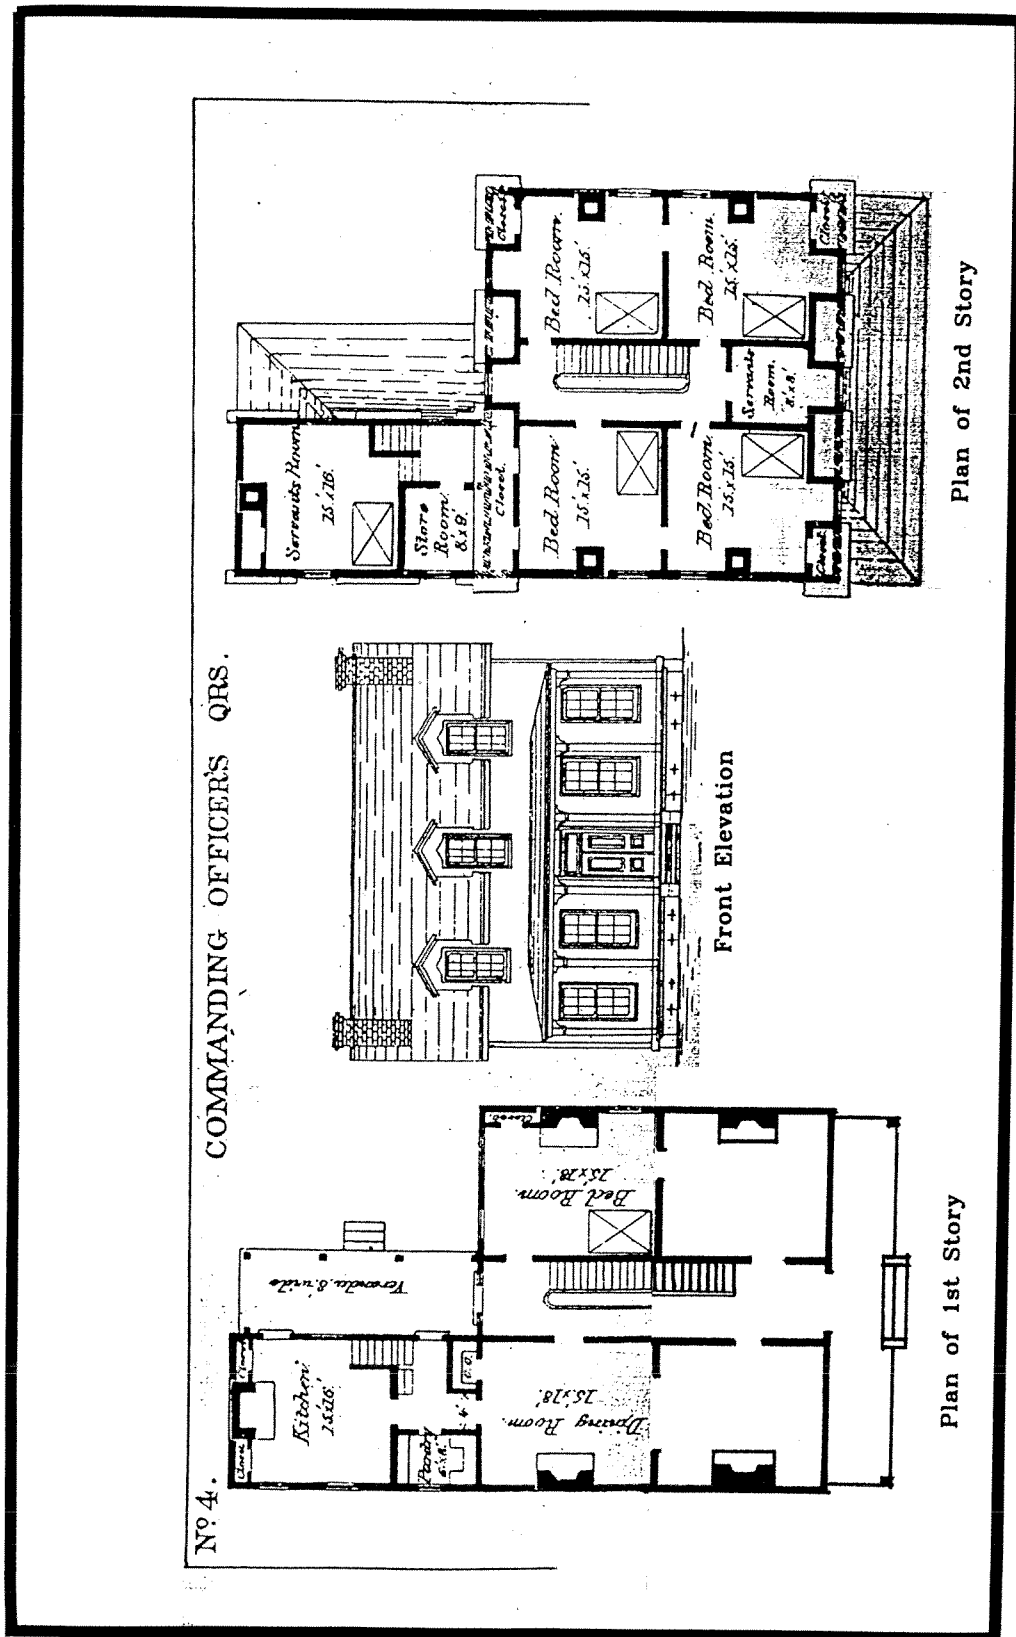
Figure III-132. Proposed 1872 Quartermaster plans for commanding officer quarters. (From War Department. *Annual Quartermaster Report*. Washington, D.C.: Government Printing Office, 1872.)

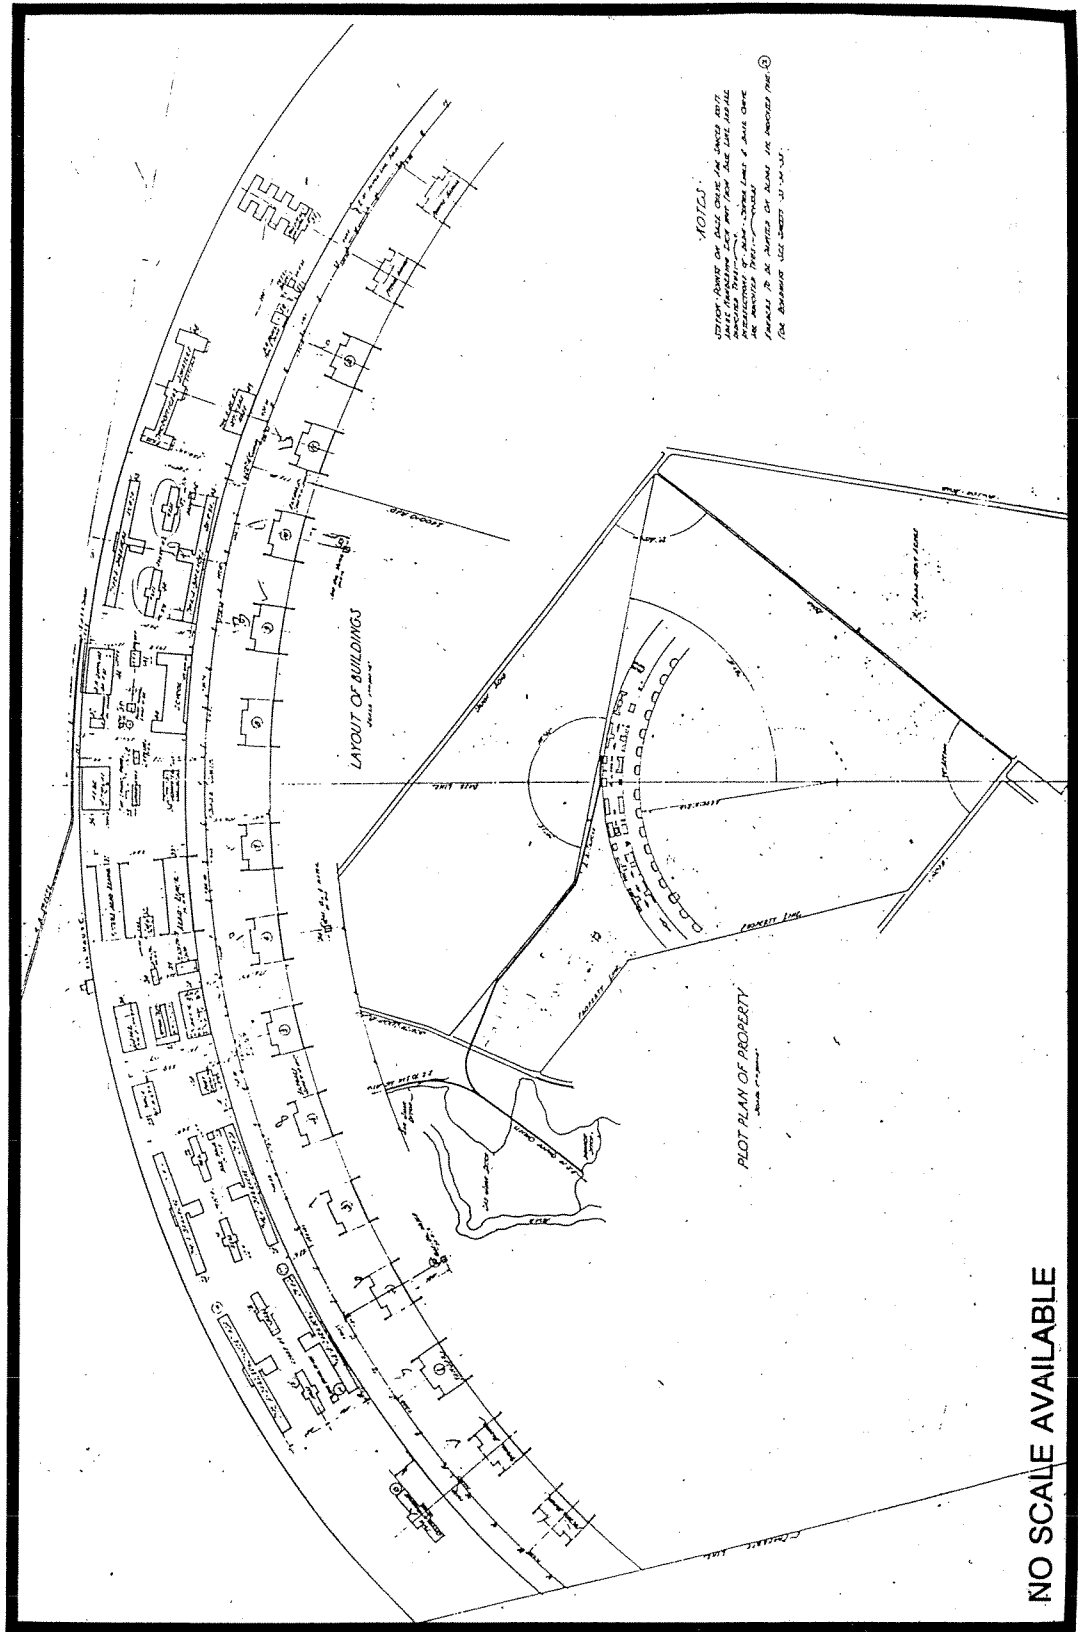
Figure III-158. Kelly Field #5 Plot Plan, 1917, Albert Kahn, Architect (From MSS files, Civil Engineering, Brooks AFB, San Antonio, Texas)
