# A HISTORY OF ARCHEOLOGICAL INVESTIGATIONS AT FORT UNION NATIONAL MONUMENT

Division of History  
Southwest Cultural Resources Center  
Southwest Region  
National Park Service  
Department of the Interior

SOUTHWEST CULTURAL RESOURCES CENTER  
PROFESSIONAL PAPERS NO. 44  
1992

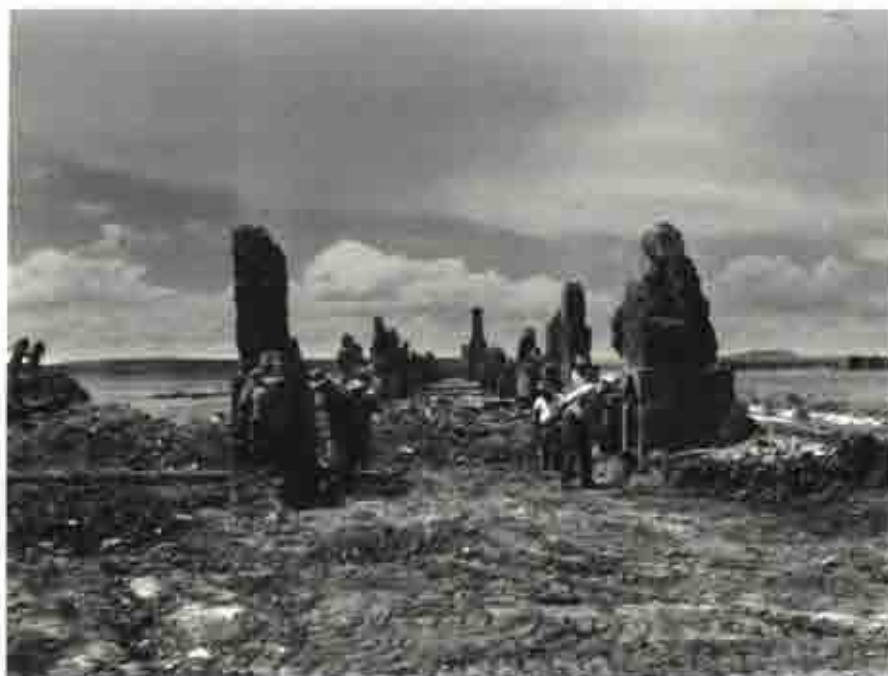
Figure 1. Photo, Excavation of Building 1-110, view from the south end. No grid or specific provenience controls were used in the excavations at Fort Union. [Wilson 8/1/1960 Neg FOUN-744(s)]

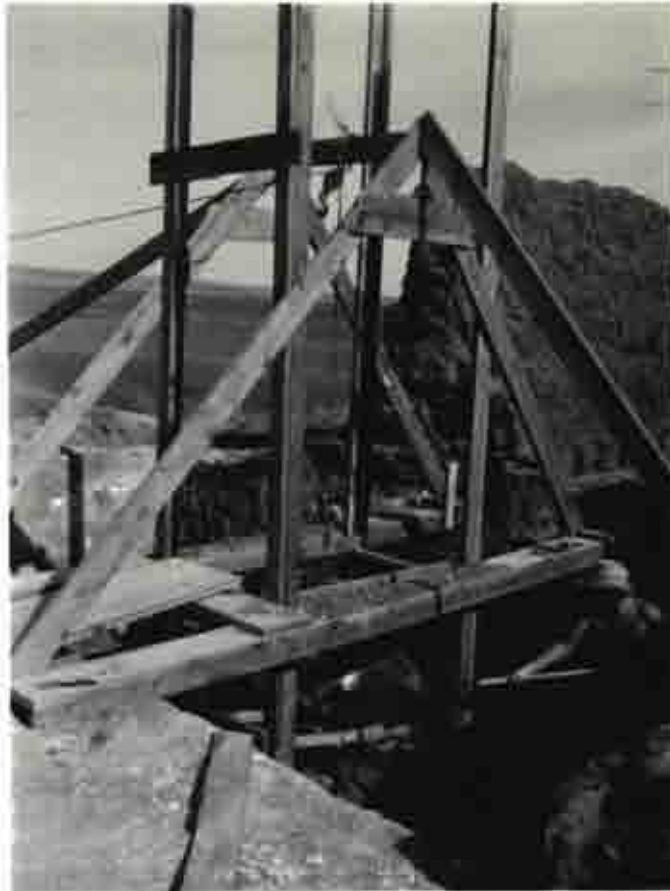
Figure 2. Photo, Excavation of sink, Room 2-715 showing the elevator used to lift the fill from the deep structures. [Cattanach 9/13/1957 Neg FOIN-168(s)]

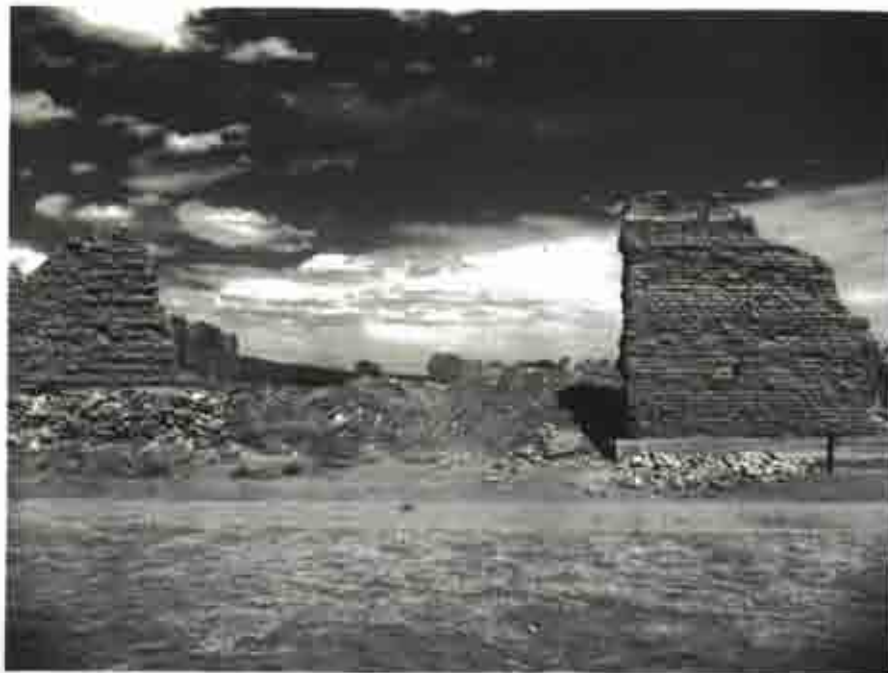
Figure 3. Photo, Dirt and Debris accumulation between Warehouse Buildings 3-410 and 3-420, view from the west side. [Wilson 4/6/59 Neg FOUN-297(s)]

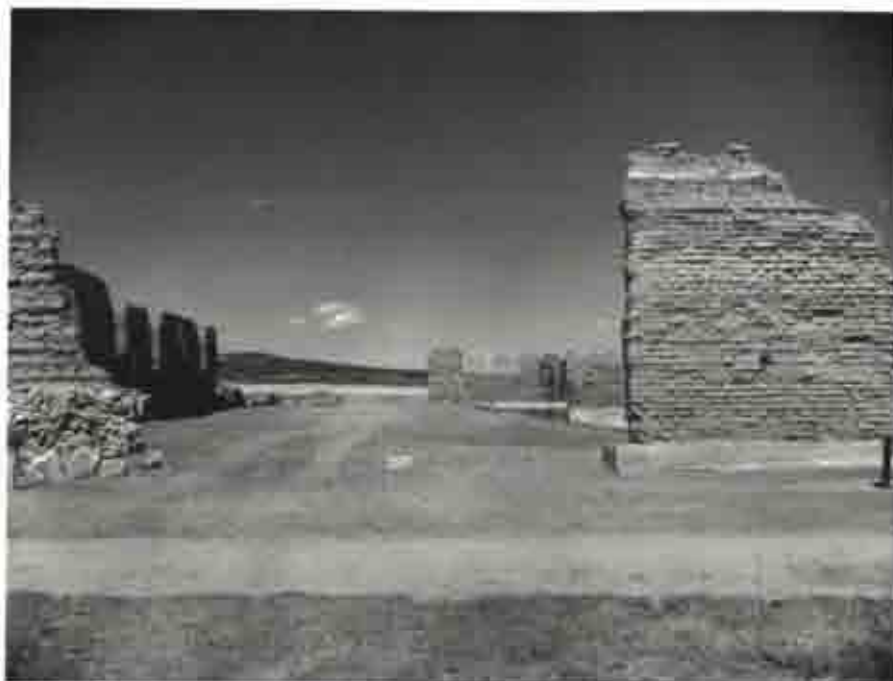
Figure 4. Same view after removal of dirt and debris. [Wilson 4/29/59 Neg FOUN-356(s)]

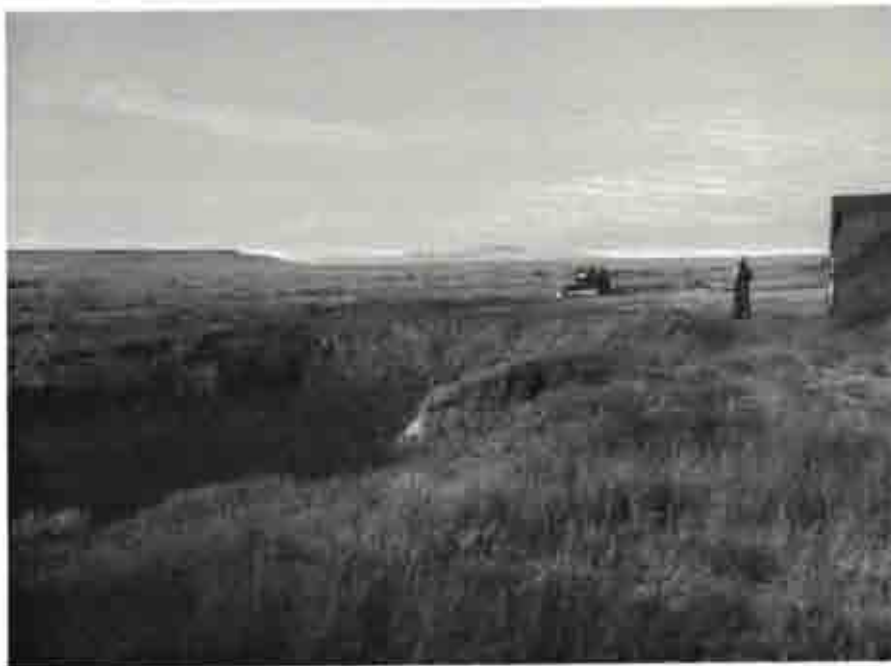
Figure 5. Photo, Dumping debris and dirt removed from the ruins into an arroyo. The workman is identified as Margarito Lovato. [Wilson 10/6/58 Neg. FOUN-219(s)]

Throughout the stabilization notebooks and field reports there are references to hauling building debris and backdirt for disposal in arroyos surrounding Third Fort. Not

every reference to hauling included a calculation of the amount hauled, but the entries that do include some quantification total well over 16,000 cubic yards of building debris removed from stabilized structures. Figures 3 and 4 are before and after photographs of the Warehouses 3-410 and 3-420 showing the vast amount of dirt and debris removed from that structure. George Cattnach recalled dumping backdirt north and west of the Clerk's Quarters [Structure 3-160] at the north end of Officer's Row. Wilson recalled dumping debris north and west of the Warehouses in a series of arroyos that had also been used for trash disposal when the Third Fort was occupied (Figure 5). Wilson may have been indicating the same area as Cattnach. Fill was also hauled from the Arsenal area and redeposited around the Visitor Center and the employee housing area.<sup>8</sup>

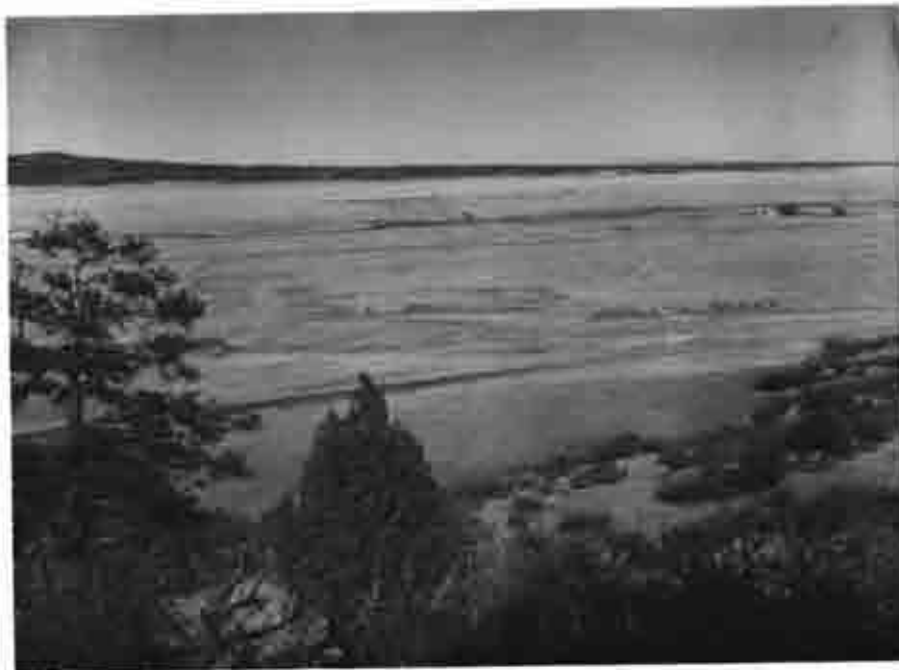
Figure 8. Photo, Overview of the Arsenal complex taken from the talus slope to the west of the site. [Wilson 4/20/60 Neg FOUN-610(s)]

First Fort and the Arsenal complex associated with Third Fort are located in the detached area a little over one mile to the west of the main monument (Figure 8). Although there has been no systematic archeological studies of the ruins associated with either First Fort or the Arsenal, it does seem from historic documents that some of the Arsenal buildings may have been built and first used during the construction of the earlier fort.<sup>16</sup> Many of the original buildings at First Fort were constructed of unpeeled, unseasoned logs. The fort began to deteriorate within a few years, and was abandoned after only ten years of service.<sup>17</sup> The short period of occupation, and the original methods of construction produced meager archeological evidence of this early occupation. The Park Service studies of the First Fort and Arsenal complex have been aimed primarily at emergency stabilization and mapping projects that attempt to relocate the structures associated with the military occupations of the site.

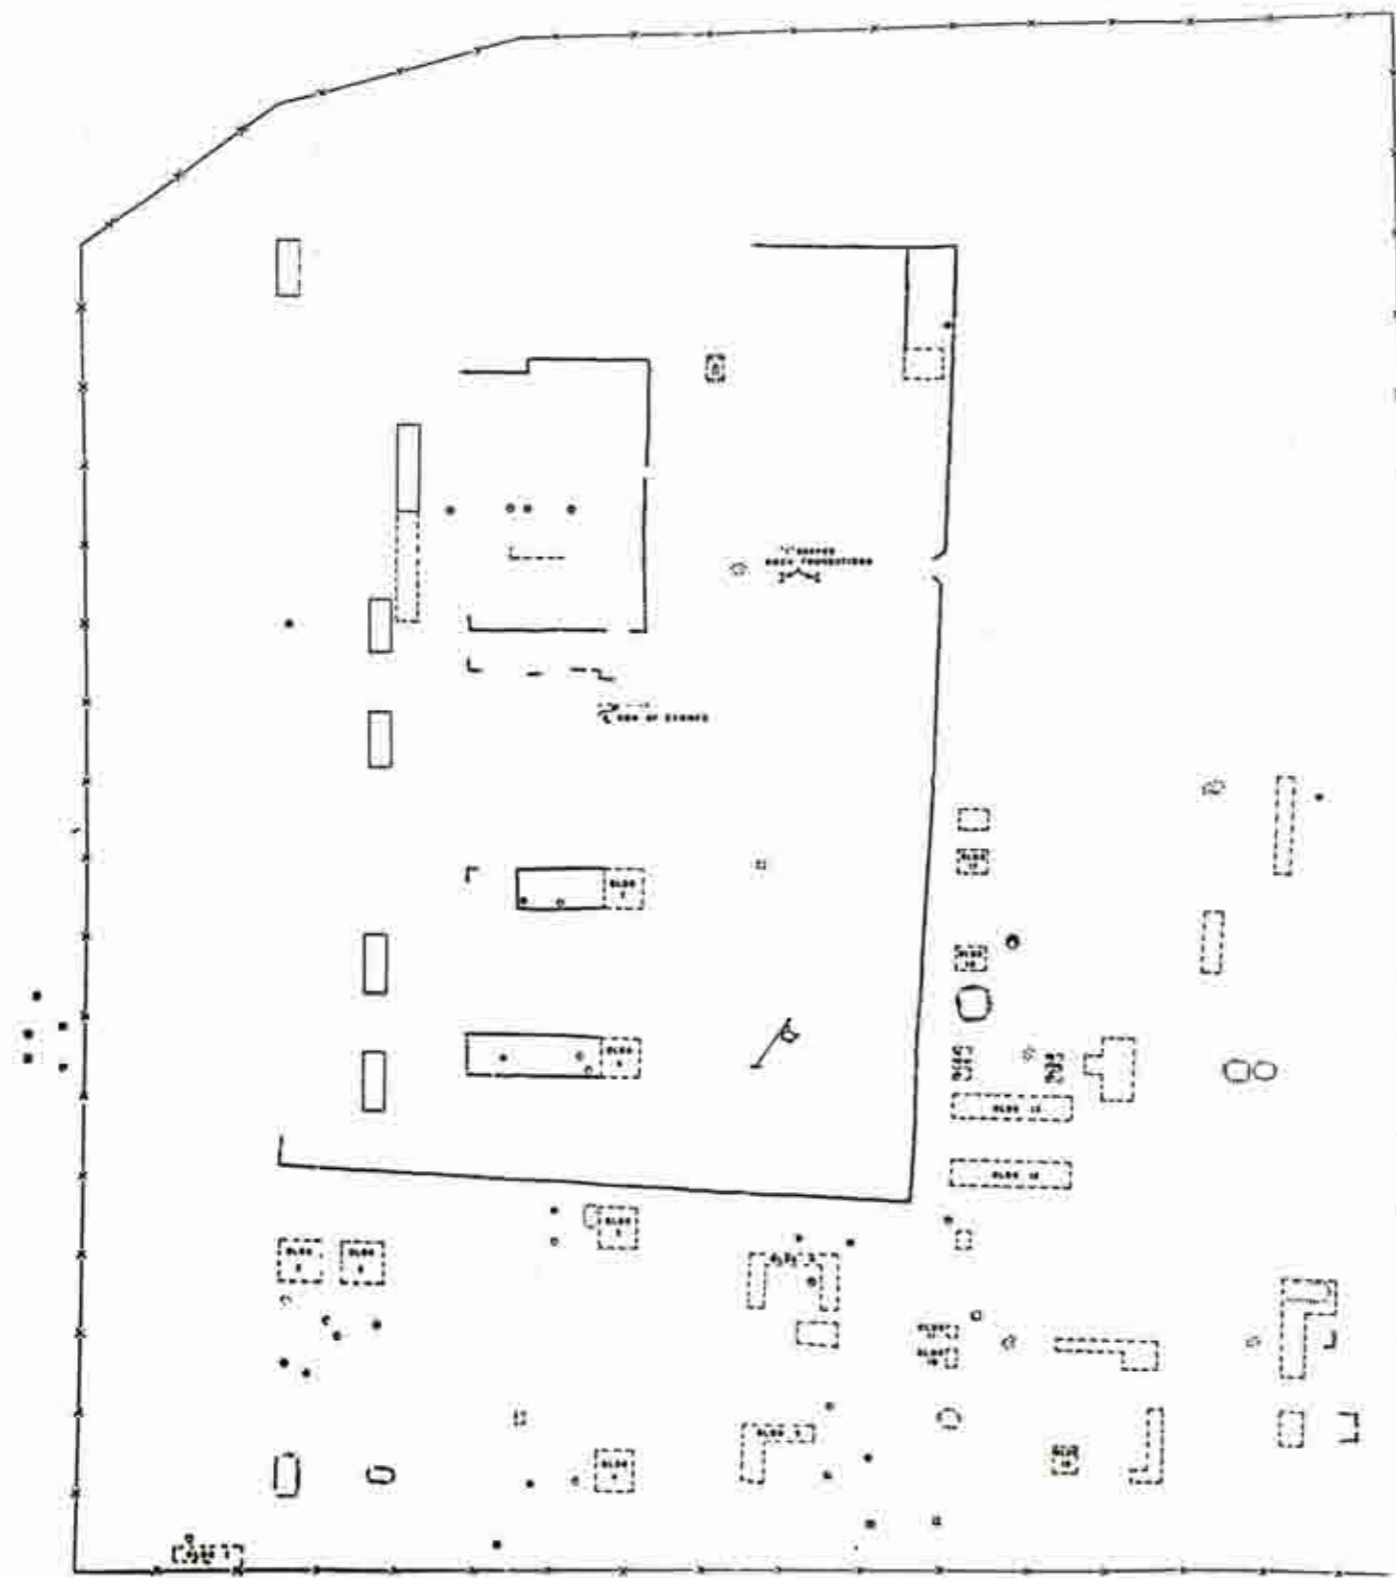
Southwest Regional Office Engineers Wohlbrandt and Colton, and Landscape Architect Marsh mapped the foundations of First Fort and the Arsenal in September 1960, and completed the mapping in July 1961. The map they produced [Figure 9] appears to have some inaccuracies regarding the distance between structures and features. An in-depth analysis of the Wohlbrandt/Colton map will be included in Jake Ivey's architectural history and archeological reconnaissance of First Fort. The field notes and measurements used to produce the map have not been relocated.

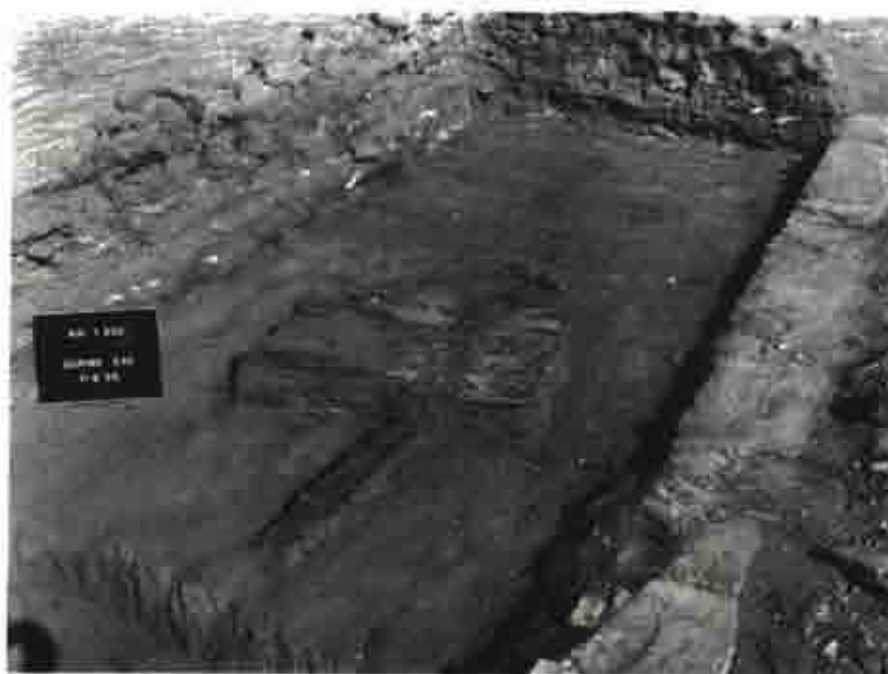
Figure 13. Photo, Room 1-252 during excavation. Note planking and floor joist. [Cattanach 11/8/56 Neg FOUN-98(s)]

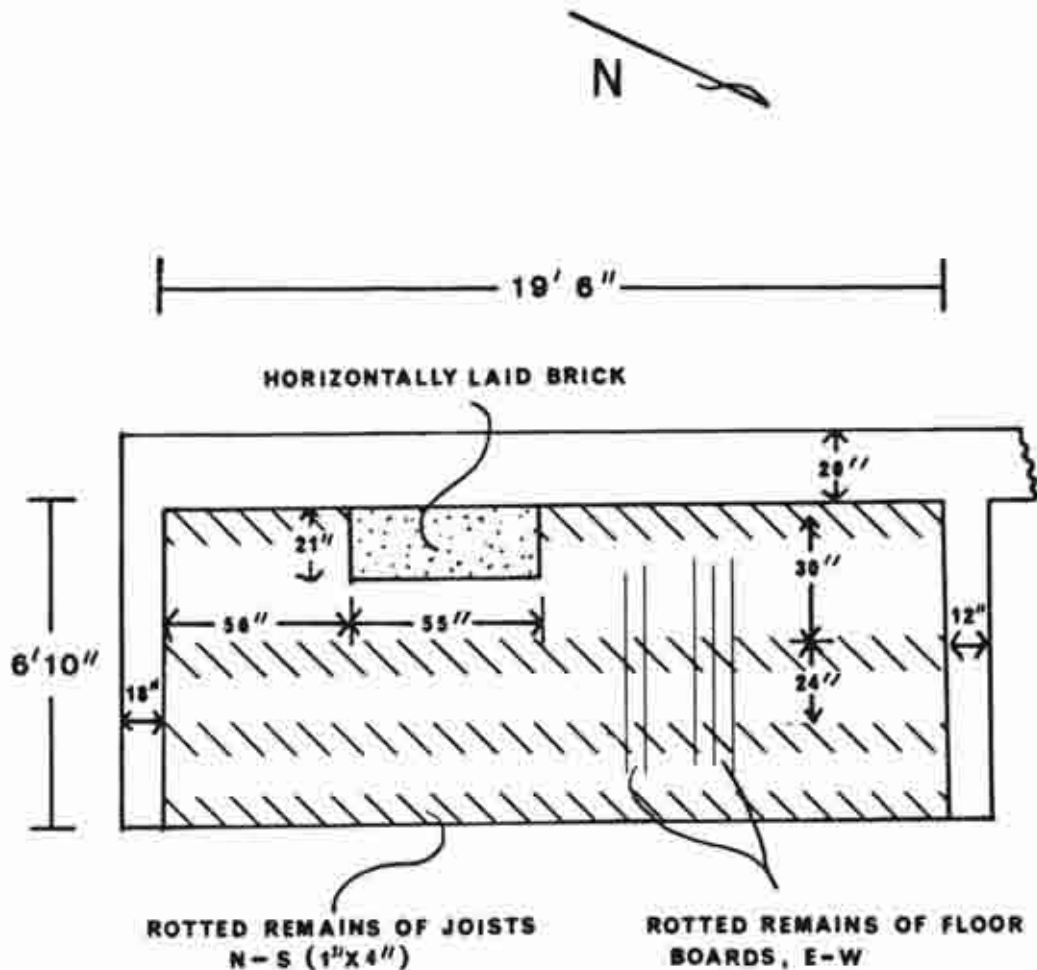
Figure 14. Plan of Room 1-255 floor features. [Field Notebook, Cattanaach, vol. 3, 7/20/57]

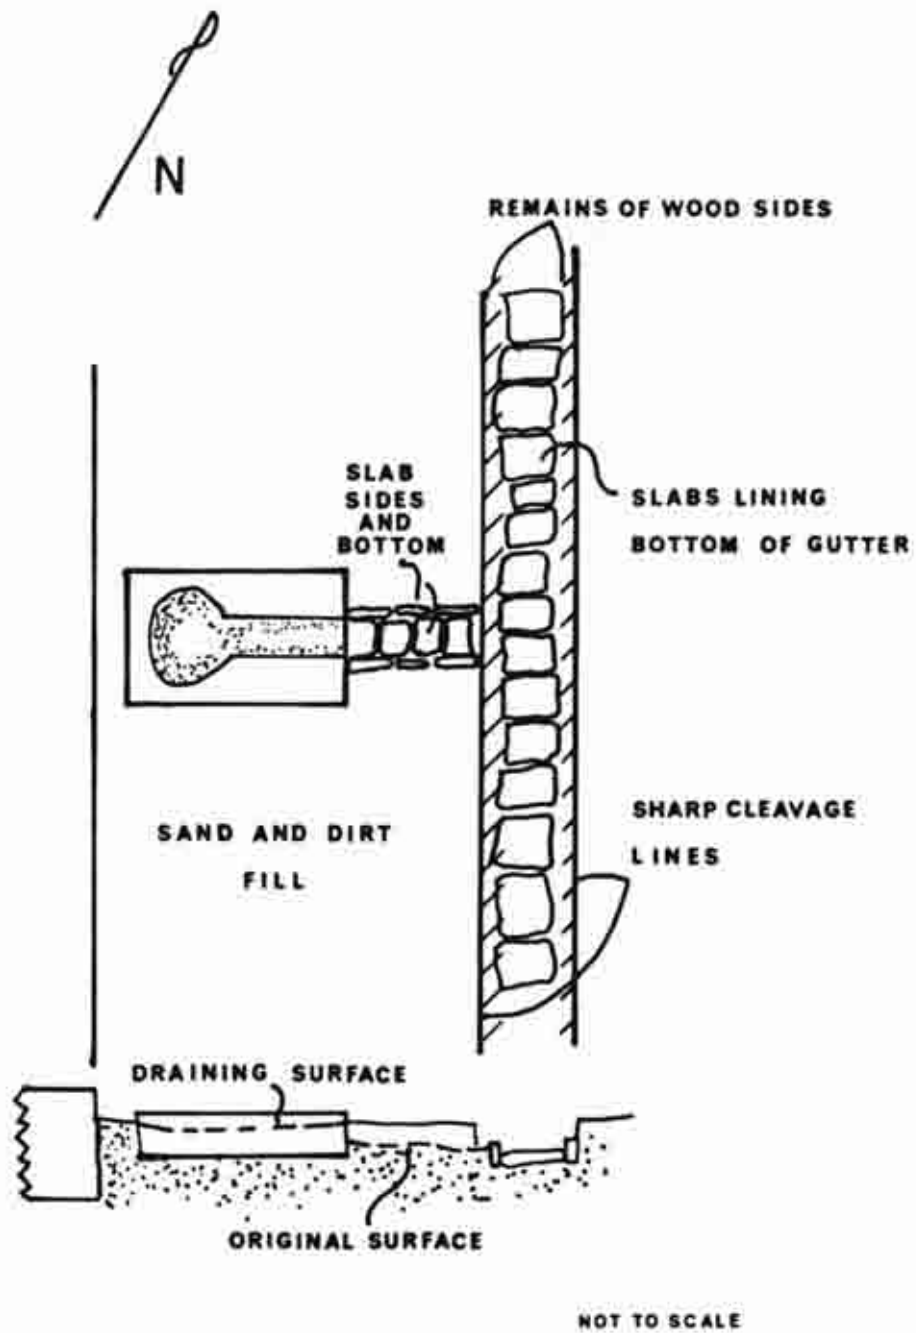
Figure 16. Plan of Building 1-420, gutter and drainage design. [Field Notebook, Cattnach, vol. 2, 2/23/57]

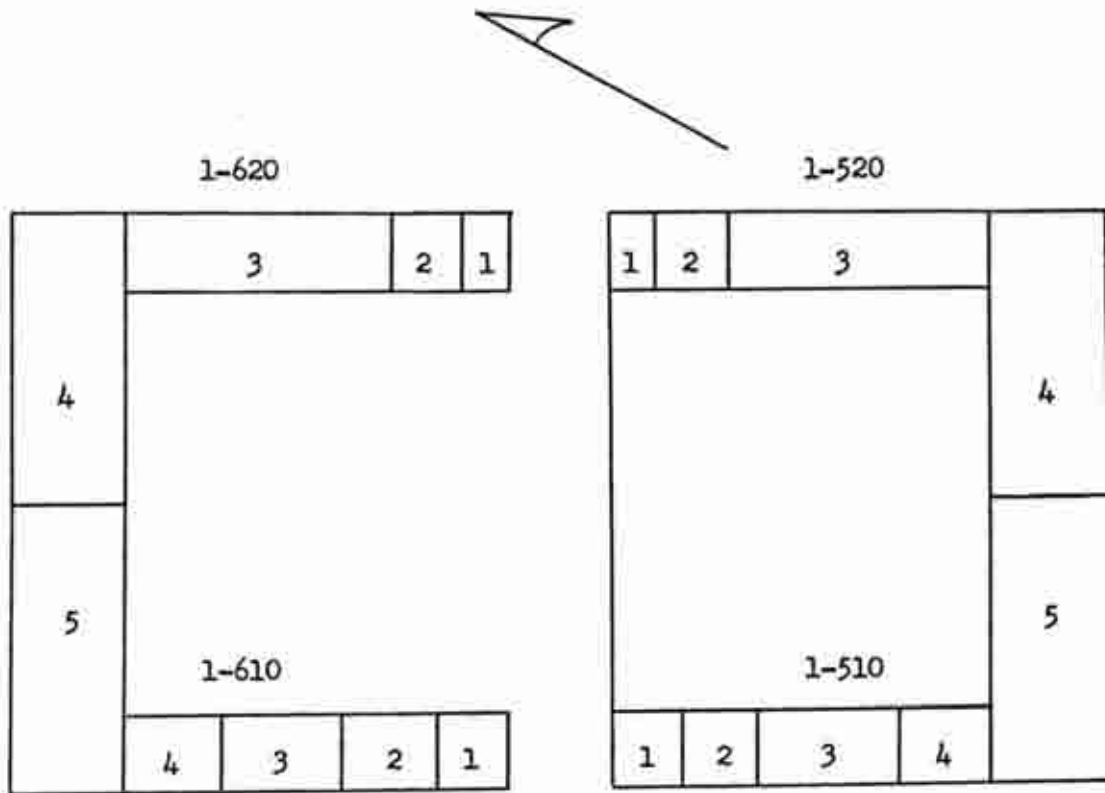
Figure 17. Numbering Plan for Company Quarters. Buildings 1-510, 1-520, 1-610, 1-620.

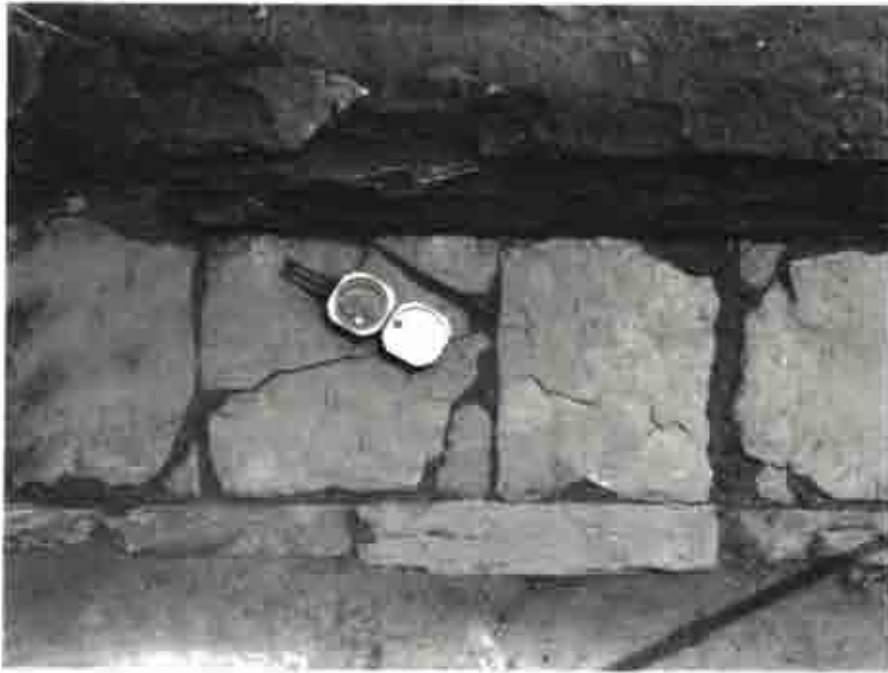
Figure 18. Photo. Stone-lined gutter east of Building 1-510. [Cattanach 6/20/57 Neg FOUN-153(s)]

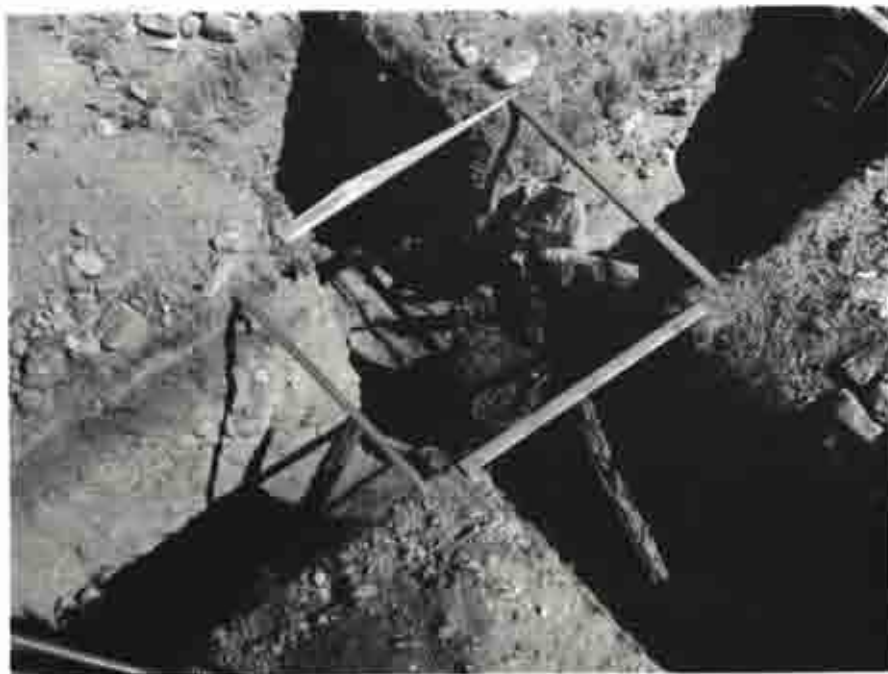
Figure 19. Photo, Feature 1-720, Middle Flagpole after excavation. [Cattanach 10/2/57, Neg FOUN-170(s)]

Excavation of two flagpole sites: Feature 1-710, the southernmost, and Feature 1-720, the middle of three flagpoles, was completed in the summer of 1957. In each a segment of the base of the wooden poles was found.

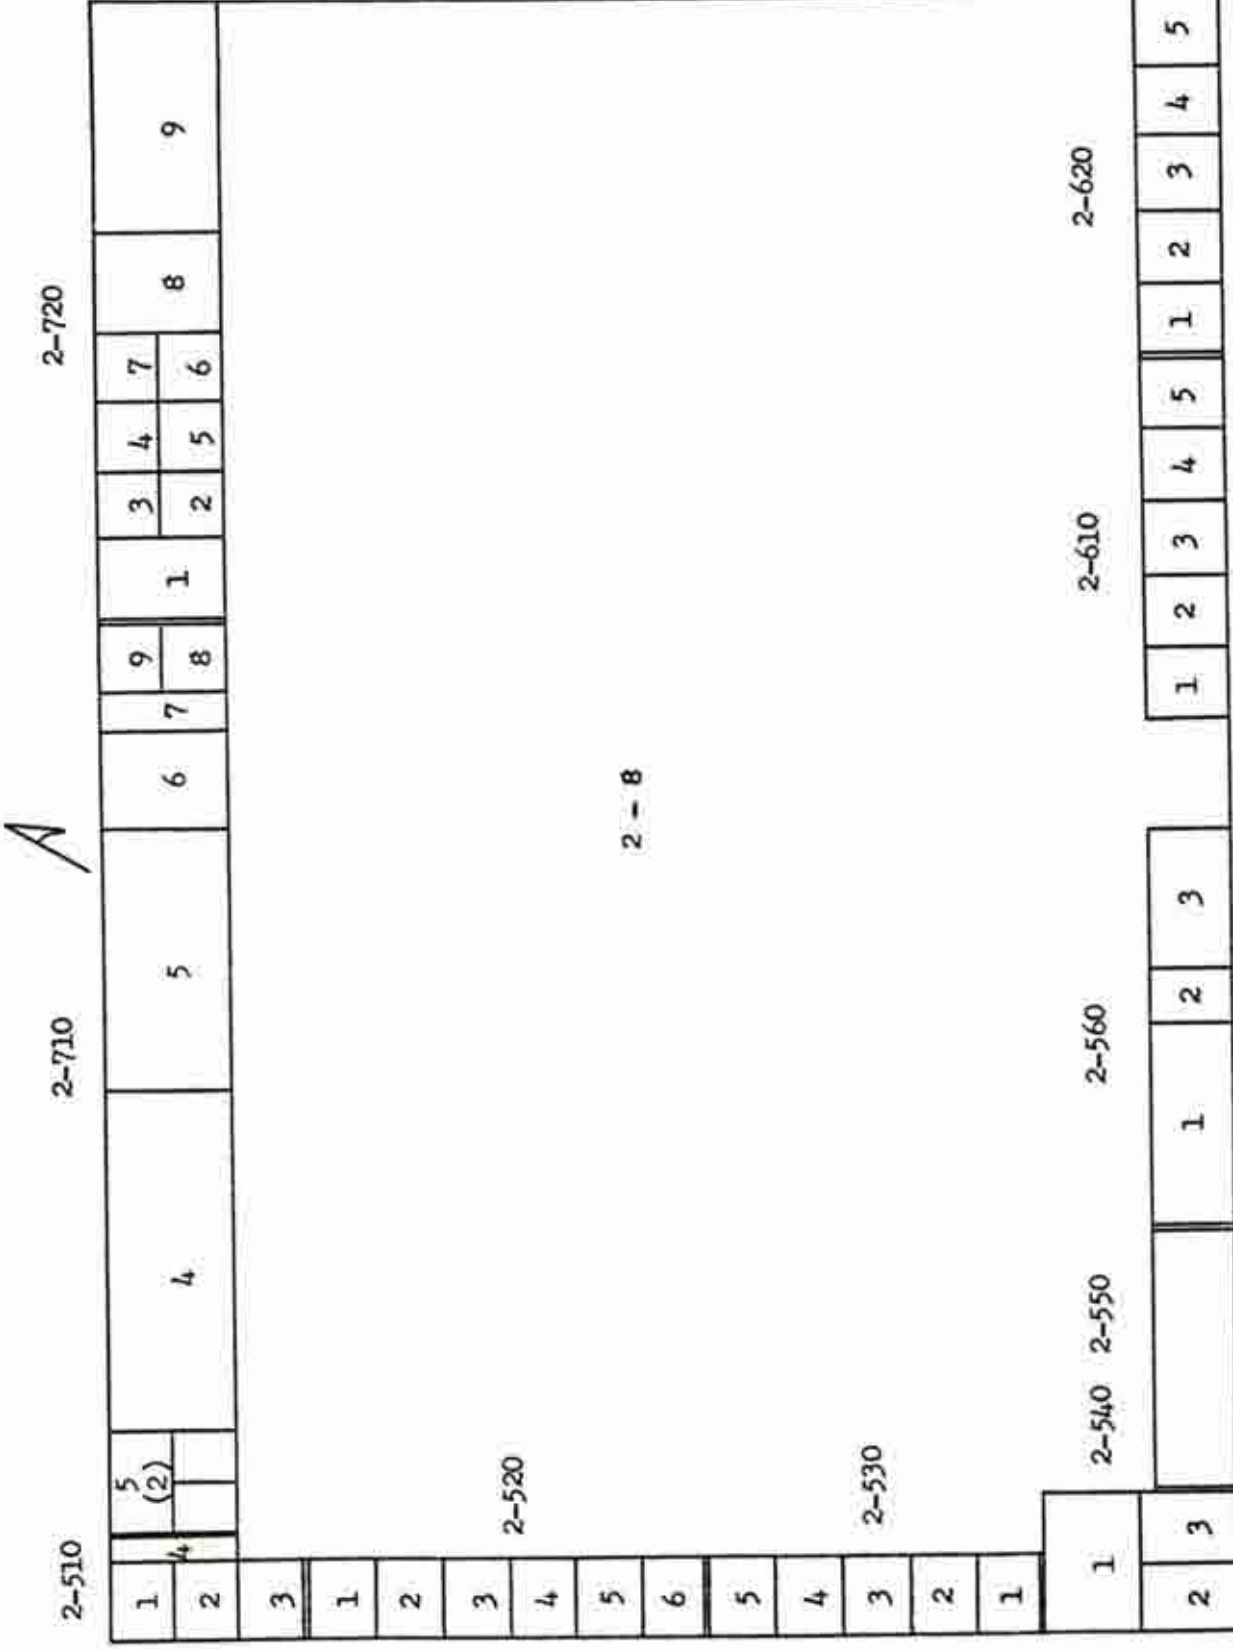
Figure 21. Numbering Plan for Bakery, Laundresses' Quarters--Company Quarters.

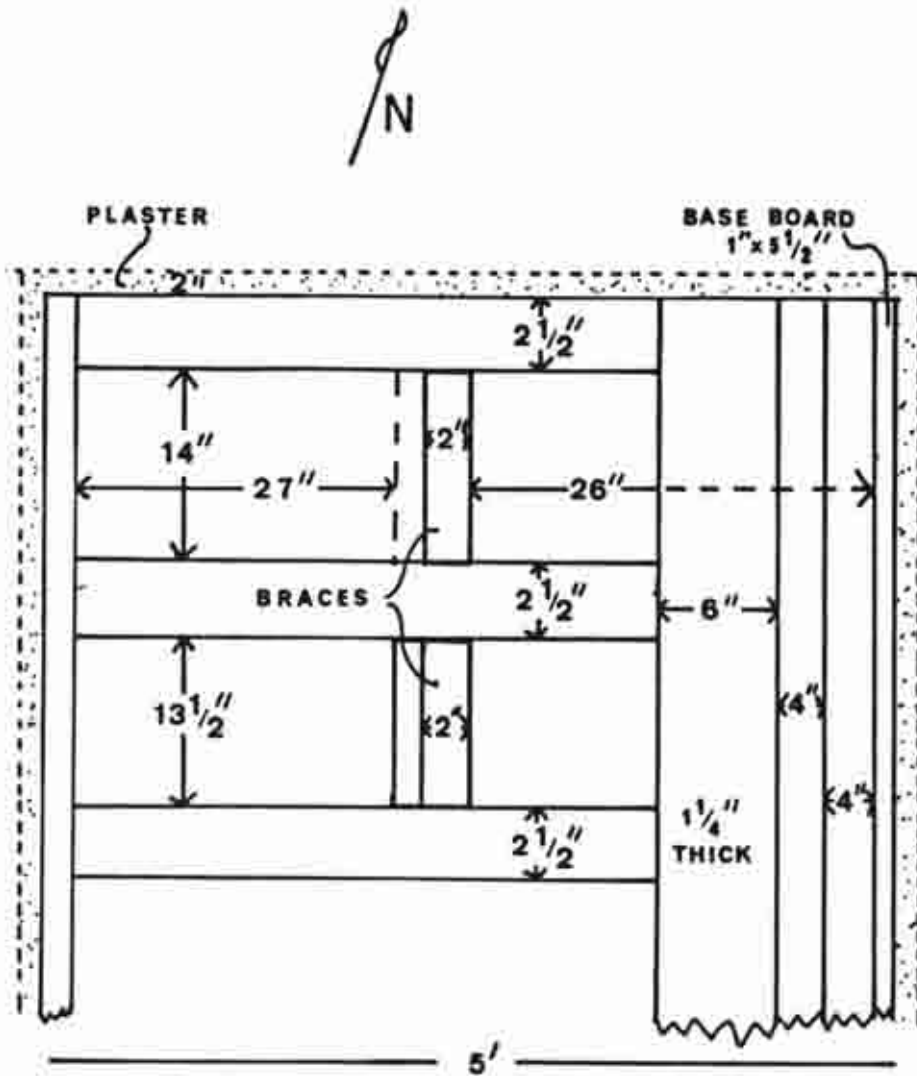
Figure 22. Plan of floor joists in Room 2-514, located in the hallway east of the Bakery. [Field Notebook, Cattanaach, vol.4, 8/27/57]

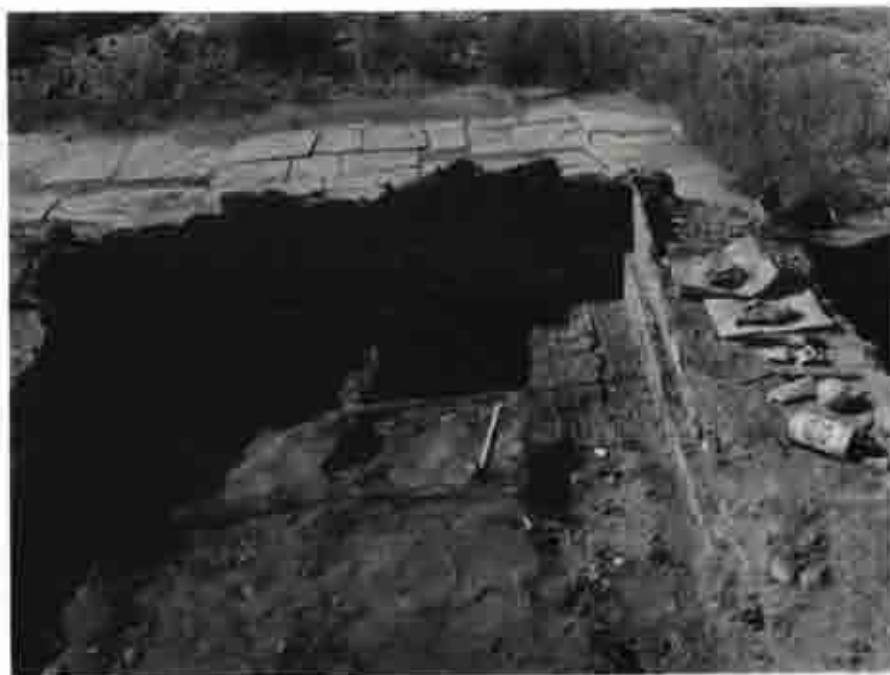
Figure 23. Photo. In progress excavation of Room 2-514 north end showing floor sills, joists and planking. [Wing 8/57 Neg FOUN-164(s)]

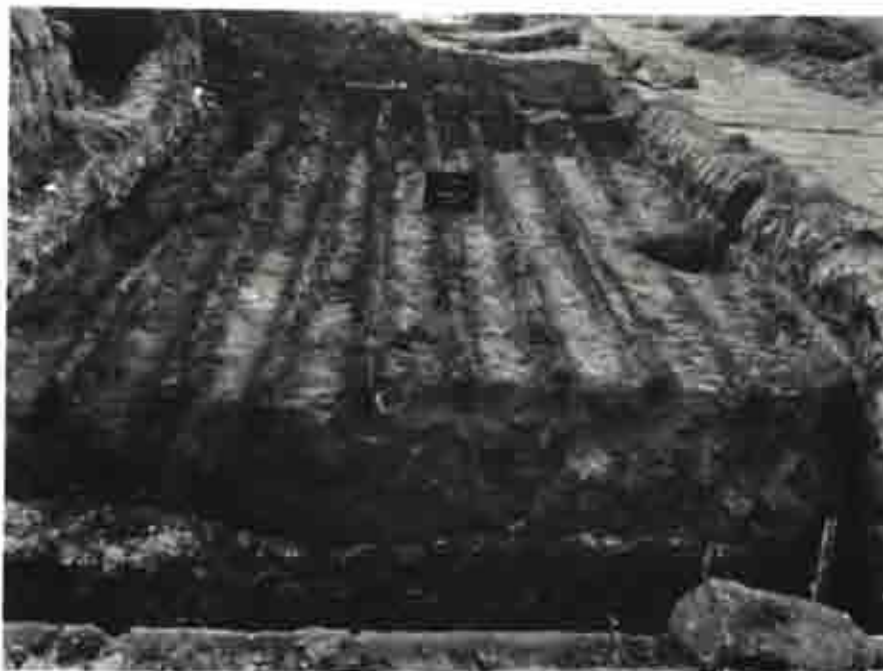
Figure 24. Photo. Floor joists in Room 2-715. [Cattanach, 9/6/57, Neg FOUN-166(s)] At the time that this room was excavated it was designated 2-712 as shown on the photo board. It was subsequently changed to 2-715.

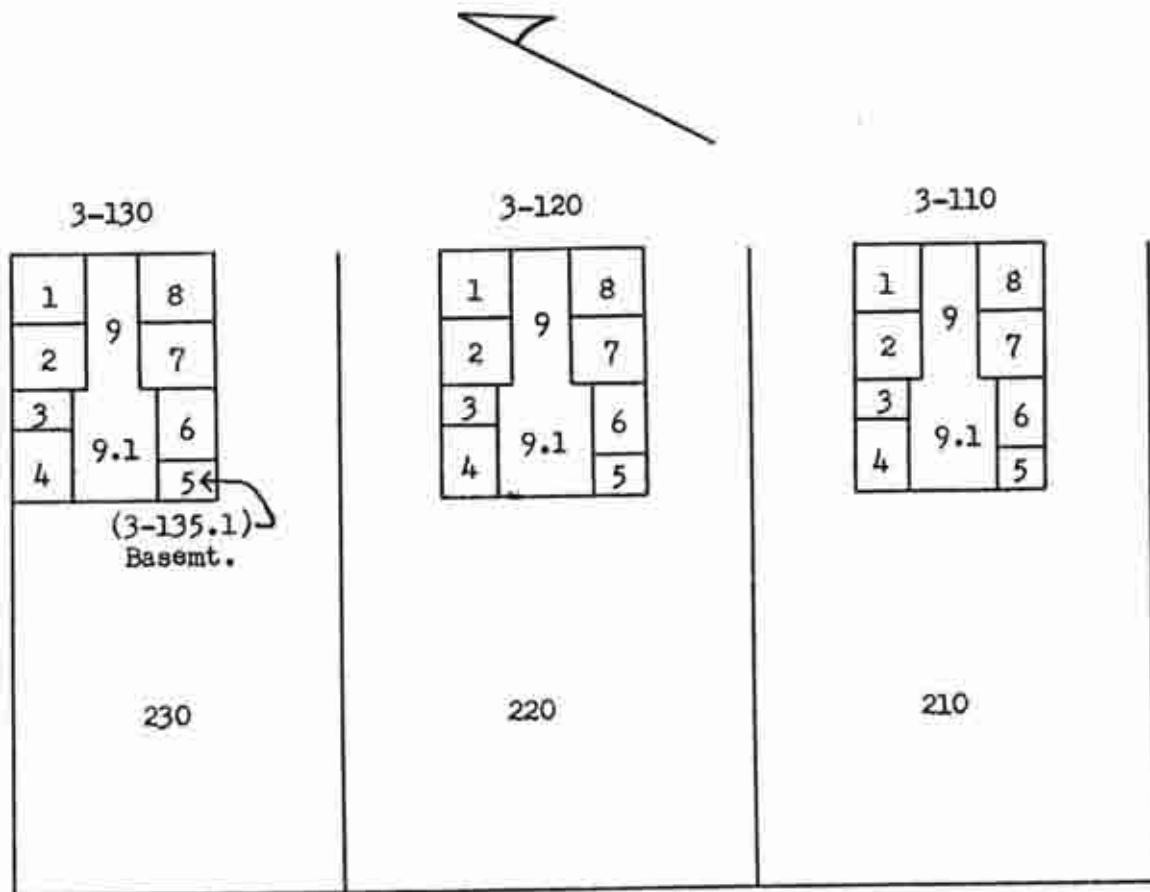
Figure 25. Numbering Plan. Depot Officers' Quarters. Buildings 3-110 to 3-130, 3-210 to 3-230.

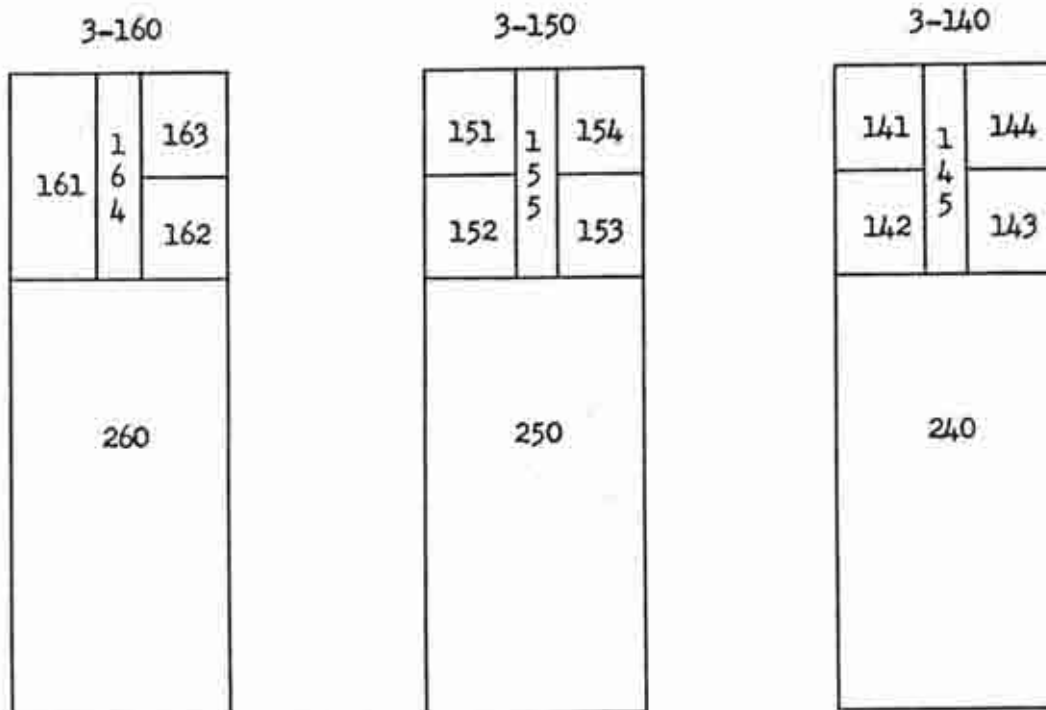
Figure 26. Numbering Plan. Quartersmaster Offices, Buildings 3-140 to 3-160, 3-240 to 3-260.

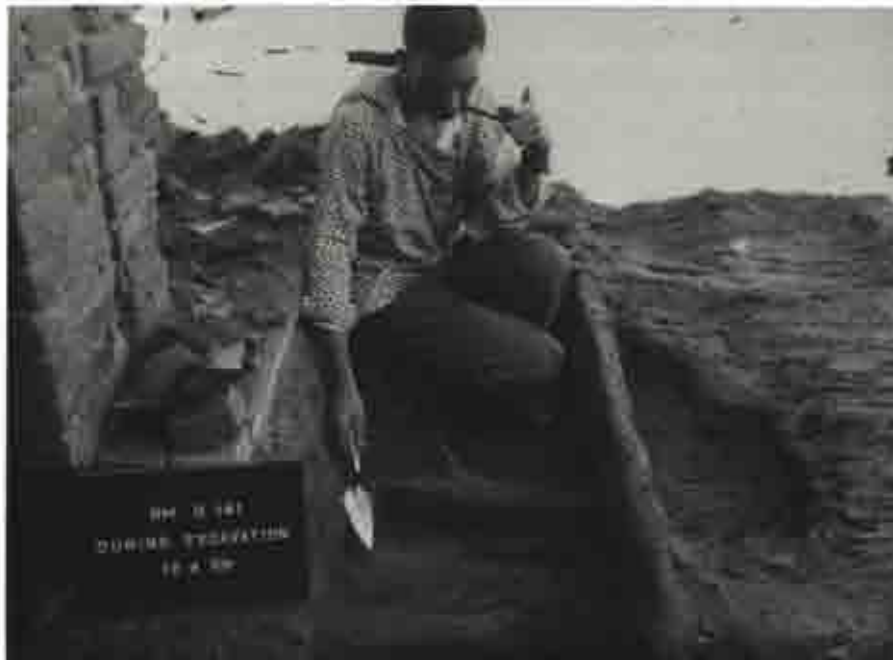
Figure 27. Photo, Room 3-141 during excavation, showing in situ floor timbers. Dick Godfrey is the archeologist in the photo. [Wilson 10/4/58, Neg FOUN-212(s)]

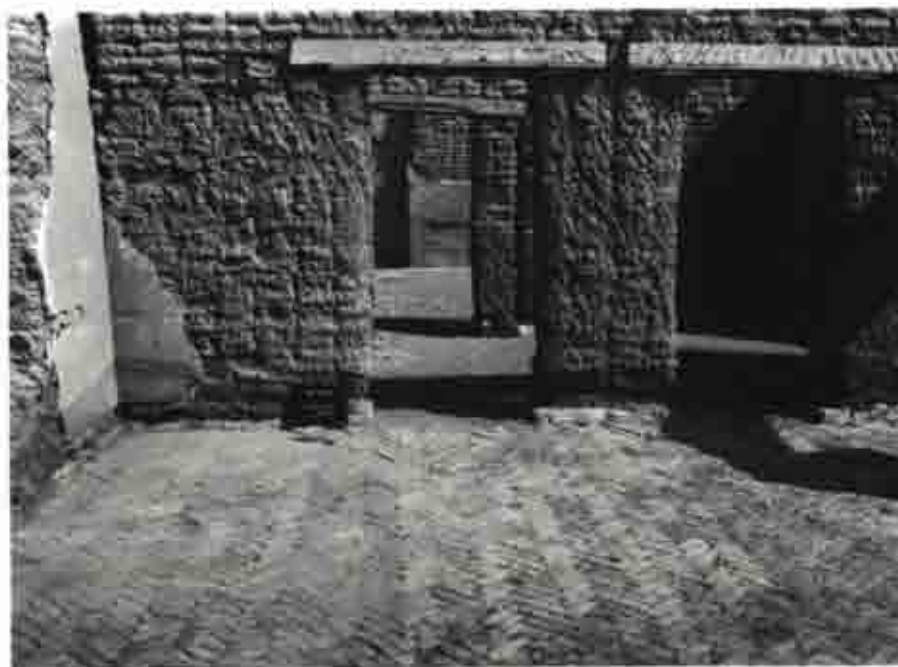
Figure 29. Photo, herringbone-pattern brick floor in Room 3-325 and east wall. [Cattanach 2/26/57, Neg FOUN-112(s)]

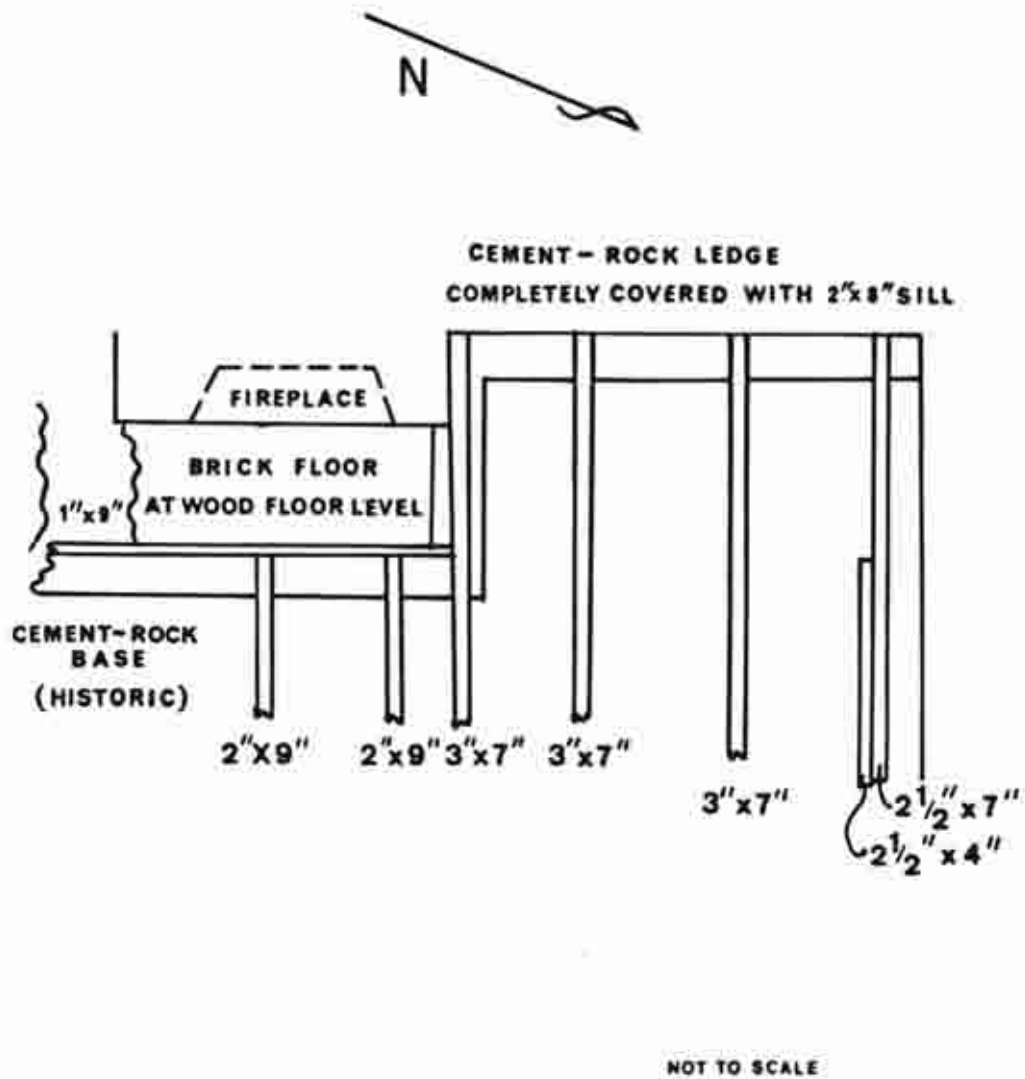
Figure 30. Plan. Floor joists in NW Quadrant Room 3-326. [Field Notebook, Cattnach, vol. 3, 8/9/57]

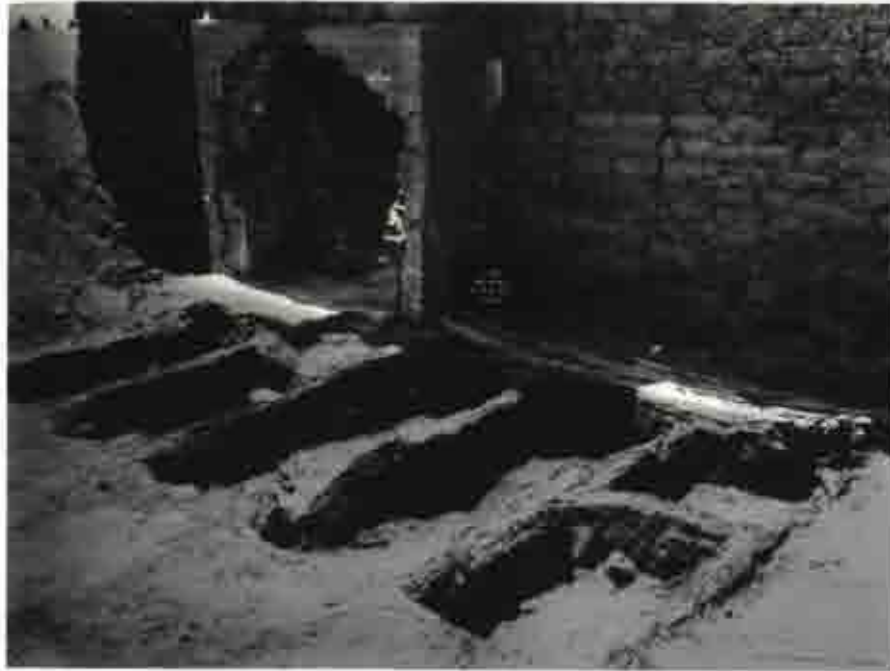
Figure 31. Photo. Room 3-326 floor joists and planking. [Cattanach 7/20/57 Neg FOUN-161(s)]

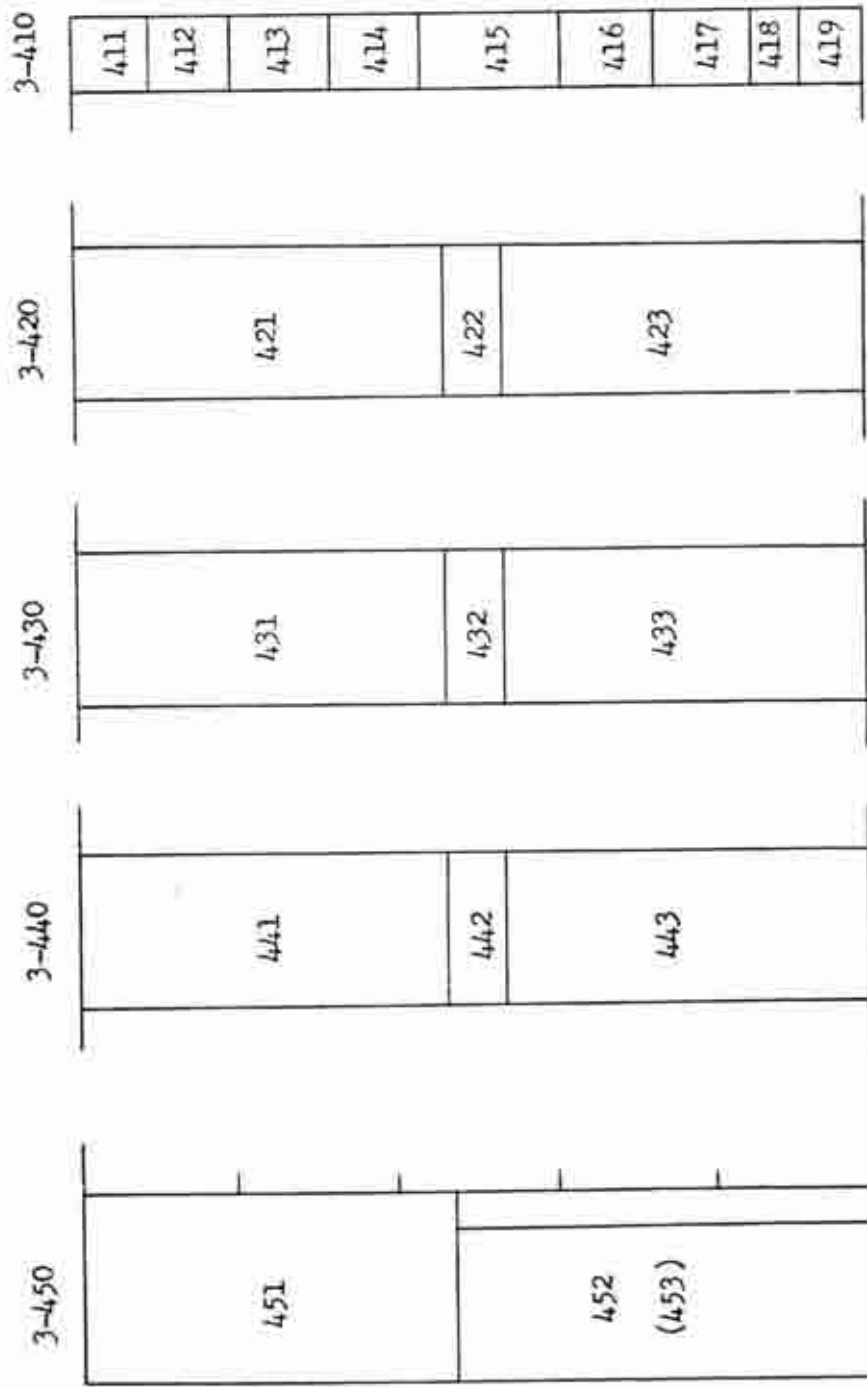
Figure 32. Numbering Plan. Warehouses, Buildings 3-410 to 3-450.

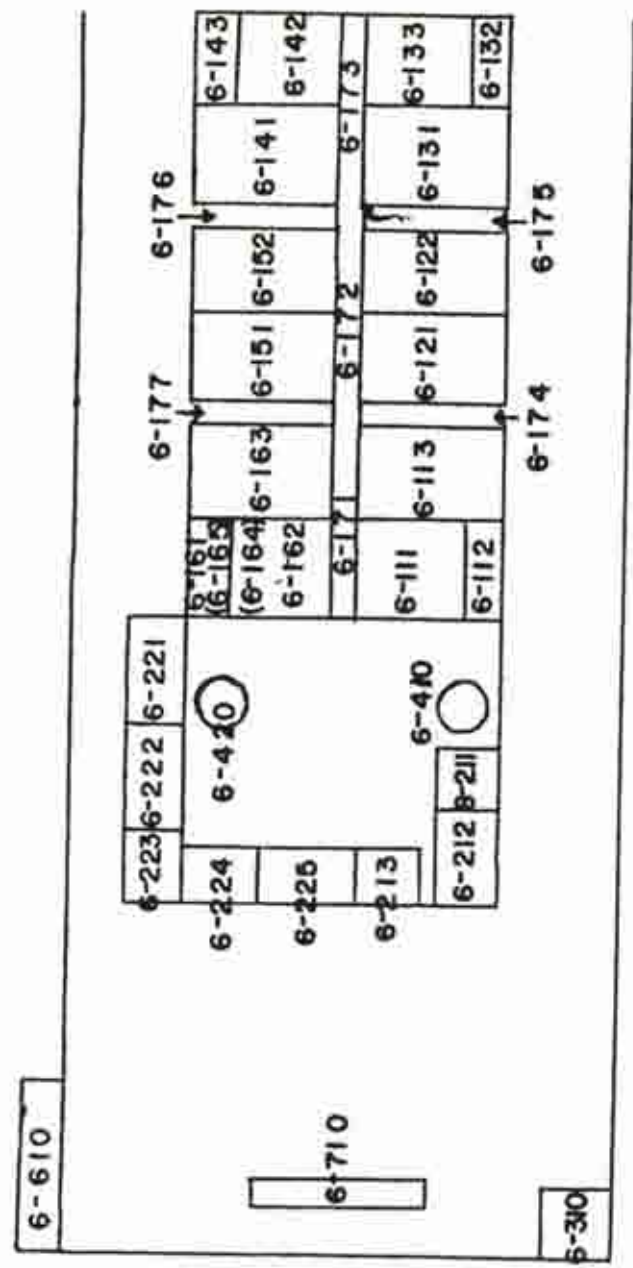
Figure 35. Numbering Plan, Hospital.
