# A HISTORY OF ARCHEOLOGICAL INVESTIGATIONS AT FORT UNION NATIONAL MONUMENT

Division of History  
Southwest Cultural Resources Center  
Southwest Region  
National Park Service  
Department of the Interior

SOUTHWEST CULTURAL RESOURCES CENTER  
PROFESSIONAL PAPERS NO. 44  
1992

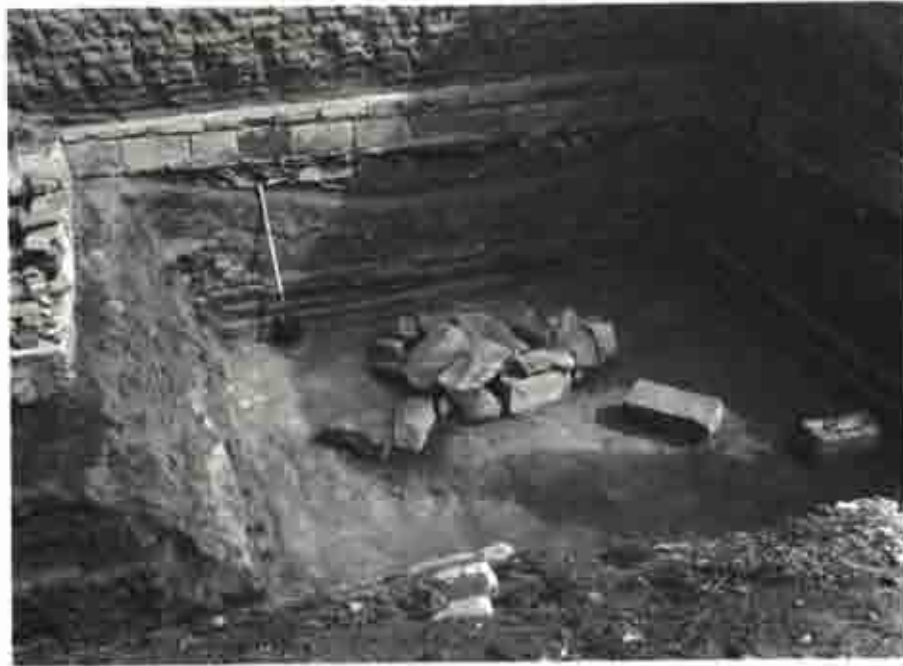
Figure 36. Cellar designated Room, 6-164, view to the north. Rock piled in the center of the room is not in situ, but were left in the room because of their weight. The room was backfilled. [Cattanach 6/13/58 Neg FOUN-178(s)]

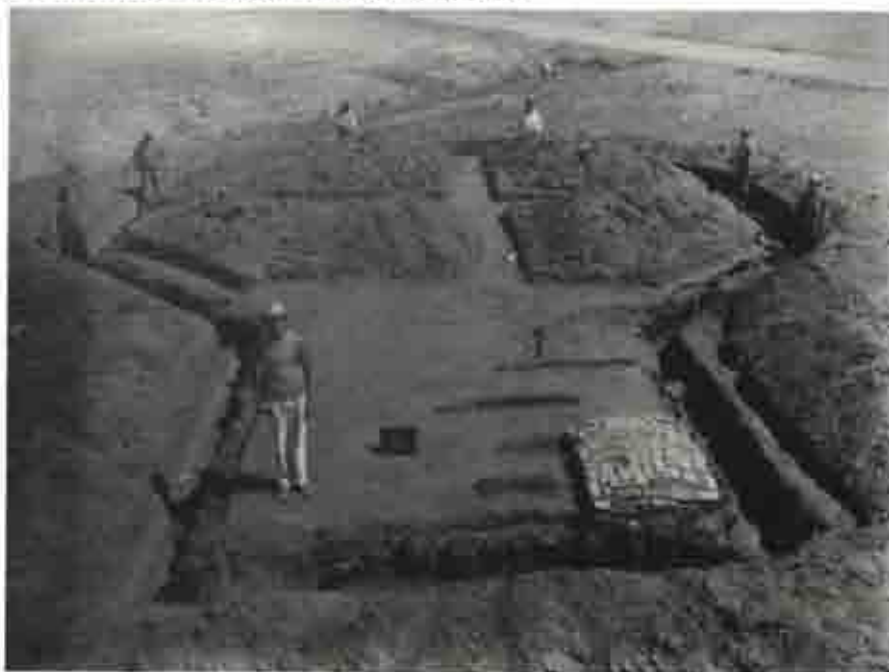
Figure 37. Photo. Outline of Building 6-510 after stabilization. [Cattanach 7/13/57 Neg FOUN-159(s)]

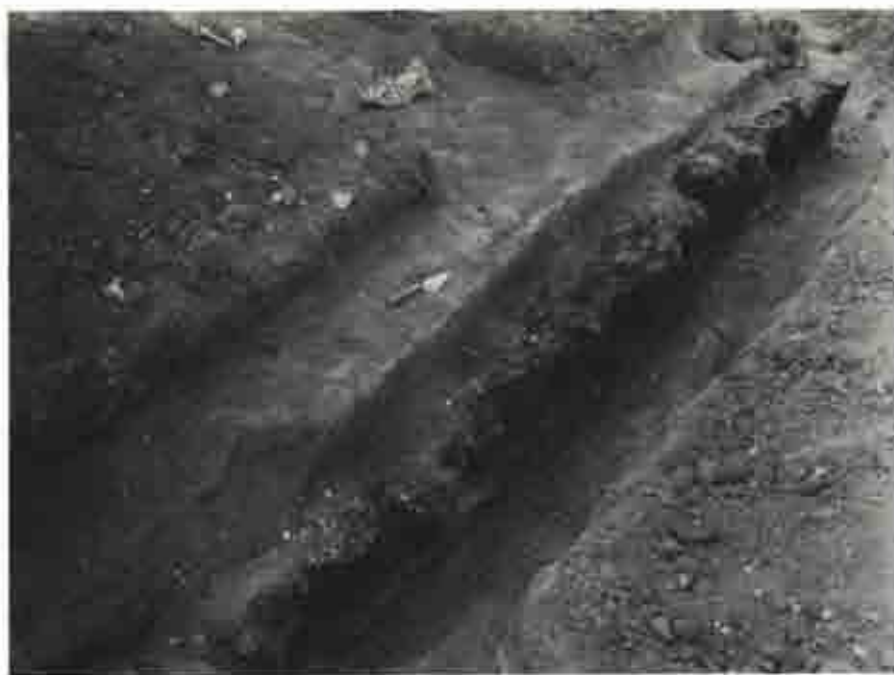
Figure 38. Photo. Building 6-510, east wall. [Cattanach 6/29/57 Neg FOUN-155(s)]

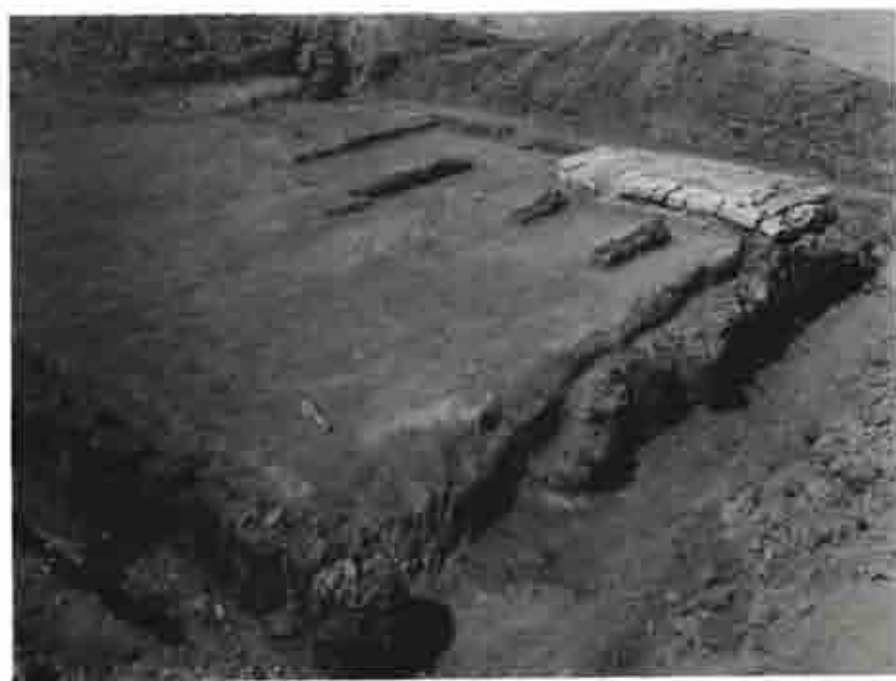
Figure 39. Photo. Building 6-510 Vestibule. [Cattanach 6/29/57 Neg FOUN-156(s)]

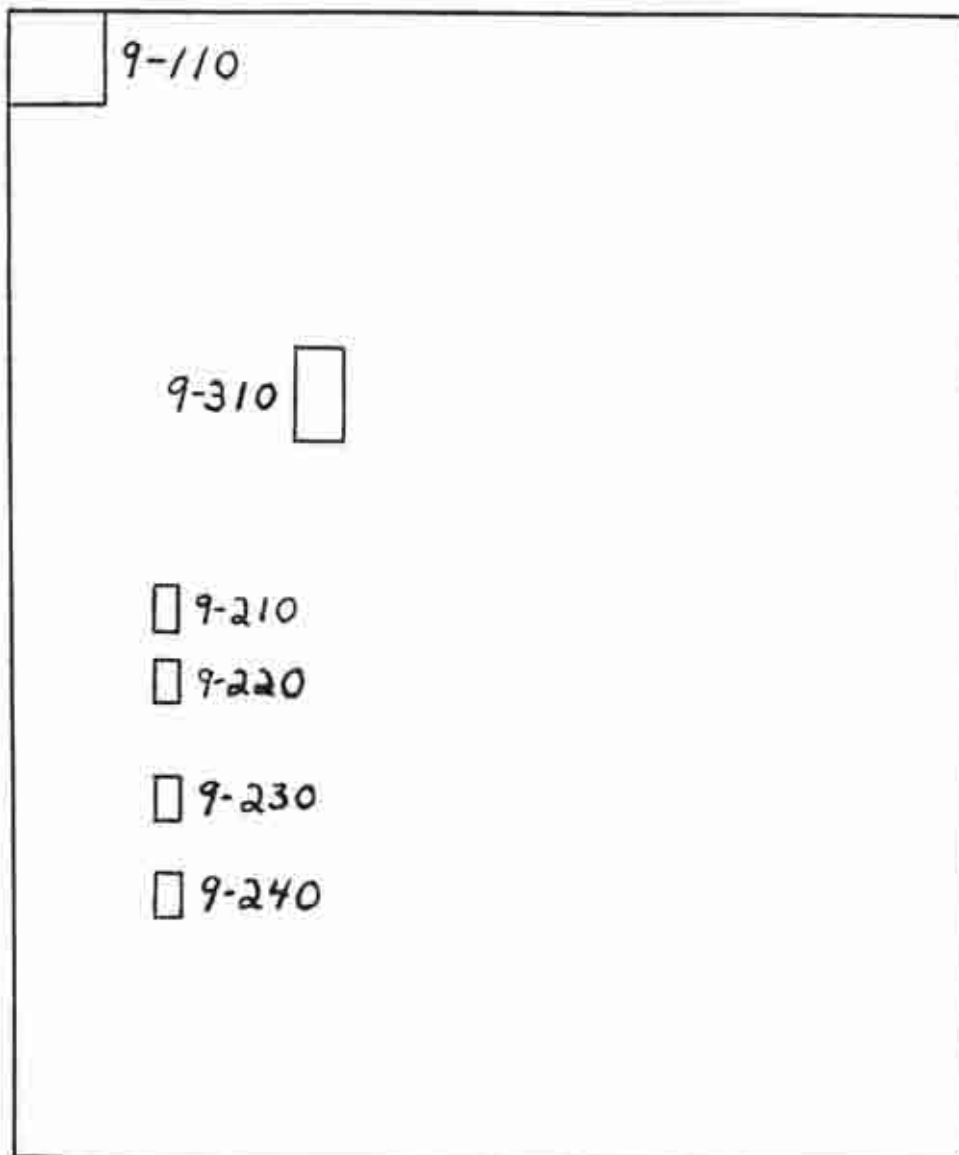
Figure 41. Numbering Plan. Arsenal-First Fort Area.
