AN EVALUATION OF AN ENGINEERING CONTROL TO PREVENT CARBON MONOXIDE POISONINGS OF INDIVIDUALS ON HOUSEBOATS

REPORT NO.:
EPHB 171-25a

REPORT DATE:
March 2001

Plant Surveyed: Wahweap Marina
Lake Powell, Arizona

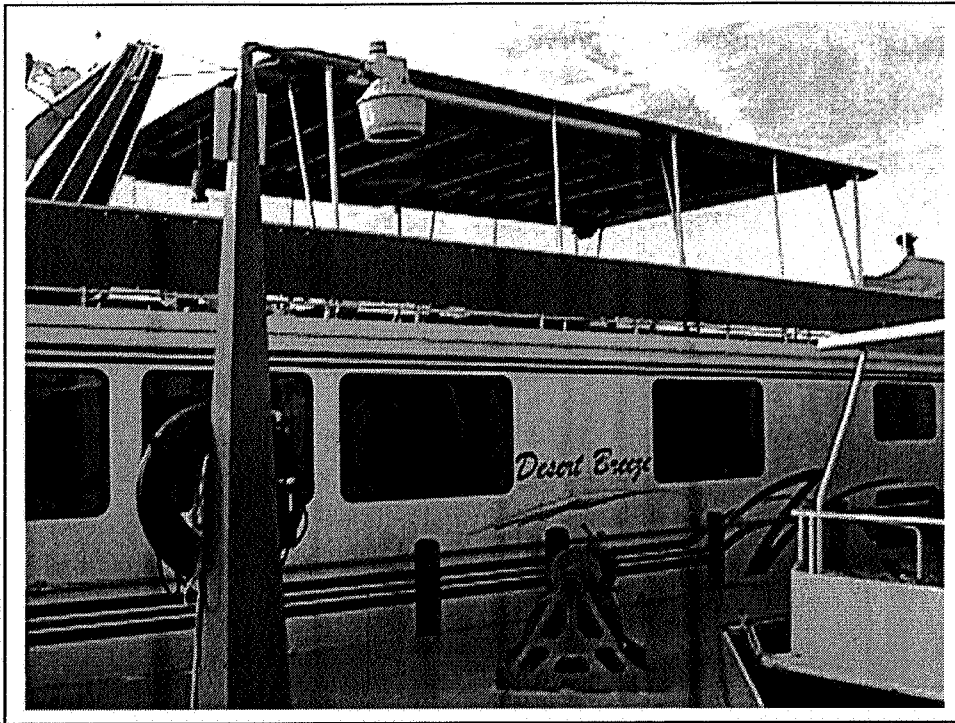
Figure 1. Photo of the evaluated Lakeview houseboat.

CO samples were collected on a five bedroom, Lakeview houseboat built in 1999 (Figure 1) having the specifications listed below.

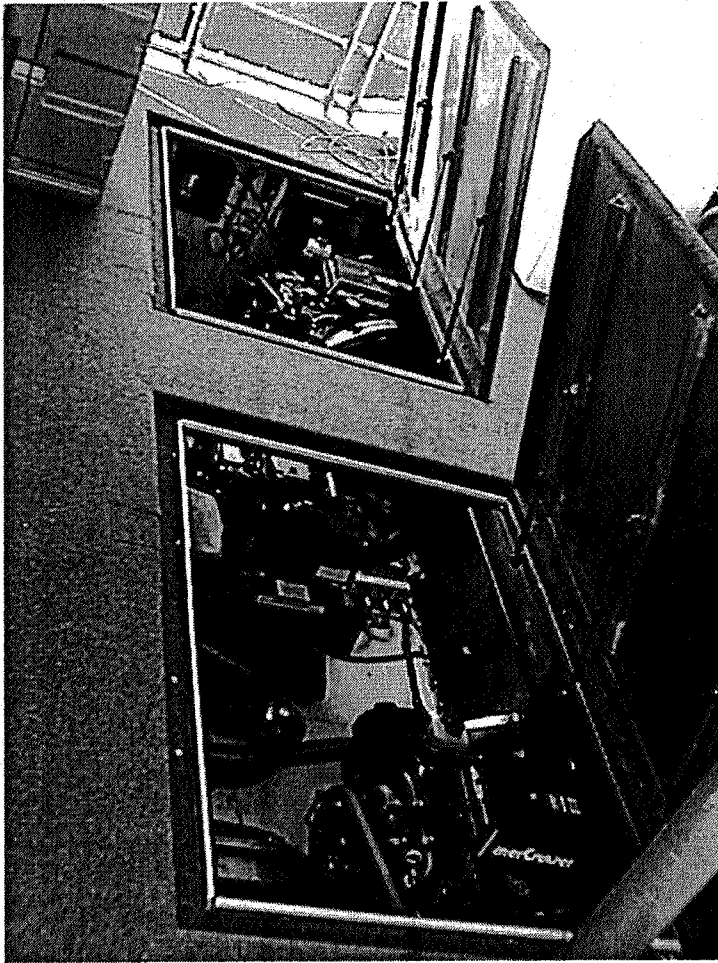
Figure 2. Engine and generator compartment with doors opened.

Two inboard Mercruiser 4.3 liter, V-6, engines were used to provide propulsion for the houseboat. These engines were housed in compartments beneath the rear swim deck of the houseboat. Access could be gained to the engines through two large doors in the floor of the rear deck (Figure 2). These engines exhausted through their propellor shaft beneath the water. A picture of one of the engines is shown in Figure 3.

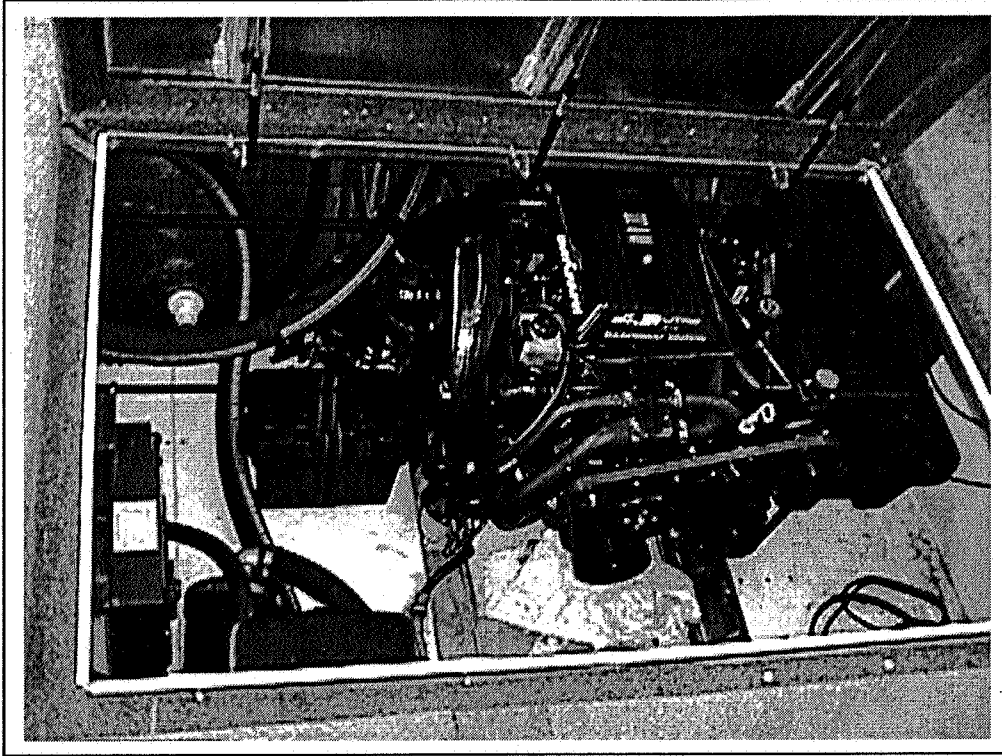
Figure 3. Photo of one of the two inboard Mercruiser, V6 engines.

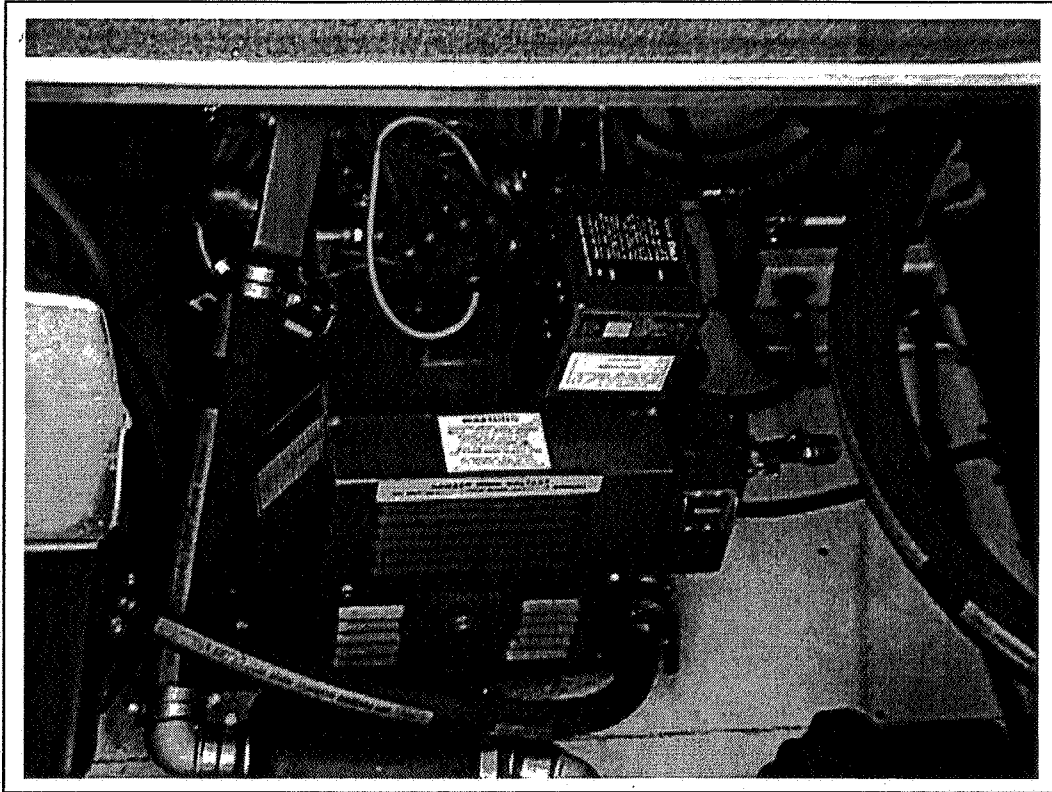
Figure 4. Photo of the Westerbeke, gasoline-powered, four-cylinder generator.

The generator on this houseboat (Figure 4) was manufactured by Westerbeke Corporation, (Avon, MA) to provide electrical power for air conditioning, electrical cooking, refrigeration, cabin appliances, navigation, and communications equipment. The generator was housed beneath the rear swim deck and was positioned between the two Mercruiser engines. The generator is a 4-cylinder, 4-stroke, gasoline-powered engine with overhead cam, that operates at approximately 1,800 revolutions per minute (rpm) and displaces 79.1 cubic inches (in³). This engine is similar in size to engines that are used on small cars. Westerbeke generators are used on nearly 75% of houseboats in the U.S. (Westerbeke 2001).

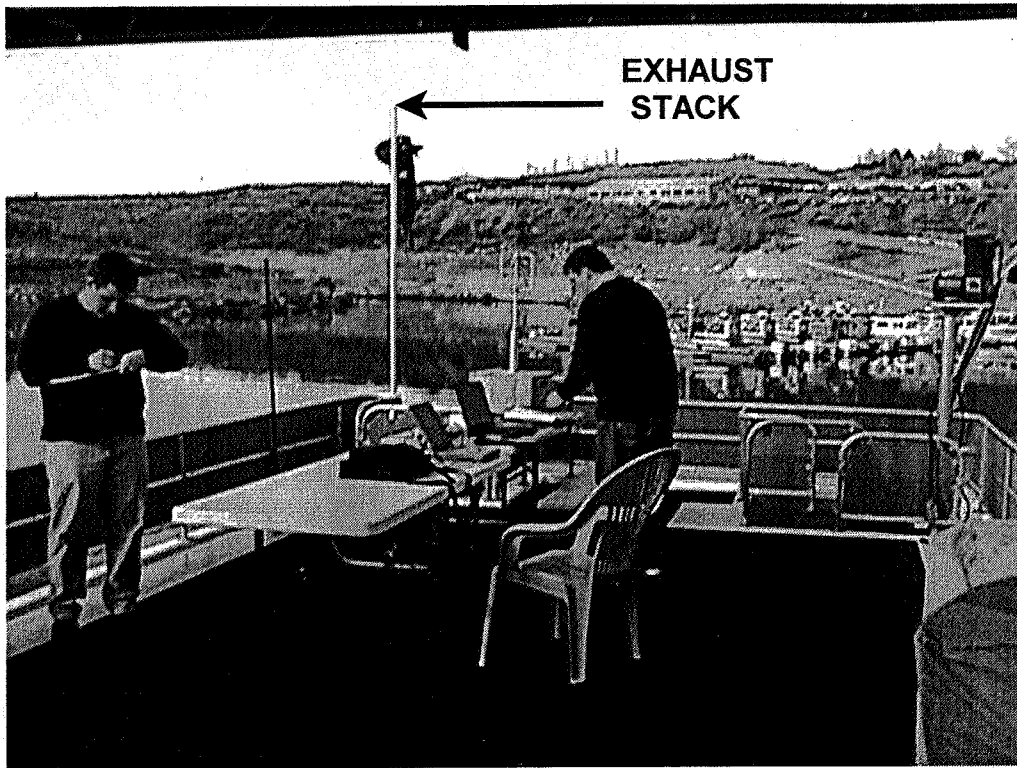
Figure 5. Photo of the generator exhaust stack near the upper deck of the houseboat.

The original exhaust system was modified to reroute the generator exhaust approximately 9 feet above the upper deck of the houseboat to prevent the buildup of hazardous concentrations of CO near the boat's lower, rear deck. An 18 foot long, schedule 40 aluminum pipe, having a 2-inch outside diameter and 1.5-inch inside diameter was used for the stack (Figure 5). NIOSH researchers were informed that this relatively thick and heavy pipe, was the only thing available in Page, Arizona, at the time of construction. To allow the pipe to pass from beneath the lower swim deck to 9 feet above the upper deck, a hole was made in the rear corner of the transom which the 2 inch pipe passed through. A Gensep[®] water/exhaust separator (Centek Industries, Thomasville, GA) was installed between the muffler and the stack, to separate the exhaust gases from the water using the force of gravity. This separator is commonly used on some houseboats and other types of boats to further reduce noise related to water surges from the lift muffler. A diagram of this system is shown in Figure 6.

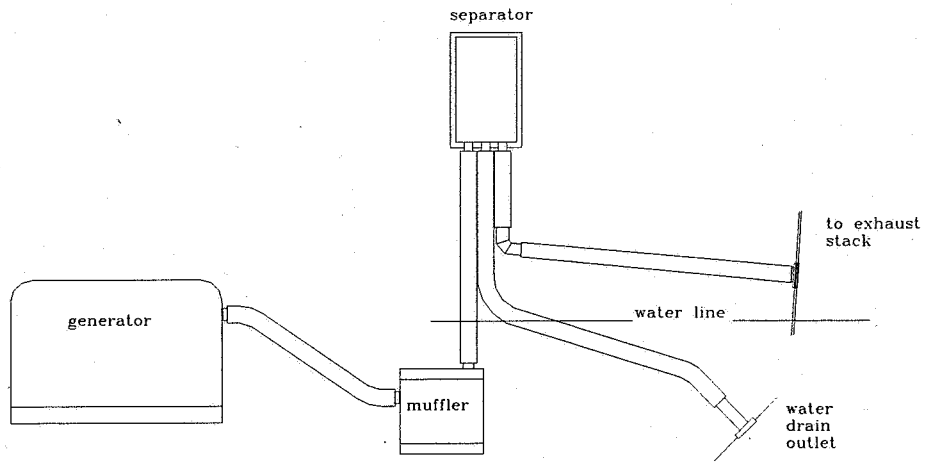
Figure 6. Configuration of the generator exhaust system.

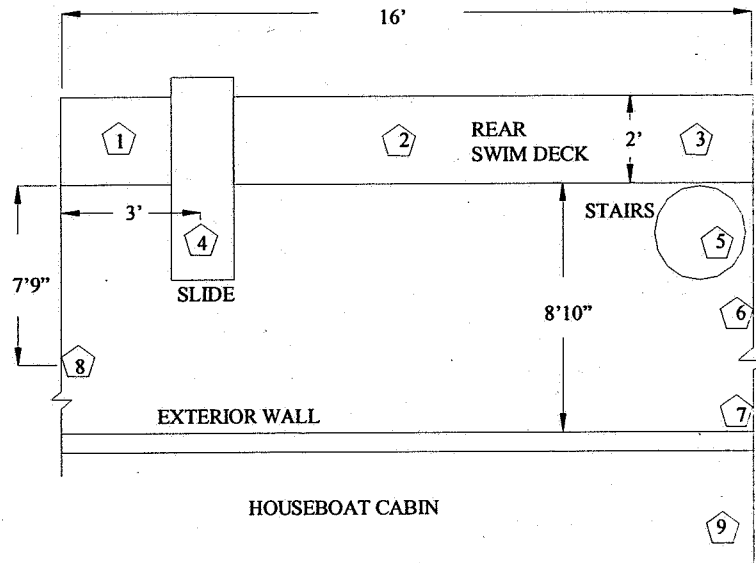
Figure 7. Sampling locations on the lower, rear deck of houseboat.

Sampling locations on the lower and upper decks of the houseboat, designated with pentagons, are shown in Figures 7 and 8. The monitors were placed at various locations on both the upper and lower decks of the houseboat to provide representative samples of where people could be positioned when the generator was operating. Because people commonly enter and exit the water via the rear swim platform of the boat, three monitors were evenly spaced across this structure (Figure 9).

- CO concentration on the center of the rear swim platform (Figure 7, Sample 2): On average, CO concentrations were reduced from 606.6 to 2.85 ppm. This is a reduction of approximately 99.5%.
- CO concentration on rear swim deck near wall separating rear deck and cabin (Figure 7, Sample 7): On average, CO concentrations were reduced from 62.5 to 5.45 ppm. This is a reduction of approximately 91.4%.
- CO concentration on the upper deck near the slide (Figure 8, Sample 10): On average, CO concentrations were reduced from 13.8 to 2.22 ppm. This is a reduction of approximately 83.9%.
- CO concentration on the upper deck near the stairs (Figure 8, Sample 11): On average, CO concentrations were reduced from 14.36 to 1.79 ppm. This is a reduction of approximately 87.5%.

The CO monitor placed at the center of the rear swim platform (Figure 7, Sample 2) indicated an average CO concentration of 2.85 ppm and a peak of 13.0 ppm with the generator operating and the stack connected. This same sample indicated an average of 606.61 ppm and a peak greater than 1,200 ppm when the generator exhausted under the rear swim deck. These results are shown in Figure 10.

Similarly, the monitor located near the wall separating the rear deck from the cabin (Figure 7, Sample 7) indicated an average CO concentration of 5.44 ppm and a peak of 15.0 ppm with the generator operating and the stack connected. This same sample indicated an average of 62.55 ppm and a peak of over 281 ppm when the generator exhausted under the rear deck. Figures 11 and 12 show results of the monitor located beneath the slide (Figure 7, Sample 4) and on the rear swim platform opposite the stack (Figure 7, Sample 3). In both cases, the CO concentrations were dramatically different with peak concentrations near baseline when exhausting the generator through the stack versus the highest peak concentrations between 400 and 1,200 ppm when exhausting under the rear deck. In virtually all samples evaluated on the rear lower deck, concentrations were dramatically worse when the main engines were started, and the houseboat remained stationary. This is shown by looking at what occurs on the right side of the graphs. On the rear lower deck, concentrations rapidly exceeded the NIOSH IDLH concentration of 1,200 ppm. The results of other samples collected on the lower level rear deck are shown in Table 1.

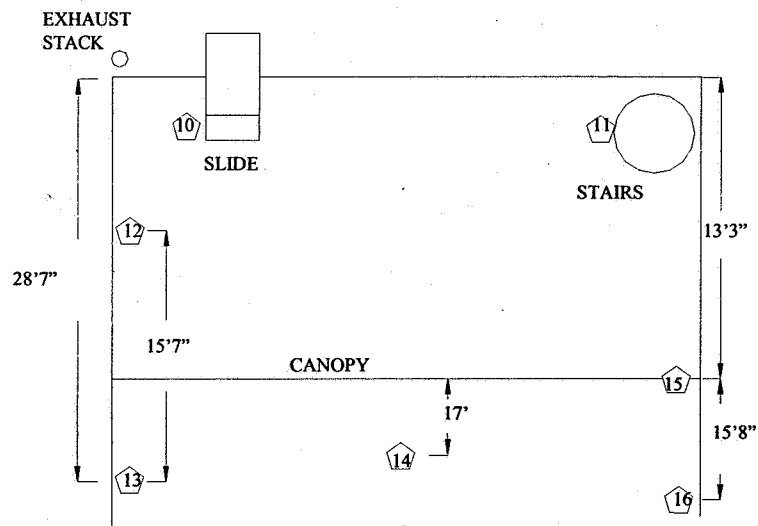
Figure 8. Sampling locations on the upper deck of the houseboat.

The CO monitor placed on the upper deck near the slide (Figure 8, Sample 10) indicated an average CO concentration of 2.22 ppm and a peak of 7.0 ppm with the generator operating and the stack connected. This same sample indicated an average of 13.8 ppm and a peak of 93.0 ppm when the generator exhausted under the rear deck. These results are presented in Figure 13. The monitor located on the upper deck near the stairs (Figure 8, Sample 11) indicated an average CO concentration of 1.79 ppm and a peak of 16.0 ppm with the generator operating and the stack connected. This same sample indicated an average of 14.36 ppm and a peak of 72.0 ppm when the generator exhausted under the lower rear deck. These results are shown in Figure 14. It is interesting to note that although the upper deck is closer to the stack exhaust than the lower deck, the CO concentrations are still lower on the upper deck when the generator exhausts through the stack than when it does not. The results of other samples collected on the upper deck are shown in Table 2.

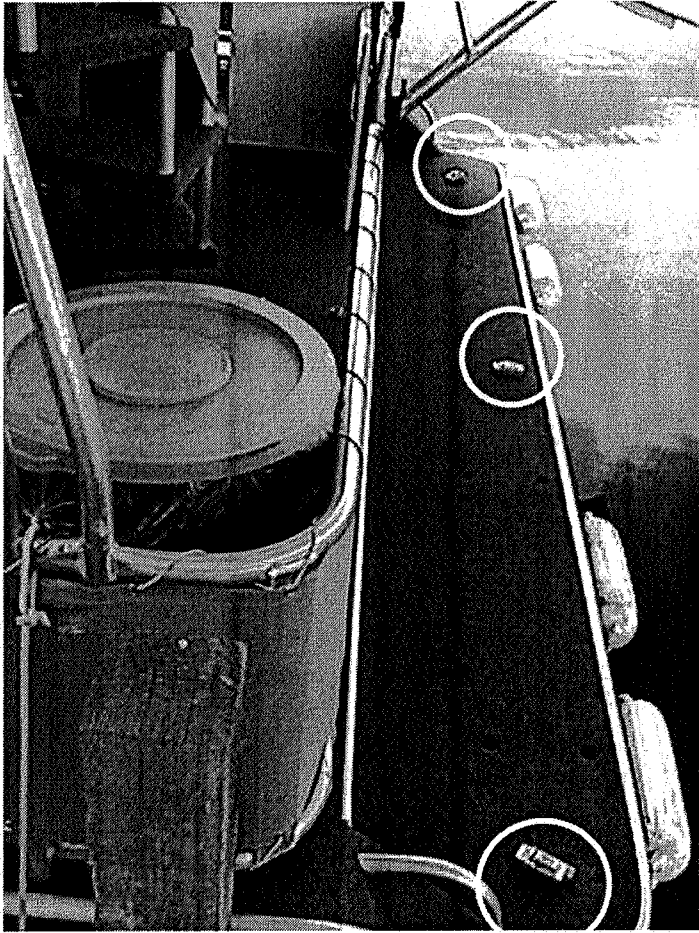
Figure 9. Three CO monitors on the rear swim platform of the houseboat.

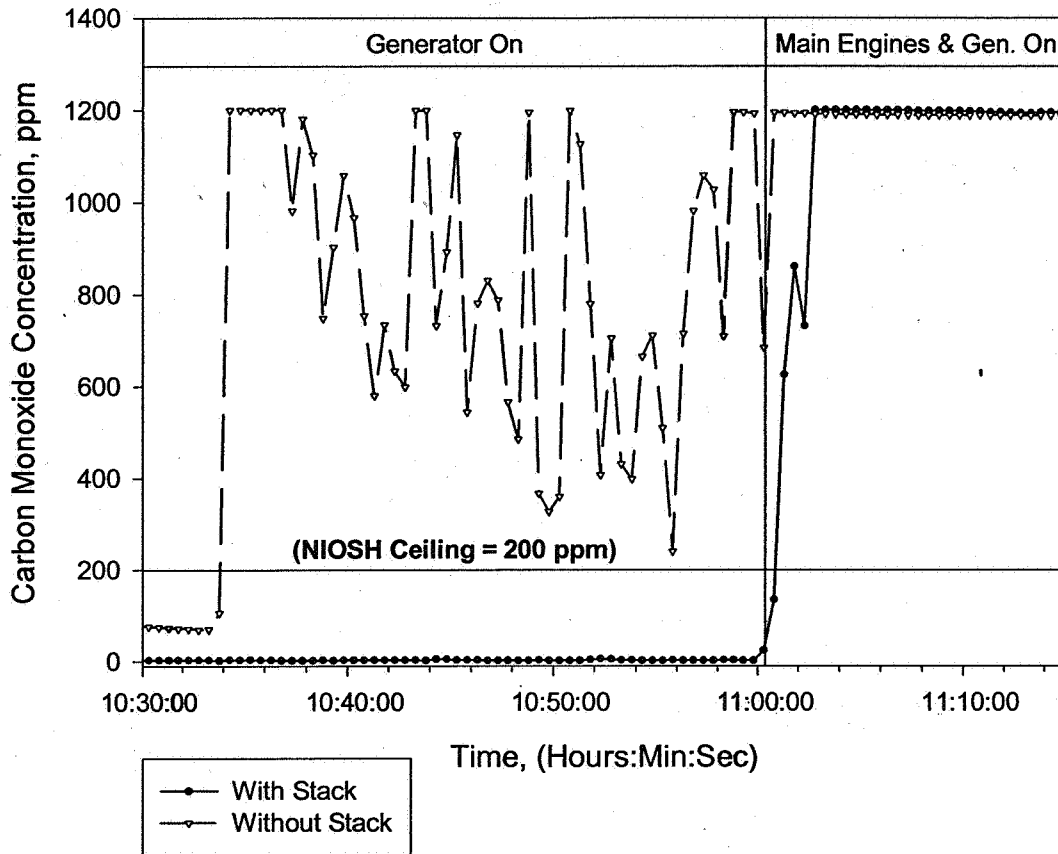
Comparison of Stack and No Stack Configuration (Sampled on center of swim platform)

Figure 10. Comparison of stack/no stack configuration (center of swim platform—Sample #2).

Real-time monitoring results for CO concentrations at various locations on the houseboat are presented in Figures 10 through 16. Figures 10 through 14 provide a comparison of CO concentrations on the houseboat when the generator exhausted through the stack and when it exhausted under the rear swim deck. Figures 15 and 16 provide a comparison of CO concentrations at multiple locations on the houseboat simultaneously, with and without the stack.

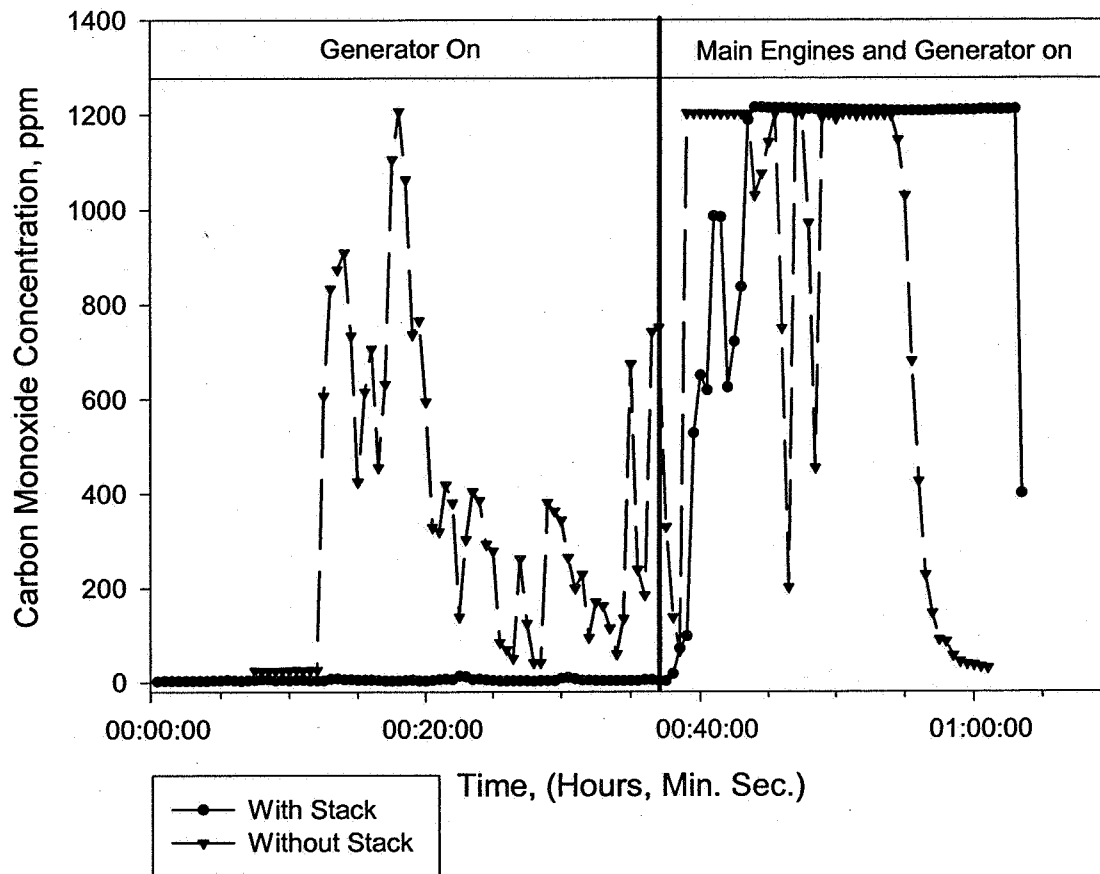
Comparison of Stack and No Stack Configuration (Sampled on rear swim deck beneath slide)

Figure 11. Comparison of stack/no stack configuration (rear deck beneath slide—Sample #4).

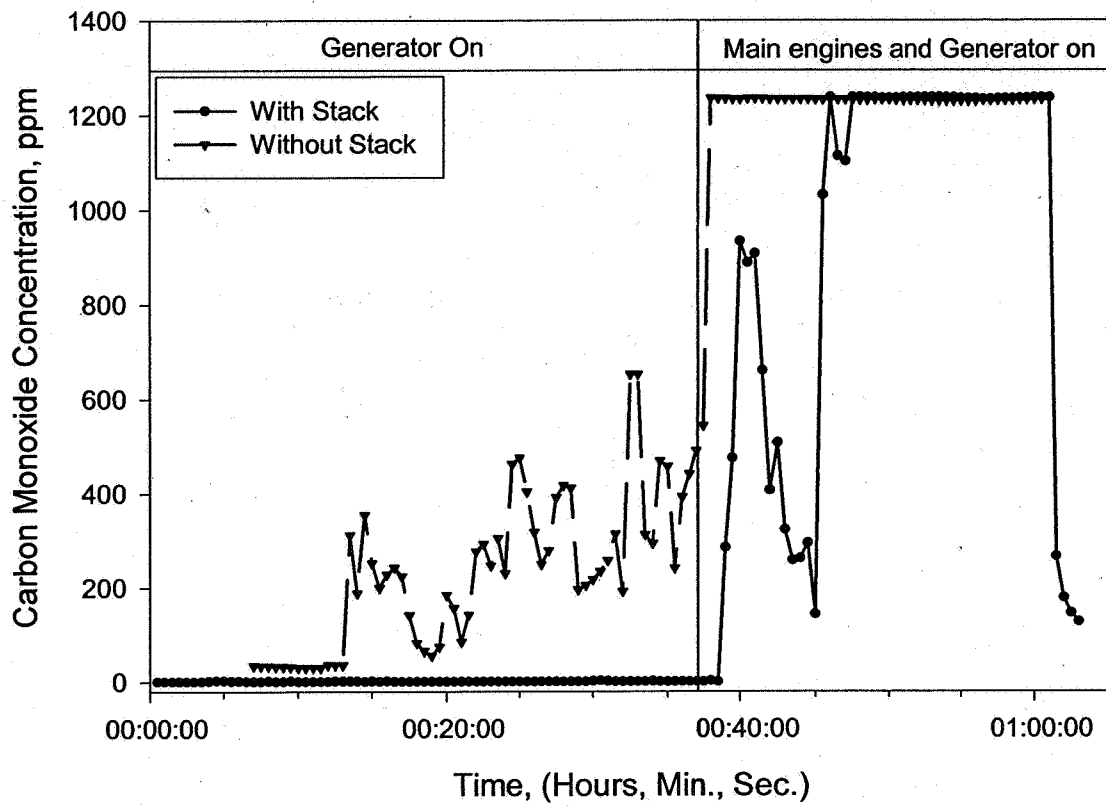
Comparison of Stack and No Stack Configuration (Sampled on rear swim deck-- near stack)

Figure 12. Comparison of stack/no stack configuration (rear swim platform, near stack—Sample #1).

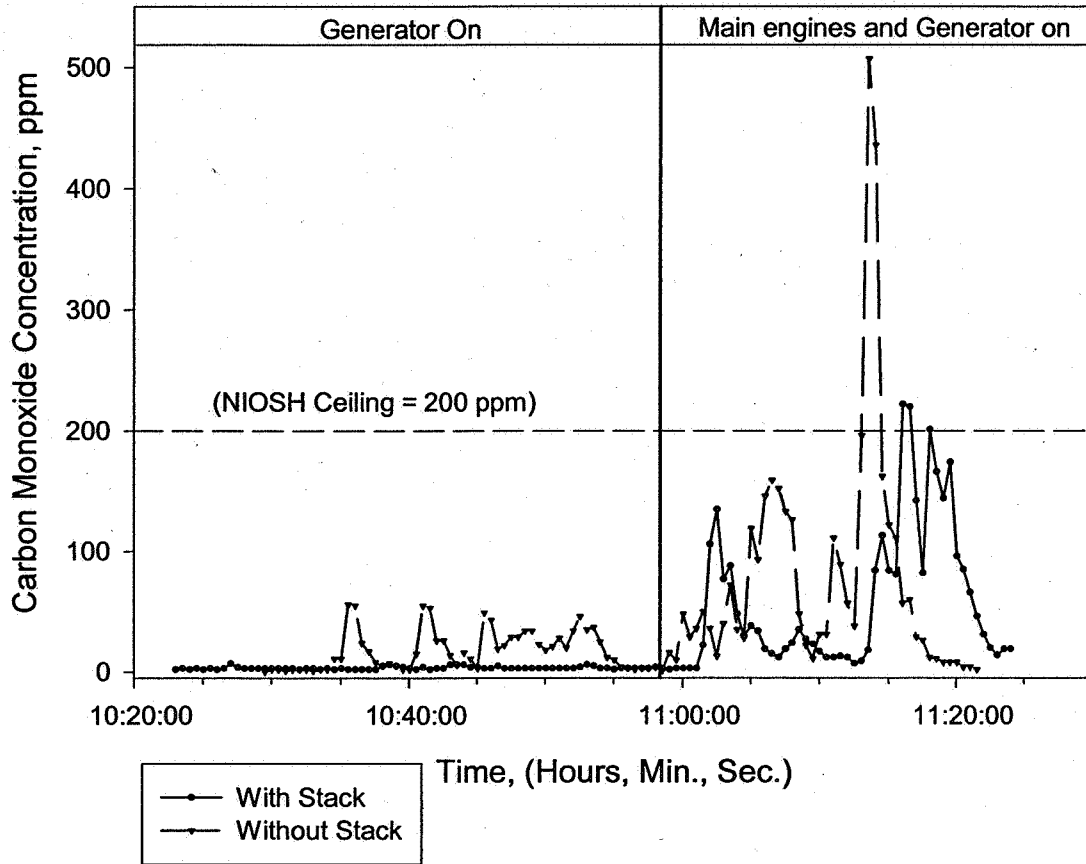
Comparison of Stack and No Stack Configuration (Sampled on upper deck near Slide)

Figure 13. Comparison of stack/no stack configuration (upper deck near slide—Sample #10).

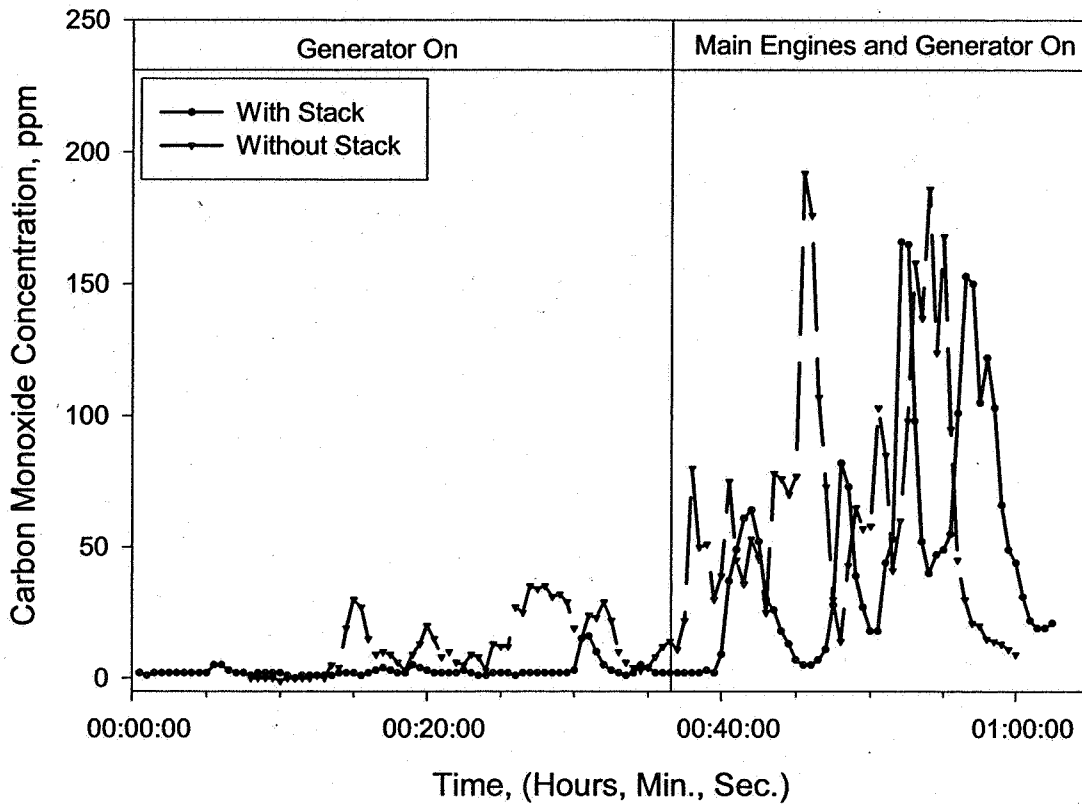
Comparison of Stack and No Stack Configuration (Sampled on upper deck-- near upper stairwell)

Figure 14. Comparison of stack/no stack configuration (upper deck near stairwell—Sample #11).

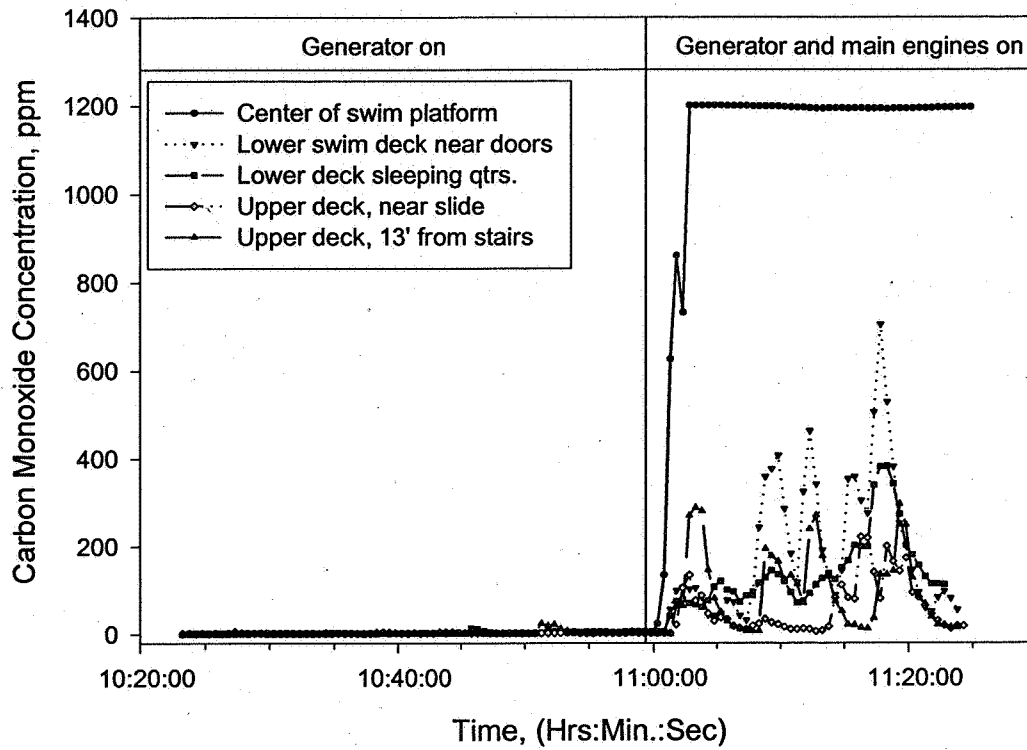
Carbon Monoxide Concentrations at various Locations on Boat (with Stack)

Figure 15. Comparison of air samples at various locations (with stack).

Figure 15 provides data showing how CO concentrations at various locations changed with time as the generator (exhausting through the stack) and later both the generator (exhausting through the stack) and main engines (exhausting through the propellor shaft) were operated. In contrast, Figure 16 provides data showing how CO concentrations at various locations changed with time as the generator (exhausting under the lower, rear deck) and later both the generator (exhausting under the lower, rear deck) and main engines (exhausting through the propellor shaft) were operated. These two graphs clearly show that the most hazardous location is the rear swim platform near the water; however, in Figure 15, it shows that the stack dramatically reduces CO concentrations in that area when only the generator is operating.

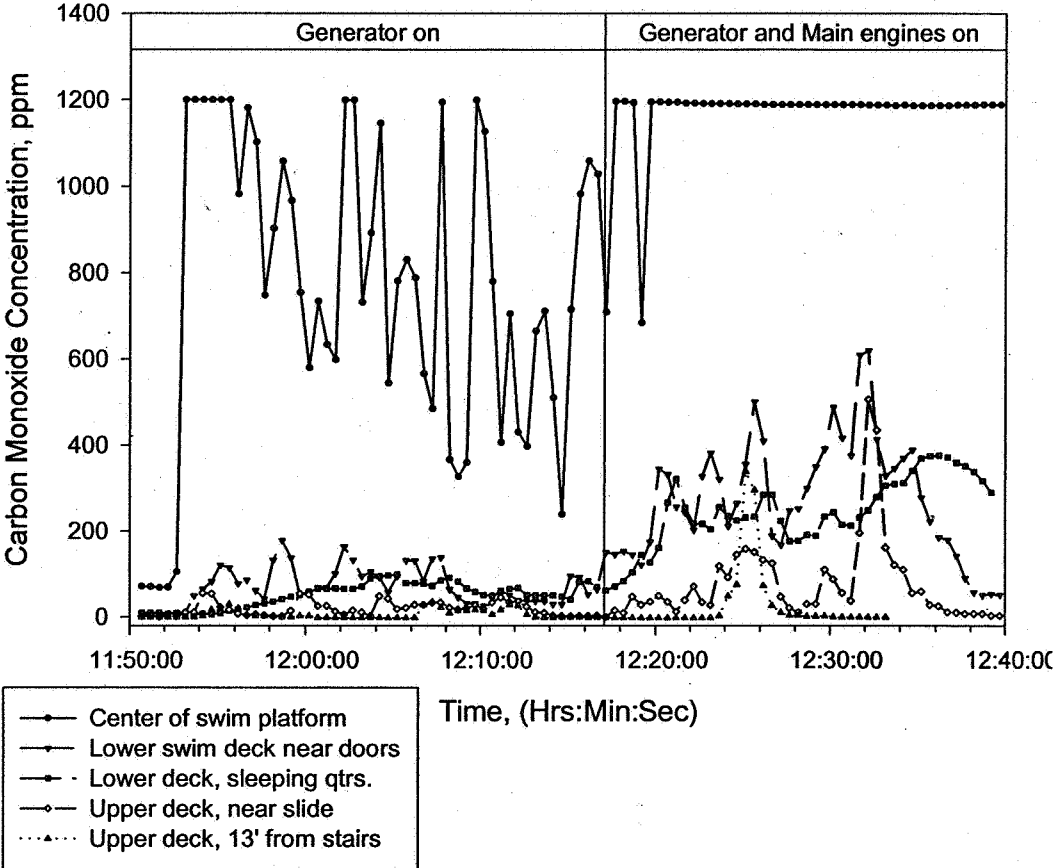
Carbon Monoxide Concentrations at various Locations on Boat
(without stack--exhausting under swim deck)

Figure 16. Comparison of samples at various locations (without stack).

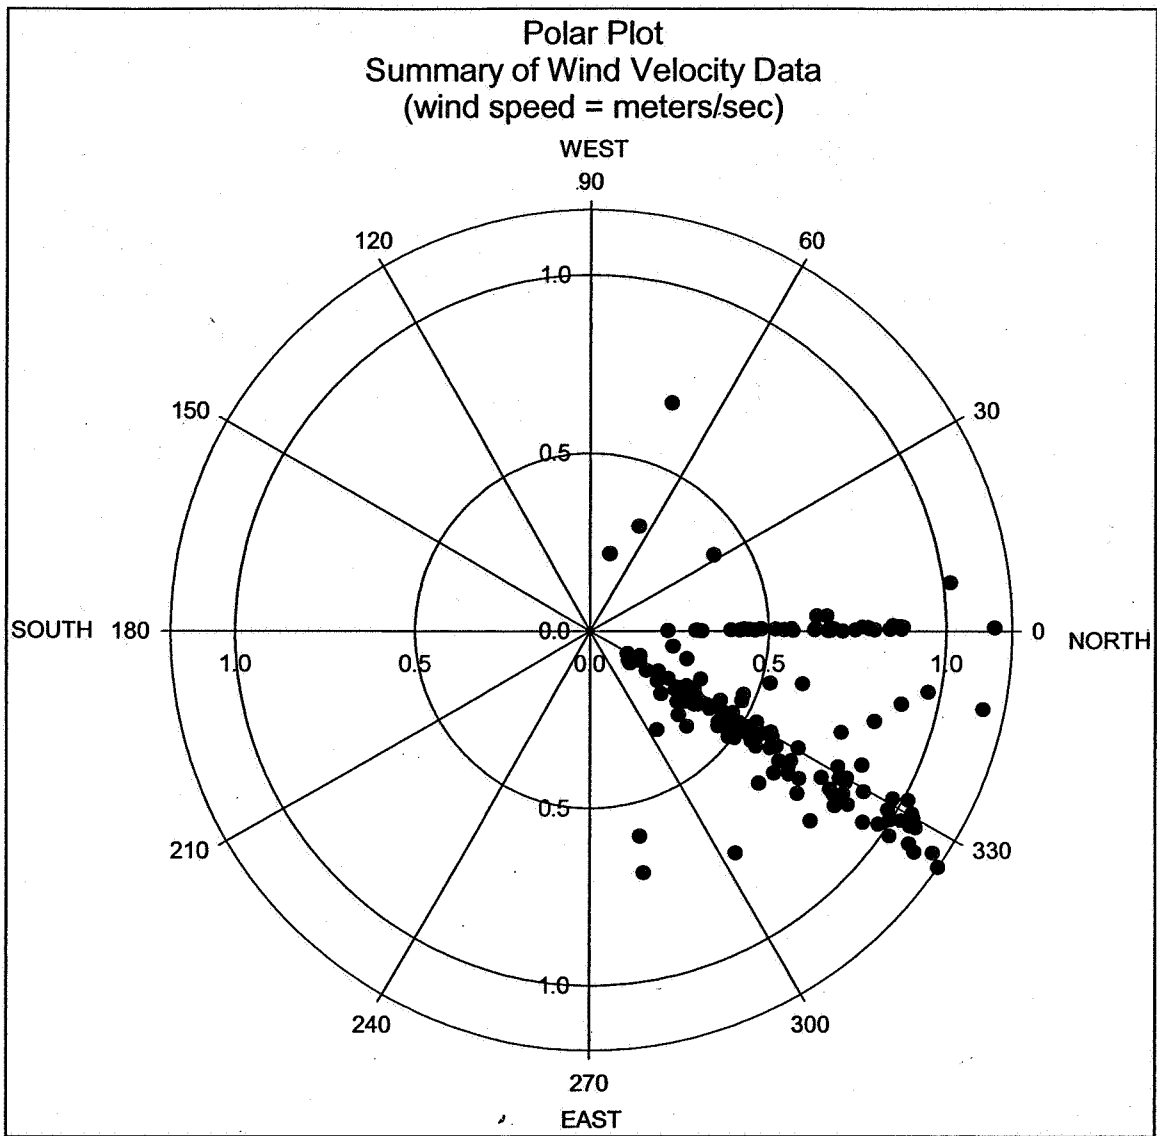
Figure 17. Summary of wind velocity data in (meters per second).

Wind velocity measurements were taken with an ultrasonic anemometer while the CO sampling data was gathered. During this study, the rear of the boat was oriented to the West on an azimuth of approximately 260 degrees with respect to magnetic North, and the boat was stationary. Wind speeds were relatively low with an average wind speed of approximately 0.60 m/sec (118.1 ft/min) and a standard deviation of 0.26 m/sec (Figure 17). Although wind direction changed periodically, on average, it was in a Northeastern direction (338.05 degrees with respect to magnetic North: where magnetic North = 360 degrees). Based upon boat orientation, the wind direction was likely to move CO in the direction of the boat after it was exhausted.

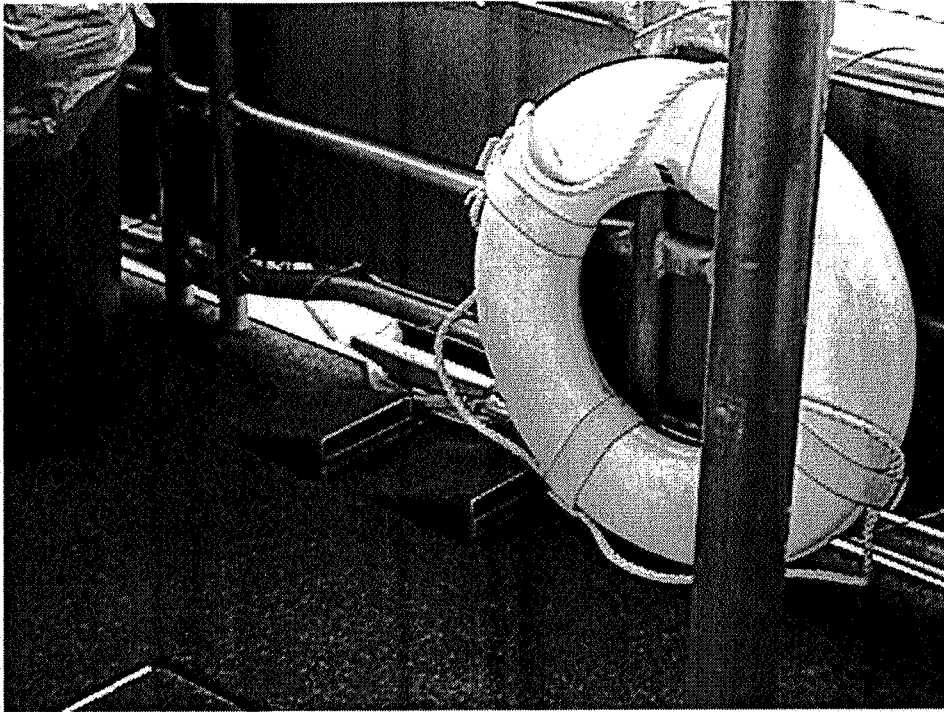
Figure 18. Two of the three ports that provide air flow to the engine compartment.

Measurements were taken at inlets to the engine compartment while the generator was operating and while both the generator and main engines were operating. Air was supplied to the engine compartment through three separate ports in the lower deck of the houseboat (Figure 18). Each of these ports had a cross-sectional area of approximately 0.0447 square feet (ft²) for a total cross-sectional area of 0.134 ft². Average air flow to the engine compartment when the generator was idling was 6.34 cubic feet per minute (cfm) with a standard deviation of 2.80 cfm. Average air flow to the engine compartment when both the generator and main engines idling was 21.47 cfm with a standard deviation of 3.65 cfm.
