## Tests of Doppler Radar Technology for Haulage Truck Backup Alarms

Reduce haulage truck accidents resulting from blind spots, with a special emphasis on reducing accidents during backing operations.

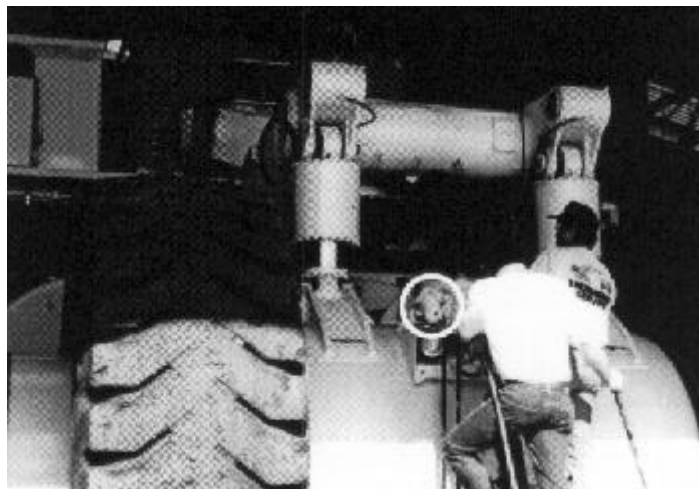
Mounting sensor on light bar.

tail lights, backup lights, and the backup alarm at an elevation of approximately 8 feet above the ground surface. The units were attached with two magnetic base plates to facilitate mounting on the truck. Mounting and wiring were accomplished in approximately 2 hours. Since the units needed to be wired into the 24-volt system of the truck, positive connections were made on the tail light circuit, the backup light circuit, and within the cab on the ignition circuit. The warning lights and alarms of the radar unit were also mounted within the cab of the truck on Velcro tape. Initial tests to determine if the units were wired correctly and were able to sense movement of targets were conducted while the truck was stationary. When the truck was started, a multitude of other alarms (air pressure, hydraulic pressure, backup alarm) were activated, totally confusing the driver's ability to distinguish when the radar sensing alarms were activated. To rectify this, the ground system on the truck's backup alarm was disconnected, disabling that system.

Numerous test configurations and positions of the devices were tested. The adjustable magnetic base plates made changing the positions of the devices easier, but aiming and adjusting gain were time consuming. Reasonable results were obtained when two sensors were mounted on a common base about 8 feet above the ground surface (on the light bar) and 25 degrees off horizontal to the ground, the gain was set at 35 percent of maximum, and the beams were positioned to cross to the opposite footprint. This placed the sensing beam 15 to 18 feet behind the wheels and about 10 feet on the centerline of movement. Further flattening of the beam from the horizontal tended to make the device more sensitive to other surrounding objects, with resulting false alarms. While this configuration could be considered operative, it still was problematic, since the distance over which an object was sensed was too restricted to give a truck driver much time to react to an alarm.
