DEEP COVER PILLAR EXTRACTION IN THE U.S. COALFIELDS

Frank E. Chase, *Research Geologist*
Christopher Mark, *Chief, Rock Mechanics Section*
National Institute for Occupational Safety and Health
Pittsburgh Research Laboratory
Pittsburgh, Pennsylvania USA

ABSTRACT

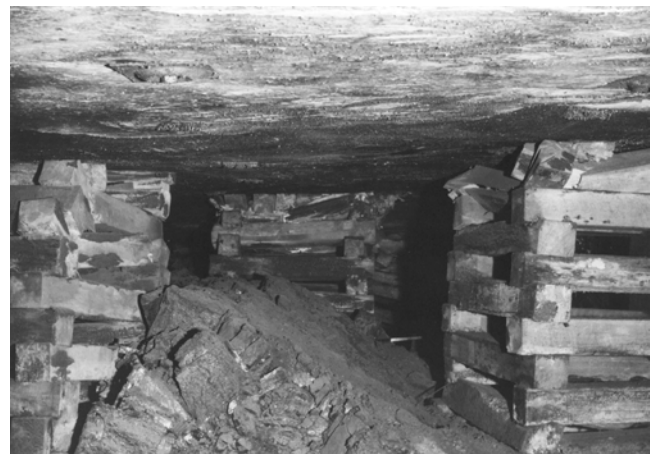
Figure 2. Excessive pillar line floor heave.

Floor failure can also be a deep cover operational issue. More typically, a competent roof tends to punch overstressed pillars into a weaker floor units causing heave in the roadways. Heave can be so extreme that equipment is not left in the working faces during idle shifts for fear of entrapment. Instances where it was necessary to use the continuous miners to regrade roadways for equipment clearance into the faces have also been documented. In one mine visited in southern West Virginia, approximately 4.5 ft of heave was observed just outby the pillar line in the 9 ft thick Beckley Coalbed (figure 2).

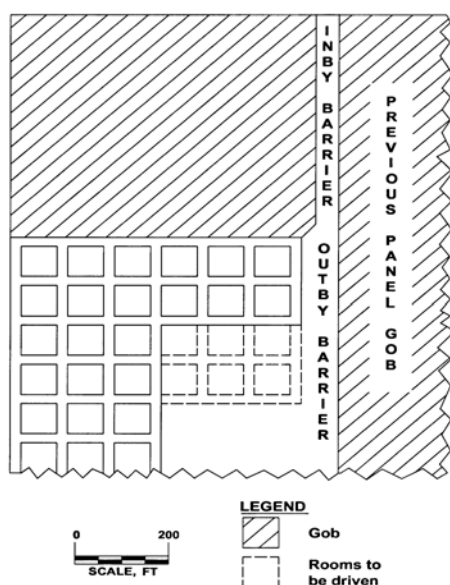
Figure 3. Panel advance and rooming out on retreat mining method.

An alternative approach is the panel advance and rooming out on retreat method (figure 3). With this method, a narrow panel (4 or 5 entries) is advanced, leaving a large barrier between the section and the previous panel gob. On retreat, rooms are driven into the barrier, and then these and the panel production pillars are recovered all the way across the section. This technique is a modified version of the Old Ben method (8) which was used in Illinois in the 1960's and 1970's. One advantage of the panel advance and rooming method is that if problems are encountered on retreat, development into the barrier can be halted and a few rows of production pillars can be left intact so as to contain or isolate the problems inby.

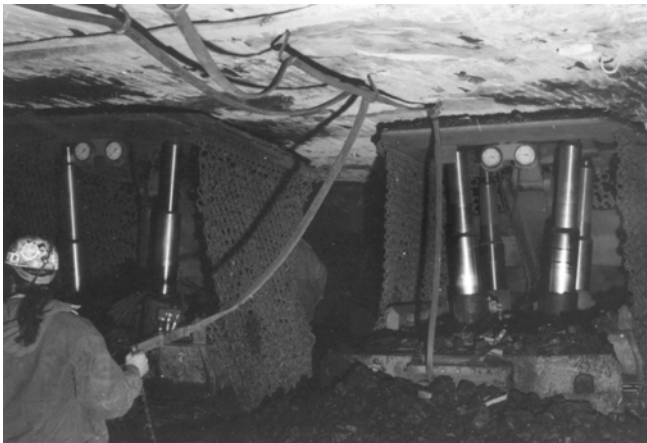
Figure 4. Full pillar extraction using mobile roof supports.

especially true in western mines where there is a scarcity of inexpensive hardwoods. In some of the 12 ft plus thick western reserves, some operators notion of retreat mining is only to mine the floor coal. To combat the posting issues, several operators have turned to mobile roof support usage (figure 4).

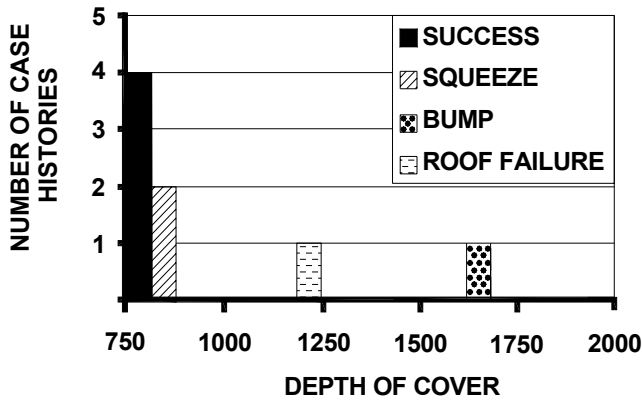
Figure 7. Deep cover weak roof rock data base.

When examining the data base (figures 7-9), it was readily apparent that there were only a handful of weak immediate roof rock cases. A total of 8 weak immediate roof rock cases were collected, and half of those were failures. In addition, the deepest successful weak roof rock case history occurred at approximately 850 ft. Given the fact that 60% of the deep cover mines were investigated during this study, the authors contend that the scarcity of weak roof rock case histories is indicative of the deep cover mine population, and does not

signify a data base quirk. Quite simply, based on past experiences, operators have determined that it is not feasible to mine under weak roof conditions in a deep cover, high stress regime. As for the remaining case histories in the data base, they were fairly evenly divided between “intermediate” and “strong” roof rock categories.

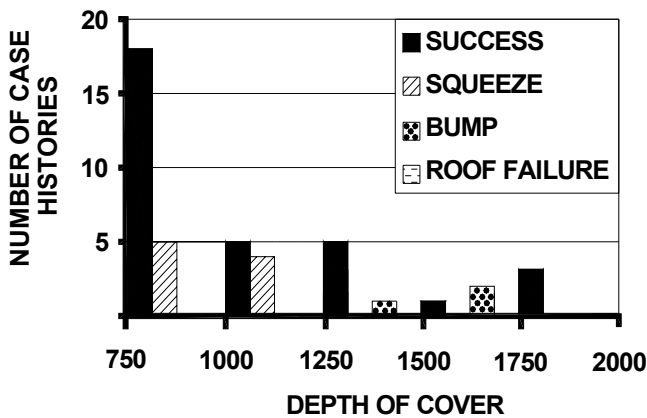
Figure 8. Deep cover intermediate strength roof rock data base.

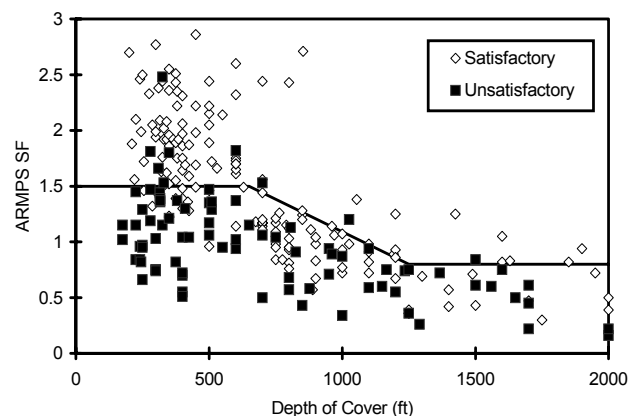
Figure 10. ARMPS case history data base.

Figure 10 compares the ARMPS SF's, depth of cover and outcomes for approximately 250 shallow, moderate and deep cover panel design case histories. Analyses indicate that an ARMPS SF of 1.5 or greater is appropriate where the depth of cover is less than 650 ft. As the cover increases from 650 to 1,250 ft, there seems to be a decreasing trend in SF's for both the successful and the unsuccessful cases. However, deeper than 1,250 ft, there does not seem to be any clear trend. These observations, combined with the fact that the most common failure mechanism shifts from a squeeze to a bump at approximately 1,250 ft of cover, seems to justify separating the data into two groups by depth. Logistic regression was used to analyze the two groups. The failures were weighted as two in order to balance the data. Because of the small number of weak immediate roof rock cases, they were added to the intermediate strength roof rock category.

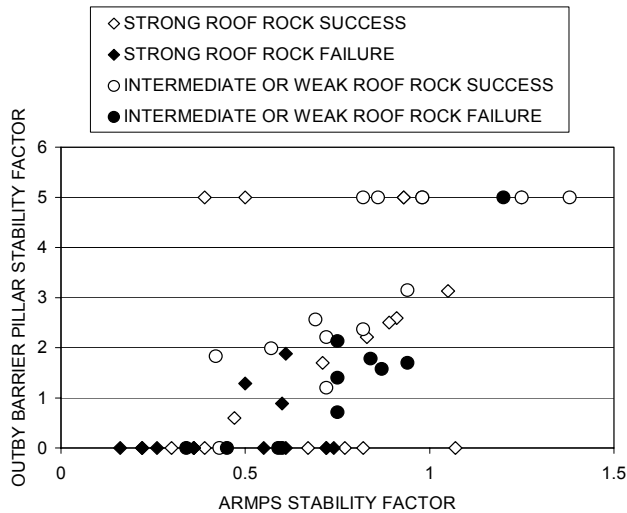
Figure 11. ARMPS and barrier pillar stability factors for the overburden exceeding 1,000 ft. data base.
