# Development of Methods for Determining Airport Pavement Marking Effectiveness

March 2003

DOT/FAA/AR-TN03/22

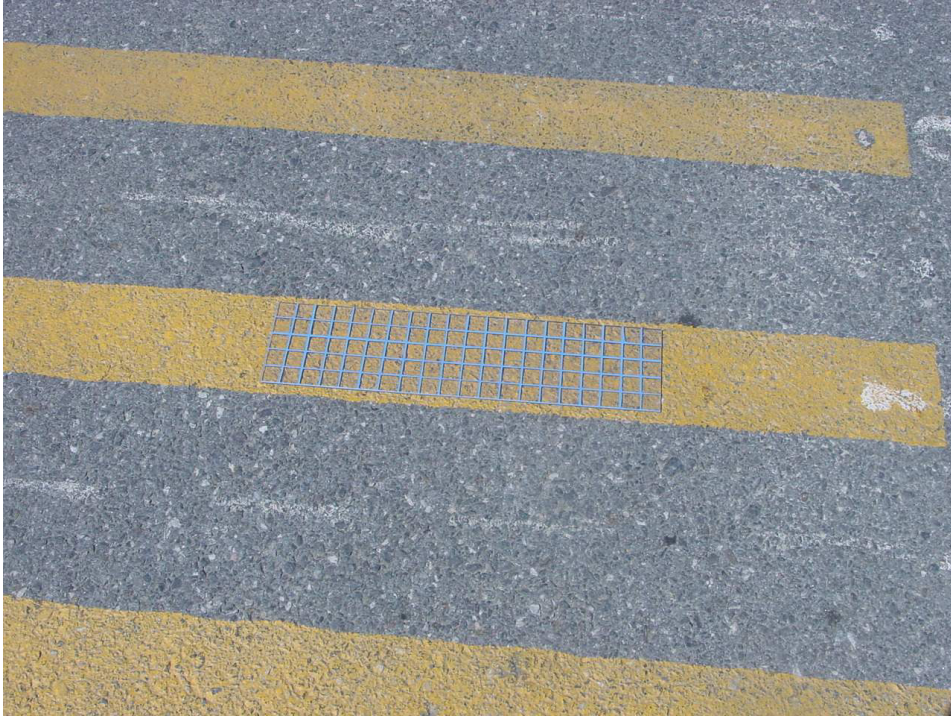
FIGURE 2. A 5- x 20-inch GRID FOR A 6-inch LINE

Coverage Check. This inspection will ensure uniformity of coverage of the entire line, such as paint cracking, peeling, and whether or not the marking has adequate coverage. One-square-inch sections of transparent material inscribed within a grid of 100 equal squares shall be used as a tool for quantitative measure of specified percentage of coverage. The grid concept was taken from the Air Force who used it for measuring rubber coverage on pavement. For a 6-inch line, it is suggested that a grid of 5 x 20 inches be used, and for a 12-inch line, a grid of 10 x 10 inches. Count the squares that have no paint, e.g., 3 out of 100 squares equal 3% of the paint gone or 97% coverage, see figures 2 and 3.

1. Using either the 10- x 10-inch grid or the 5- x 20-inch grid, place the grid on the line to be evaluated.
2. Count the squares that have no paint.
3. The number of squares without paint will be the percentage of paint gone. In other words, if there are 30 out of 100 squares that have no paint, then 30% of the paint is gone.

For paint coverage, a transparent grid was fabricated. The grid concept was taken from the Air Force who used it for measuring rubber coverage on pavement. The grid can be 10 x 10 inches or 5 x 20 inches, each having 100 1-inch squares. The transparent grid is placed on a pavement marking, and the squares without paint are counted. This will give the percent of squares without paint. The paint marking coverage should be 50% or higher. Anything below this, the pavement marking becomes difficult to discern.

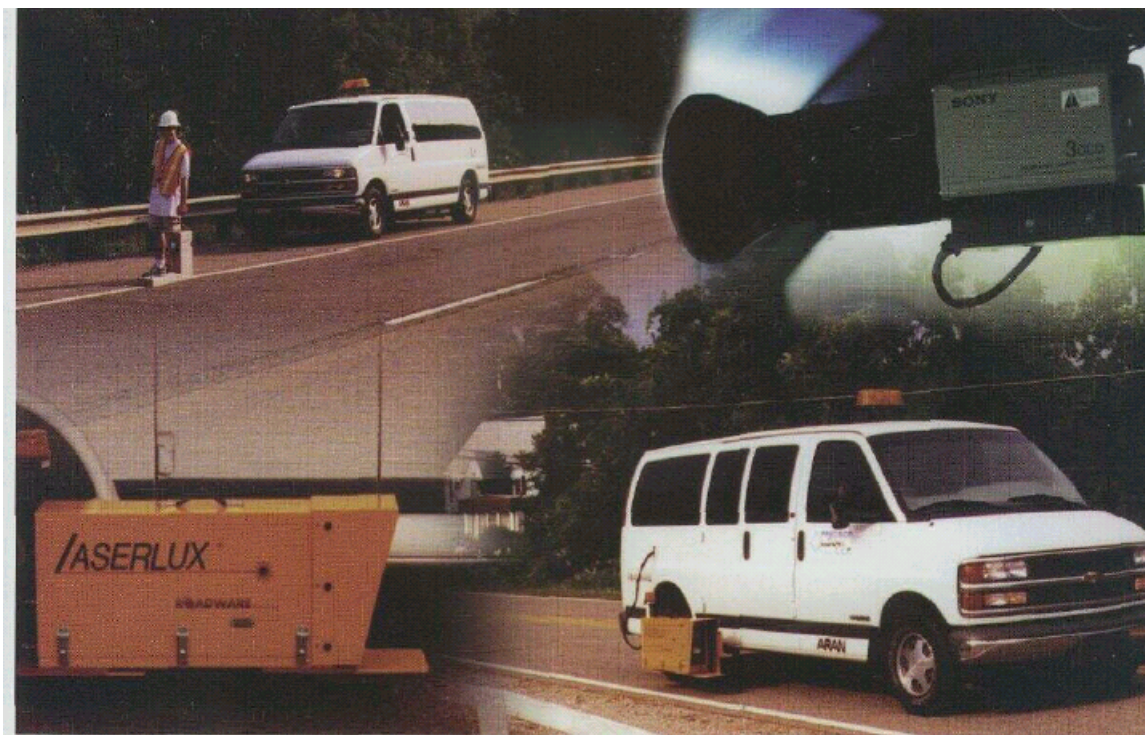
FIGURE 4. VAN-MOUNTED RETRO-REFLECTOMETER

All known manufacturers of a van-mounted retro-reflectometer were contacted for a briefing on their equipment. From this effort, a van-mounted Laserlux was chosen to perform this portion of the test (see figure 4). Software modifications had to be made in order to accommodate an airport environment. These modifications included changing the distance measuring instrument software from 100- to 10-ft station intervals. The Laserlux has an accuracy of  $\pm 15\%$ , whereas the manual LTL-2000 retro-reflectometer has an accuracy of  $\pm 5\%$ .

The equipment needed to perform a van-mounted retro-reflective check, is a computer, a printer, and a video camera.

The automated method is a much quicker and time-efficient method, but it carries a higher cost and a lower degree of accuracy than the manual method. A van-mounted Laserlux or similar mobile unit was used. The data collection is automated such that the averaging and graphing of the data is done by the computer onboard the mobile unit can be printed out. Also, while collecting the data, the van-mounted Laserlux takes a video of the pavement markings so that immediate results can be shown if a line passes or fails. The reports provided after the van-mounted Laserlux had collected the data were data reports and graphs for the retro-reflectivity (LTL-200) readings and data reports and graphs for the spectrophotometer (Color-Guide) readings.
