HIGHLIGHTS OF THE NIOSH HEALTH HAZARD EVALUATION

The National Institute for Occupational Safety and Health (NIOSH) received a request from the Ohio Civil Service Employees Association for a health hazard evaluation at the Ohio Department of Transportation District 8 Main Garage in Wilmington, Ohio. NIOSH investigators were asked to address concerns about exposure to carbon monoxide and metals such as arsenic, cadmium, and lead. We conducted a site visit in October and December 2006.

On August 15, 2006, NIOSH received a request from the OCSEA for a HHE at the ODOT District 8 Main Garage in Wilmington, Ohio. The OCSEA expressed concern about workplace exposure to CO from vehicle exhaust and exposure to metals such as arsenic, cadmium, and lead that may have accumulated on work surfaces over many years of garage operation.

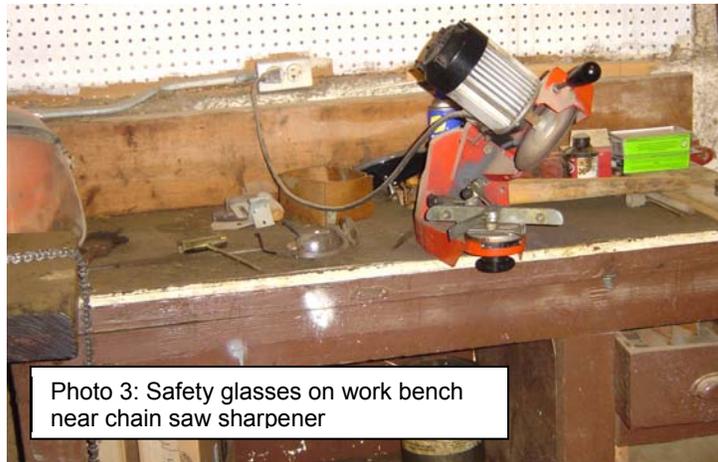
NIOSH investigators observed a pair of safety glasses on the workbench near the chain saw sharpener during the initial walkthrough at the facility and again during the subsequent evaluation. Although only trace concentrations of lead were found on the surface wipes collected on the safety glasses, high concentrations of lead were found on the workbench. Placing safety glasses on a dirty workbench or other dirty surface during periods of non-use increases the chance of contamination and subsequent exposure when the safety glasses are later worn.
