HAZARD ALERT BULLETIN

Gas Inundation of a Strip Mine

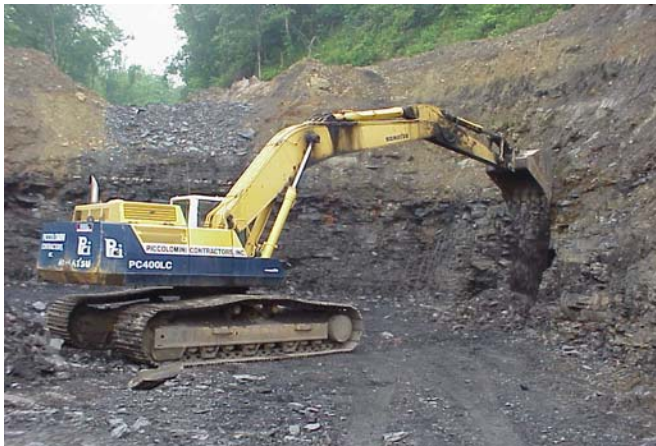
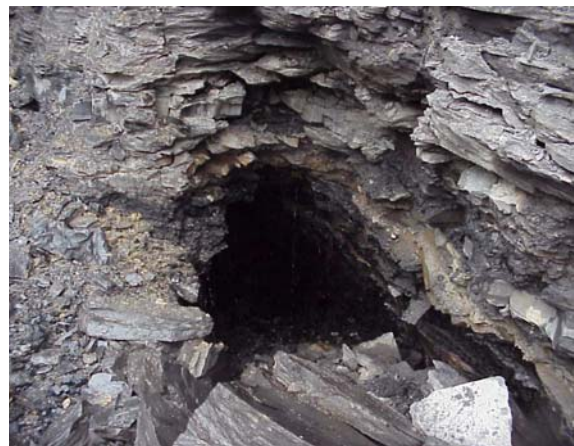
On June 16, 2003, during removal of overburden, two openings into an abandoned underground mine were encountered. Work continued without incident the rest of the shift. No one worked at the site the following day. On June 18, an MSHA inspector arrived to inspect the mine. Finding no miners in the general area, he drove into the pit where his government vehicle stalled and could not be re-started. When the inspector exited the vehicle, he became light-headed and experienced tightness in his chest. The inspector was able to walk out of the pit and telephone the field office supervisor who immediately dispatched another inspector to the site.

An investigation of the area was conducted using detection equipment. Oxygen readings, as low as 9.3 percent, were found in the pit. To protect persons from entering the affected area, the access road was barricaded and a red closure tag was placed on it identifying the hazard. An Order was also issued. The operator was contacted by telephone and notified of the condition and action taken.

- When old mine openings are encountered, stop all work. A qualified person, using the proper equipment, must examine the area before any further work takes place. Record results of the examination, including all hazards identified.
- If hazardous conditions are found, evacuate all persons until the conditions have been corrected.
- As soon as practicable after discovery, back fill mine openings encountered.
- Develop a plan that addresses examinations for gases, under what conditions to evacuate, and procedures to follow to correct the conditions when (surface) mining near known abandoned underground workings.
