DESIGN AND CONSTRUCTION UPDATES

Alkali-Silica Reaction (ASR)

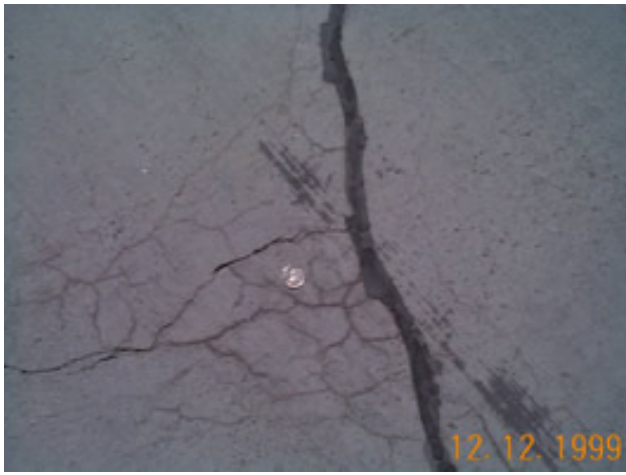
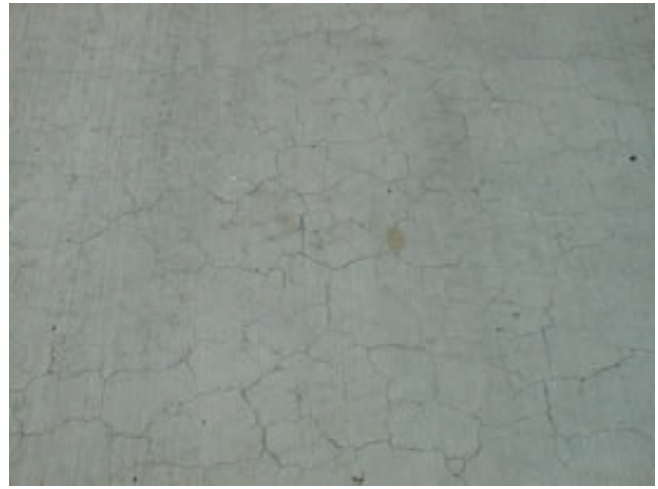
What is ASR? ASR is a deleterious chemical reaction between the aggregate and the surrounding cement paste. The most common reaction is that between the active silica constituents in the aggregate and the alkalis in the cement. The reaction starts with the attack on the siliceous minerals in the aggregate by the alkaline hydroxides derived from the alkalis in the cement. As a result, an alkali-silicate gel is formed, and alteration of the borders of the aggregate takes place. The gel is an unlimited swelling type by imbibing water and increasing in volume. Since the gel is confined by surrounding cement paste and aggregate, internal pressures eventually result in expansion and cracking of the cement paste. The reaction may not occur for several years depending on temperature and size of the siliceous particles. It is identified by a hand- to foot-size cracking pattern. The following photos show the cracking pattern and deterioration from ASR.

The expansion eventually effects adjacent structures and pavements. Structures may not withstand the pressures and pavements will heave or buckle.

What can you do if it exists? There is no proven method for overlaying or sealing to stop this reaction. Individual slabs will eventually have to be removed and replaced when the deterioration presents FOD problems or damage to adjacent structures from the pressures. When this occurs, adjacent slabs will expand even more rapidly without the restraints. Eventually the entire area will have to be reconstructed. Recent testing shows some promise for the use of a lithium to slow the reaction. It is sprayed on the surface in a sufficient quantity to saturate the cracks and retard the alkali-silica reaction. This, however, is not anticipated to be a permanent repair.
