EMERGENCY AND LONG-TERM RESTORATION PLANNING FOR THE 1999 OLYMPIC PIPE LINE COMPANY SPILL, WHATCOM CREEK, BELLINGHAM, WASHINGTON, USA¹

ABSTRACT: *The restoration planning efforts for the June 10, 1999, Olympic Pipe Line Company gasoline spill illustrate the benefits of cooperative and restoration-based damage assessment. The Incident resulted in the release of approximately 236,000 gallons of gasoline into Whatcom Creek, Bellingham, Washington. The spilled gasoline ignited, burning much of the riparian vegetation including a large section of mature forest in an urban park. The combination of the spill and fire resulted in the complete elimination of terrestrial and aquatic biota in several miles of the creek. Affected biota included several species of juvenile salmonids, including chinook salmon, which are listed as threatened under the Endangered Species Act. The Incident also resulted in recreational fishing and park closures. The Oil Pollution Act regulations require the Trustees to invite the Responsible Party to participate in the damage assessment and restoration process. By working together, restoration of injured resources and services may be achieved more rapidly and cost

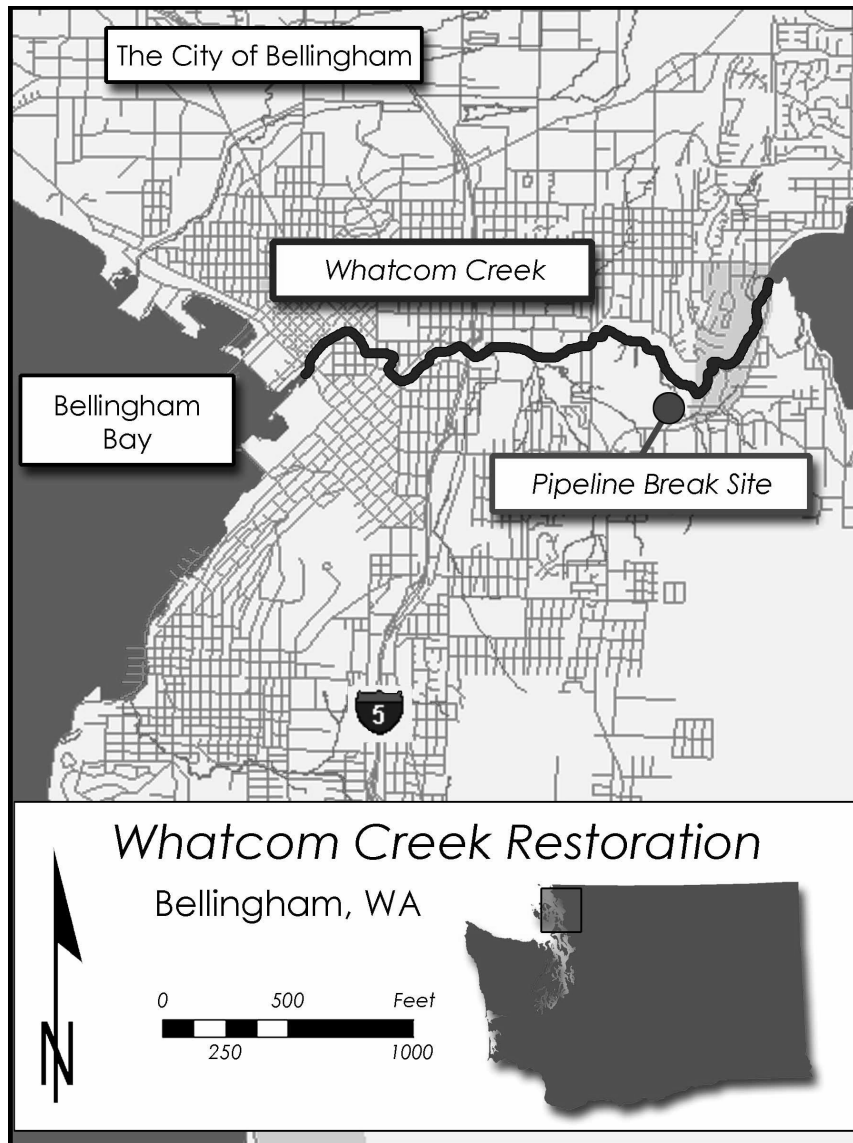
Figure 1. Spill site.

On June 10, 1999, a rupture occurred in a pipeline owned by the Olympic Pipe Line Company. The Company operates a pipeline system that runs from Ferndale, Washington, to Portland, Oregon. The rupture occurred at a location where the pipeline crosses Whatcom Falls Park within the City of Bellingham, Washington (Figure 1). The U.S. Environmental Protection Agency and the Washington Department of Ecology report the spill volume as approximately 236,000 gallons. Released product

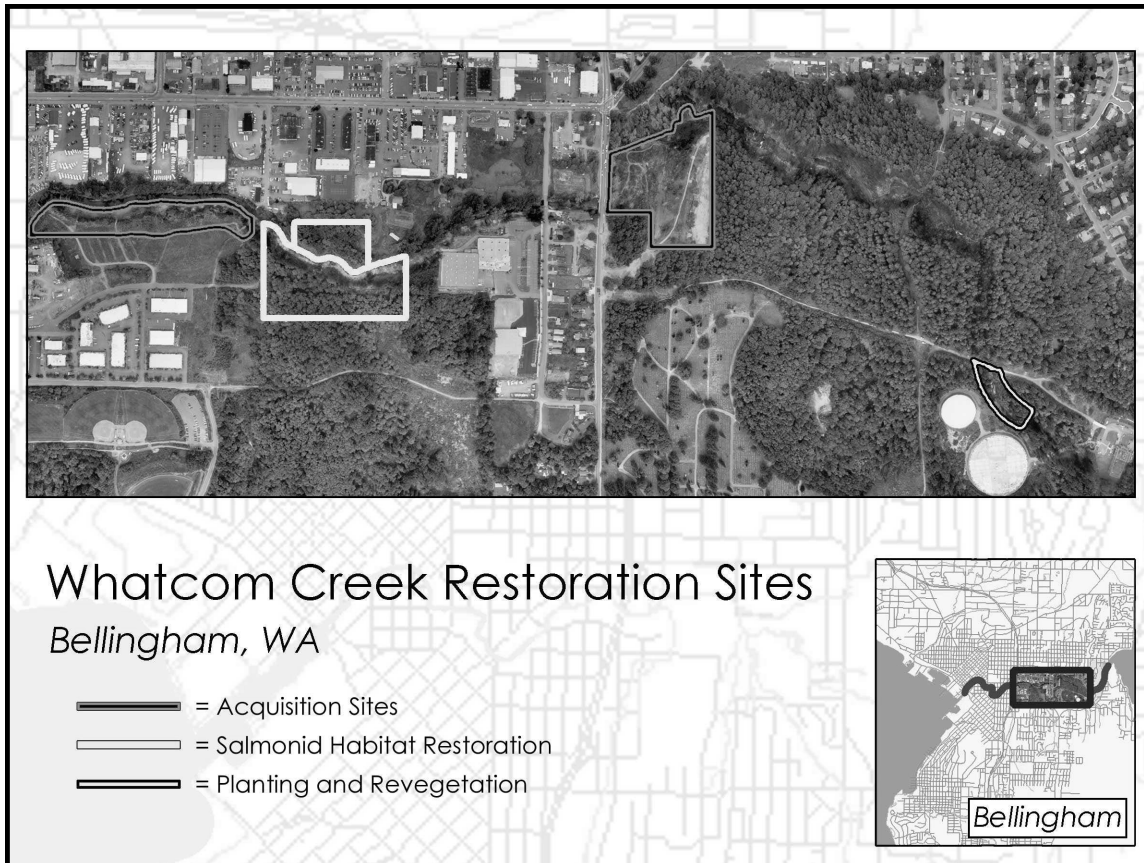
Figure 2. Long-term restoration sites.

Land acquisition and park enhancements. This element of the restoration plan includes acquisition of 13.5 acres of land along the creek that was slated for development for use as parklands and to protect riparian habitats. The primary purpose of these projects is to compensate for recreational losses resulting from the Incident, but the lands will also be available for long-term fish, wildlife, and riparian habitat restoration projects. An access road, parking lot, and restroom facility will be constructed on a small portion of one of the sites to facilitate park use. The acquired lands are also expected to have significant collateral benefits for salmonids by protecting water quality and maintaining a healthy riparian zone. One of the important injuries documented by the Trustees was closure and destruction of park resources and properties. The property acquisition, combined with park improvements and recreational trails, is expected to compensate for these injuries and loss of services by increasing park visitation and trail usage opportunities without increasing congestion and user density. As the plantings mature and other improvements are made, the Trustees expect that the parcels will be a seamless addition to the Whatcom Falls Park and Trail System.

Fish habitat projects. One of the major impacts documented by the Trustees was injury to anadromous and resident salmonids, fish, and other aquatic resources. This element of the plan involves construction of two projects. One project involves construction of a backwater channel within a historic meander of the Whatcom Creek to improve winter refuge habitat for juvenile salmonids. The other project involves construction of pools, wetlands, and salmon rearing habitat on Cemetery Creek near the confluence with Whatcom Creek. These projects are expected to directly address two known limiting factors: 1) the limited availability of cool water refugia during the summer months, and 2) the limited availability of off-channel habitat that is normally provided when streams are allowed to meander onto the floodplain and form secondary channels. The projects are also expected to benefit other fish, amphibians, aquatic invertebrates, and freshwater and riparian habitats, and generate benefits for water quality, recreation, vegetation, and wildlife.
