# Health Consultation

HURRICANE RESPONSE SAMPLING ASSESSMENT FOR  
GULF COAST VACUUM SERVICES

ABBEVILLE, VERMILION PARISH, LOUISIANA

SEPTEMBER 26, 2006

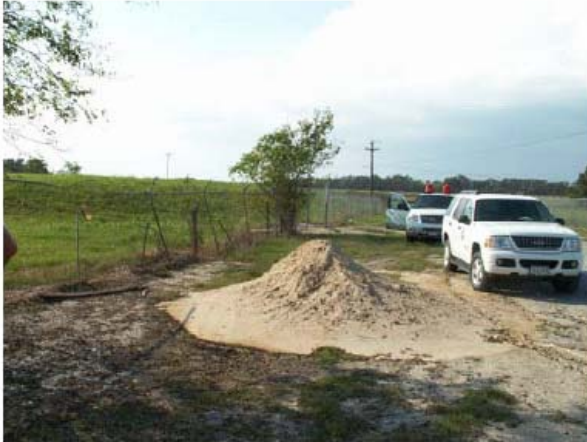
**File Name:** GSV\_photo1.JPG  
**Date/Time Taken:** 01 Oct 2005 1625  
**Description:** Fence line of site intact and not compromised by storm, view to west.  
N29°57'29.9"; W92°11'11.3"

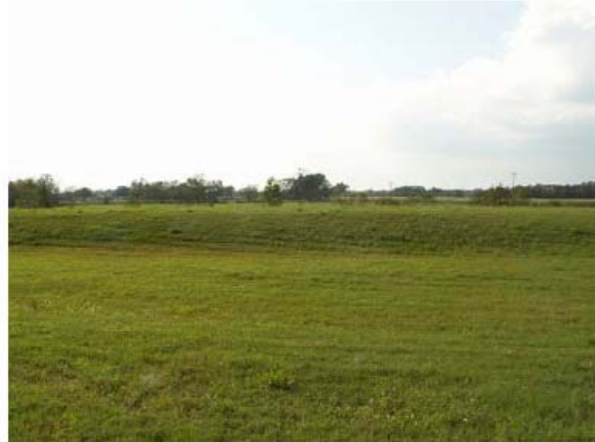
**File Name:** GSV\_photo2.JPG  
**Date/Time Taken:** 01 Oct 2005 1631  
**Description:** View to northwest of cap, showing no subsidence, ruts, or cracks due to storm.  
N29°57'28.1"; W92°11'11.4"

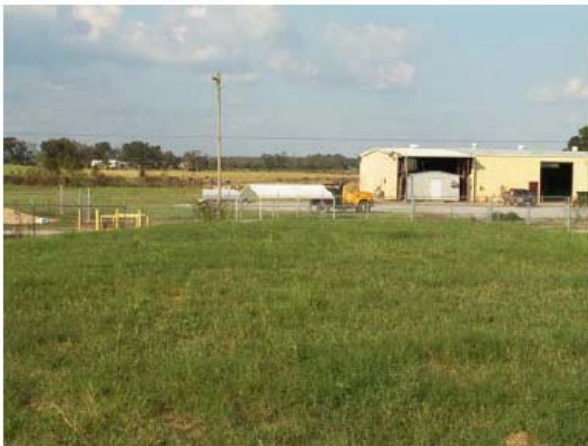
**File Name:** GSV\_photo3.JPG  
**Date/Time Taken:** 01 Oct 2005 1636  
**Description:** Eastern portion of cap, with equipment storage/maintenance facility in background, view to north.  
N29°57'28.1"; W92°11'11.4"

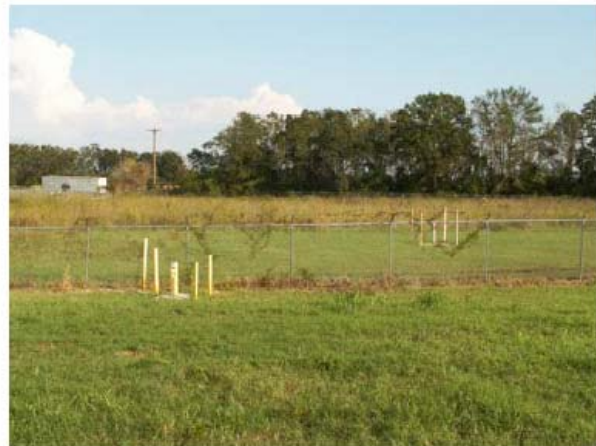
**File Name:** GSV\_photo4.JPG  
**Date/Time Taken:** 01 Oct 2005 1641  
**Description:** Boundary fence between Gulf Coast Vacuum and D.L. Mud sites, view to east.  
N29°57'28.1"; W92°11'11.4"

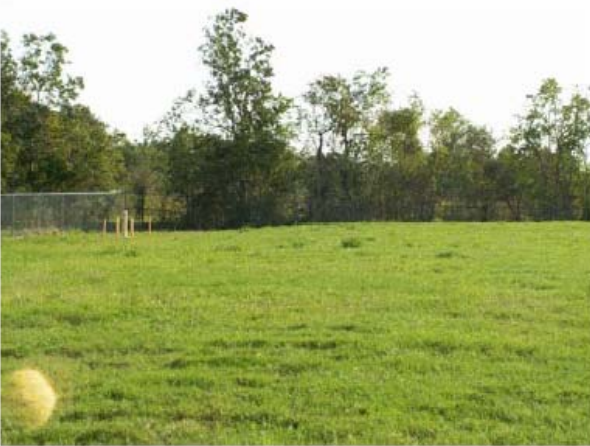
**File Name:** GSV\_photo5.JPG  
**Date/Time Taken:** 01 Oct 2005 1642  
**Description:** Monitoring well D-7R and site boundary, view to southwest.  
N29°57'28.1"; W92°11'11.4"

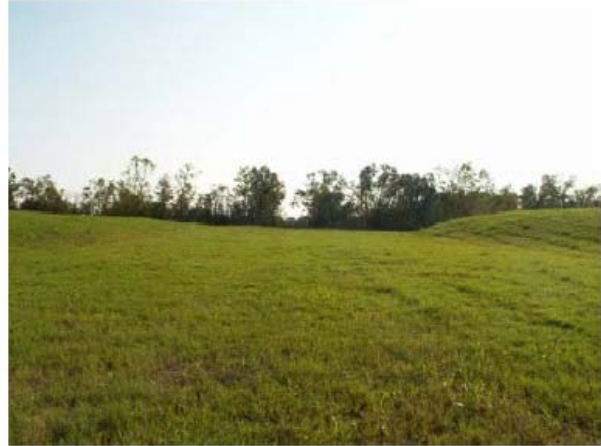
**File Name:** GSV\_photo6.JPG  
**Date/Time Taken:** 01 Oct 2005 1649  
**Description:** Low area between eastern and western caps, view to south.  
N29°57'29.3"; W92°11'11.6"

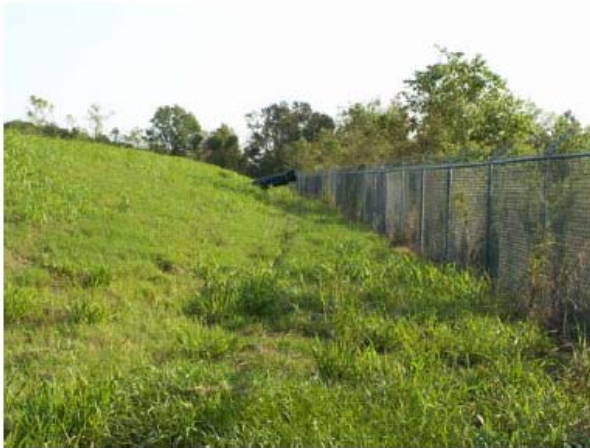
**File Name:** GSV\_photo7.JPG  
**Date/Time Taken:** 01 Oct 2005 1652  
**Description:** View to south along western fence and site boundary, showing intact sumps on side of cap.  
N29°57'31.9"; W92°11'14.1"

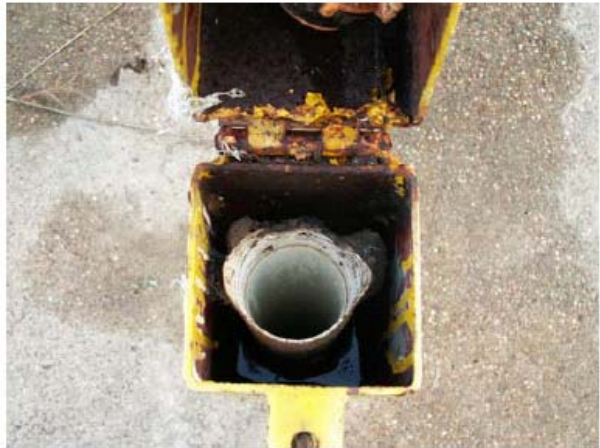
**File Name:** GSV\_photo8.JPG  
**Date/Time Taken:** 01 Oct 2005 1733  
**Description:** Warped top of riser pipe, well D-3R.  
N29°57'26.2"; W92°11'13.1"

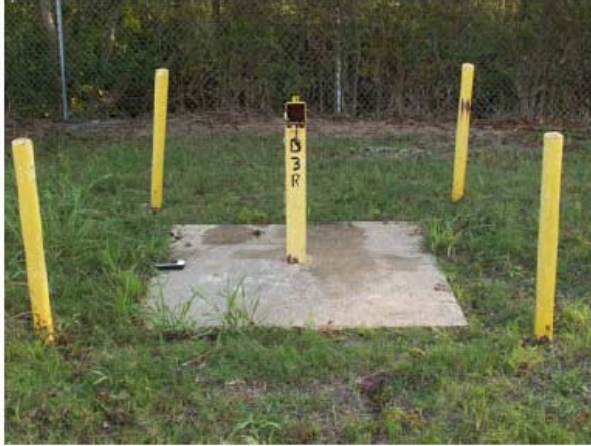
**File Name:** GSV\_photo9.JPG  
**Date/Time Taken:** 01 Oct 2005 1634  
**Description:** View to south of well D-3R (location for sample GCV001).  
N29°57'26.2"; W92°11'13.1"

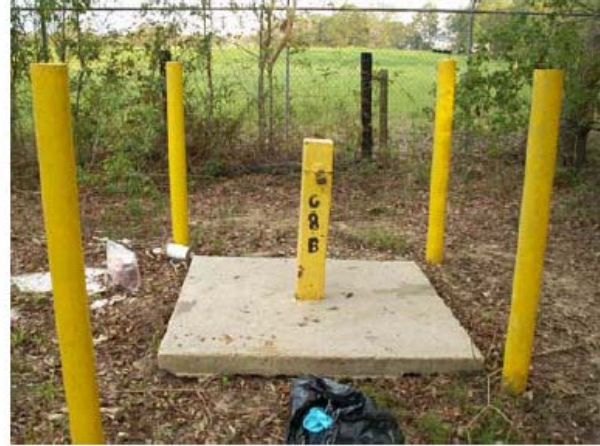
**File Name:** GSV\_photo10\_WellPad\_G-8D-3.JPG  
**Date/Time Taken:** 01 Oct 2005 1730  
**Description:** Well G-8B (location for sample GCV002).  
N29°57'26.8"; W92°11'14.4"

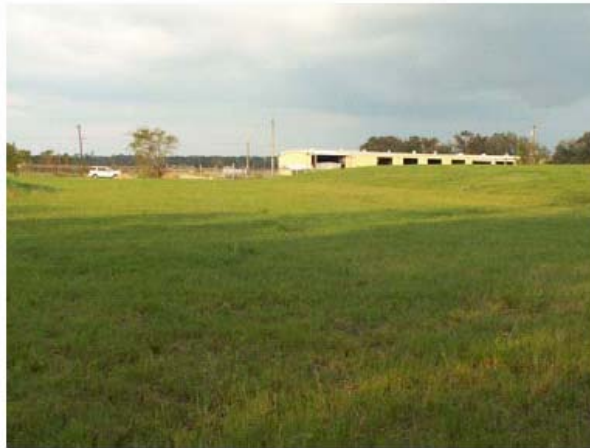
**File Name:** GSV\_photo10\_NorthView.JPG  
**Date/Time Taken:** 01 Oct 2005 1757  
**Description:** View to north of western and eastern caps, showing no apparent storm impact.  
N29°57'26.6"; W92°11'14.0"
