Health Consultation

CEDAR SERVICE SITE

CITY OF MINNEAPOLIS, HENNEPIN COUNTY, MINNESOTA

MAY 22, 2006

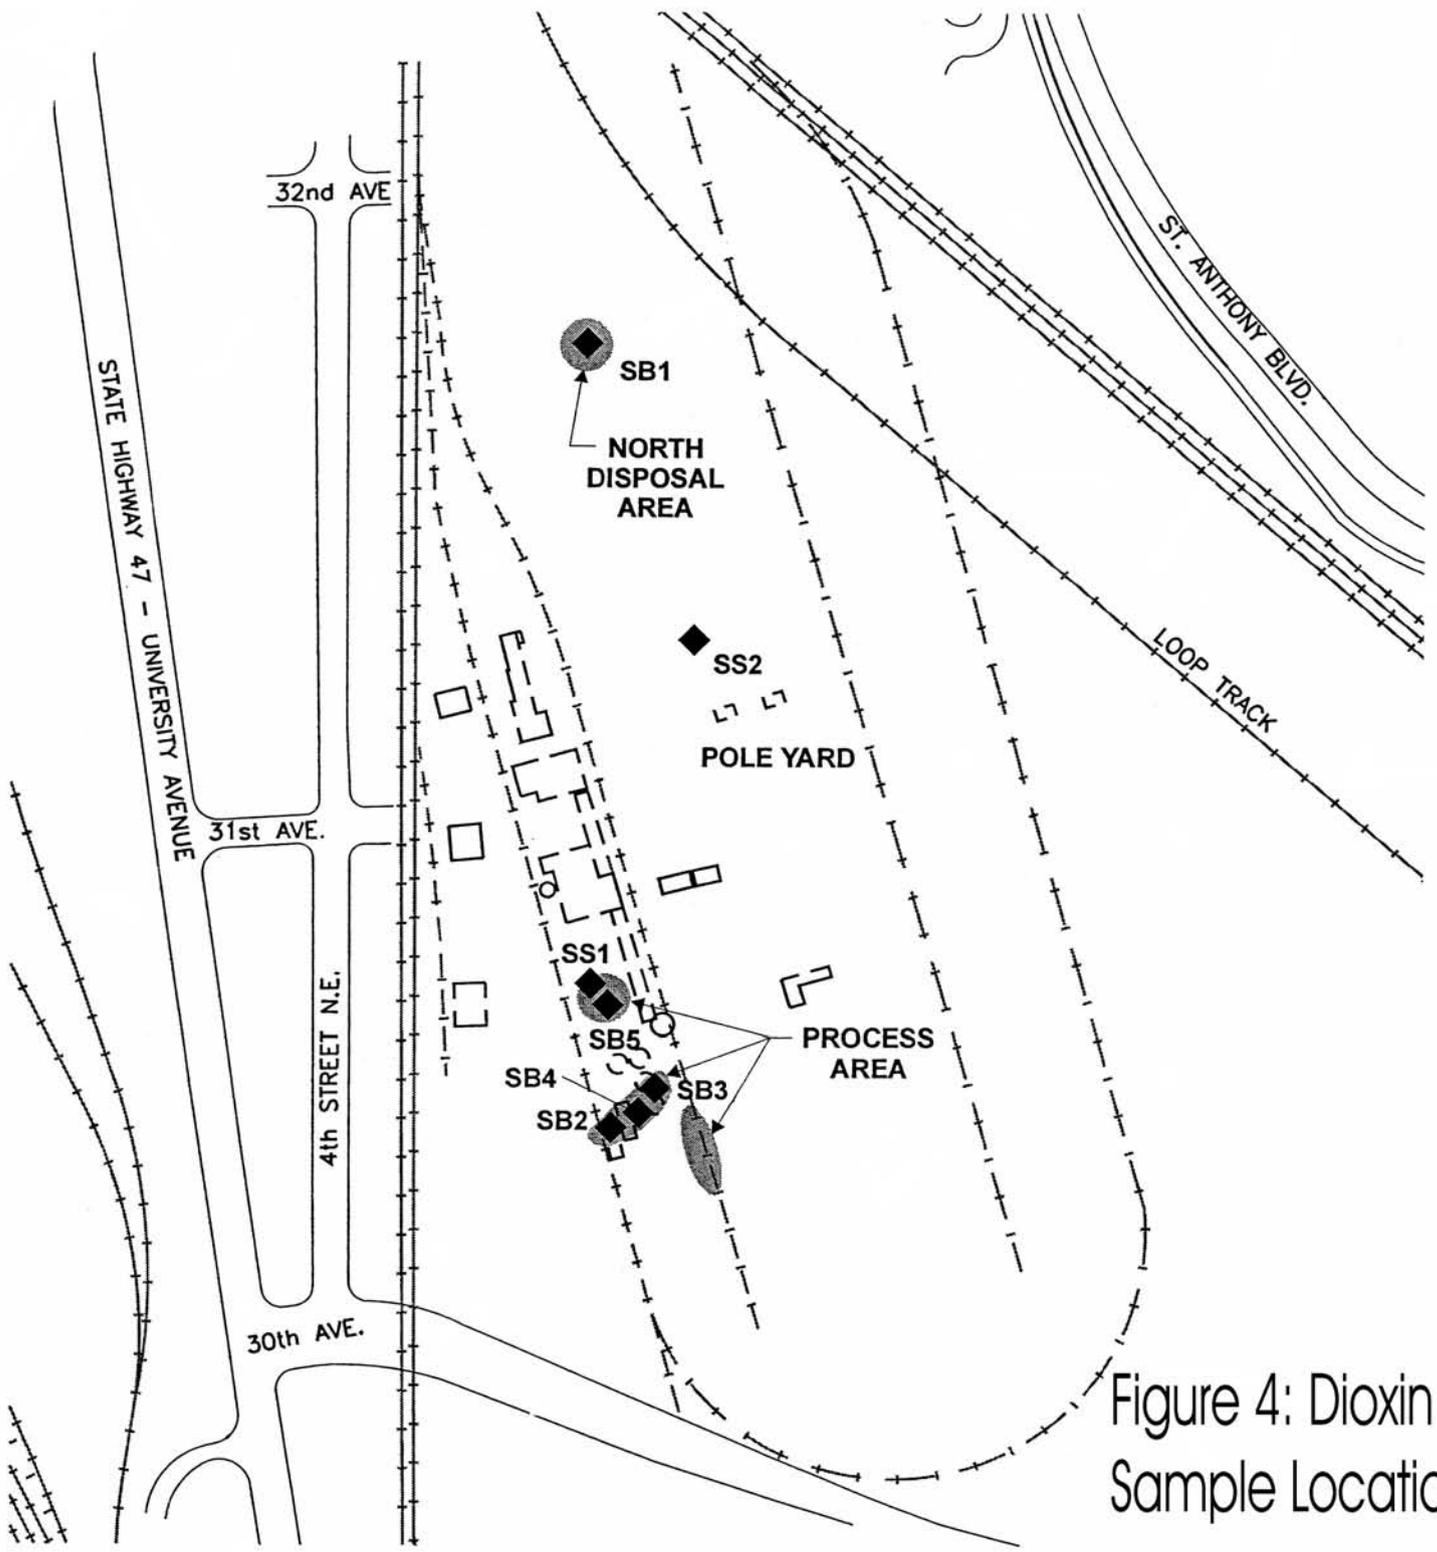
Figure 4: Dioxin Soil Sample Locations

- ++ Historical Railroad
 - + Railroad
 - ⌚ Historical Structure
 - Structure
 - PCP Concentrations >150 mg/kg (0-12 ft depth)
 - ◆ Soil Sample Locations
- Source: Barr 1997

In 1997, Soo Line proposed a Corrective Action Plan (CAP) to address the soil contamination at the site (Barr 1997). Prior to implementing the CAP, surface soil samples were collected from two locations at the site and five soil borings were advanced to collect sub-surface soil samples to further characterize soil contamination. Samples collected from the soil borings were screened (visually and using field instruments) for the presence of PCP and oil contamination, and the two surface soil samples and two sub-surface soil samples thought to be most contaminated were analyzed in a laboratory for dioxins and furans, which are known contaminants of PCP (see below). One subsurface sample was collected from soil boring SB-1 at a depth of 10.6 to 12 feet. This samples was designated sample SB-1-6, and had a strong odor and heavy oil sheen. The other subsurface sample (designated SB-5-C) was a composite of multiple samples from soil borings SB-3, SB-4, and SB-5 that appeared the most heavily contaminated, and no to weak odor, and only a trace of oil sheen. The surface soil sample and soil borings locations are shown in Figure 4.

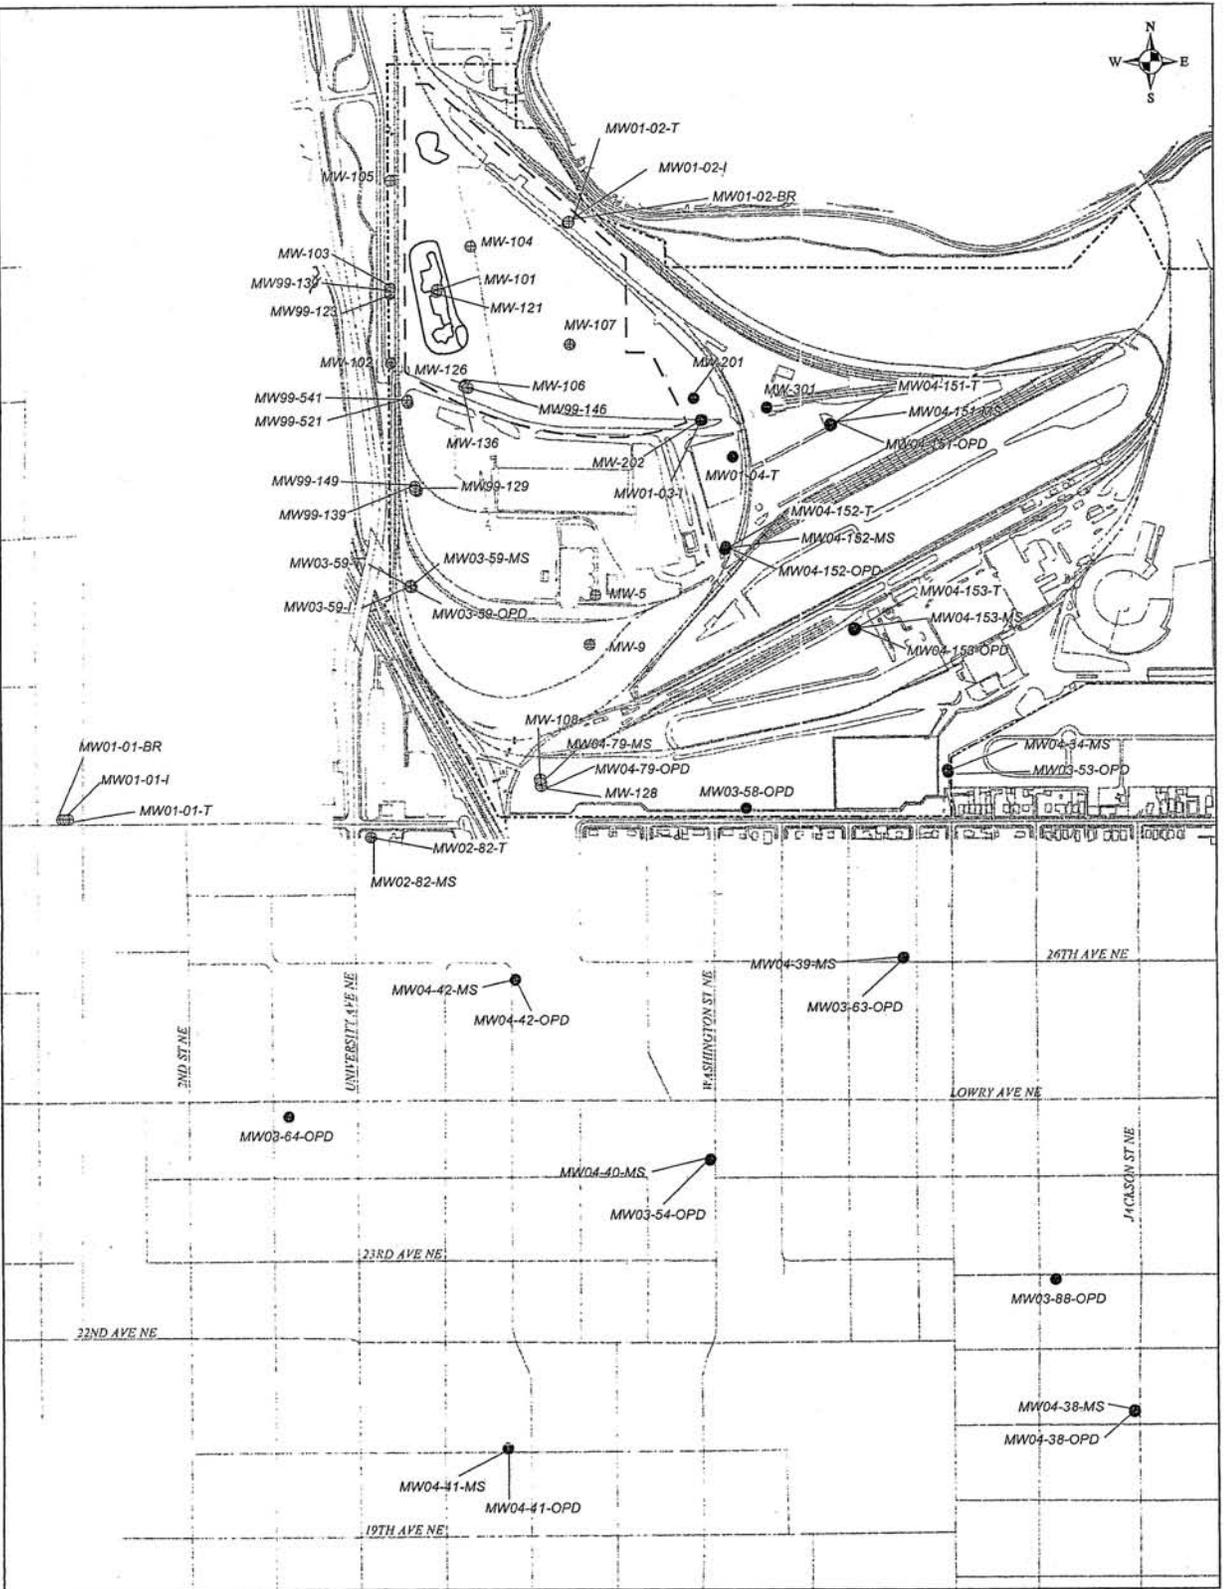
- ⊕ MW99-133 Monitoring Well (Cedar Service)
- MW03-63-OPD Monitoring Well (Non-Cedar Service)
- Area of Prior Excavation
- - - Approximate Site Boundary
- Facility Boundary

Since site investigation activities began, numerous monitoring wells have been installed on and off the site to evaluate groundwater conditions. These include monitoring wells installed at the Cedar Service site, on the adjacent Dworsky Barrel site, and elsewhere on the Soo Line Shoreham Yards property. Five monitoring wells were originally installed by Barr in 1995 to evaluate groundwater quality (Barr 1996). PCP was detected at a concentration of 8,400 micrograms per liter ($\mu\text{g/L}$) in MW-101, which was installed in the former process area. PCP was found at very low levels in two other monitoring wells. Total PAHs were reported at a concentration of 6,200 $\mu\text{g/L}$ in MW-101, and were below detection limits in the other four wells. Low levels of several petroleum-related VOCs were also found in MW-101, but not in any of the other monitoring wells. The locations of all monitoring wells at and near the site can be found in Figure 6.

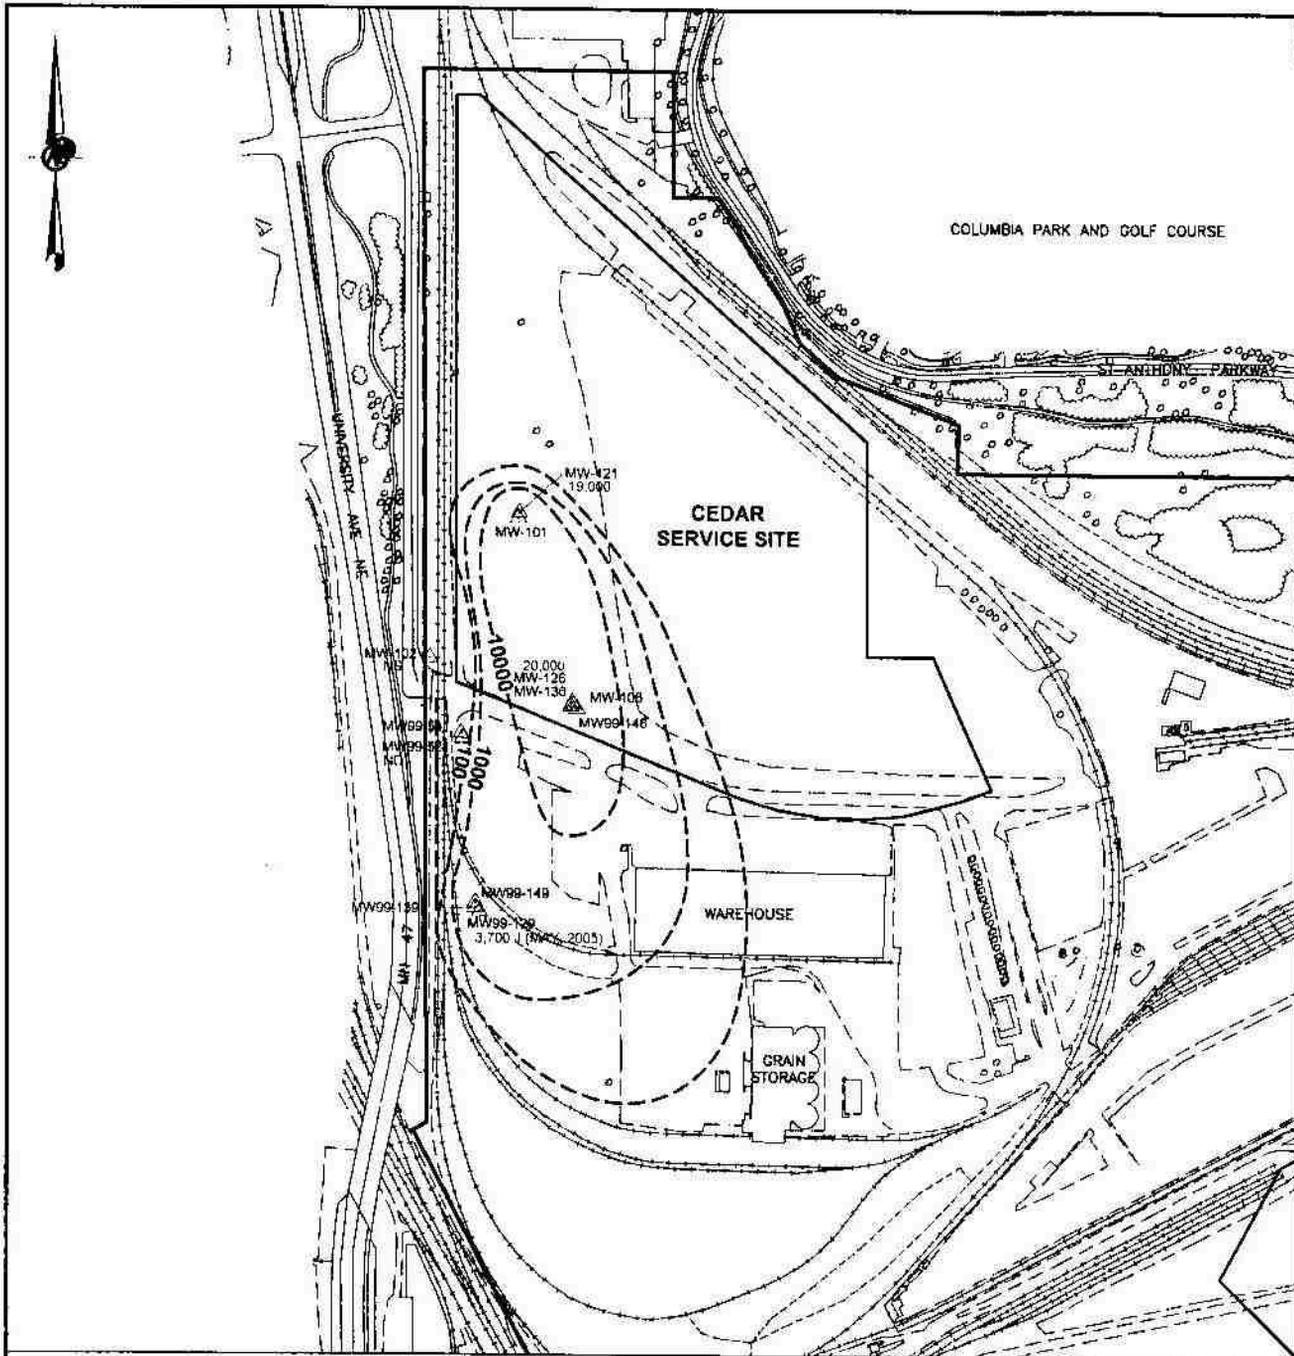
PROJECT NOVEMBER PCP ISOCONCENTRATION CONTOURS: OVERBURDEN 760-800 FT MSL	TITLE NOVEMBER PCP ISOCONCENTRATION CONTOURS: OVERBURDEN 760-800 FT MSL	PROJECT 500 LINE SHOREHAM FACILITY CEDAR SERVICE 2005 GROUNDWATER MONITORING REPORT MINNEAPOLIS, MINNESOTA	<p>Golder Associates Philadelphia USA</p>
PRODUCED BY: J. J. SHAW, P.E. FILE NO.: 023-8103 REV. 0: SHAW, AS SHOWN DESIGN: W. J. SHAW, P.E. CHECK: J. J. SHAW, P.E. DATE: 12/15/05 DRAWN: J. J. SHAW, P.E. DATE: 12/15/05

The PCP results have been roughly stratified and plotted by the depth of well completion, and are presented in Figures 8 and 9. In the unconsolidated sediment wells, the highest level of PCP observed (20,000 µg/L) was in MW-126, south of the former process area. The map shows concentrations of PCP in excess of 100 µg/L extending south of the Cedar Service site boundary; the full extent of the contamination is not shown.
