Health Consultation

TOWN AND COUNTRY CLEANERS

NASHVILLE, DAVIDSON COUNTY, TENNESSEE

AUGUST 18, 2005

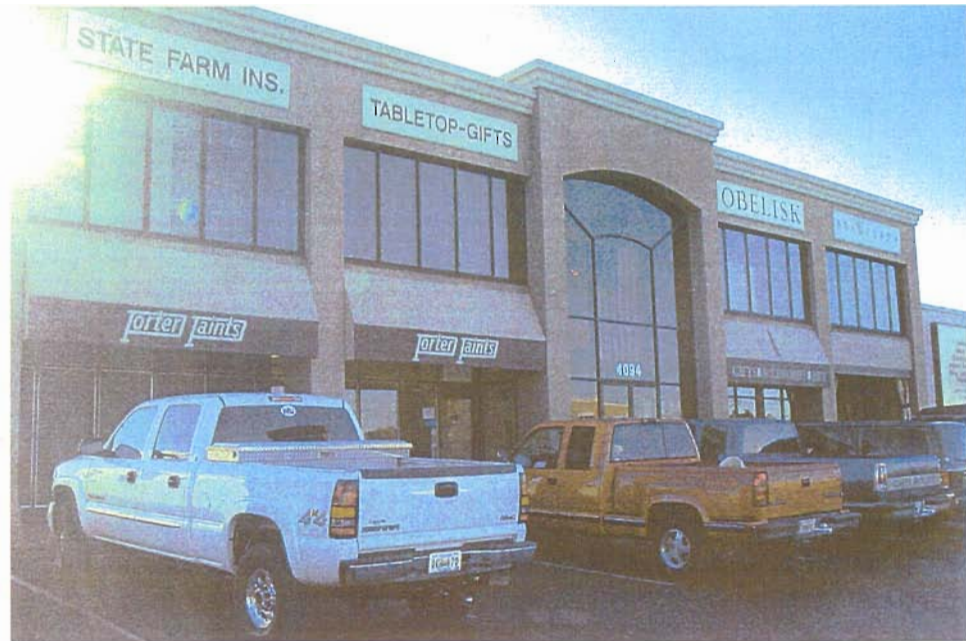
FIGURE 4 - Schematic Layout of the Town and Country Cleaners site and the adjacent properties and businesses. Also denoted on this drawing are the air (vapor) sampling locations within the Bradford Building (Station B, C, and D). (Drawing credit: ENSAFE Inc.)

On September 16, 2004, ENSAFE Inc., was authorized by DCERP, to collect indoor air samples utilizing standard SUMMA canisters. The canisters were placed in the Town and Country Cleaners site (Station A), and within the Bradford Building basement (Stations B & C).

Following the December 2004 sampling event, it was discovered that Town and Country Cleaners was operating as an active drycleaner under new management. Since PCE was being utilized inside the facility, the DCERP project manager determined that Station A would no longer be utilized as an indoor air sampling point. The indoor air samples that would have been collected at Station A were then assigned to a new sample point located in the basement of the Bradford Building. The new sampling point, designated as Station D, is located in the retail showroom area approximately 20 feet north of Station B (Figure 4).

On March 24, 2005, ENSAFE Inc. collected the third quarter indoor air samples. The SUMMA canisters were placed only within the Bradford Building basement at the designated indoor air sampling points (Stations B, C, & D). The DCERP project manager determined that Station A's previous indoor air sampling results from the cleaners should not be included in this document as this is an active drycleaner facility. Thus, the laboratory analytical data from the storage room sump water and indoor air samples collected from the Bradford Building basement will be the focus of this health document.

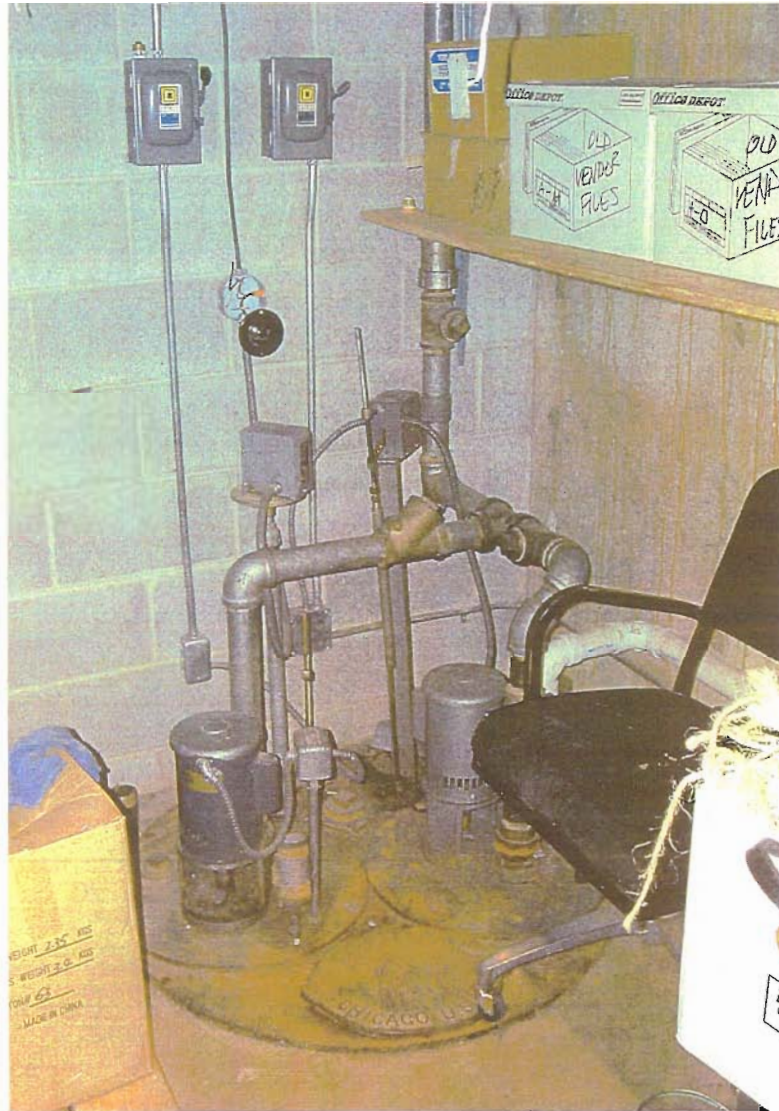
FIGURE 5 - The small enclosed storage space (air sampling Station B) within the Bradford Building where a sump pump is located. The groundwater samples were collected from this sump. (Photo credit: David Borowski, TDH, 12/20/04)

The Bradford Building had problems with water intrusion into the basement after its construction was completed. A drainage system was installed in the basement floor to intercept and direct the water into three sumps. The water collected in the sumps is then pumped to the sanitary sewer. The amount of water present in the sumps appears to vary with the seasons. DCERP documents report that only two of the three sumps have had sufficient levels of water to collect samples during scheduled environmental sampling events. The two sumps that could be sampled were both found to contain PCE and its break down products. The highest contaminant concentrations were detected in the samples obtained from the sump located in the small basement storage room (Figure 5).

Water samples have been collected from two of the Bradford Building's three sumps. Of the two sumps sampled, the water in the storage room sump was found to contain higher concentrations of drycleaner solvent and its breakdown products. This sump is located on the west side of the building and corresponds to Station B as shown in Figure 4. The storage room is approximately 6 feet by 8 feet wide and 9 feet in height. The sump is in the southwest corner of the storage room and is approximately 4 feet in diameter and 5 feet in depth (Figure 5).
