NATIONAL REGISTER OF HISTORIC PLACES

4 Name of Property
1. Name of Property
historic name OCOEE CHRISTIAN CHURCH
other names/site number/8OR8130
2. Location
street & number 15 South Bluford Avenue N/A not for publication
city or town Ocoee N/A vicinity
state FLORIDA code FL county Orange code 095 zip code 34761

Section number	7	Page	1	OCOEE CHRISTIAN CHURCH
			*************************************	Ocoee, Orange County, Florida

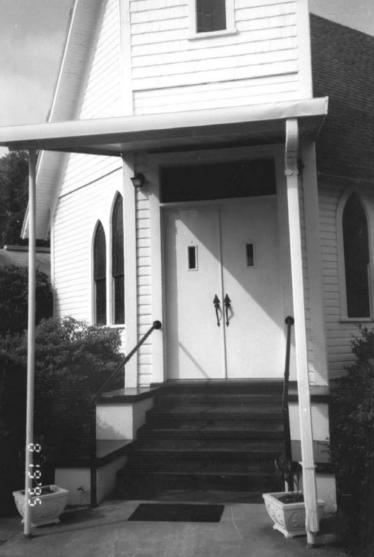
OCDEE CHRISTIAN CHURCH ORANGI Coming FireLLA 2 OF 14

- 6. Main entrance, camera facing southwest.
- 7. #2 of 14
- 6. North elevation, transept, camera facing south.
- 7. #3 of 14
- 6. East elevation, vestibule exterior wall, camera facing west.
- 7. #4 of 14
- 6. West elevation (rear), camera facing southeast.
- 7. #5 of 14
- 6. Covered walkway, education/fellowship hall, camera facing south.
- 7. #6 of 14
- South elevation, camera facing northwest.
- 7. #7 of 14
- 6. View of roof and steeple, camera facing south.
- 7. #8 of 14
- 6. Interior view of center aisle, stained glass, camera facing east.
- 7. #9 of 14

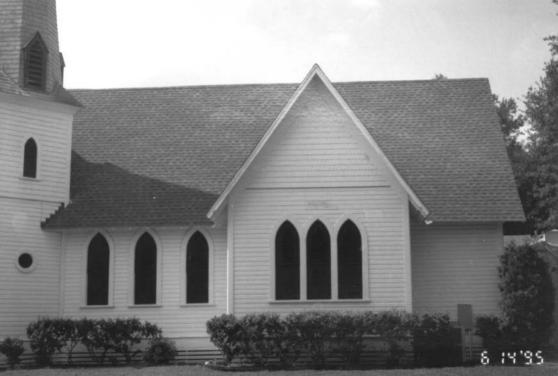
3 OF 14

The north elevation has six stained glass, lancet windows in groups of three (Photo 3). The first group is on the side of the nave and set wide apart. The next set is on the side of the transept and grouped close together. The transept has a steeply pitched gable roof.

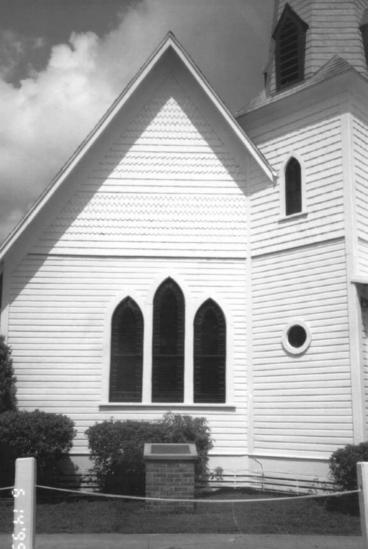
OCOEE CHRISTIAN CHURCH ORANGE COUNTY FLORIDA 4 OF 14

The east (front) elevation has three closely set lancet windows, like those on each side of the transept except that the center window is taller (Photo 4). The vestibule is canted at the northeast corner of the main block. It has small, round windows on each side.

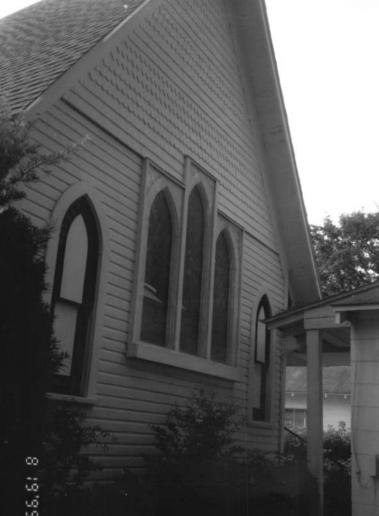
OCOEE CHRISTIAN CHURCH ORANGE COUNTY FLORITA 5 OF 14

The west (rear) elevation has an original tripartite window flanked by single, 1/1, lancet, sashed windows (Photo 5). Also, the west elevation is separated from the educational/fellowship hall by a covered walkway (Photo 6). The south elevation is similar to the north elevation except it has an entrance to the chancel at the southwest corner (Photo 7).

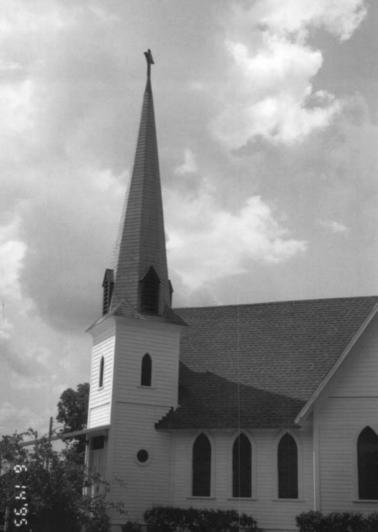
8 OF 14

The roof is believed to have been originally covered with wood shingles. Now the roof over the sanctuary has fiberglass architectural shingles and the steeple is asbestos covered, with copper louvers topped with a rebuilt Celtic cross (Photo 8).

The Ocoee Christian Church today is very much as it was when built in 1891. It has been very well maintained. Most of the windows in the sanctuary are the original stained glass, with the exception of panes that had to be replaced. The impressive church spire with a rebuilt Celtic cross rises high above the vestibule. The original cast-iron church bell still welcomes parishioners to worship. The church is the earliest religious structure in Ocoee and the finest example of Carpenter-style architecture in town.

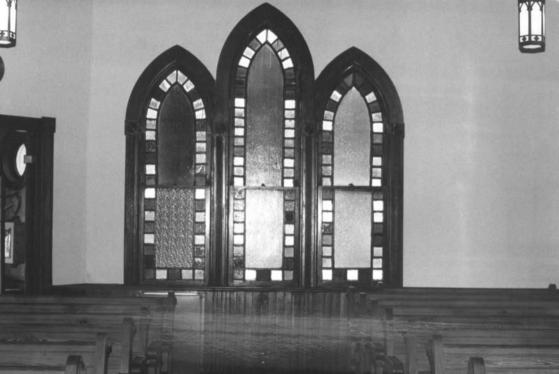
OCOEE CHRISTIAN CHURCH ORANGE COUNTY FLORIDA 9 OF 14

With the exception of some changes to the chancel, this building has retained its original integrity. A small, copper edged lamp hangs from the ceiling inside the vestibule where an original communion service is displayed. Inside the main sanctuary, the nave has a center aisle (Photo 9). The church contains an exposed roof truss system which features a scissors truss and hammered beams. The vaulted ceiling, floors, door surrounds, chancel furnishings, and pews are all made of pine. The walls are plastered and painted, and have wainscoting. All the windows in the nave and transepts, with the exception of a few replaced panes, are the original stained glass (Photo 10). The lancet windows throughout the sanctuary are filled with Queen Anne style wooden sashes containing colored glass. The tripartite lancet window over the altar contains symbolic, leaded stained glass which include pressed glass "jewels". The baptistry, designed for total immersion, is located beneath the chancel.

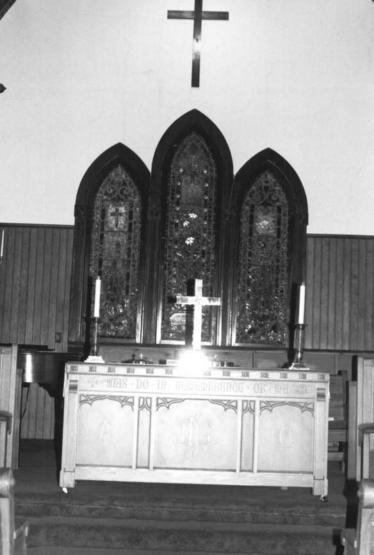
OCOEE CHRISTIAN CHURCH ORANGE COUNTY, FLORIDA 10 OF 14

- 6. Interior view of altar, stained glass, camera facing west.
- 7. #10 of 14
- Non-contributing education/fellowship hall, camera facing northwest.
- 7. #11 of 14
- 6. Non-contributing education/fellowship hall, camera facing west.
- 7. #12 of 14
- 6. Front of education/fellowship hall, facing Bluford Avenue, camera facing west.
- 7. #13 of 14
- 6. Storage shed, north end of Fellowship Hall, camera facing southwest.
- 7. #14 of 14

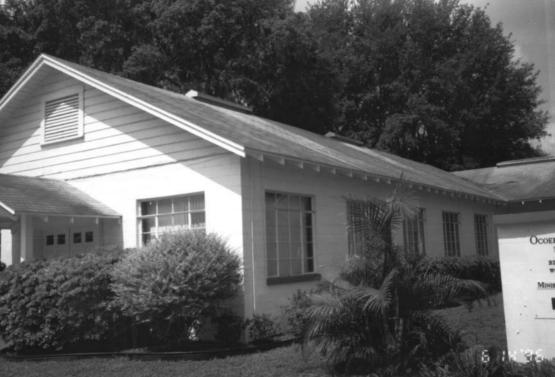
11 OF 14

The adjacent educational/fellowship hall was added in two phases: first, an educational building was added in 1947 (Photo 11); ten years later, another addition was made to provide a fellowship hall and a kitchen (Photo 12). It is not attached to the original church, but can be reached from the church building via a covered walkway. The front of the educational/fellowship hall, like the church, faces Bluford Avenue (Photo 13). The hall is a

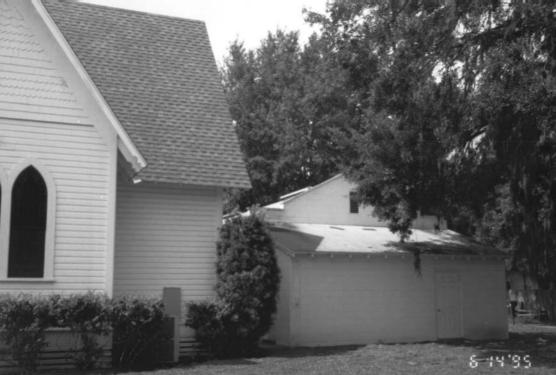
OCOEE CHRISTIAN CHURCH ORANGE COUNTY FLORIDA 14 OF 14

concrete block, single-story, structure which includes a large meeting room with an attached kitchen, the rector's study, classrooms for Sunday School groups, and a storage shed attached to the north end (Photo 14).
