Watershed Science Institute

## A Reflection on the Johnson Creek Watershed Water Quality Improvement Project 1982–1999

by **Stefanie Aschmann** NRCS, Watershed Science Institute

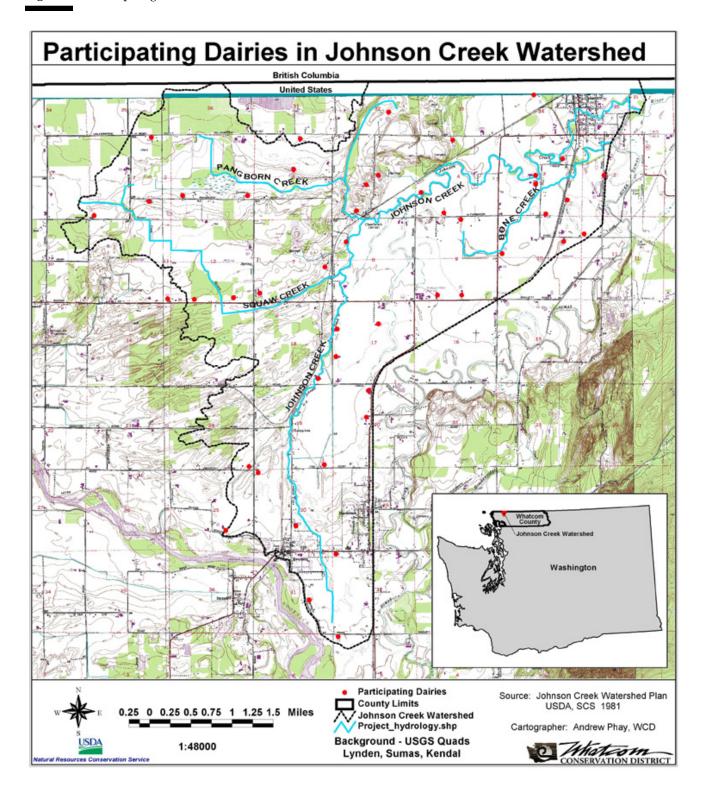
Johnson Creek Watershed occupies about 21 square miles (13,450 acres) in the north-central portion of Whatcom County, Washington. This county is in the northwest corner of the state and abuts the U.S.-Canadian border. Johnson Creek drains into the Sumas River and occupies about 40 percent of the Sumas drainage area. Three principle tributaries, Squaw Creek, Pangborn Creek, and Sumas Creek, drain uplands along the western and northwestern

The Johnson Creek Watershed is a 13,450-acre watershed dominated by dairy operations in north central Whatcom County, Washington (fig. 1). In 1982, a PL-566 watershed restoration project was initiated to improve water quality to meet State Class A stream standards in Johnson Creek, thereby improving 11 miles of coho salmon and cutthroat trout fish habitat. Before the PL-566 project was initiated, the Whatcom County Conservation District and Consolidated Drainage District No. 313 had already begun rehabilitating the 11 miles of stream corridor. They were working under the guidance of the U.S. Fish and Wildlife Service, Washington State Department of Fish and Game, and the Soil Conservation Service (now the Natural Resources Conservation Service). Rehabilitation consisted of:
