**Subject: Submittal of the Investigation Work Plan and the Historical Investigation Report for Upper Sandia Canyon Aggregate Area**

- Enclosures: 1) Two hard copies with electronic files - Investigation Work Plan for Upper Sandia Canyon Aggregate Area (EP2008-0139)  
2) Two hard copies with electronic files - Historical Investigation Report for Upper Sandia Canyon Aggregate Area (EP2008-0140)

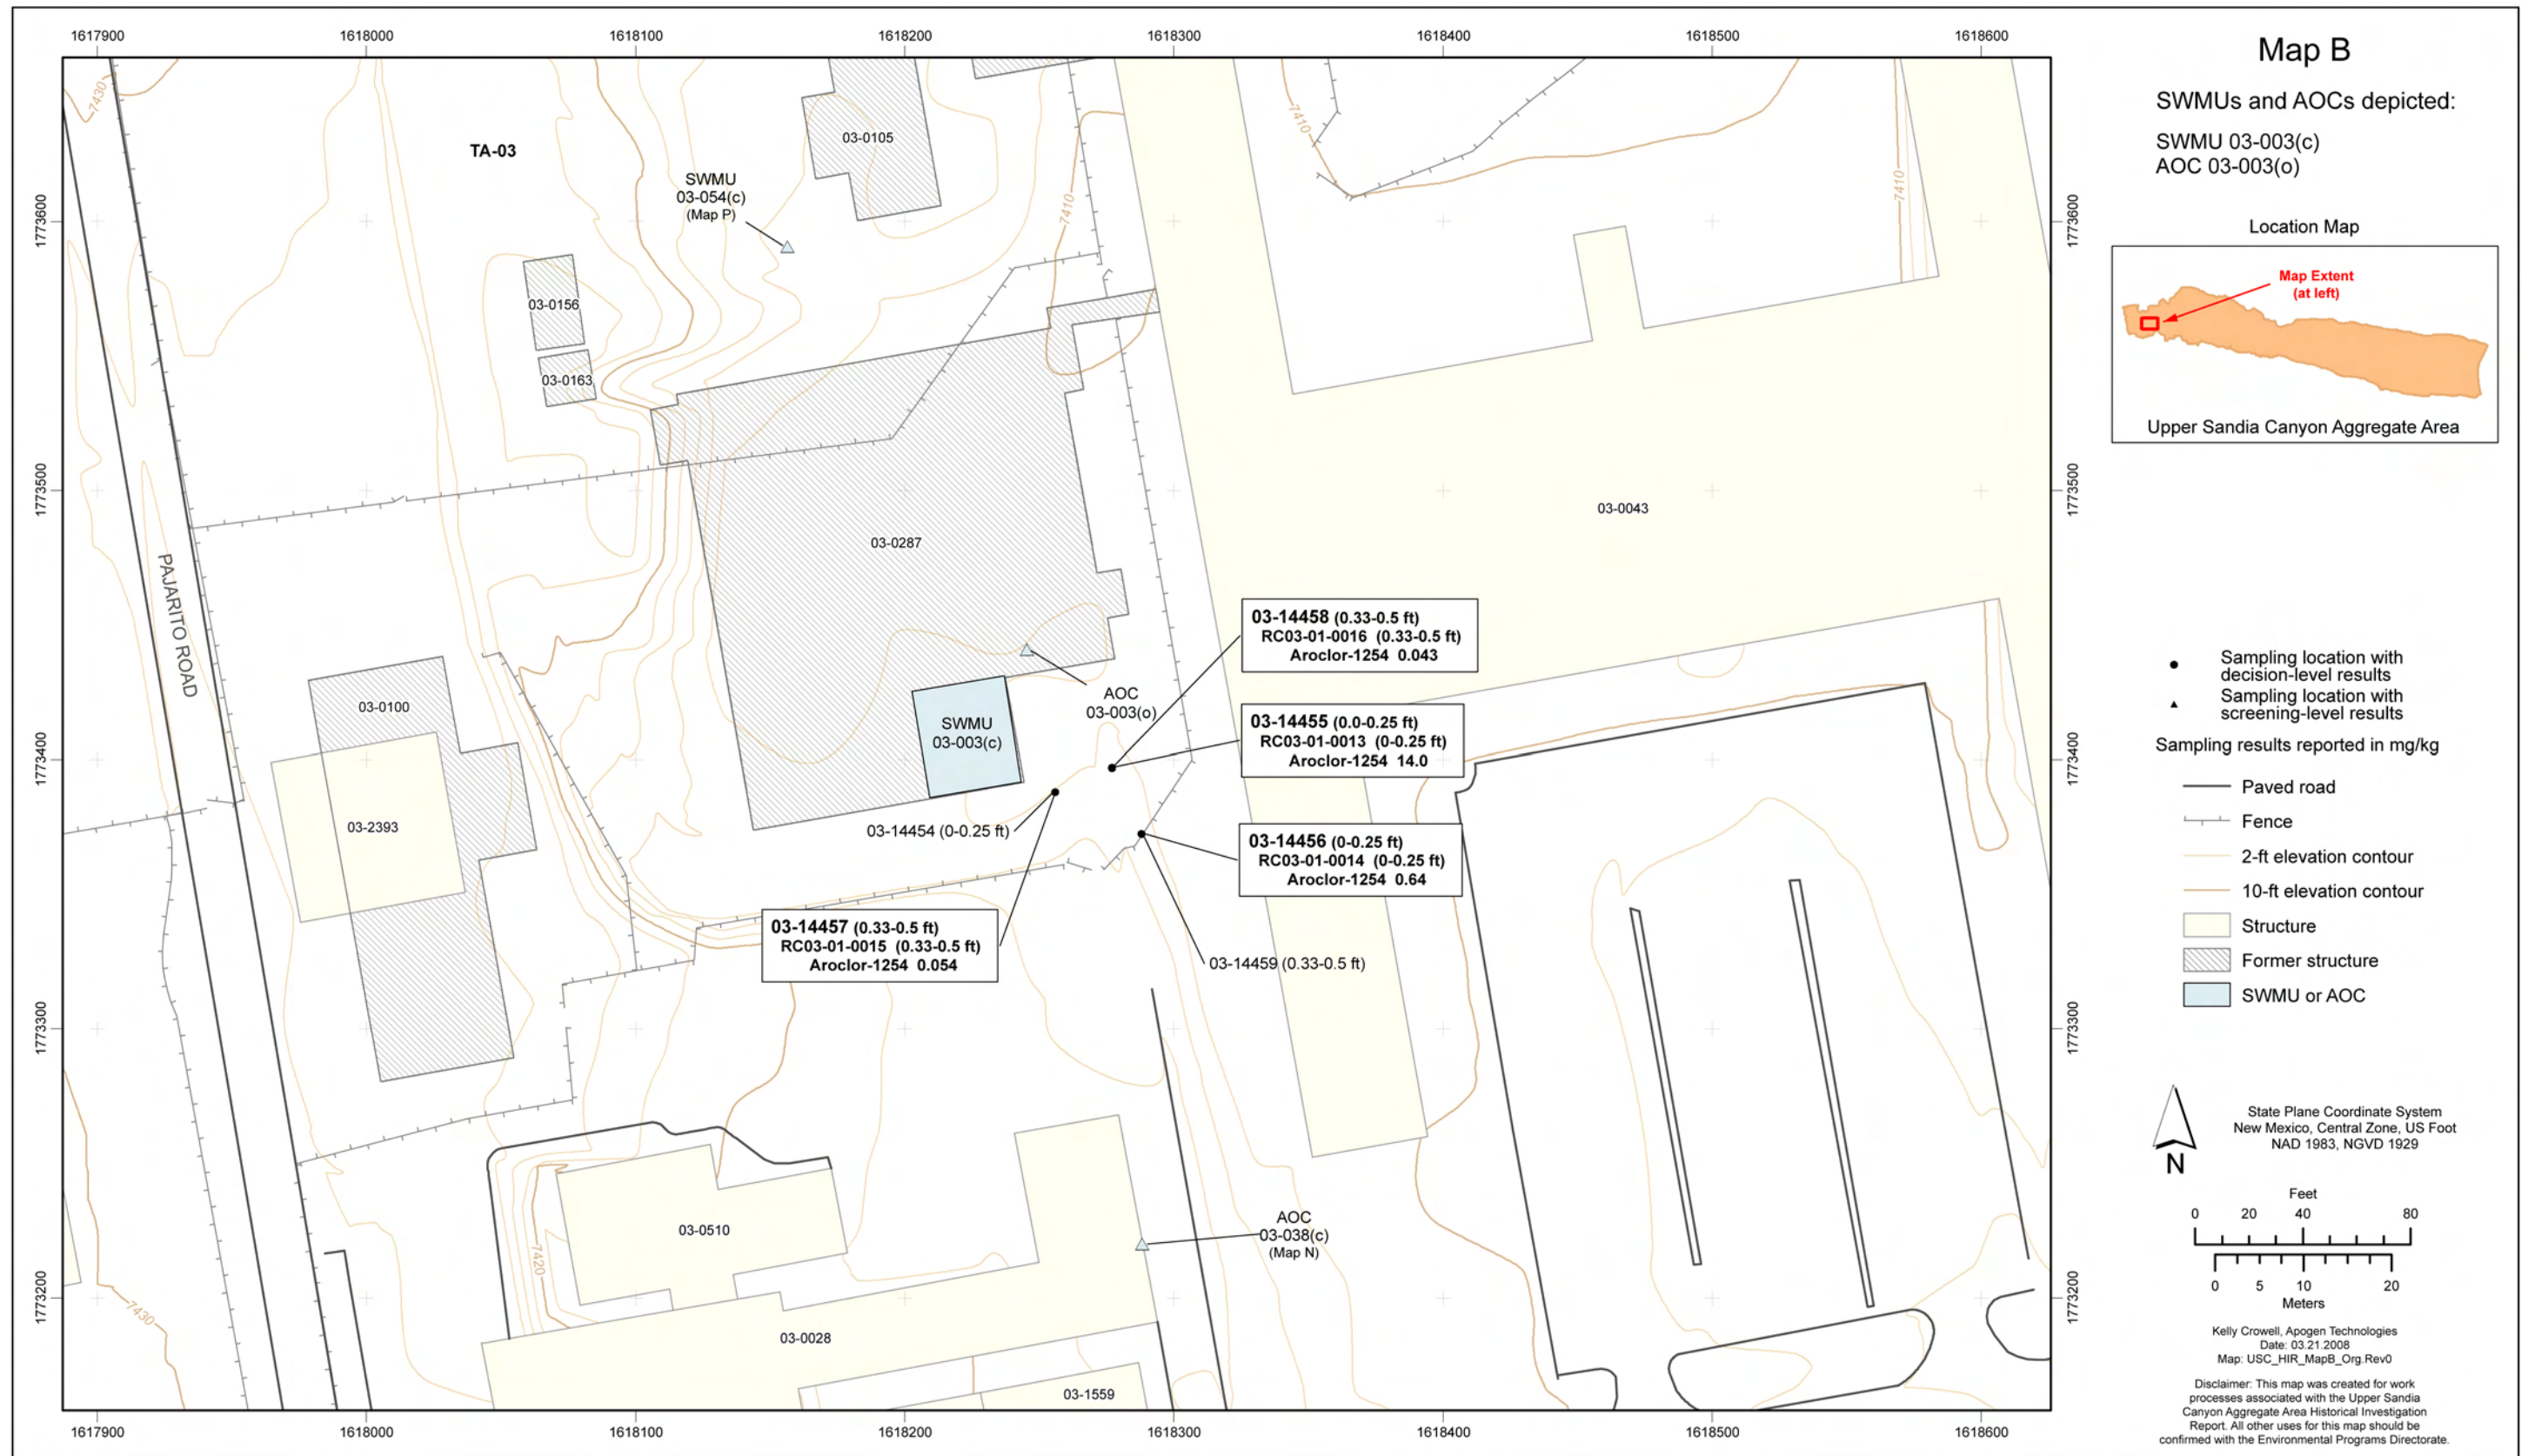
Figure 2.2-2 Map B organic chemical sampling locations and detected results

Data are of decision-level quality and are presented in Tables 2.0-6 and 2.0-9. Sampling locations and detected results are shown on Figure 2.2-2. Aroclor-1254 was detected in two fill samples and two asphalt samples.

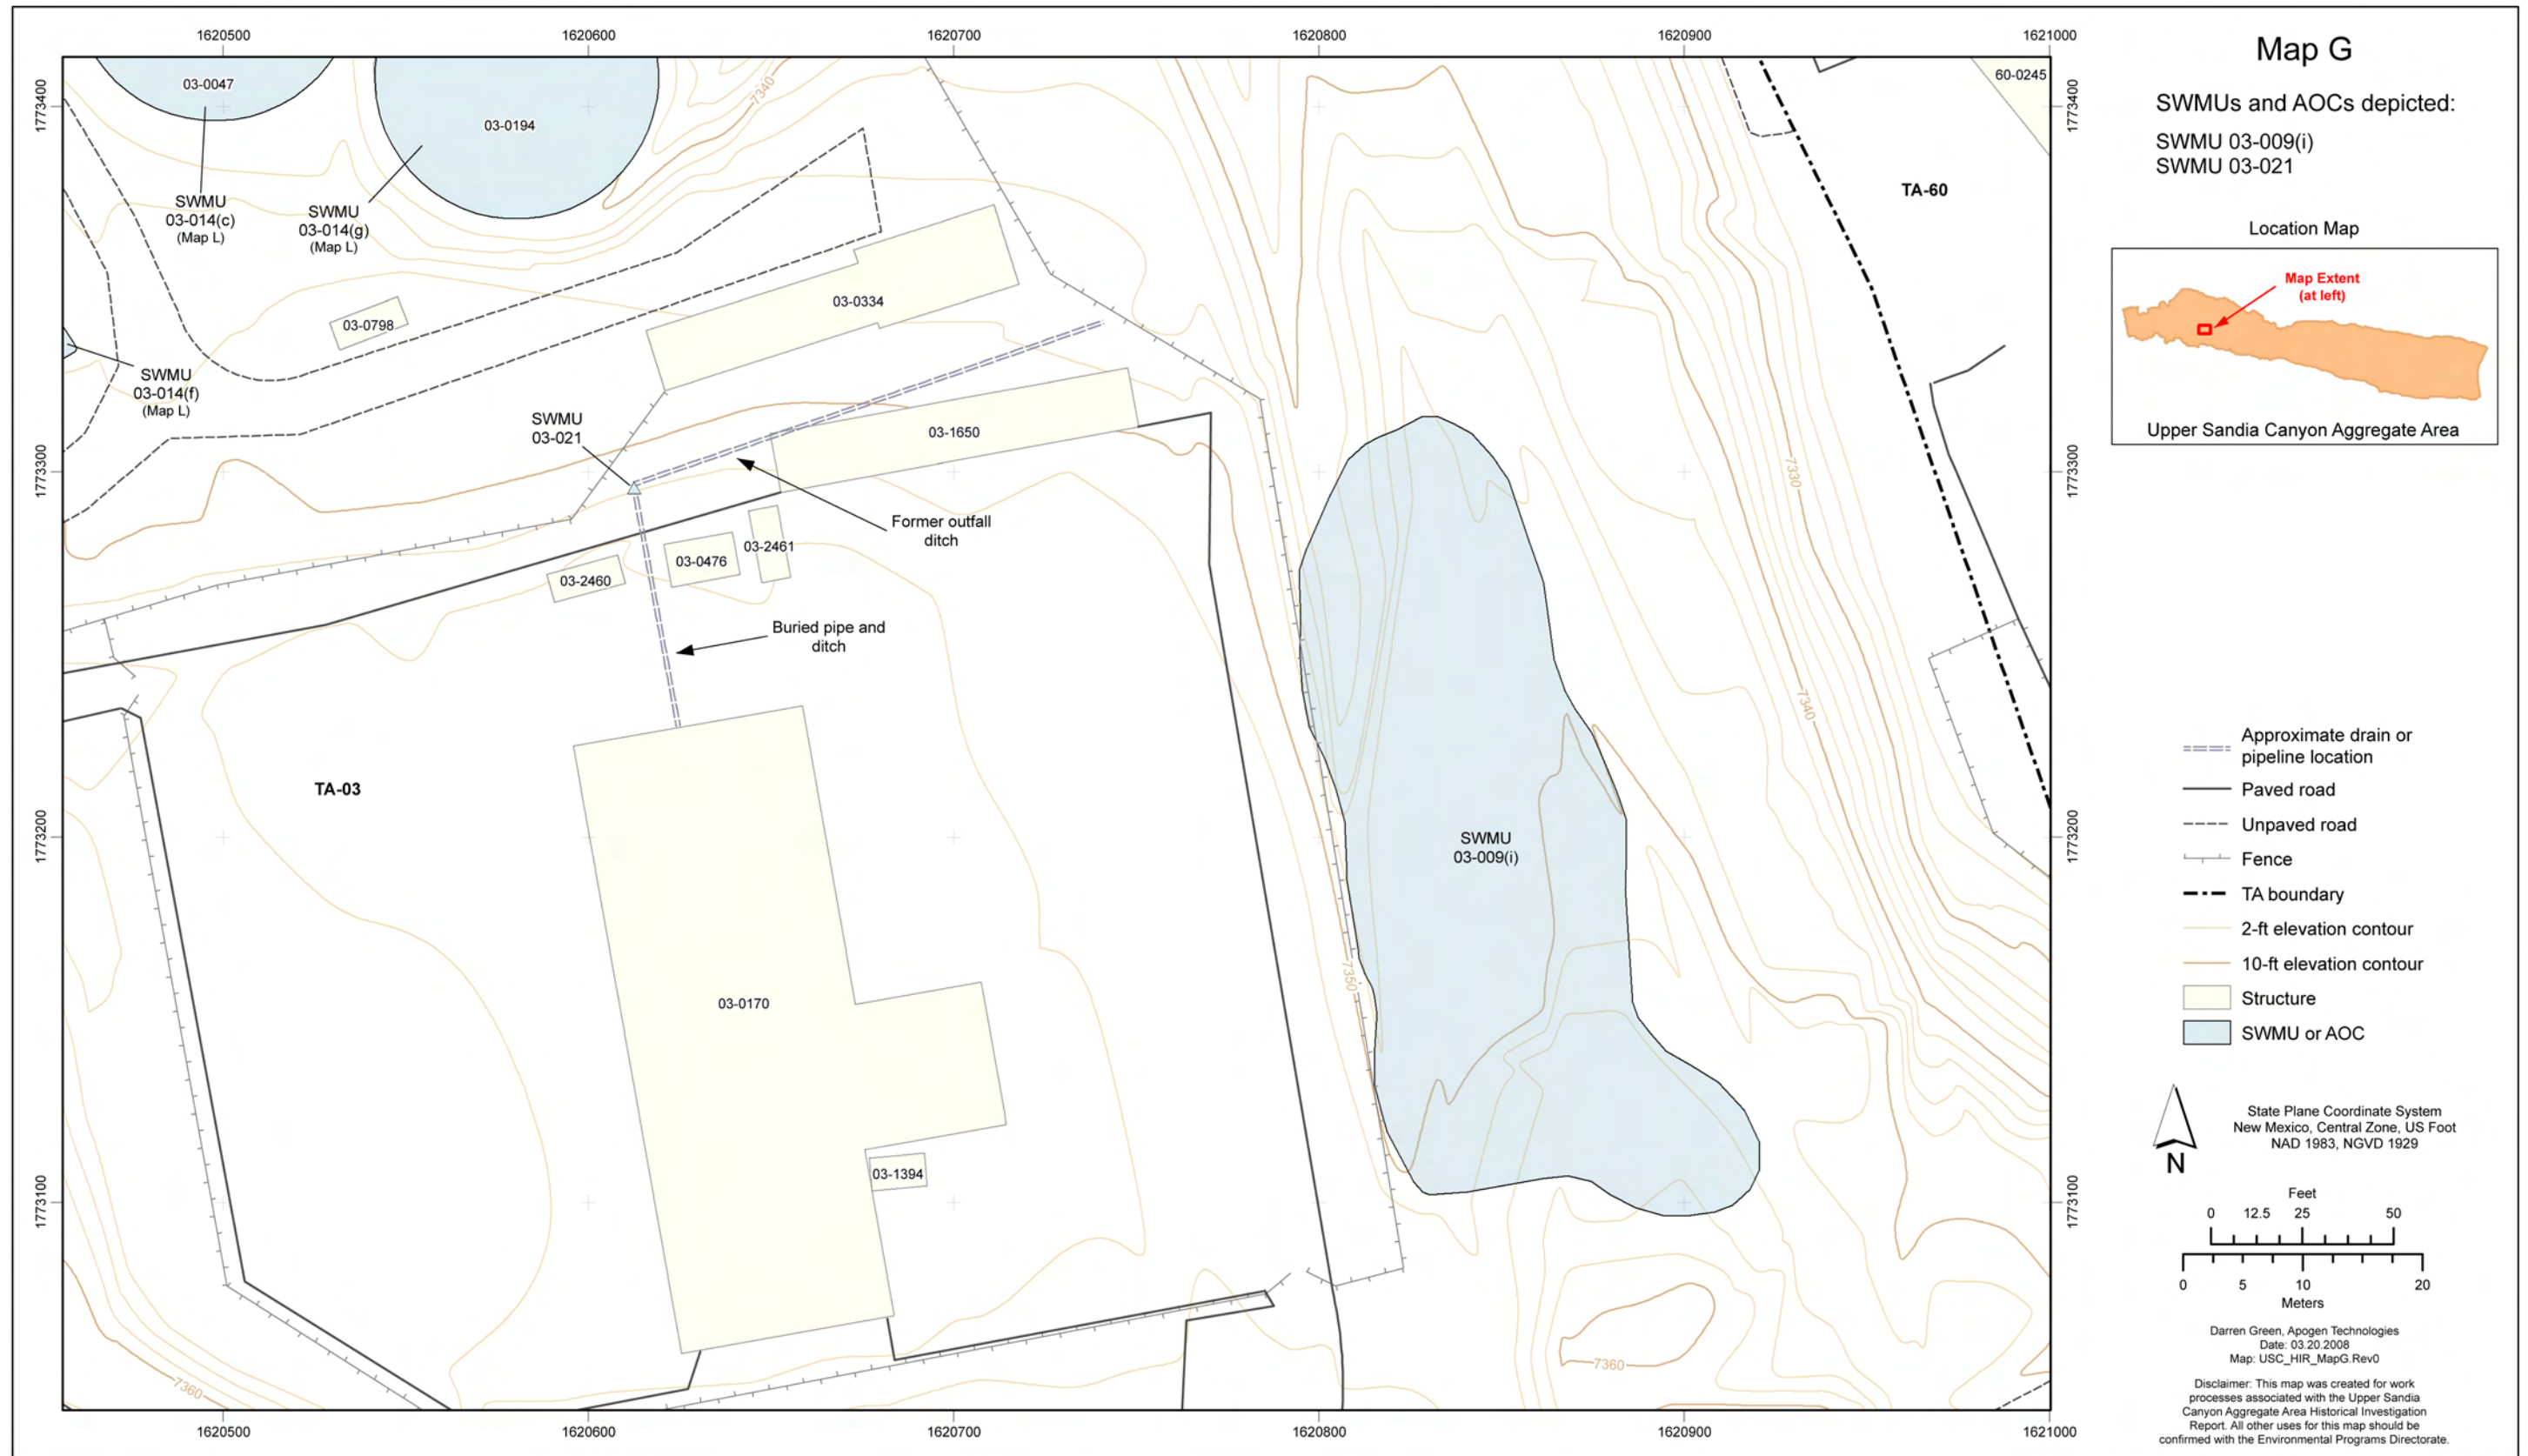
Figure 2.8-1 Map G site location

SWMU 03-009(i) is an inactive construction debris surface disposal site located east of the liquid and compressed gas facility (building 03-0170) (Figure 2.8-1). Construction debris at the site consists of crushed tuff, pieces of concrete, rock, and piles of fill. Use of this surface disposal site was discontinued in 1980 (LANL 1995, 057590, p. 6-4).

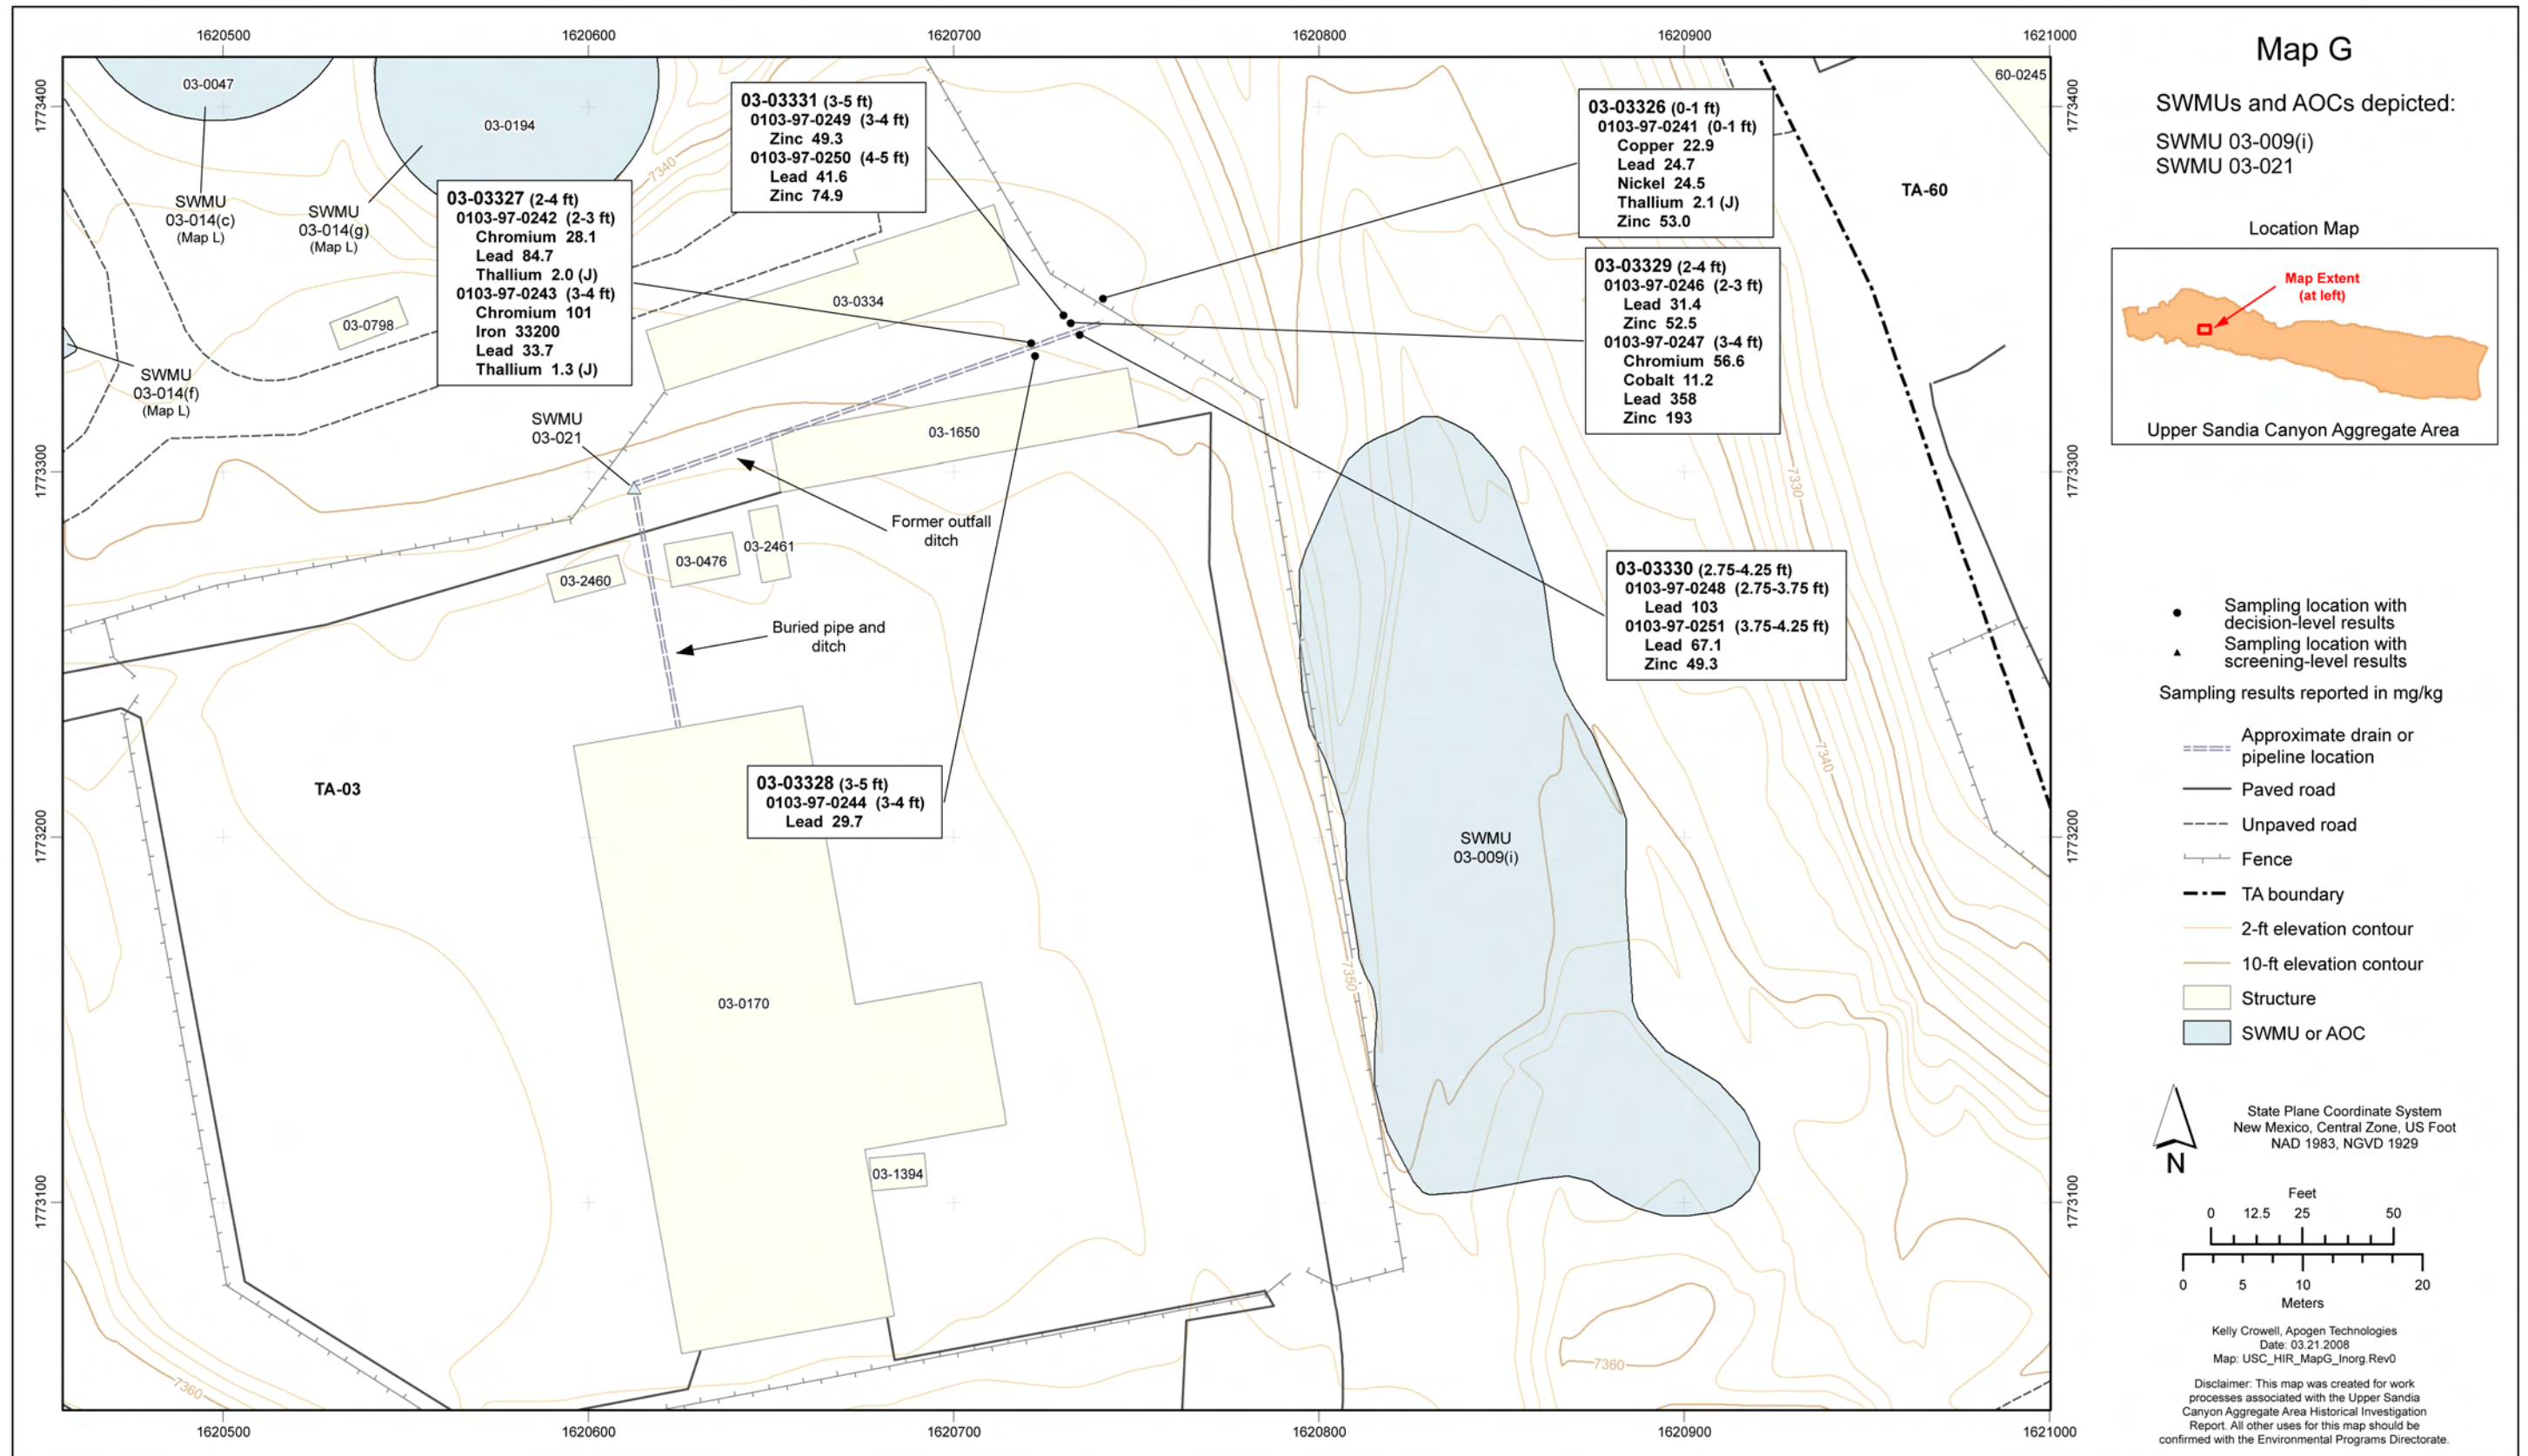
Figure 2.8-2 Map G inorganic chemical sampling locations and results detected above BVs

Samples have not been collected at this SWMU. Although there is no data specific to this SWMU, the location of the SWMU in relation to other sampling locations and detected results is shown on Figures 2.8-2 and 2.8-3.

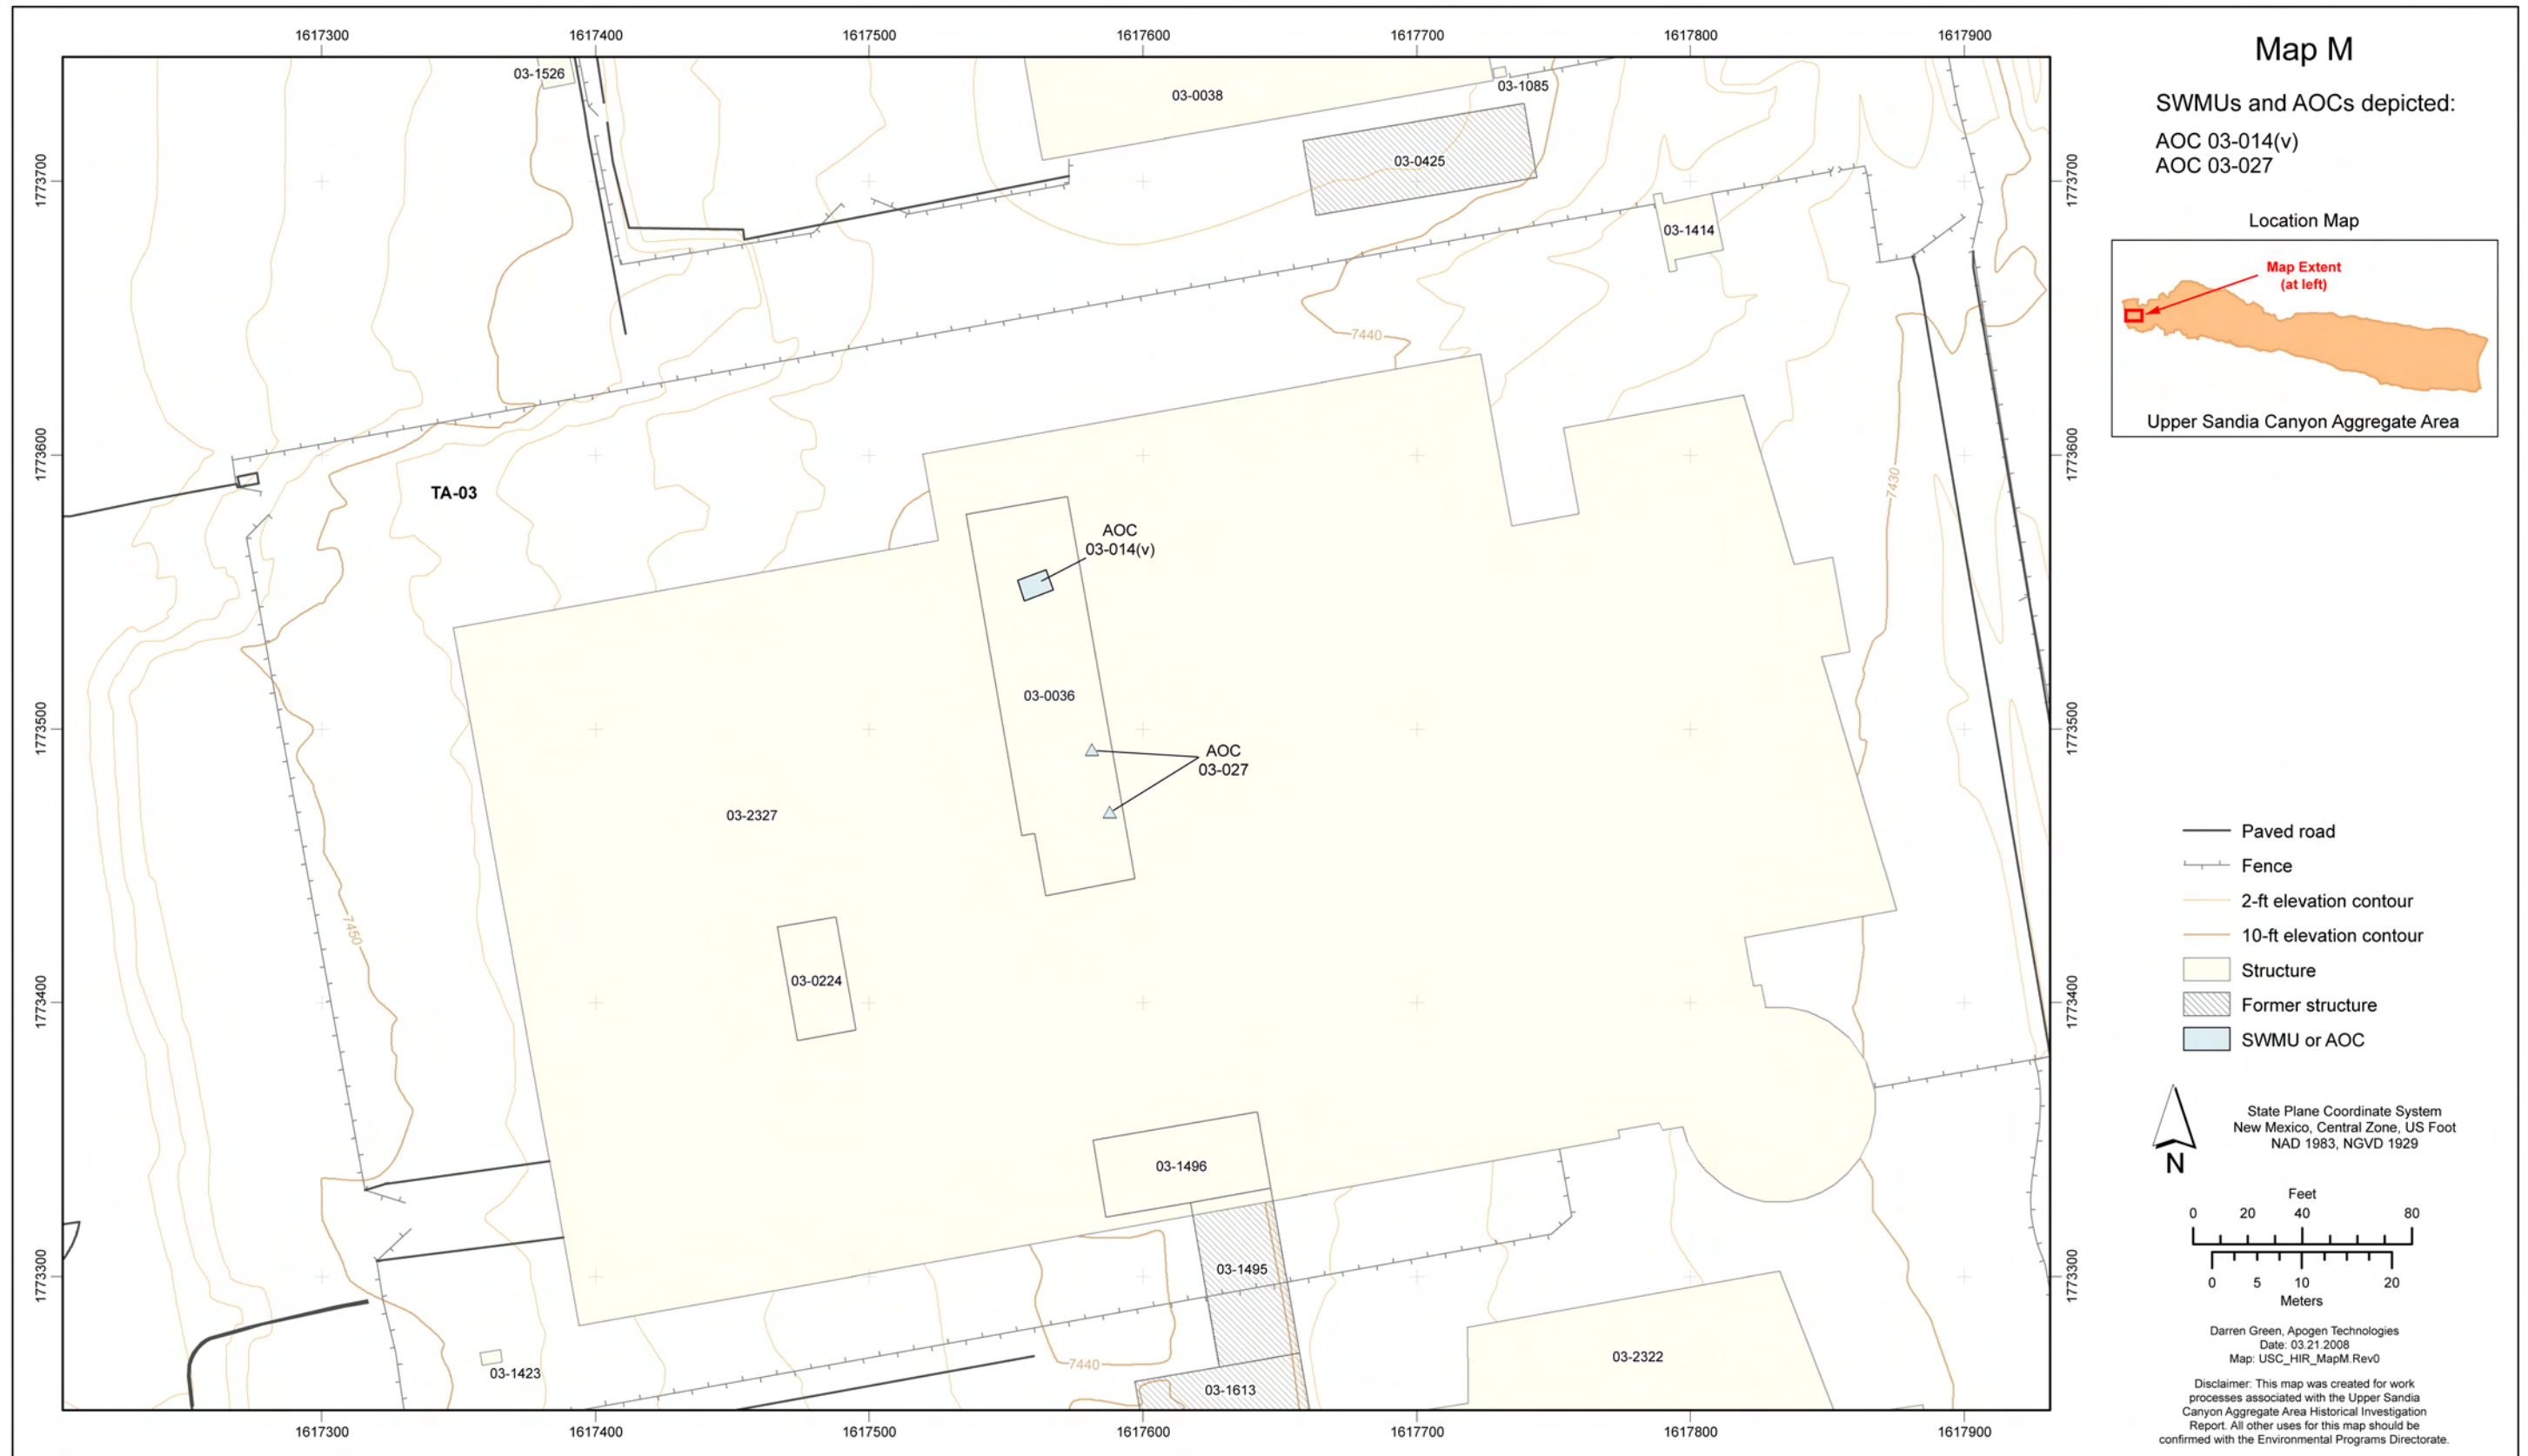
Figure 2.16-1 Map M site location

AOC 03-014(v) was a floor drain within a former garage (building 03-0036) (Figure 2.16-1). The drain was connected to the sanitary sewer line, which flowed to the WWTP. The drain was installed in 1953 (LANL 1990, 007511, p. 3-014).

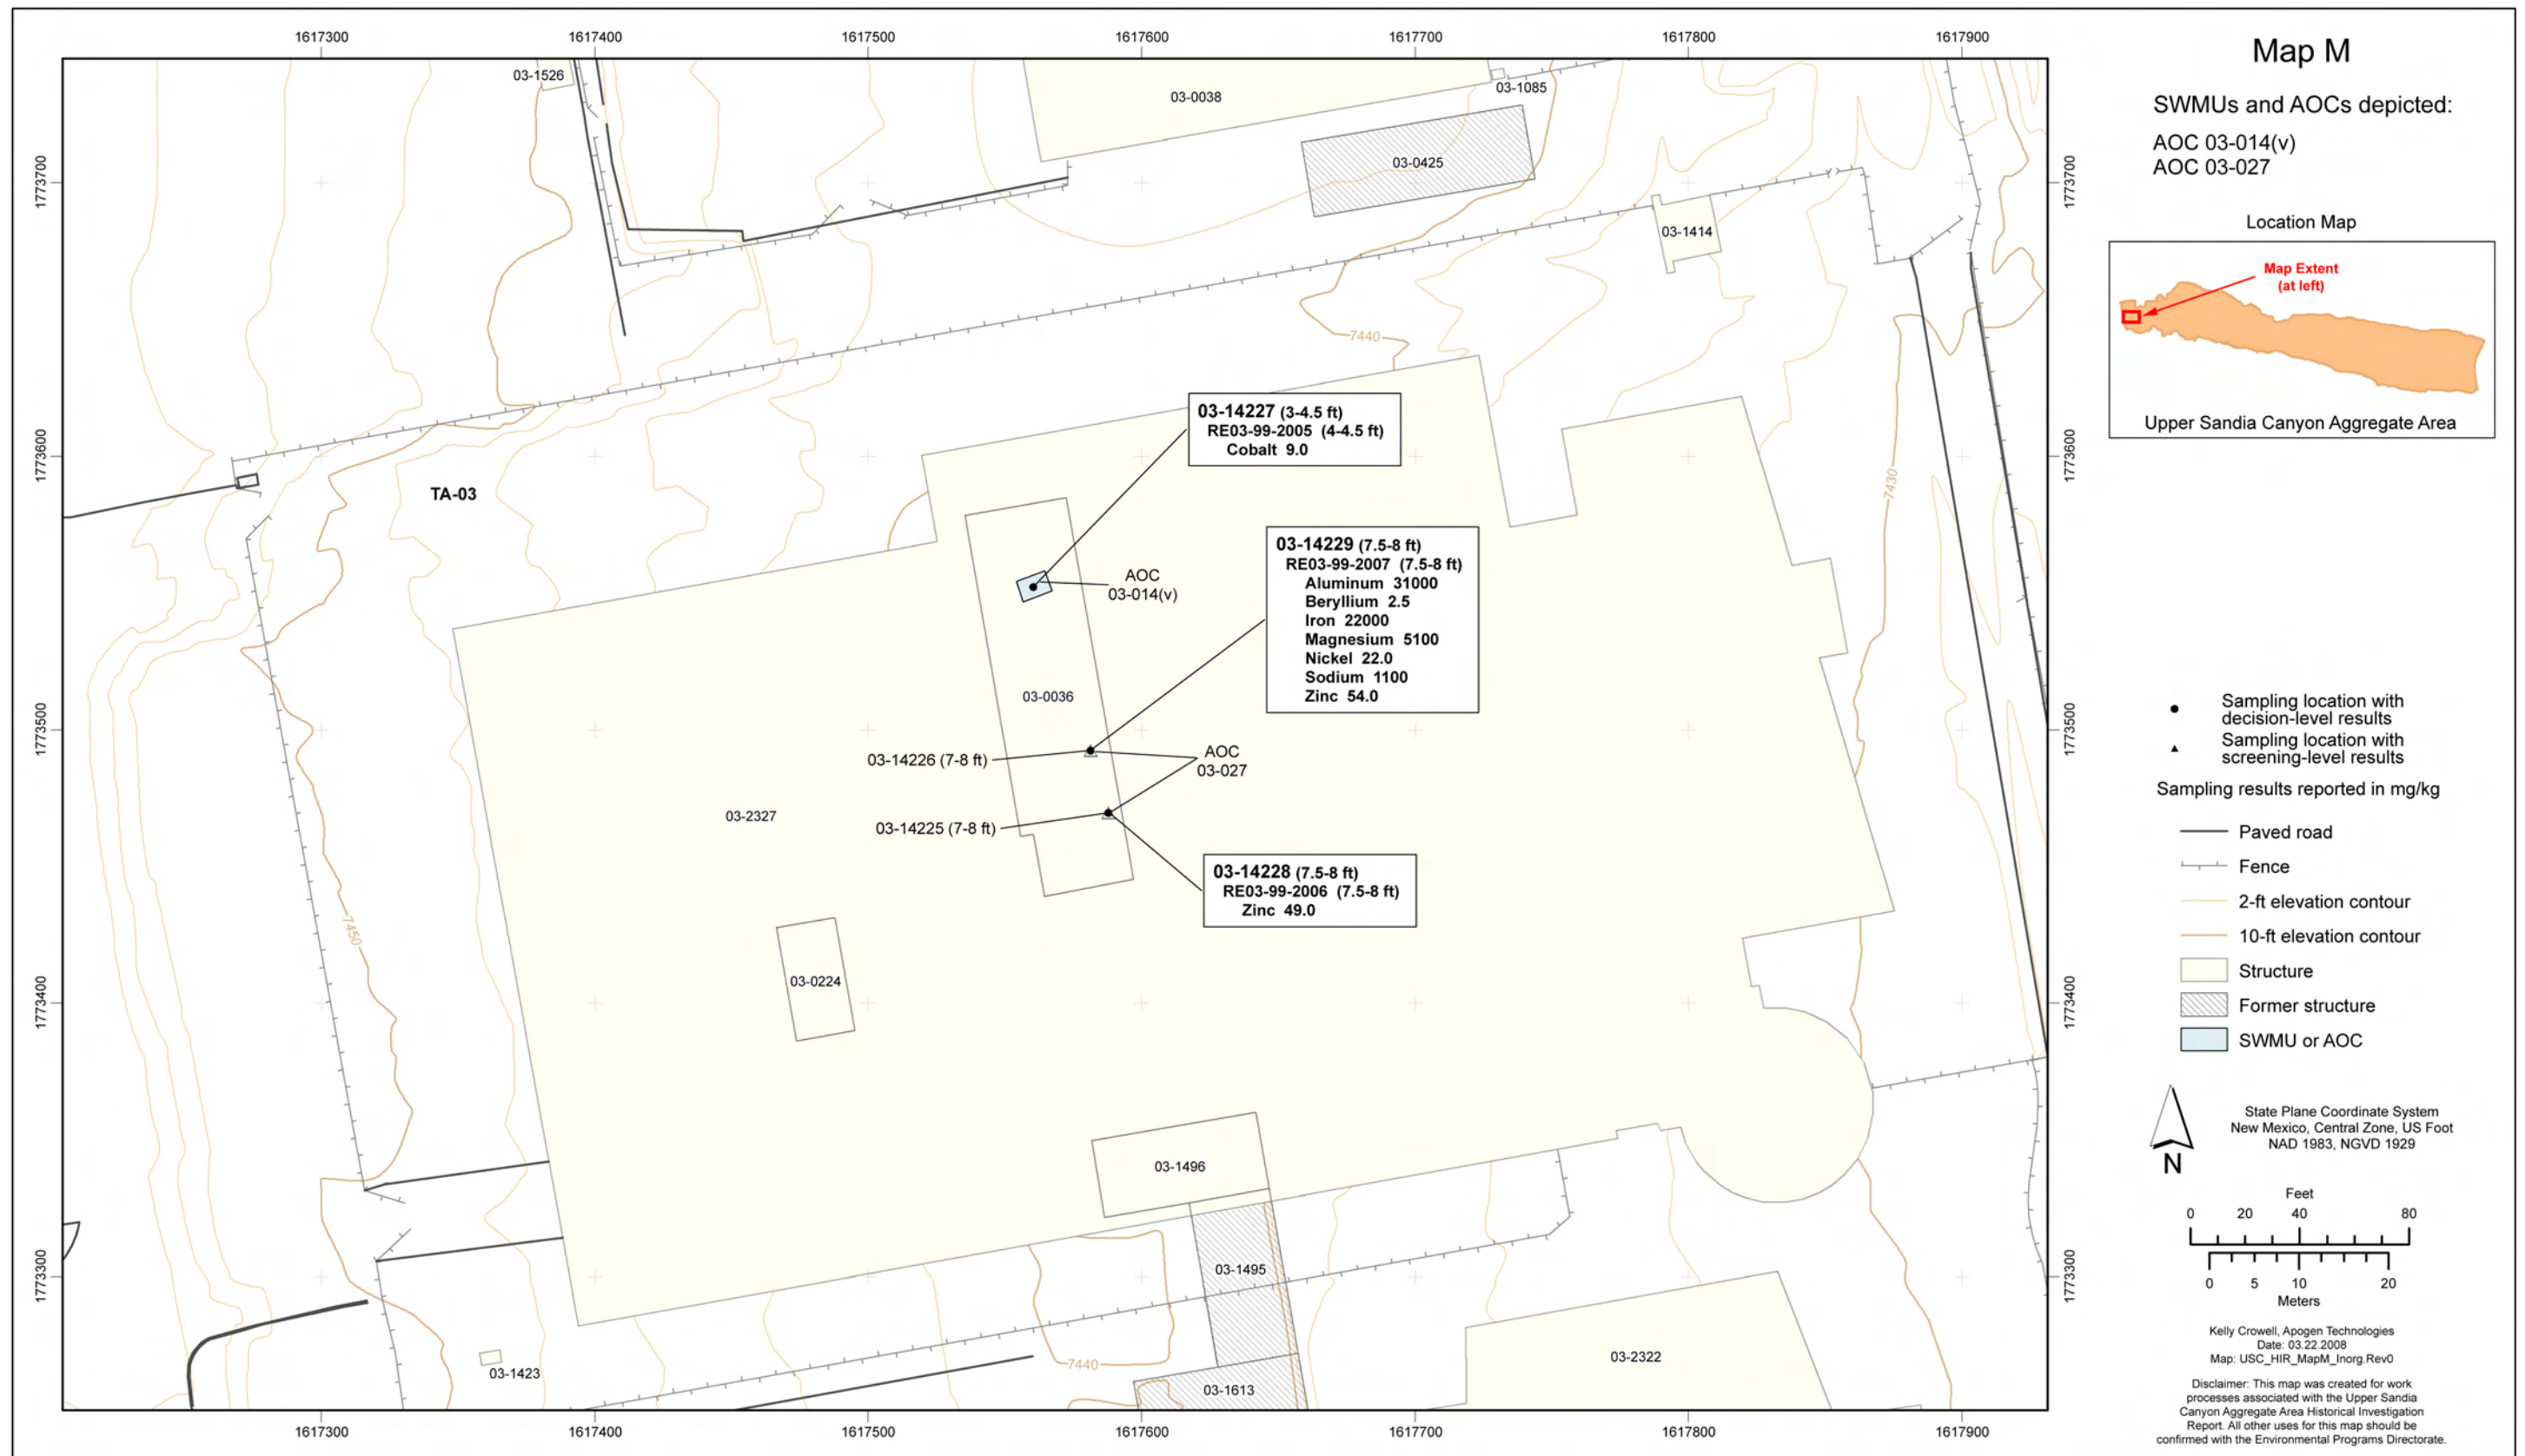
Figure 2.16-2 Map M inorganic chemical sampling locations and results detected above BVs

Data are of decision-level quality and are presented in Tables 2.0-3 and 2.0-6. Sample locations and detected results are shown in Figures 2.16-2 and 2.16-3. Cobalt was detected slightly above its BV in one sample and TPH-DRO was detected in both samples.

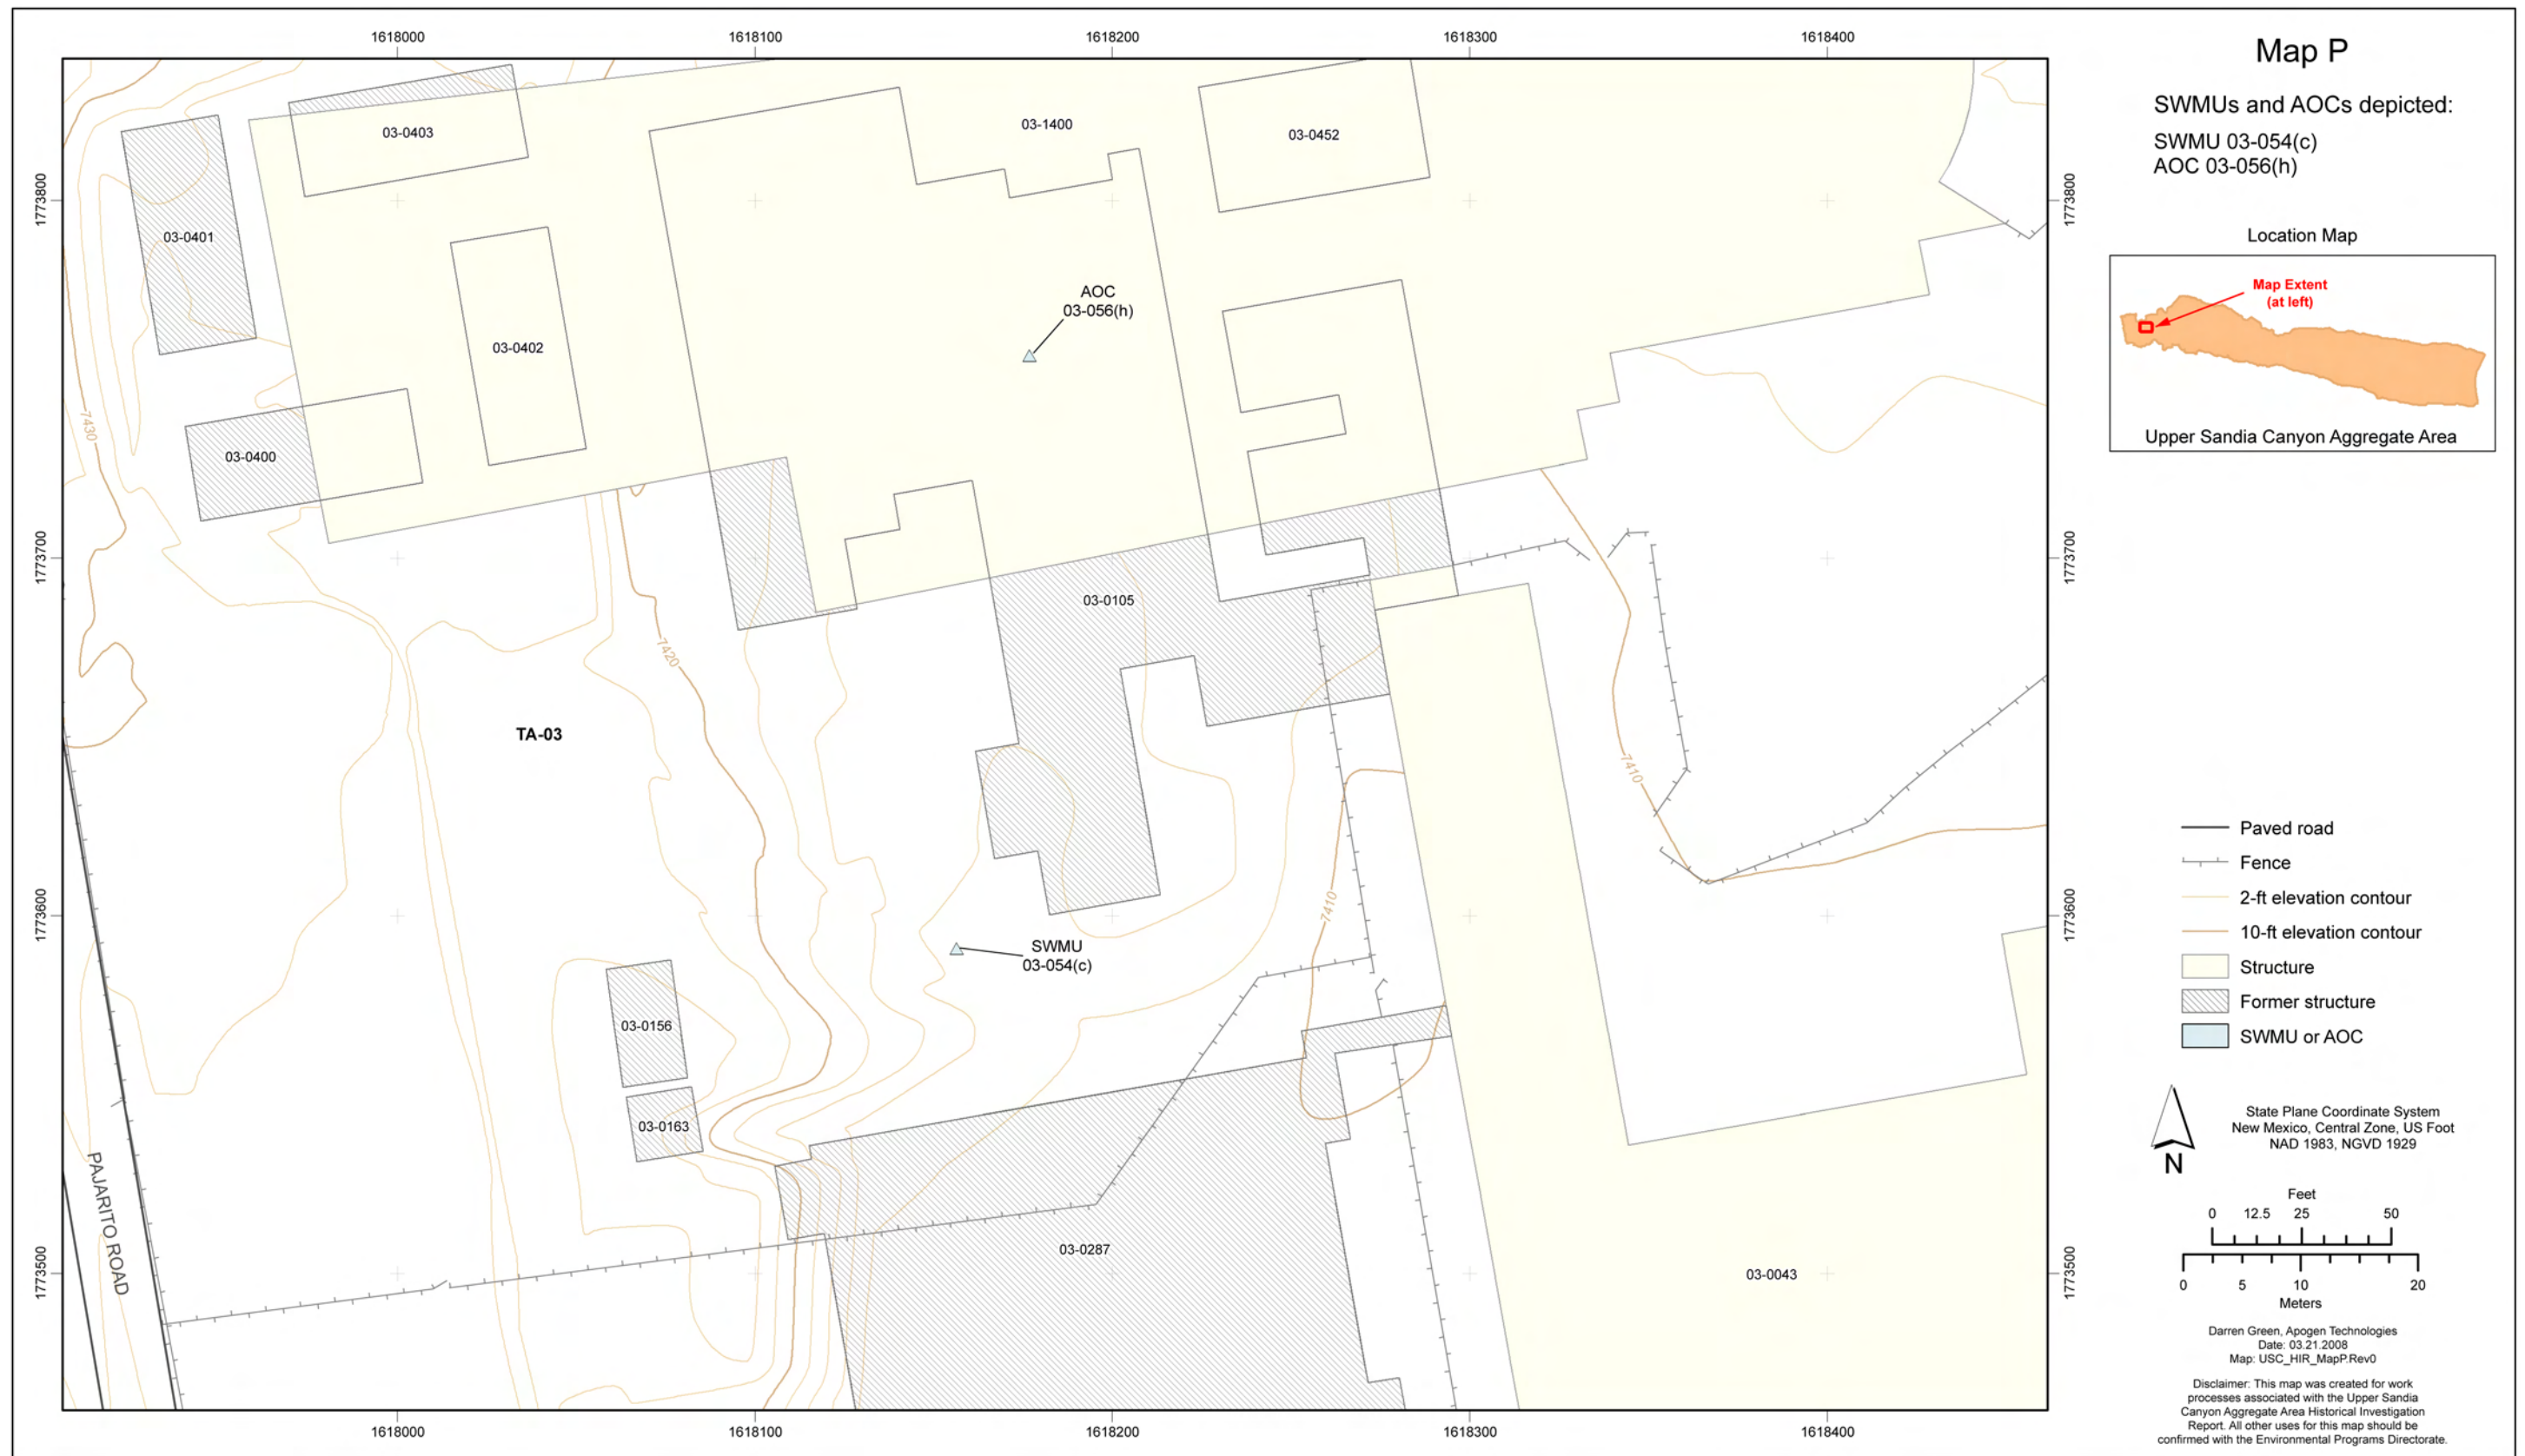
Figure 2.38-1 Map P site location

AOC 3-056(h) is listed in the 1990 SWMU Report (LANL 1990, 007511) as a container storage area near former buildings 03-0105 (the Sherwood Complex) and 03-0287 (the Syllac Building) (Figure 2.38-1) (LANL 1990, 007511, p. 3-056.2). Several areas of potential contamination were identified with this AOC. Areas near former building 03-0287 were addressed under SWMU 03-003(c) and AOC 03-003(o) (sections 2.2 and 2.6, respectively). Building 03-0105 underwent D&D activities in 2001 (LANL 2002, 073868.4, Appendix B-7 p. 1). The site is currently occupied by the NSSB (building 03-1400).
