**Subject: Submittal of the Investigation Work Plan and the Historical Investigation Report for Upper Sandia Canyon Aggregate Area**

- Enclosures: 1) Two hard copies with electronic files - Investigation Work Plan for Upper Sandia Canyon Aggregate Area (EP2008-0139)  
2) Two hard copies with electronic files - Historical Investigation Report for Upper Sandia Canyon Aggregate Area (EP2008-0140)

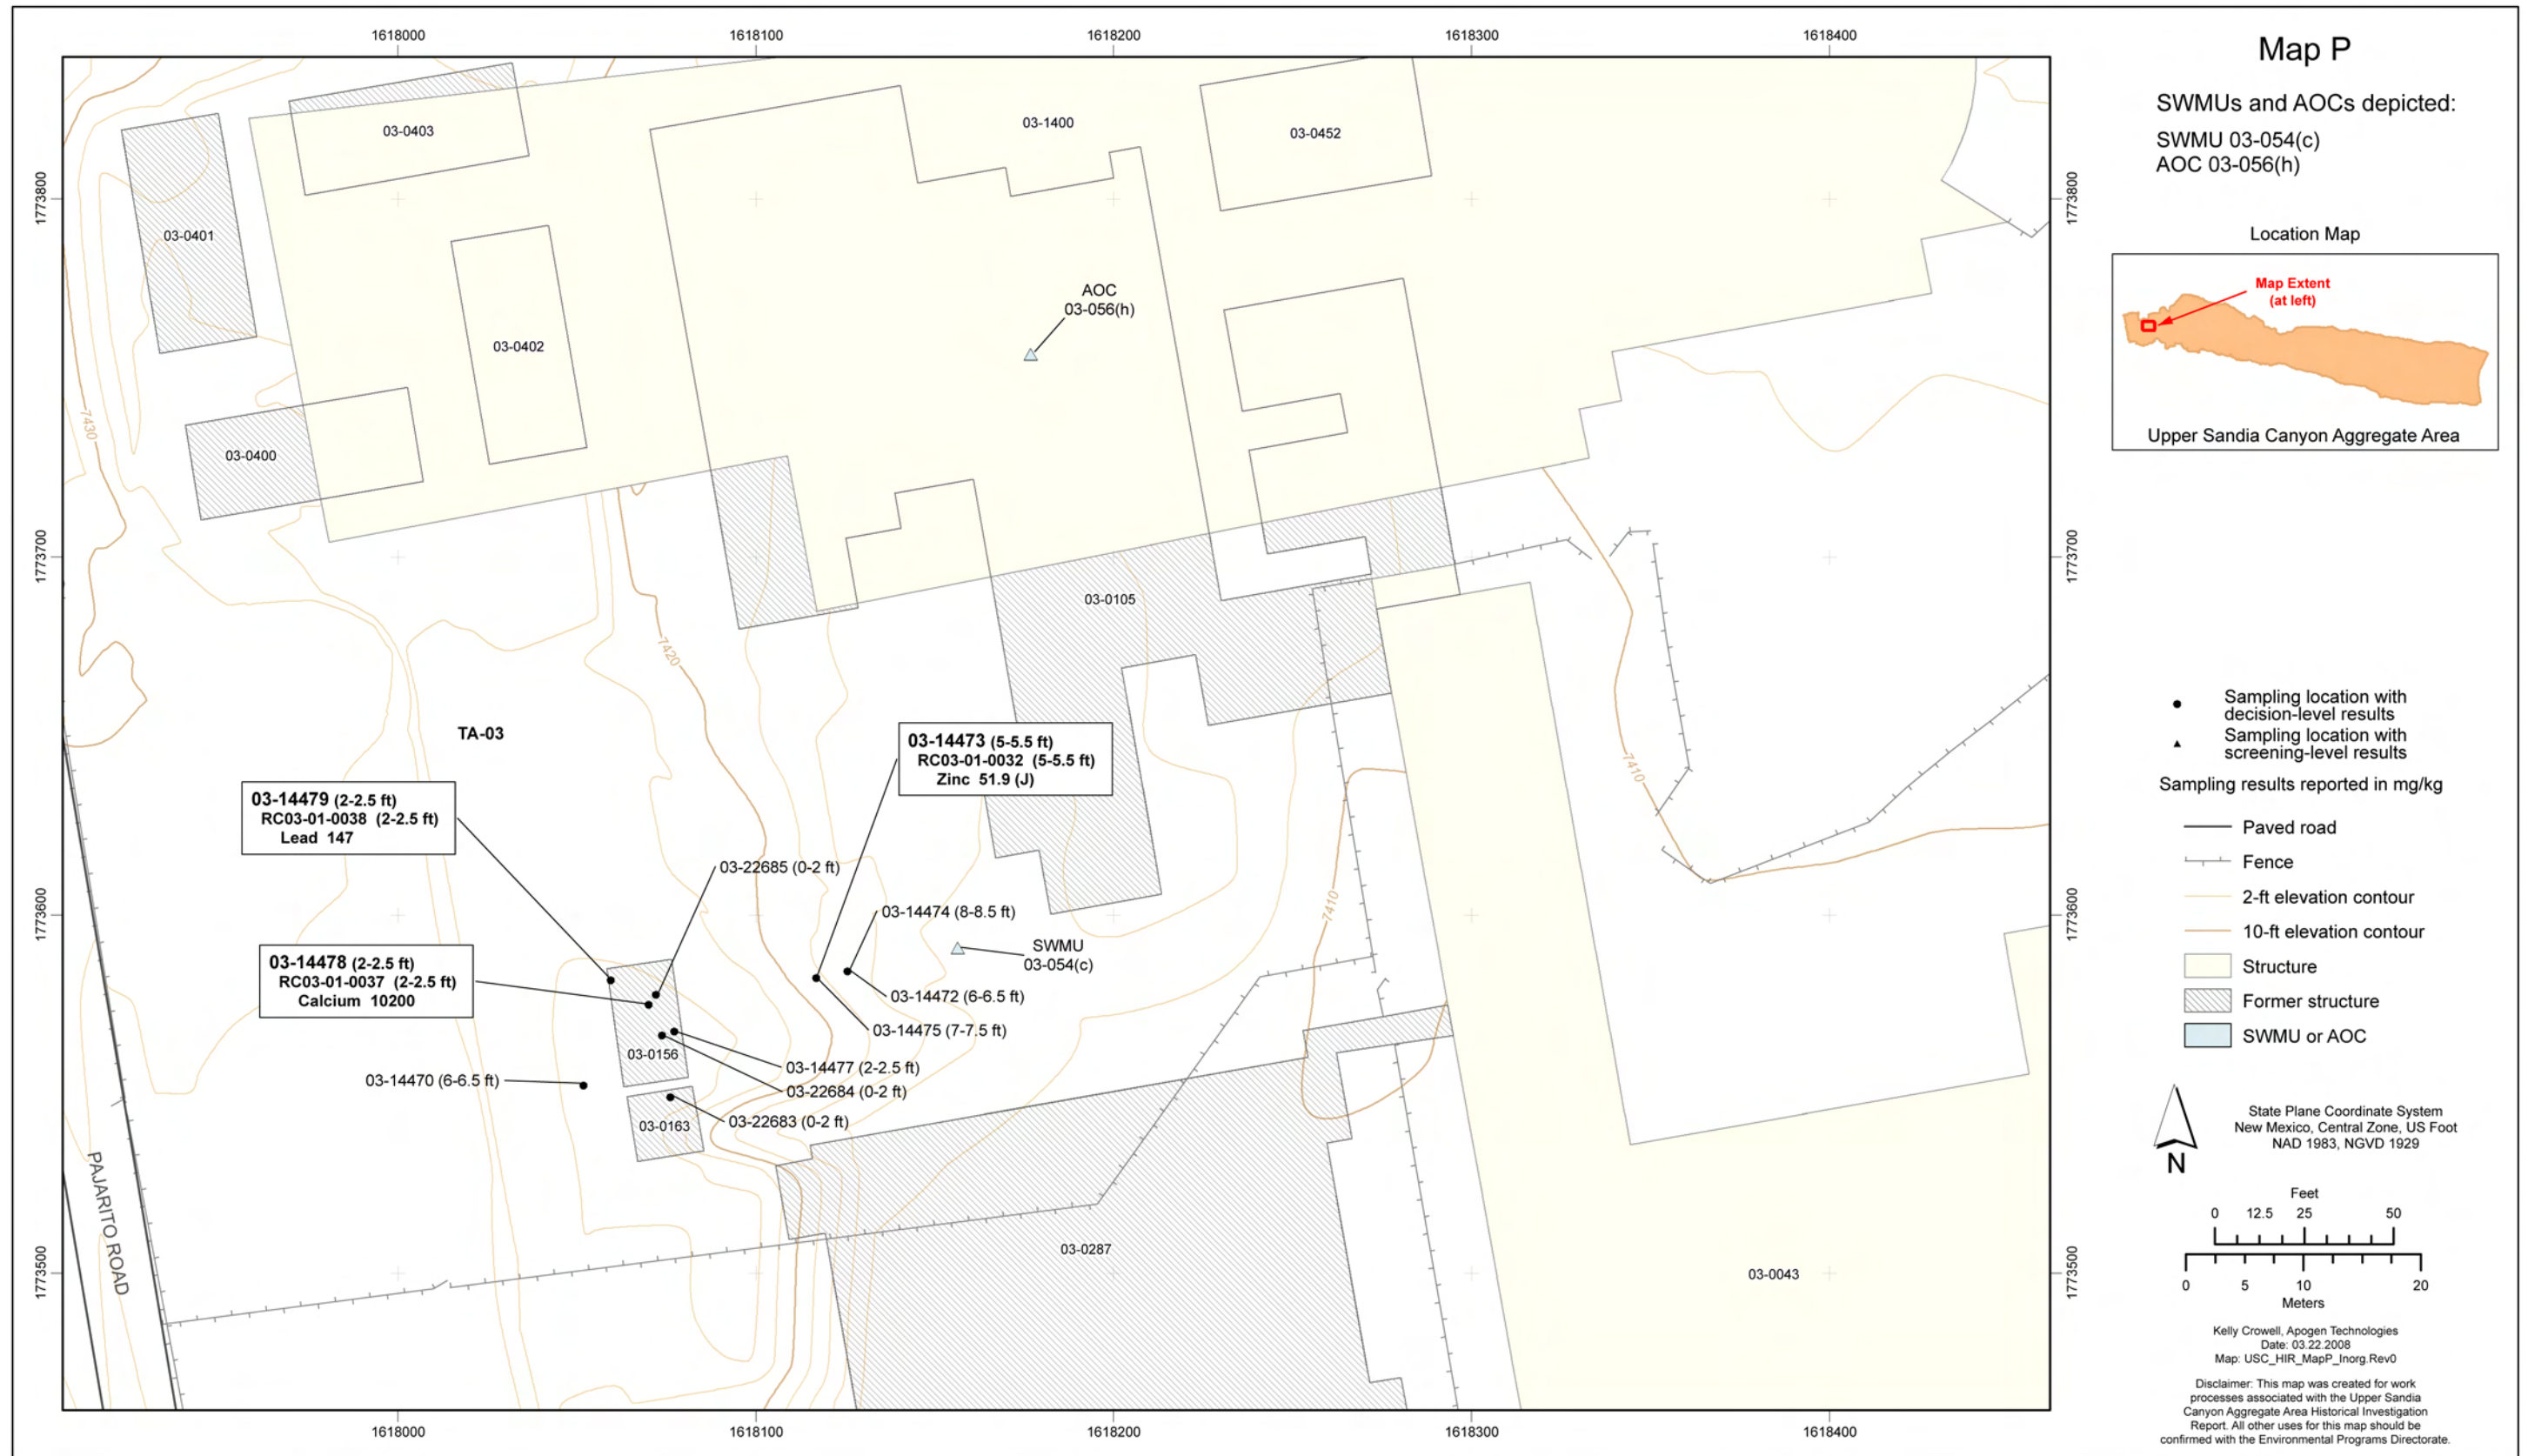
Figure 2.38-2 Map P inorganic chemical sampling locations and results detected above BVs

Data are of decision-level quality and are presented in Table 2.0-3. Sample locations and detected results are shown in Figure 2.38-2. Calcium, lead, and zinc were each detected above BVs in one sample. The detection limit for antimony was greater than the BV in all samples. Hexavalent chromium was not detected.

Data are of decision-level quality, but are not presented since no metals were detected above BVs. Sample locations are shown in Figure 2.38-2.

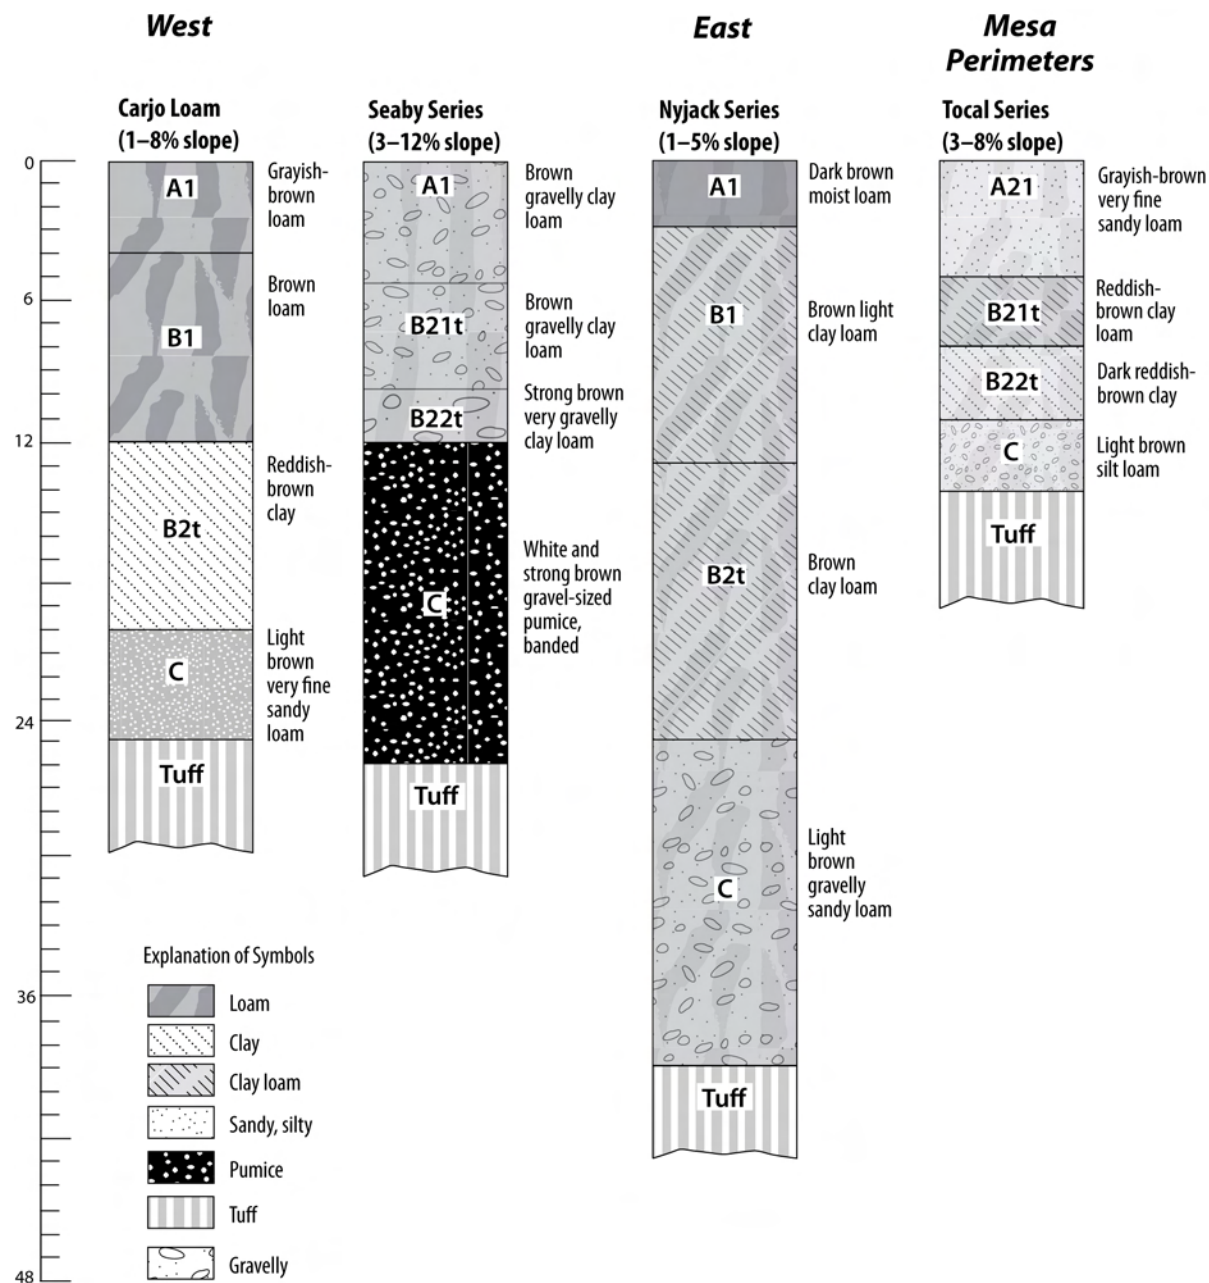
Figure 3.1-1 Typical profiles of common soils at OU 1114 Operable Unit.

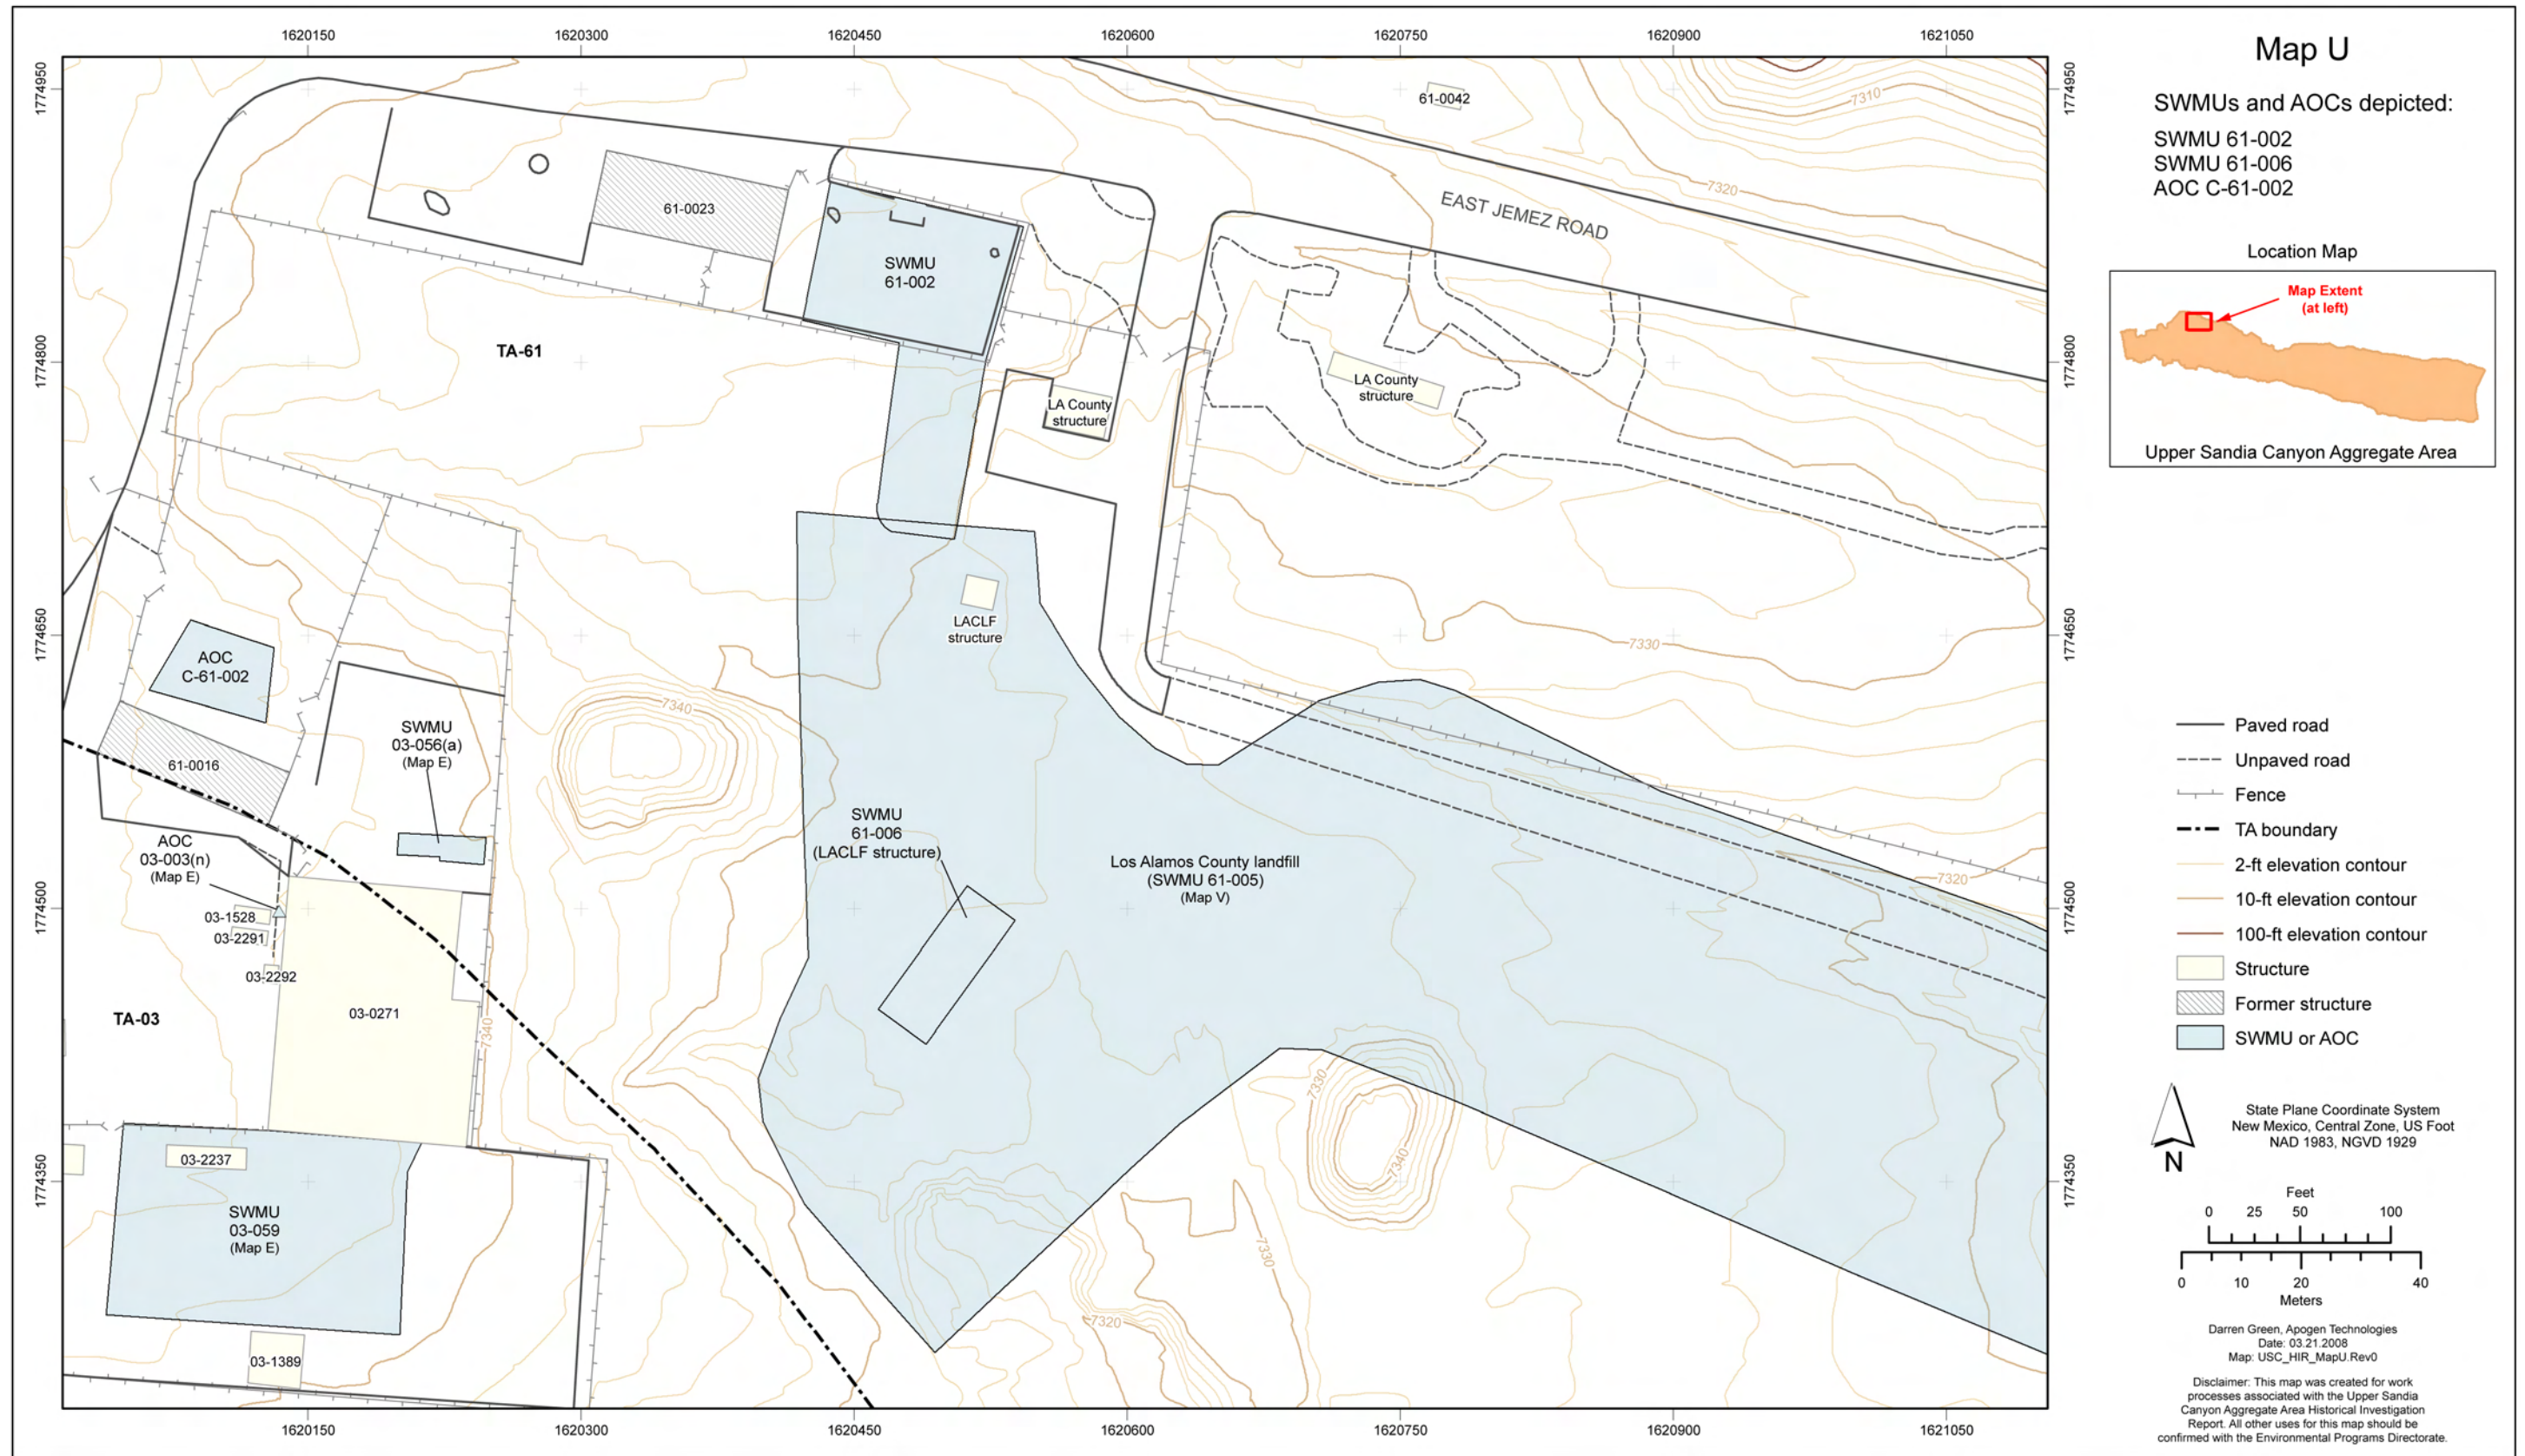
Figure 4.3-1 Map U site location

SWMU 61-002 is a former storage area at TA-61, east of the Radio Repair Shop (building 61-0023, formerly building 03-0282) on East Jemez Road (Figure 4.3-1). This storage area is part of a fenced area that measures 81 ft x 91 ft. Historically, the area was used to store capacitors and transformers. In addition, the storage area contained several oil-filled containers and unmarked containers. Before 1985, containers of PCB-contaminated oil were stored in this area and were known to have leaked. In 1986, elevated PCB concentrations were detected in 32 soil samples collected at this area. The area was subsequently excavated, backfilled with clean soil, and paved over with asphalt. After the 1986 remediation, the east side of the storage area was used to store electrical equipment, some of which contained PCBs (LANL 1993, 020947, p. 5-101). All storage operations were discontinued in 1992. Staining was observed on the surface of the asphalt. Potential contaminants are PCBs and possibly lead (LANL1996, 052930, p. 201).

SWMU 61-006 is an active oil recycling area located at the Los Alamos County landfill (SWMU 61-005) (Figure 4.3-1). The oil recycling area consists of an open, lined pit approximately 10 ft × 20 ft × 7 ft deep that contains a 2500-gal. holding tank. An 8-ft-long pipe leads to a filling bin at ground level. Historically, three underground tanks were in the pit; in 1989, two of the tanks were removed (LANL 1990, 007514, p. 61-006). The area where the former tanks were located was excavated as a disposal pit for use at the landfill (LANL 1993, 020947, p. 6-10). The third tank was moved to its current location in the open, lined pit. The pit was covered, a leak detection system installed on the tank, and the pit was relined with an improved liner (LANL 1993, 020947, p. 6-10). Upgrades were completed in 2000.

AOC C-61-002 is an area of subsurface contamination that was encountered in 1995 during a drill rig test. The area is located in TA-61, approximately 15 ft north of building 61-0016, a former storage building (former structure 03-0326) (Figure 4.3-1). During the drilling test, an odor was noted, and contamination was encountered at 7 to 8 ft bgs. The contamination was suspected to be petroleum-based (e.g., diesel). A sample of the tuff was collected and the analysis showed the presence of diesel. Interviews conducted with personnel after the drilling was completed indicated that the source of the diesel may have been the previous road maintenance support work performed in the area (LANL 1995, 049550, p. 2).

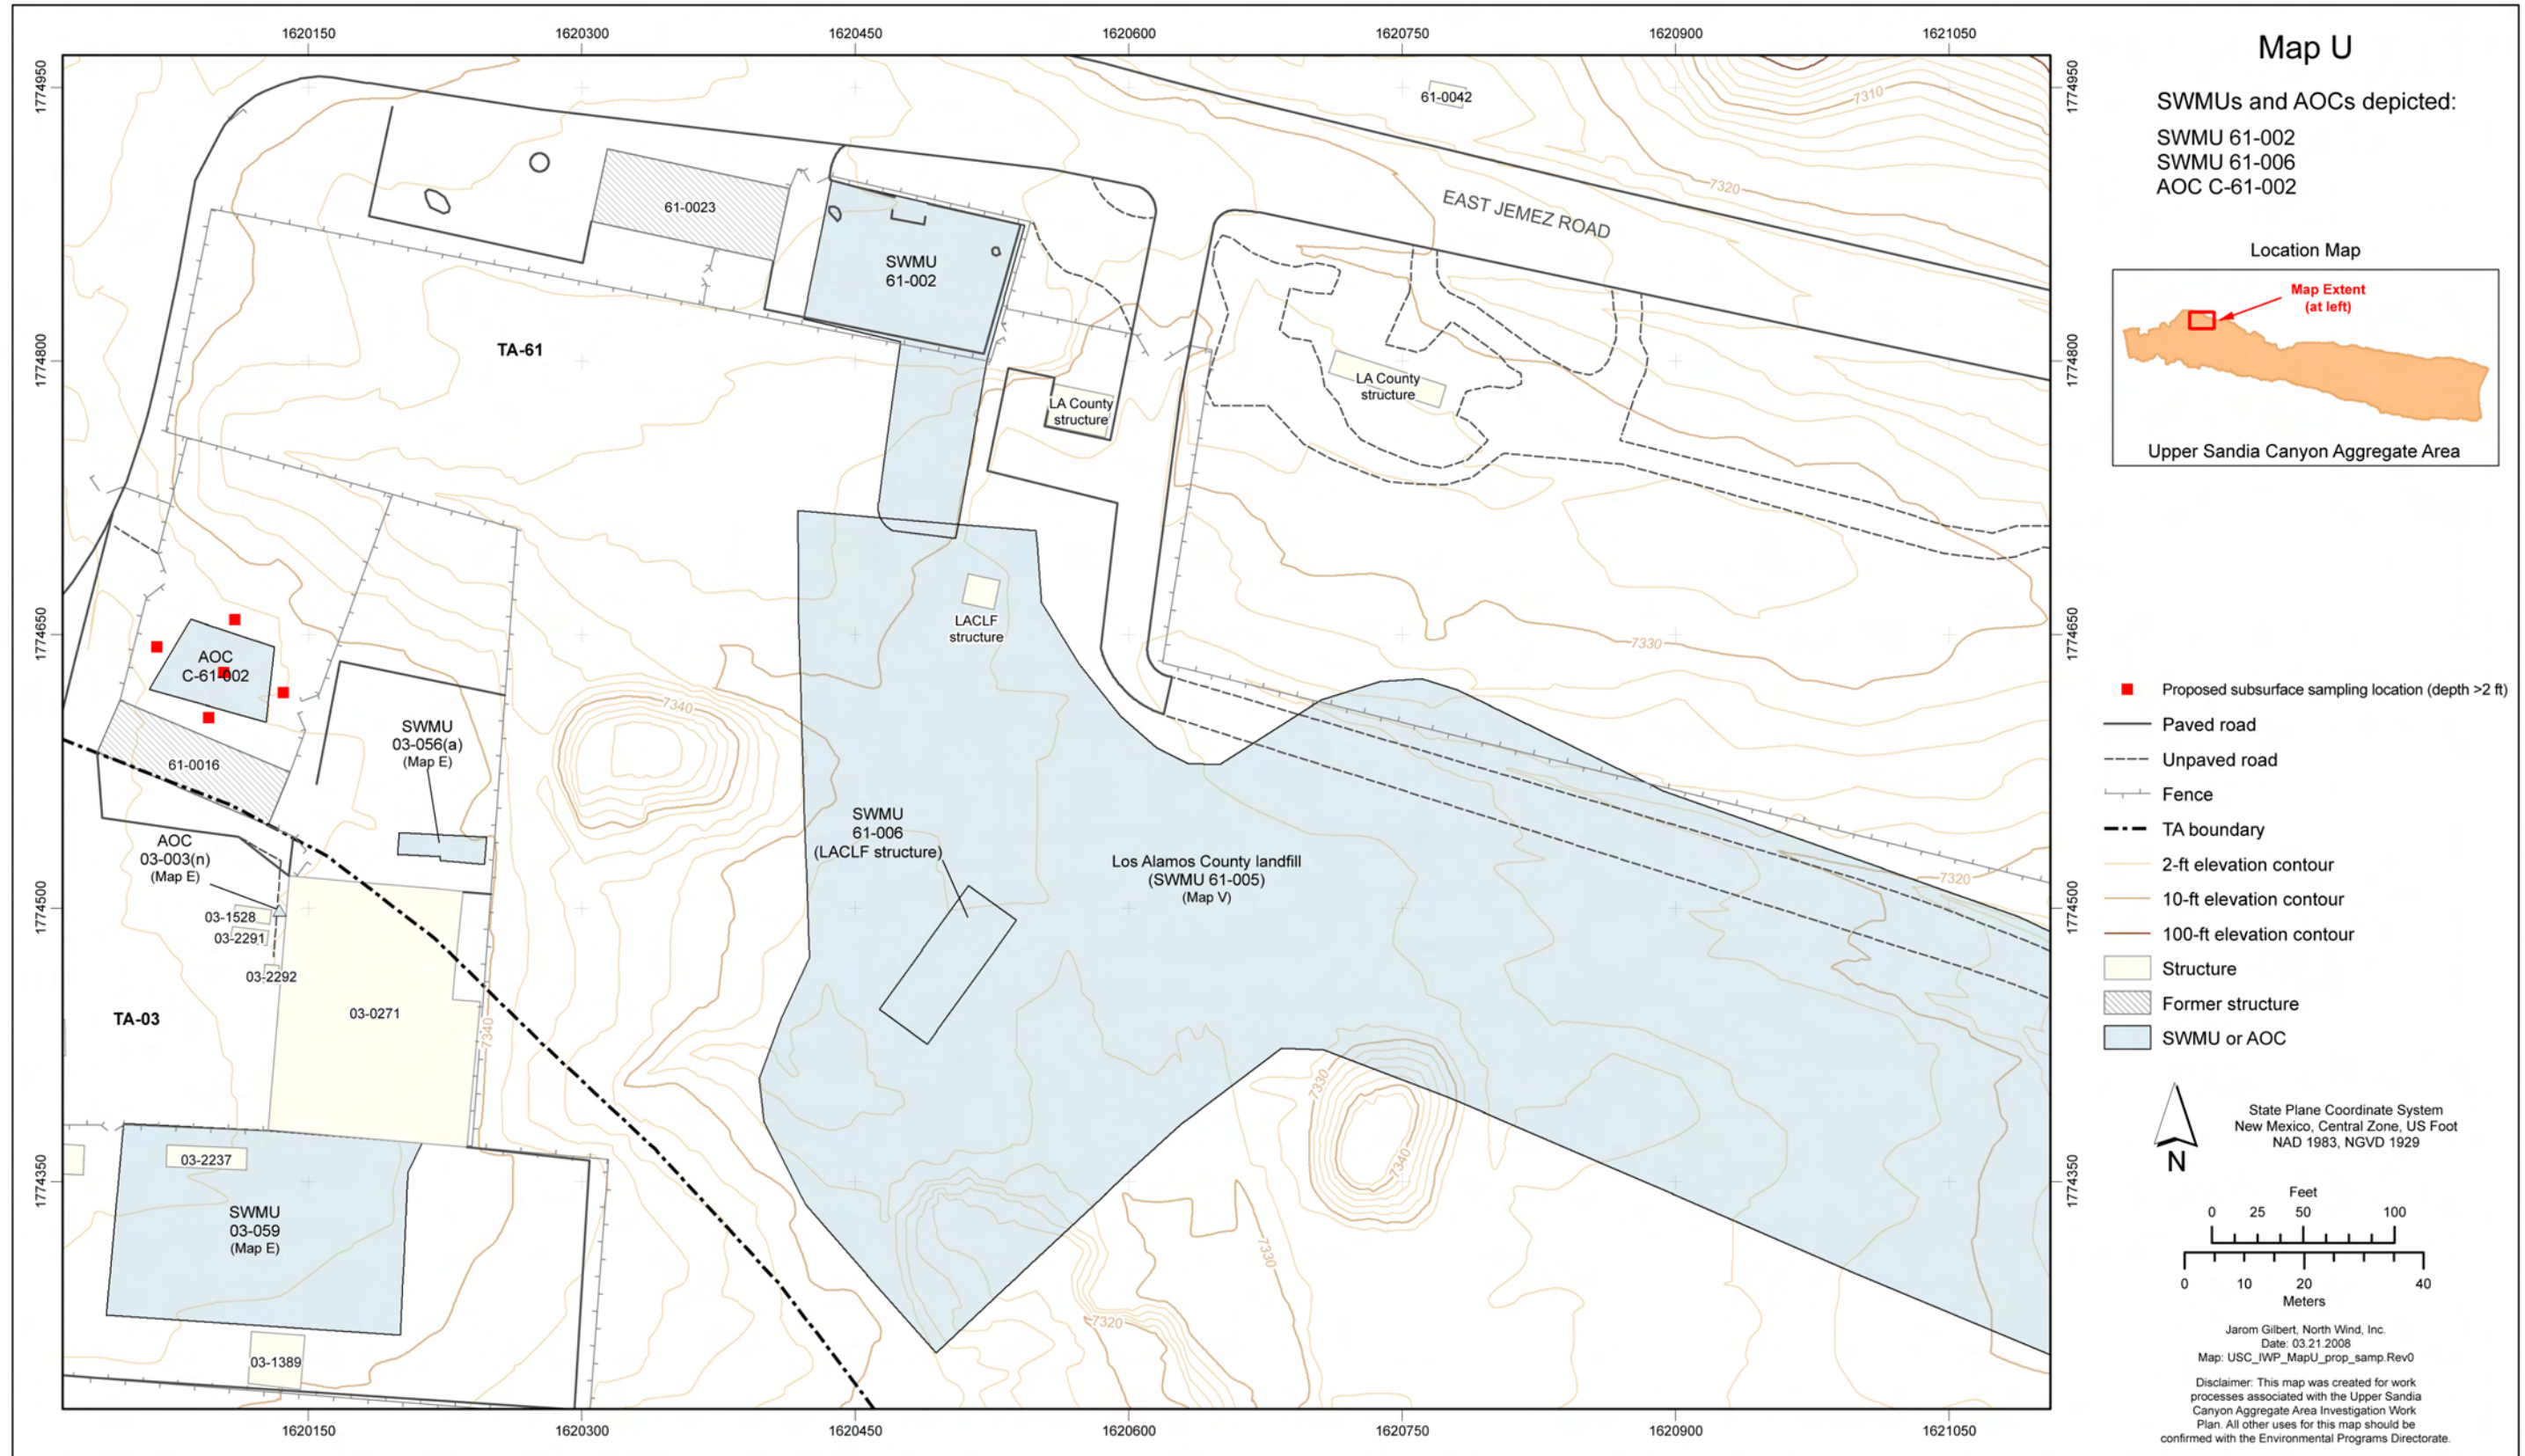
Figure 4.3-2 Map U proposed sampling locations

The nature and extent of contamination have not been defined at this site. Thirty samples will be collected from five boreholes to define nature and extent of contamination (Figure 4.3-2). Samples will be collected from six depths (3 to 4 ft, 5 to 6 ft, 7 to 8 ft, 9 to 10 ft, 11 to 12 ft, and 14 to 15 ft) and analyzed for inorganic chemicals, VOCs, SVOCs, cyanide, and TPH-DRO. Table 4.0-1 provides a summary of the proposed sampling locations, depths, and analytical suites.
