# SHERIDAN DISPOSAL SERVICES (WALLER COUNTY) TEXAS

## EPA REGION 6 CONGRESSIONAL DISTRICT 10

Updated: April 2009

EPA ID# TXD062132147 Site ID: 0602108

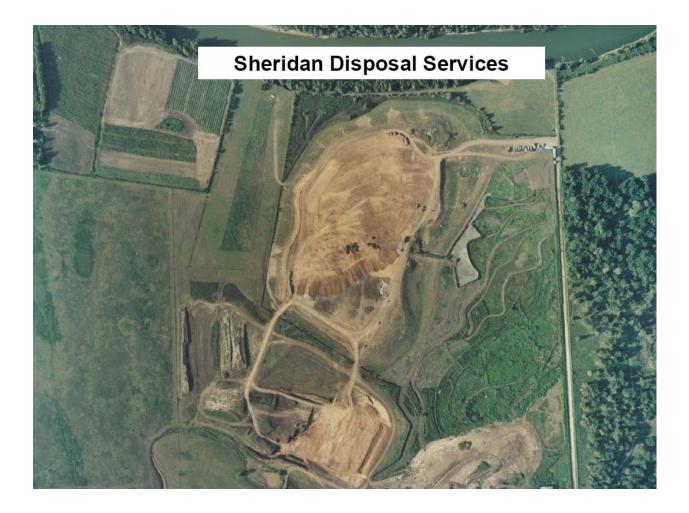
Sheridan Disposal Services

Location:	The site is about nine miles northwest of Hempstead in Waller County, at the border of Washington County, Texas. The facility is bounded by the Brazos River (north) and Clark Road (south) and the surrounding area is primarily farm and grazing land.
Population:	Hempstead, which is the county seat of Waller County, has an estimated population of 4,700 people.
Setting:	The site area is agricultural and includes a 15-acre lagoon and 40-acre evaporation pond.
Site Map—
